State of Oregon  
Department of Environmental Quality

Memorandum

**Subject:** Elk Ridge Estates Development, ECSI #4857; Staff Memorandum in support of a Conditional No Further Action determination

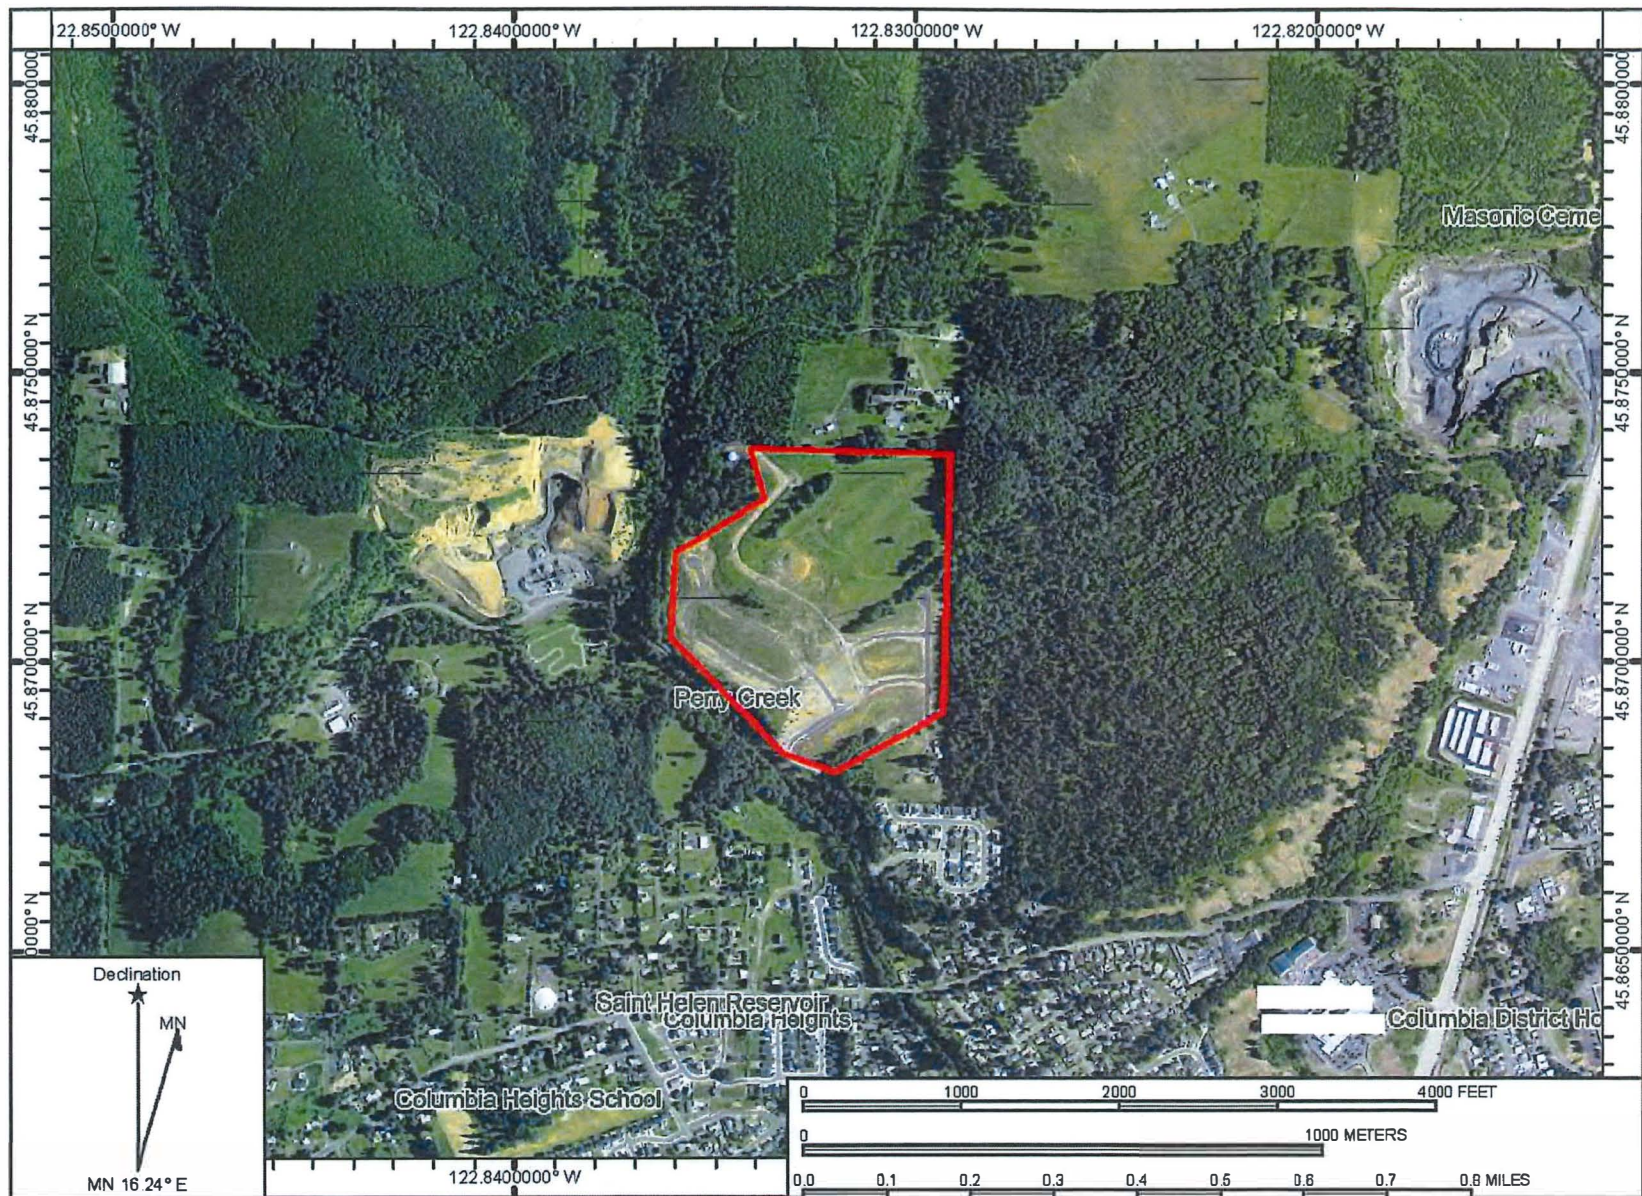
Project No.  
 826-12001-01  
 Attachment  
 2

## Aerial Photo Map

Elk Ridge Estates is a single-family residential development being constructed on a south-facing hillside at the north end of the City of Saint Helens. See Attachment 1 for a topographic map of the area and Attachment 2 for an aerial photo of the site. A Former Solid Waste Disposal Area ("the landfill") is present at the bottom of the hill at the south end of the development. An Upper Solid Waste Disposal Cell ("the disposal cell") is present in a transmission line right-of-way near

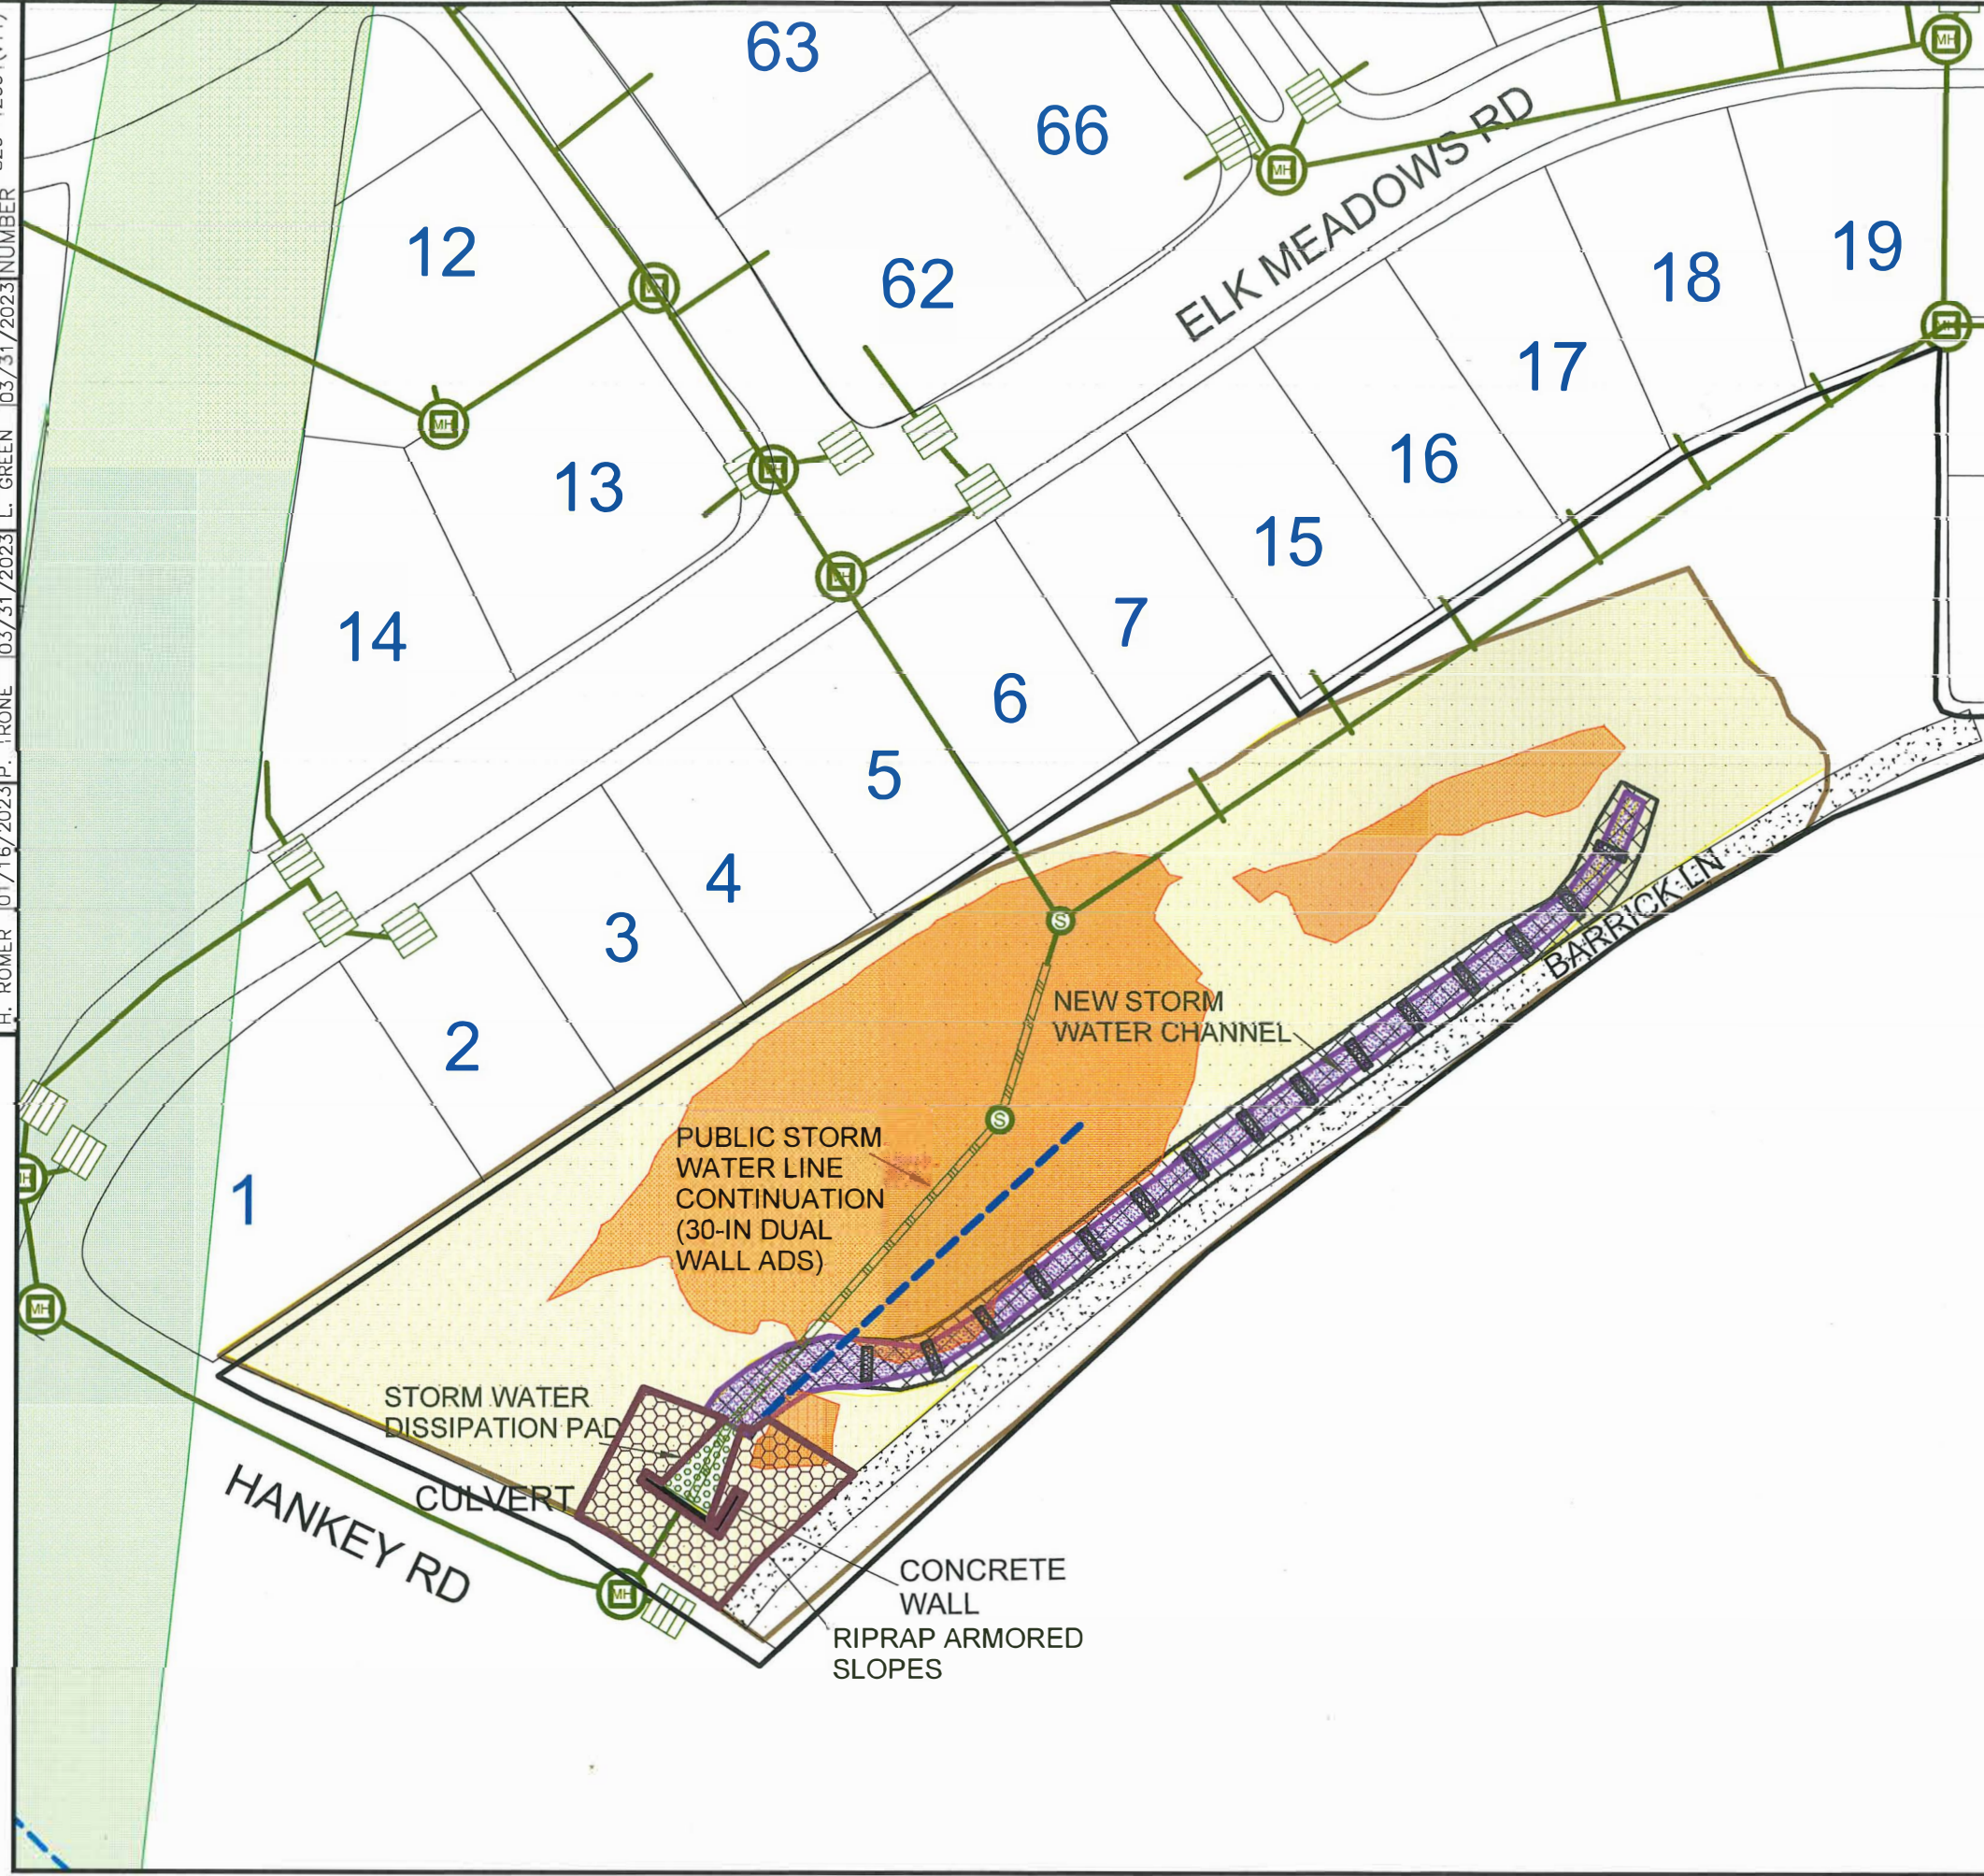
- LEGEND:
- 146 APPROXIMATE LOT BOUNDARIES AND LOT NUMBERS
  - FSWDA
  - REWORKED SOIL/WASTE INCREASED GRADE
  - IMPORTED CLEAN SOIL CAP
  - NEW STORM WATER CHANNEL
  - CHECK DAMS IN NEW STORM WATER CHANNEL
  - ROCK ON JUTE MAT BETWEEN CHECK DAMS
  - UNDERDRAIN (180-FT-LONG BY 8-FT-WIDE BY 3-FT-DEEP WITH A 6-IN PERFORATED ADS PIPE BEDDED AND COVERED IN DRAIN ROCK AND WRAPPED IN NON-WOVEN GEOTEXTILE)
  - STORM SYSTEM
  - SEDIMENTATION MANHOLE (POLLUTION CONTROL)
  - CATCH BASIN
  - STORM WATER MANHOLE

FSWDA = FORMER SOLID WASTE DISPOSAL AREA

Work to regrade the gully and cap the landfill began in September 2022. A stormwater pipe, 155 feet long with a 30-inch inside diameter, was installed to convey stormwater from Elk Ridge Estates to an energy dissipation pad below the landfill and above the Hankey Road culvert. An underdrain (180 feet long, 8-9 feet wide, and up to 3 feet deep) was installed at the bottom of the gully to carry water emerging from the toe of the landfill to the Hankey Road culvert. The underdrain was filled with 3-inch drain rock wrapped in non-woven geotextile and topped with 1-2 feet of additional rock.

In October, the regraded landfill was topped with “orange demarcation non-woven geotextile” and 9,400 cubic yards of imported clean cap soils. A total of 242.27 tons of soils and solid wastes were removed from the landfill during the regrading work and shipped to the Hillsboro

Landfill for disposal. The disposal cell was capped with orange demarcation geotextile and 2,000 cubic yards of imported clean soils in December 2022. The CMMP and SCMP were completed in February and April 2023, respectively. See Attachment 14 for an as-built diagram of the regraded and capped landfill.
