**ENVIRONMENTAL SITE
CLEANUP REPORT**

**16590 SE 114TH AVENUE
CLACKAMAS, OREGON 97015**

ALPHA ENVIRONMENTAL SERVICES, INC.

Date Issued: February 6, 2024
Alpha Project Number: 23-52876

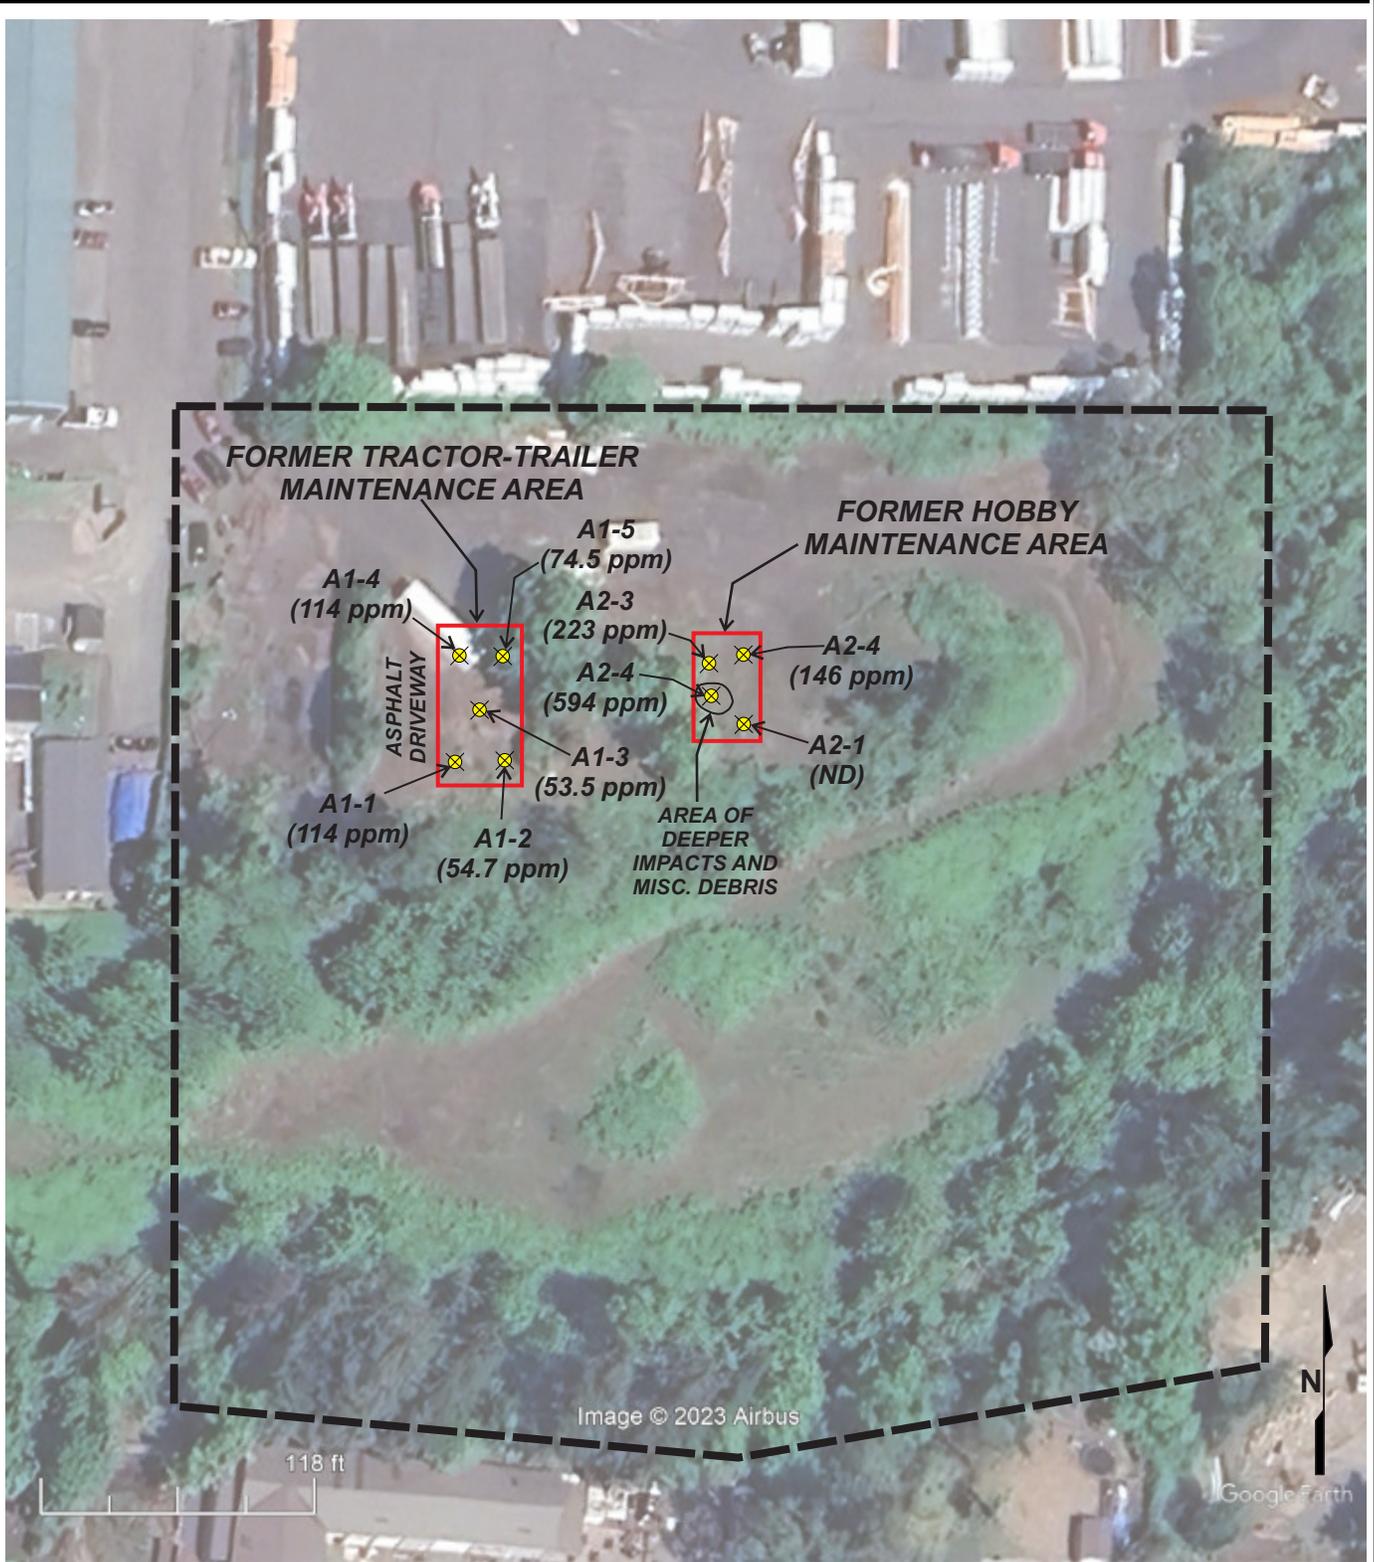
- PROPERTY BOUNDARY
- ✕ SOIL SAMPLE LOCATIONS
- FORMERLY IMPACTED AREAS

On December 12 & 13, 2023, Alpha mobilized to the site with excavation equipment and dump trucks. Using a mini excavator, impacted surface soils in the two impacted areas were removed and placed in the waiting trucks. This continued downward to approximately one foot in the tractor trailer maintenance area (Area 1) and approximately one to three feet in the former hobby area (Area 2).

All excavations continued until there were no visual signs of impacts observed. Approximately 134.85 tons of soil were removed in this manner. Nine confirmation soil samples were collected from the bottom of the excavations to ensure completion of the remediation.

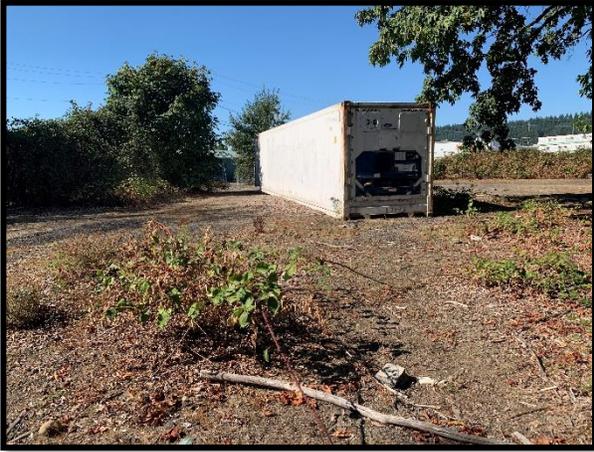
PHOTOGRAPH NO. 1 – Area 1 prior to removal.

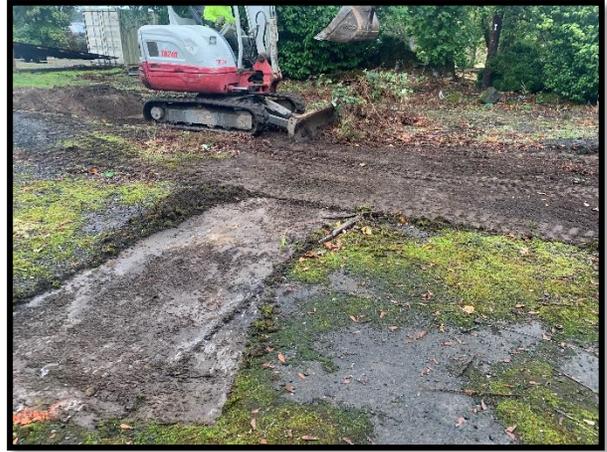
PHOTOGRAPH NO. 2 – Area 1 initial scraping. Asphalt driveway can be observed in foreground.

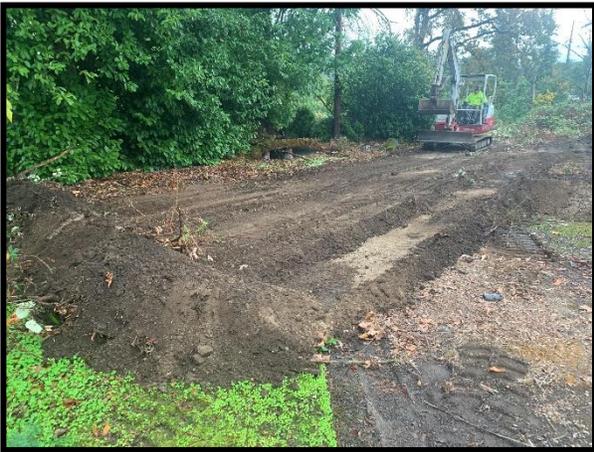
PHOTOGRAPH NO. 3 – Area 1 continued excavation.

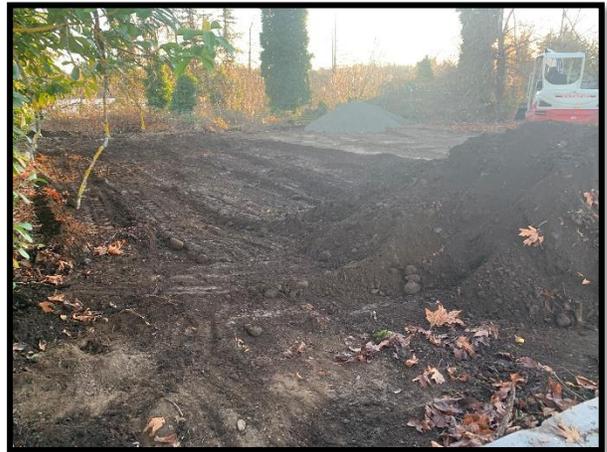
PHOTOGRAPH NO. 4 – Area 1 continued excavation.

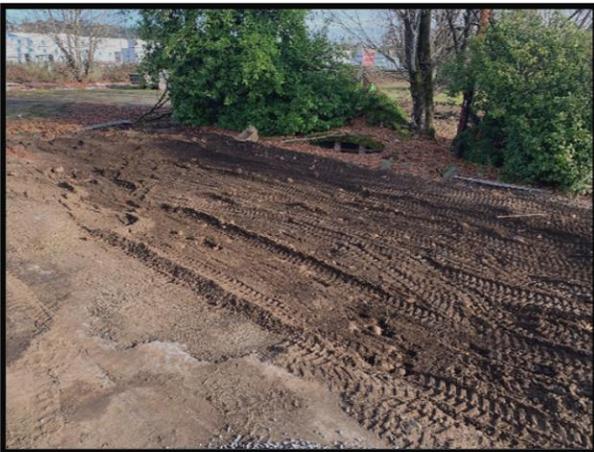
PHOTOGRAPH NO. 5 – Area 1 final excavation.

The analytical results indicate that heavy oil was detected at low concentrations in samples A1-1 (144 ppm), A1-2 (54.7 ppm), A1-3 (53.5 ppm), A1-4 (113 ppm) and A1-5 (74.5 ppm). The detected concentrations were compared to the DEQ Risk levels and all detected concentrations are below the RBCs for applicable receptors.

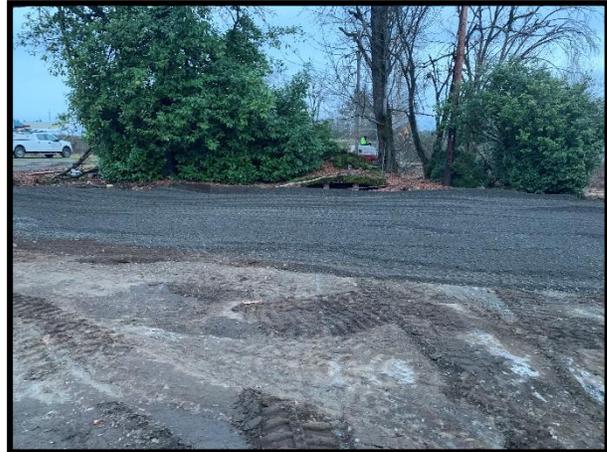
PHOTOGRAPH NO. 6 – Area 1 completed backfill.

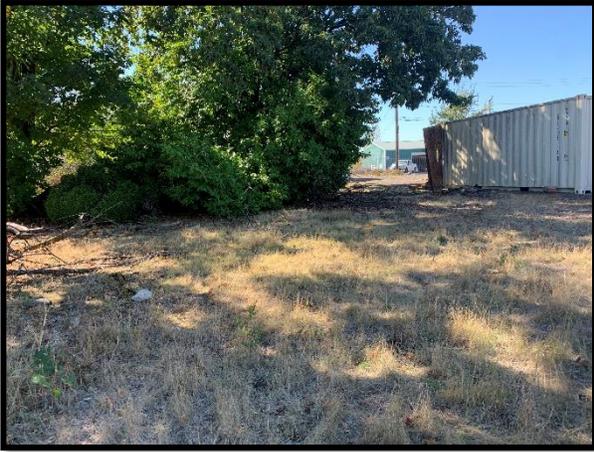
PHOTOGRAPH NO. 1 – Area 2 prior to removal.

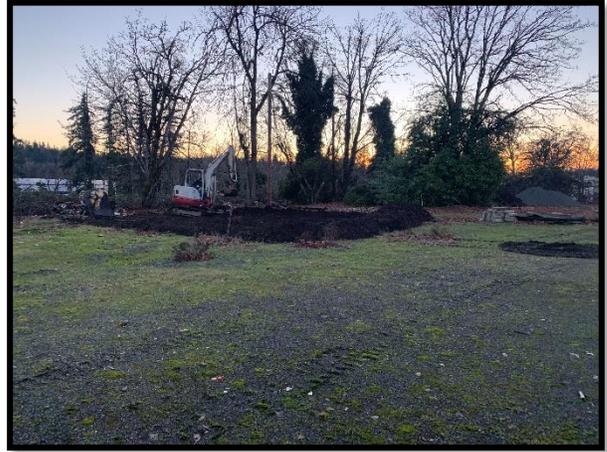
PHOTOGRAPH NO. 2 – Area 2 initial scraping.

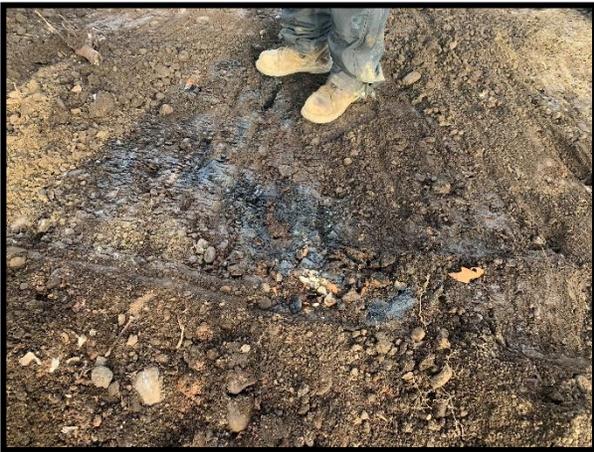
PHOTOGRAPH NO. 3 – Area 2 stained soils.

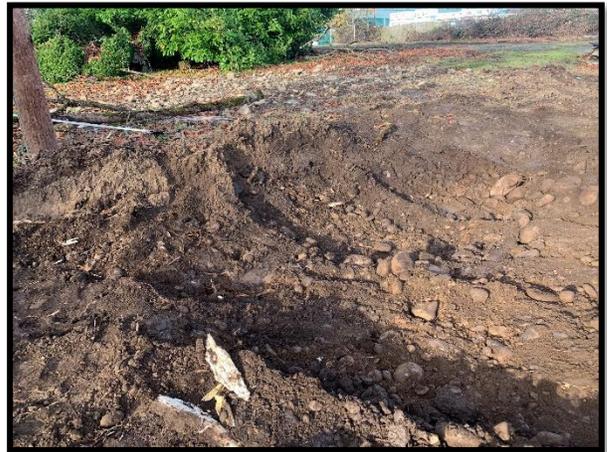
PHOTOGRAPH NO. 4 – Area 2 deep removal of impacted soils.

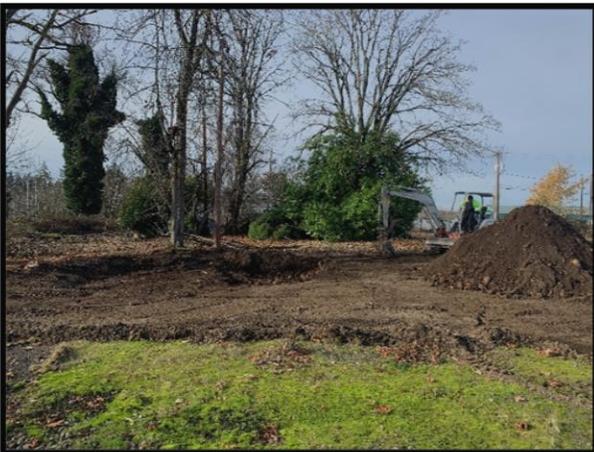
PHOTOGRAPH NO. 5 – Area 2 final excavation.

The analytical results indicate that heavy oil was detected at low concentrations in samples A2-2 (146 ppm oil & 58.3 ppm diesel), A2-3 (226) and A2-4 (594 ppm). The detected concentrations were compared to the DEQ Risk levels and all detected concentrations are below the RBCs for applicable receptors.

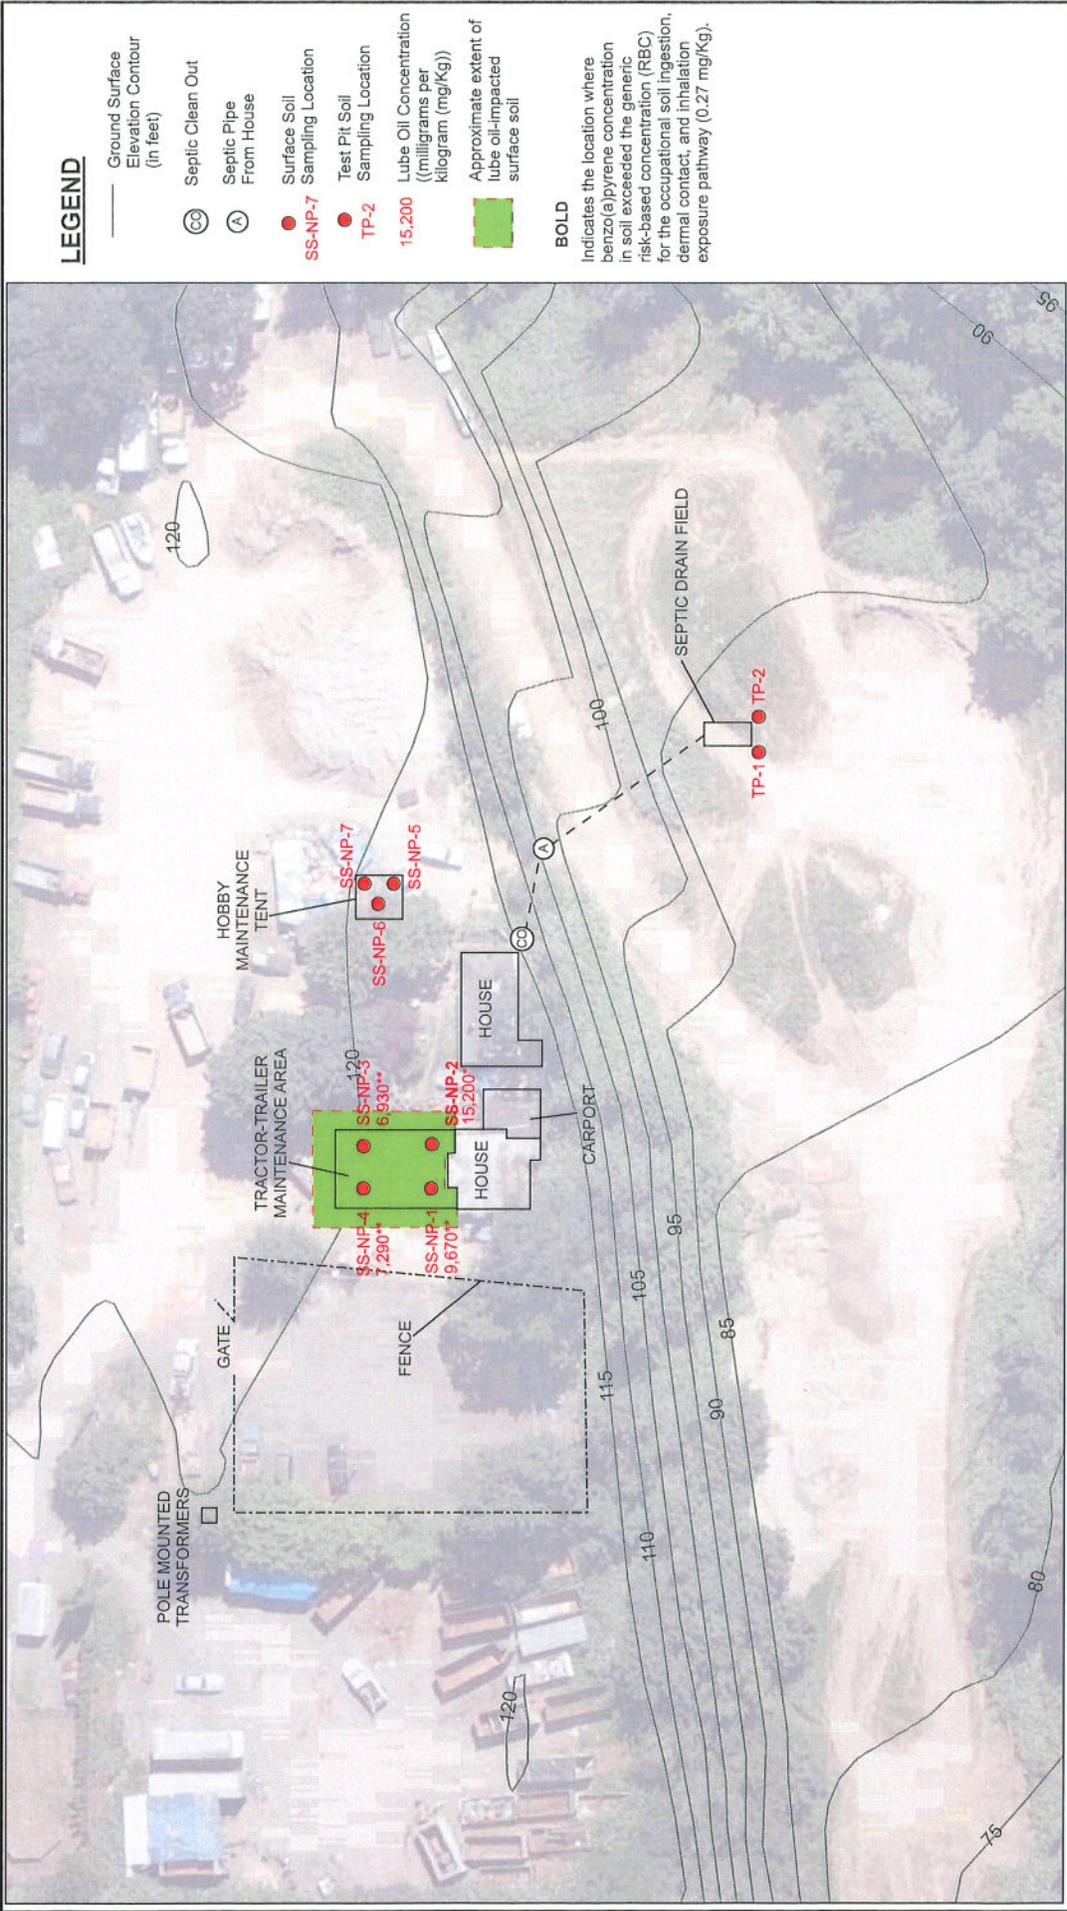
KLEINFELDER MAP AND SOIL CONCENTRATIONS 2010

- Ground Surface Elevation Contour (in feet)
- Ⓢ Septic Clean Out
- Ⓐ Septic Pipe From House
- SS-NP-7 Surface Soil Sampling Location
- TP-2 Test Pit Soil Sampling Location
- 15,200 Lube Oil Concentration ((micrograms per kilogram (mg/Kg)))
- Approximate extent of lube oil-impacted surface soil
- BOLD** Indicates the location where benzo(a)pyrene concentration in soil exceeded the generic risk-based concentration (RBC) for the occupational soil ingestion, dermal contact, and inhalation exposure pathway (0.27 mg/Kg).

Soil samples were collected and tested for RCRA metals as part of the Kleinfelder Phase II ESA from 2010.
