State of Oregon  
Department of Environmental Quality

Memorandum

**Subject:** Arcoa Building, ECSI #6199; Staff Memorandum in support of a Conditional No Further Action determination

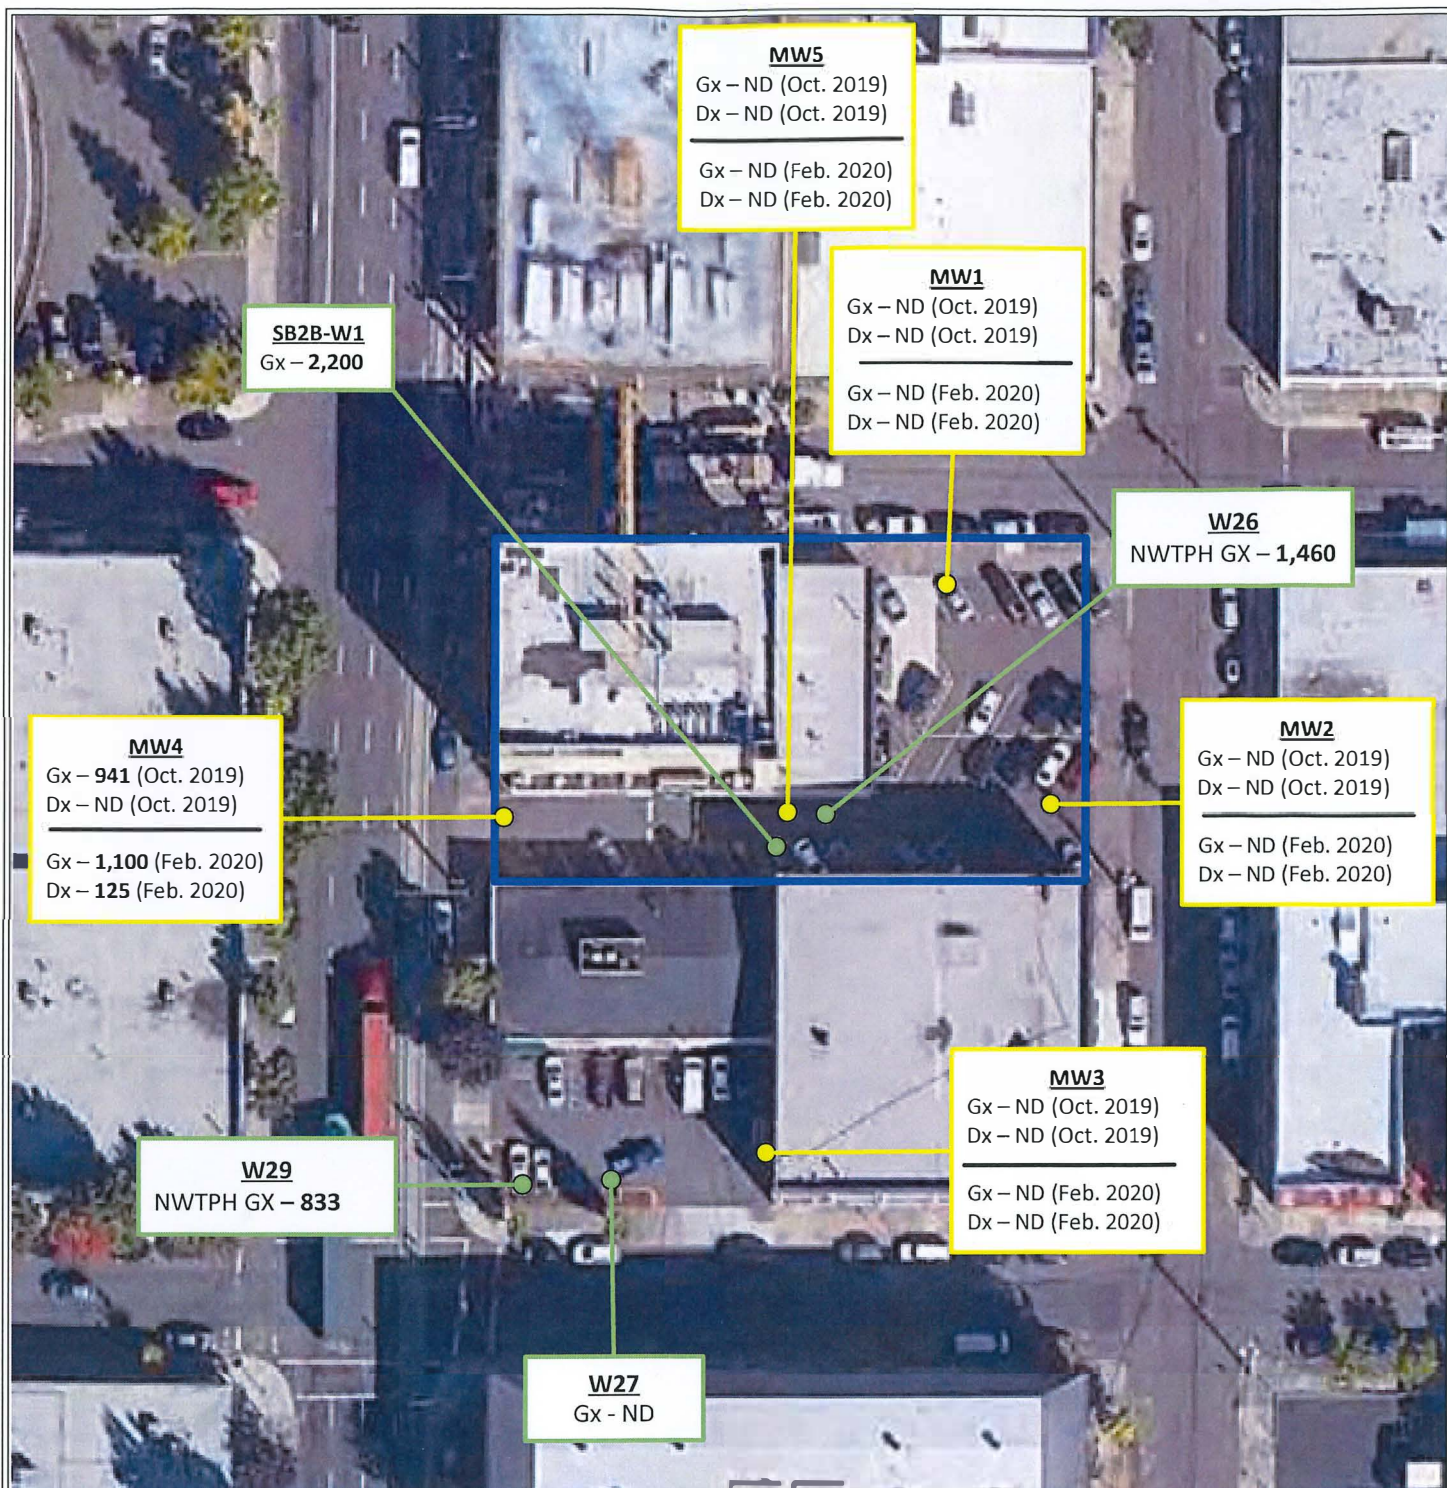
**FIGURE 10 - WATER SAMPLE LOCATION DIAGRAM**

Five groundwater monitoring wells were installed on the block in August 2019. The locations of the wells, labeled MW-1 through MW-5, are shown on Attachment 10. Eight soil samples were collected during installation of the wells. Samples were collected from the soil/groundwater interface in each well (at depths ranging from 26 to 39 feet bgs), and from three intervals that showed indicia of contamination. The eight soil samples were analyzed for extractable petroleum hydrocarbons (EPH) and volatile petroleum hydrocarbons (VPH) in addition to total petroleum hydrocarbons and VOCs to enable the calculation of contaminant-specific risk-based

concentrations for the Stoddard solvent. Stoddard solvent was detected in MW-3 (at the south end of the block) at 36 feet bgs at a concentration of 194 ppm, and in MW-4 (on the west edge of the block) at concentrations of 556 ppm at 15 feet bgs and 673 ppm at 34 feet bgs. In the center of the block (MW-5), Stoddard solvent was detected at a concentration of 23,100 ppm at 9 feet bgs, decreasing to 535 ppm at 31 feet bgs. VOCs included ethylbenzene (3.19 ppm), isopropylbenzene (13.2 ppm), naphthalene (12.8 ppm), 1,2,4-trimethylbenzene (479 ppm), 1,3,5-trimethylbenzene (147 ppm), and xylenes (49.0 ppm), with the highest concentrations at 9 feet bgs in MW-5.
