## Construction Completion Report

BRIO Lofts (Solterra Property)  
3912 North Vancouver Avenue  
Portland, Oregon 97227

ECSI #6219

October 7, 2022

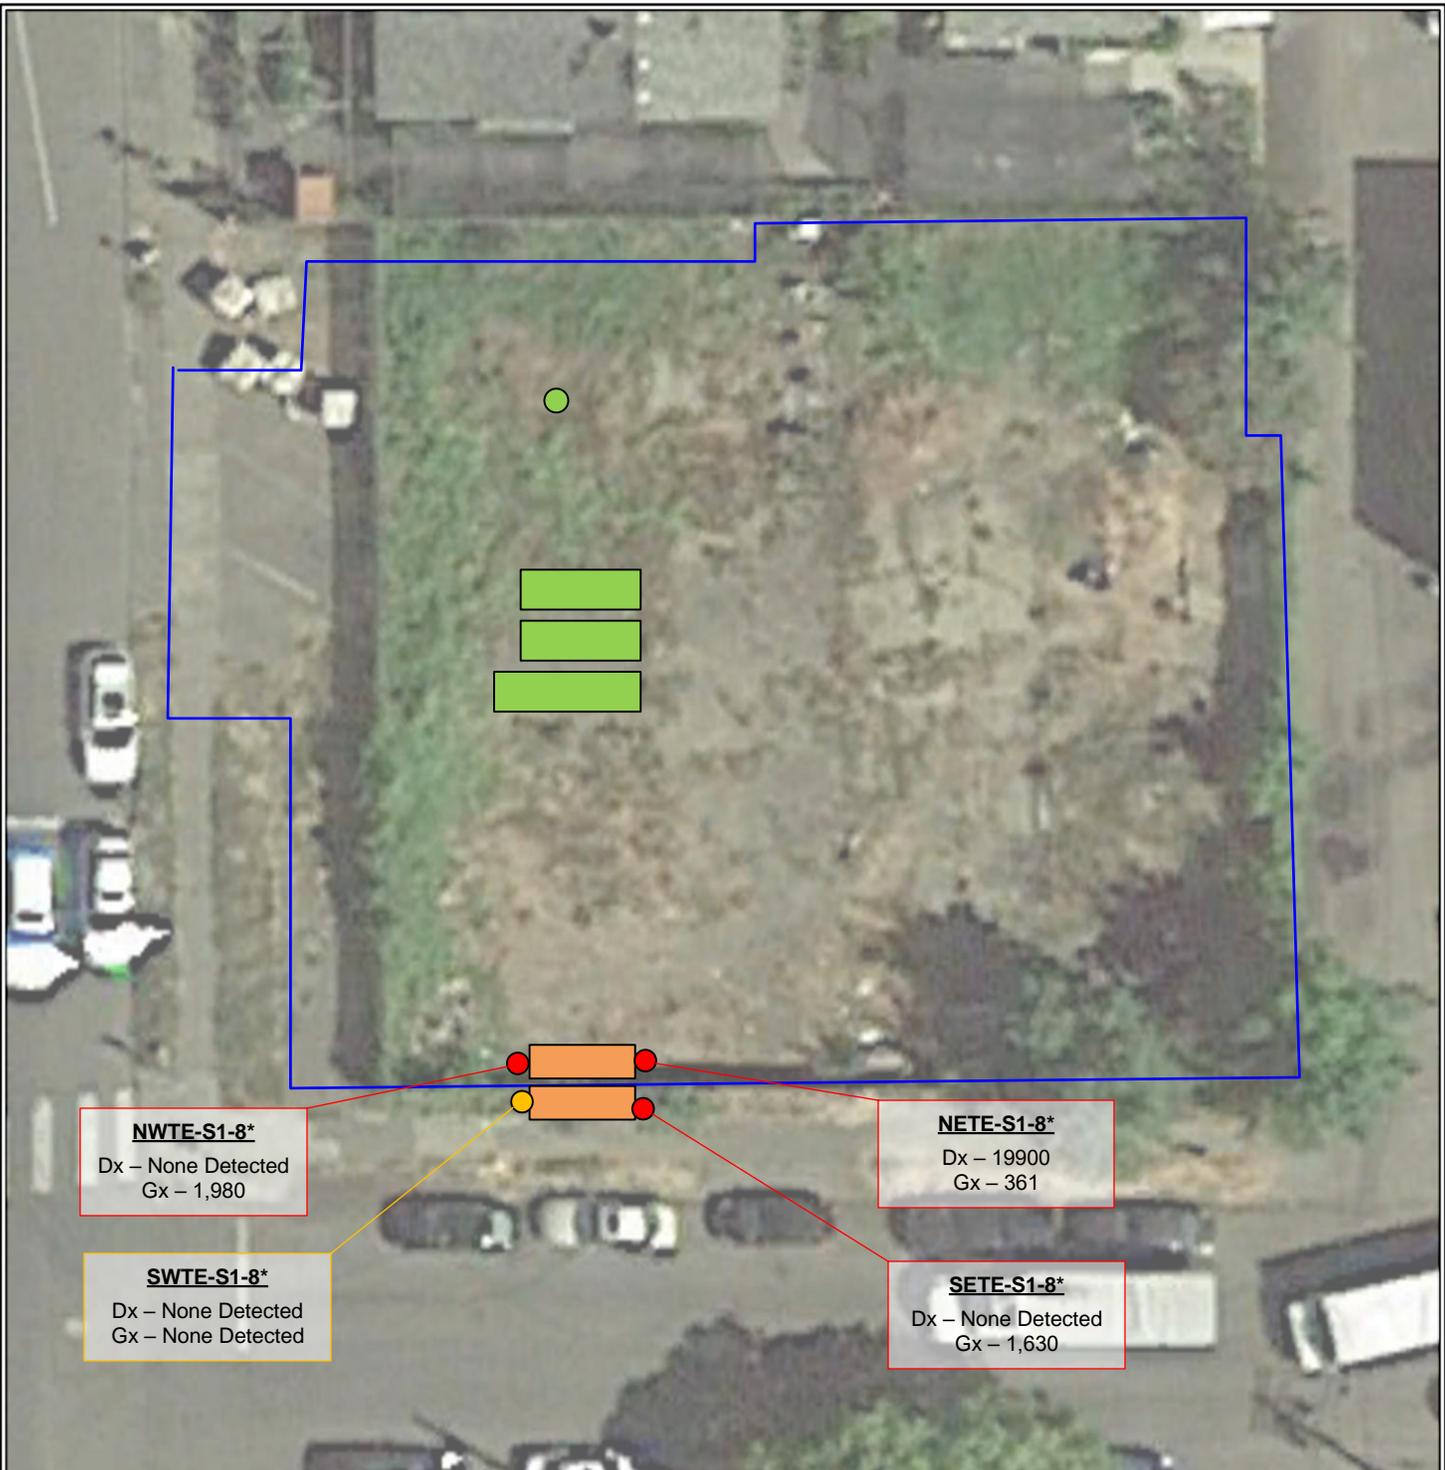
**FIGURE 4: FORMER UST LOCATIONS**

On January 11, 2019, both tanks were removed from the ground and transported off-site for recycling as scrap. Staining and odors indicative of a petroleum hydrocarbon impact was noted in the UST cavity following removal. Further excavation of the contaminated soils was put on hold until the surrounding grade could be reduced, and perimeter shoring was started. A map showing the former tank soil sample locations is including in **Figure 4**.

- Sample NWTE-S1 was collected from the floor of the UST excavation at 8.0 feet bgs at the northwest tank end. Indications of soil contamination in the form of staining, odor, or volatile organic compound (VOC) detections with a hand-held photo-ionization detector (PID) were noted in this location. A soil sample was collected from the bucket of an excavator.

- Sample NETE-S1 was collected from the floor of the UST excavation at 8.0 feet bgs at the northeast tank end. Indications of soil contamination in the form of staining, odor, or volatile organic compound (VOC) detections with a hand-held photo-ionization detector (PID) were noted in this location. A soil sample was collected from the bucket of an excavator.

- Sample SWTE-S1 was collected from the floor of the UST excavation at 8.0 feet bgs at the southwest tank end. Indications of soil contamination in the form of staining, odor, or volatile organic compound (VOC) detections with a hand-held photo-ionization detector (PID) were noted in this location. A soil sample was collected from the bucket of an excavator.

- Sample SETE-S1 was collected from the floor of the UST excavation at 8.0 feet bgs at the southeast tank end. Indications of soil contamination in the form of staining, odor, or volatile organic compound (VOC) detections with a hand-held photo-ionization detector (PID) were noted in this location. A soil sample was collected from the bucket of an excavator.

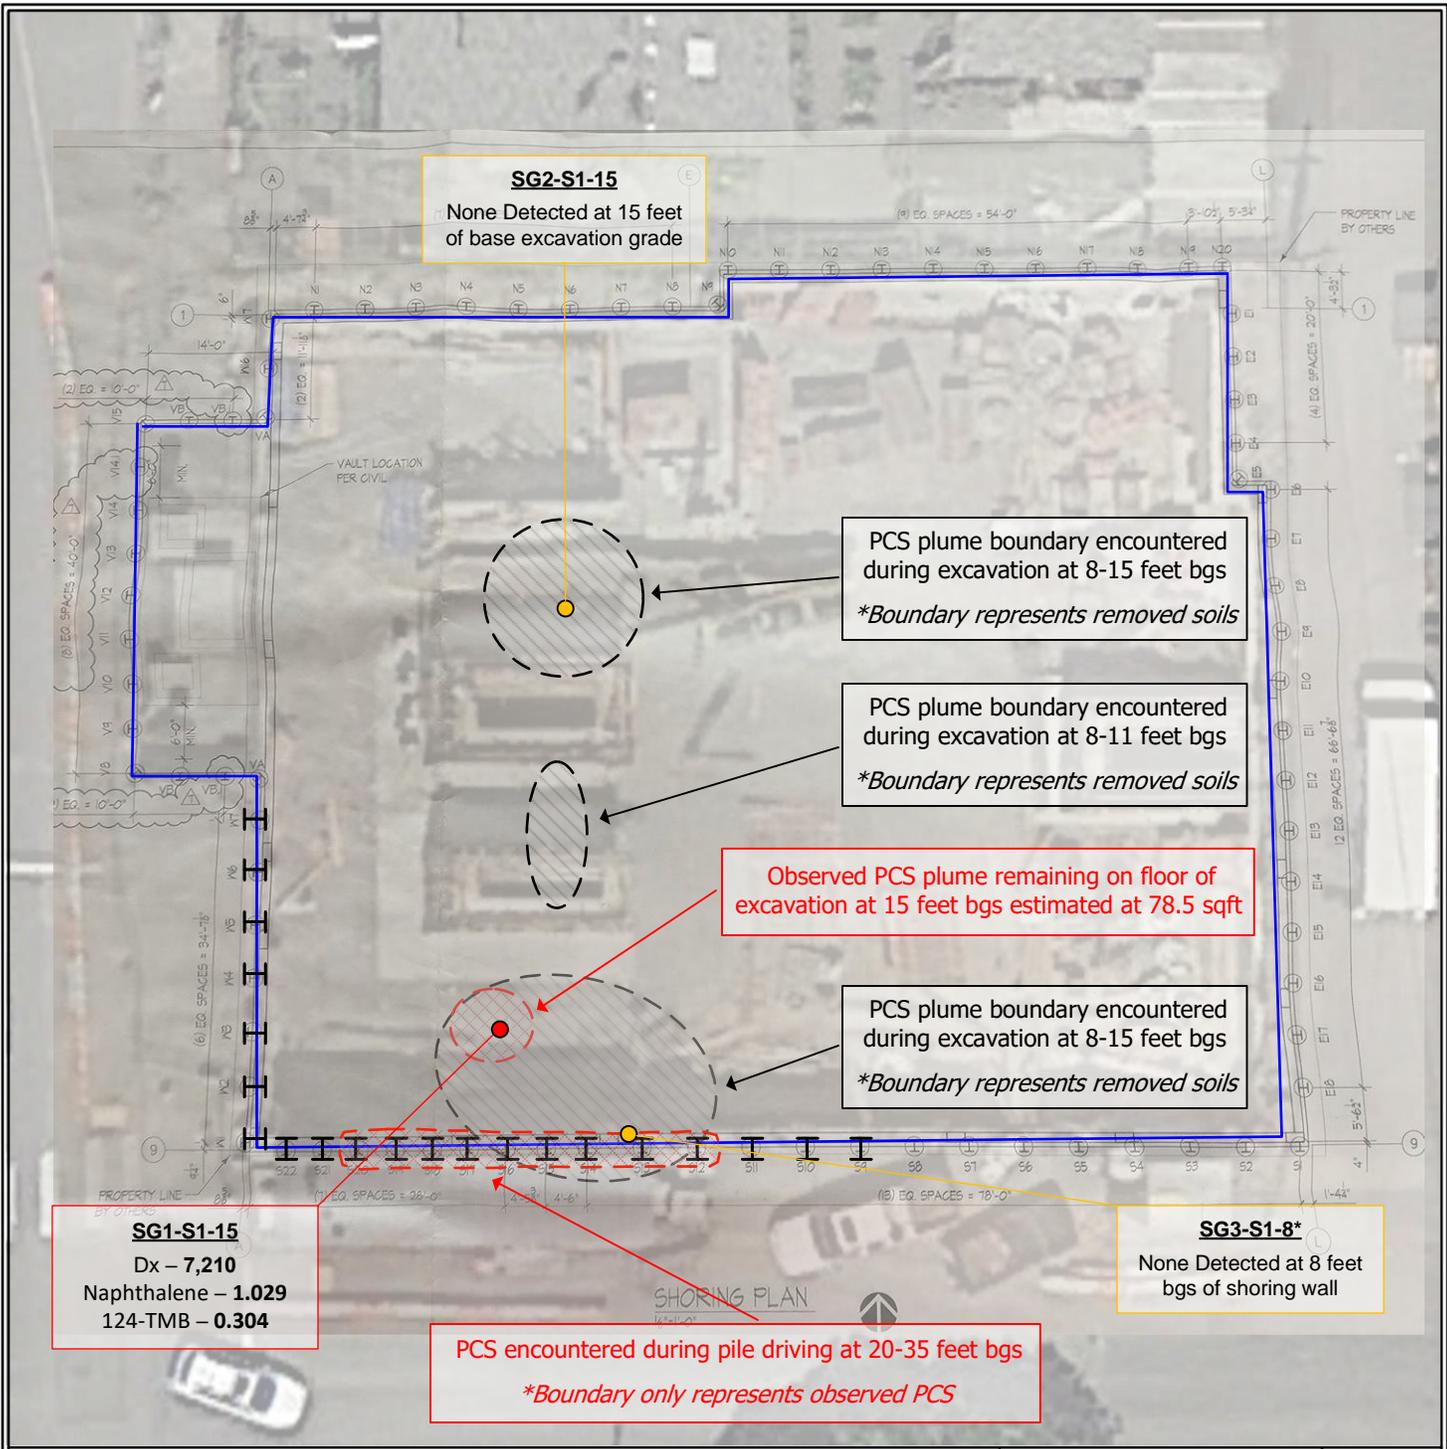
**FIGURE 5: MASS EXCAVATION & PCS BOUNDARIES**

Between January 7 and 17, 2019, Point Source oversaw the installation of 24 soldier piles to a depth of 35 feet bgs. Point Source documented 9 of the 24 observed piles to have encountered PCS at depths ranging from 20-35 feet bgs, all in the southwest portion of the Site. All contaminated soil encountered during pile driving activities was transported to the Waste Management Hillsboro Subtitle D Landfill for disposal under profile #129414OR. Soldier Pile locations are including in **Figure 5**.

- Sample SG1 was collected from the floor of the mass excavation at 15.0 feet bgs using the bucket of an excavator in a localized lens of observed PCS spanning northward in the soil profile from the plume created from the former USTs removed in 2019. Indications of soil contamination in the form of staining, odor, or volatile organic compound (VOC) detections with a hand-held photo-ionization detector (PID) were noted in this location at the final grade and an estimated 78.5 square feet of stained soil remain in this location based on visual observations.

- Sample SG2 was collected from the floor of the excavation at 15.0 feet bgs using the bucket of an excavator in an area where previously identified PCS was encountered higher up in the soil profile from the former USTs removed in 2014. No indications of soil contamination in the form of staining, odor, or volatile organic compound (VOC) detections with a hand-held photo-ionization detector (PID) were noted in this location at the final grade.

- An approximate 78.5 square foot lens observed by visual observations and confirmed by soil sample SG1-S1-15 collected in close proximity to soil boring SB11/SB11B from the floor of the mass excavation at 15 feet bgs. Vertical delineation was not possible, and for feasibility reasons could not be determined in the field during the excavation activities. Therefore, a conservative assumption that contamination terminates vertically between 50 to 60 feet bgs is assumed based on nearby soil boring SB11 and SB11B. Based on this assumption, approximately 167 cubic yards of contaminated soil lie beneath the Site in the area confirmed by SG1-S1-15 at a depth of 15 to 60 feet bgs.

- An approximate 369 square foot lens observed using visual and olfactory observations during pile driving activities in the southwest corner of the Site, extending from 20 feet bgs to the base of the piles at 35 feet bgs. Confirmation samples could not be collected from this area due to feasibility restrictions, therefore the size of the plume at the base of the piles is only known by field observations and results from the 2017 Subsurface Investigation. Therefore, a conservative assumption that contamination terminates vertically between 50 to 60 feet bgs is assumed and it is estimated that 615 cubic yards of PCS extends beneath the Site near the southern property line at a depth of 20 to 50 feet bgs.

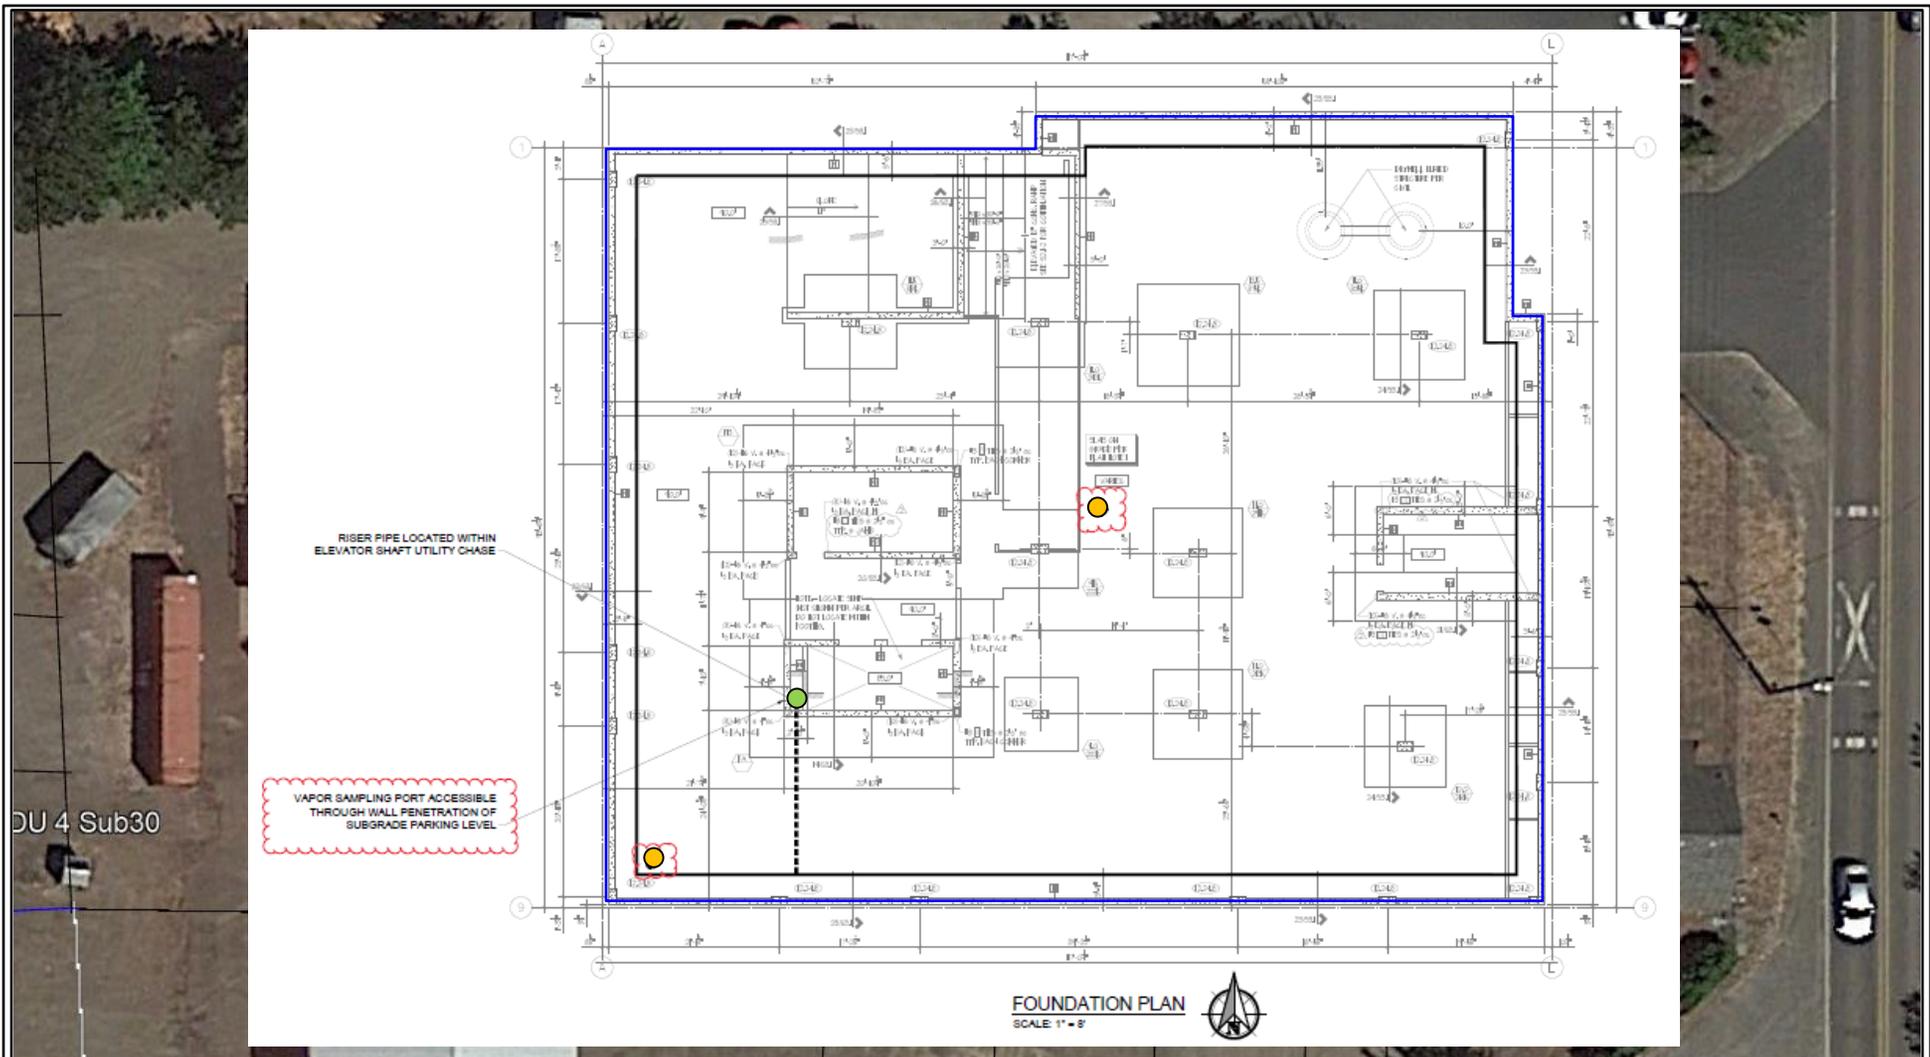
**FIGURE 7: PASSIVE VENTILATION SYSTEM**

Building Foundation Boundary
-

Point Source observed the installation of the Absolute 40 mil Barrier. Point Source, with a representative from Raven Industries, confirmed the proper installation to manufacturer recommendations. On June 7, 2019, Nathan Williams, Professional Engineer (PE) with PBS performed smoke testing to detect any tears or holes in the barrier. No impairments to the barrier were noted during the smoke test. A copy of a memorandum

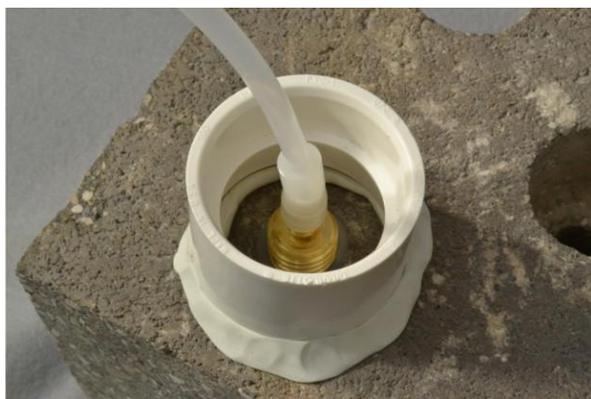
10) Conduct leak tests in accordance with applicable guidance. If the method of leak testing is not specified, an alternative can be the use of a water dam and vacuum pump, as described in SOP Leak Testing the VAPOR PIN® sampling device via Mechanical Means (Figure 6). For flush-mount installations, distilled water can be poured directly into the 1 1/2 inch (38mm) hole.

Figure 6. Water dam used for leak detection

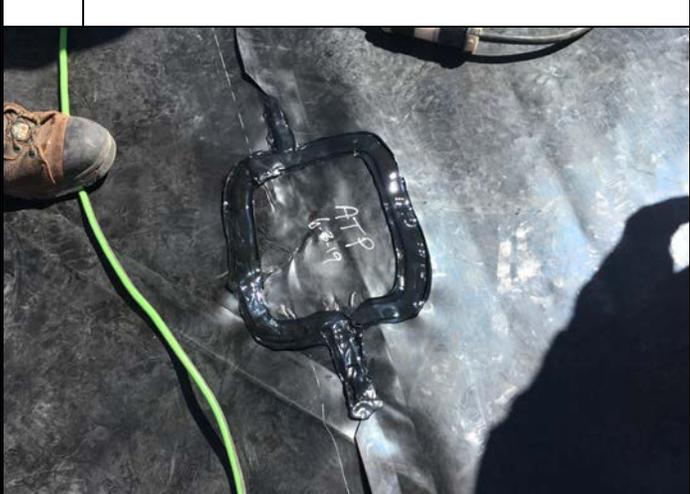
<p>Photo #5: View of Certified Extrusion Weld</p>	<p>Photo #6: View of Completed Section of Barrier</p>

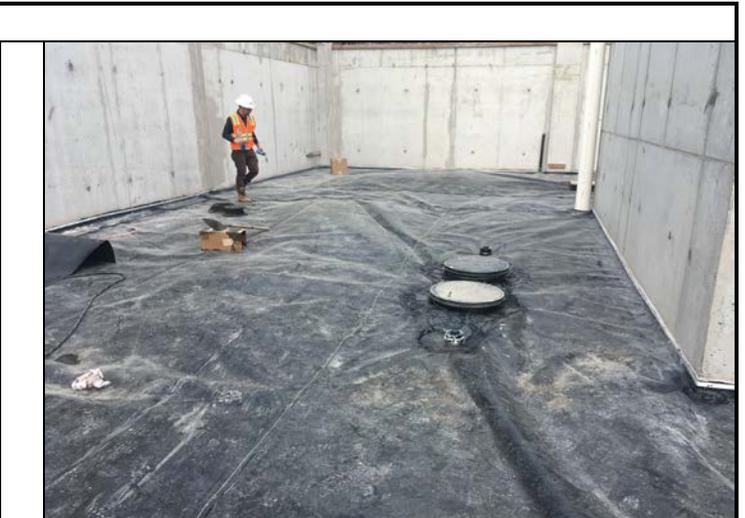
<p>Photo #7:</p>	<p>View of Smoke Test Equipment</p>	<p>Photo #8:</p>	<p>View of PBS Engineer Inspecting Absolute Barrier® for Leaks</p>
