## Construction Completion Report

BRIO Lofts (Solterra Property)  
3912 North Vancouver Avenue  
Portland, Oregon 97227

ECSI #6219

October 7, 2022 (Revised February 20, 2024)

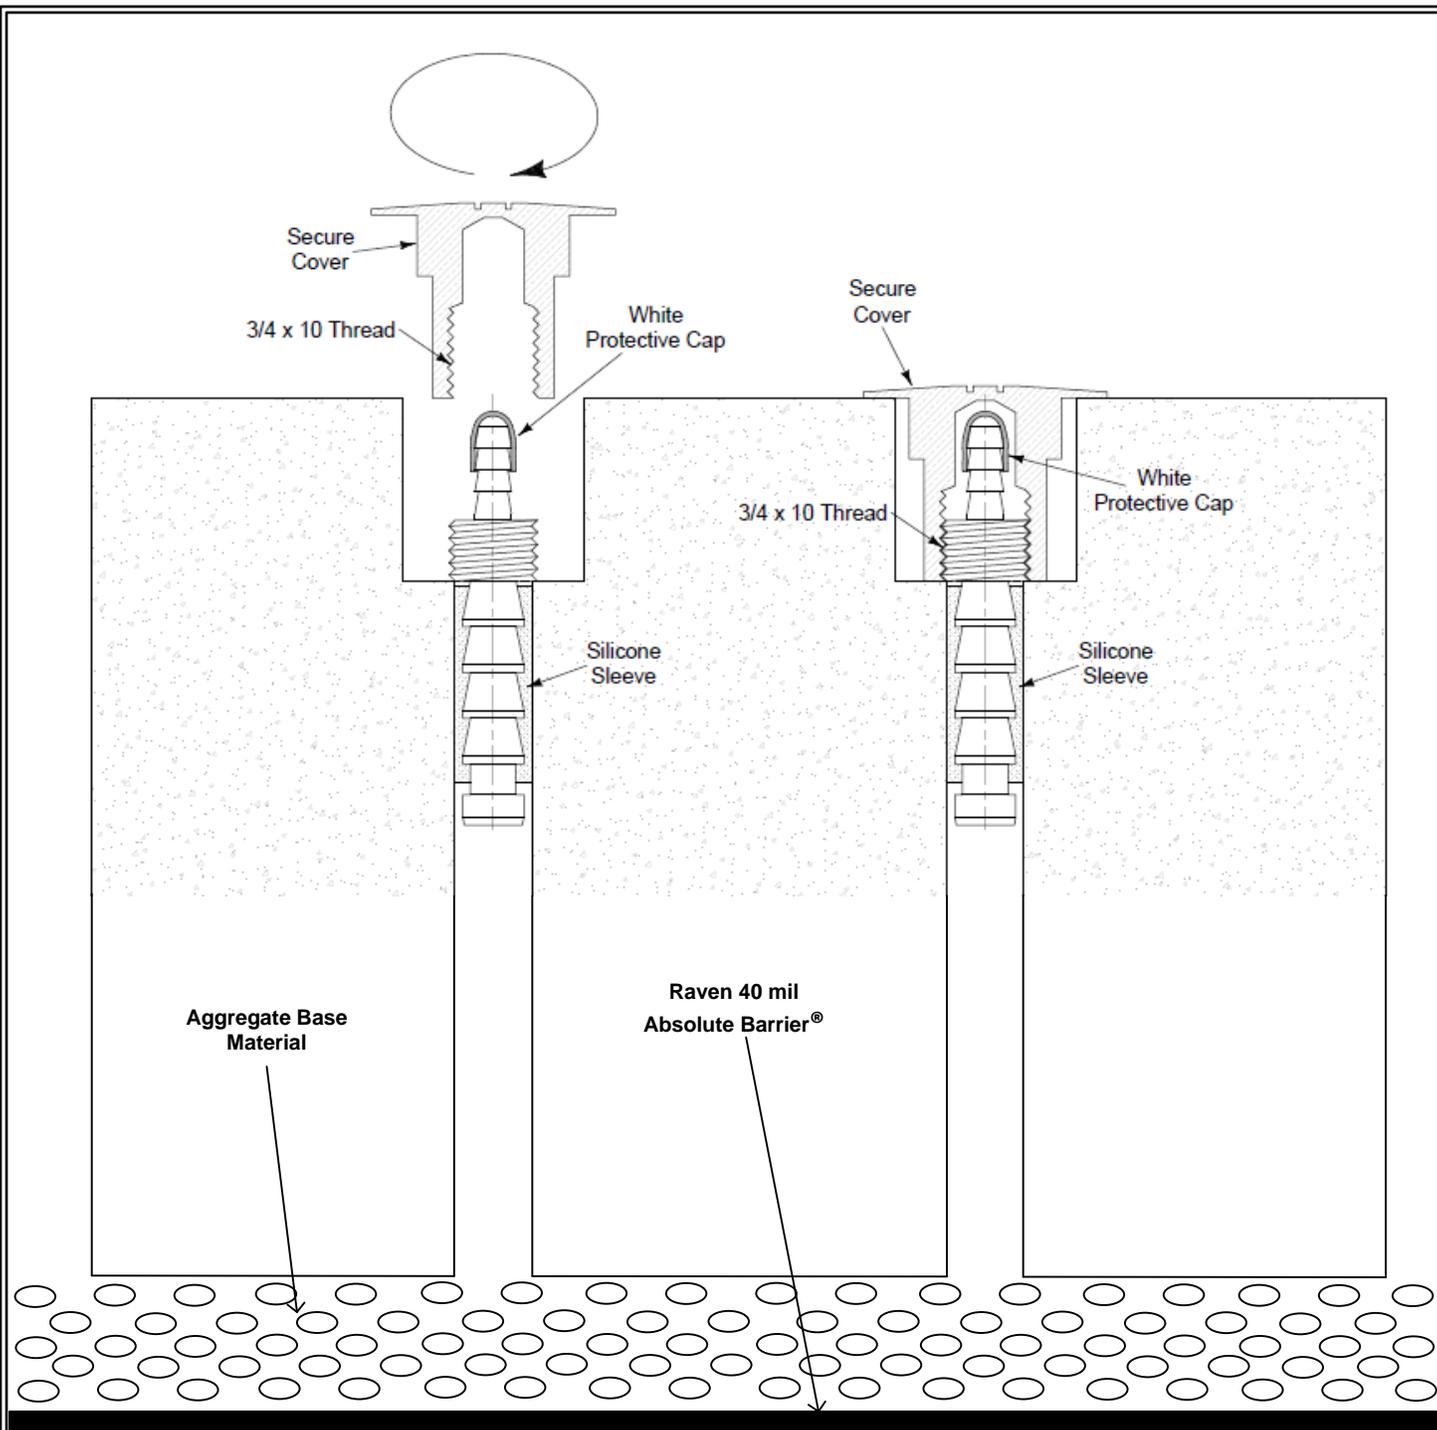
**FIGURE 6: SUB-SLAB MONITORING PROBE DETAIL**

Stainless Steel Vapor Pin® and Secure Cover

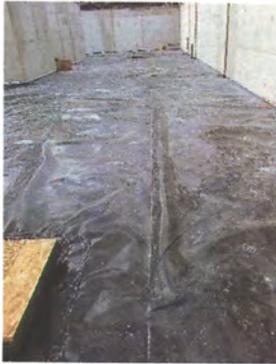
Photo 1. Foundation Seam

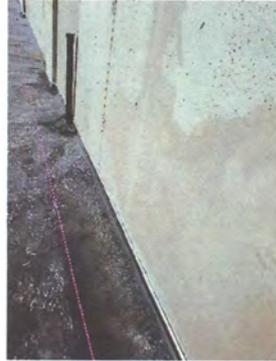
Photo 2. Foundation Seam

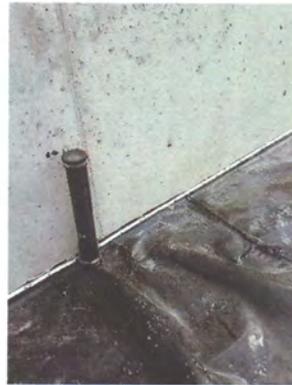
Photo 3. Drain Intrusion

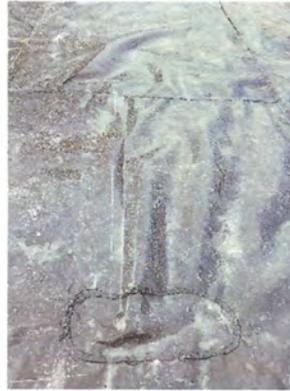
Photo 7. Previously Repair Seam

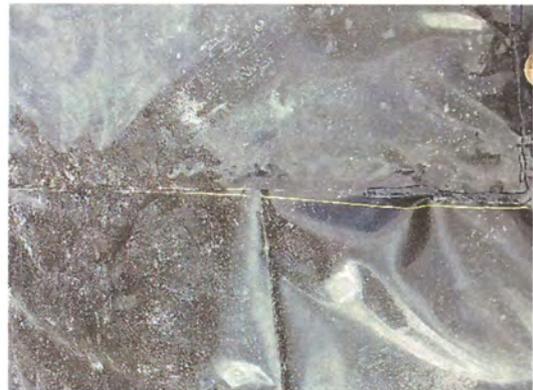
Photo 9. Single Welded Seam

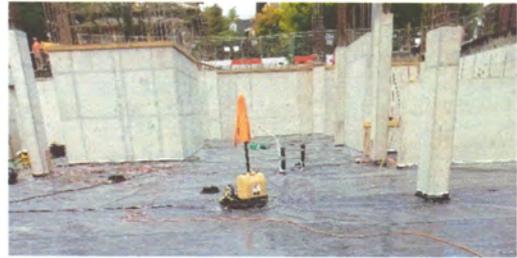
Photo 19. Liner Under Pressure

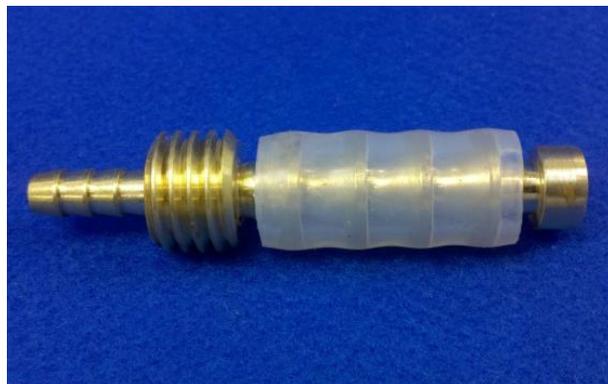
Figure 1. Assembled VAPOR PIN® sampling device

- Assembled VAPOR PIN® sampling device [VAPOR PIN® sampling device and silicone sleeve (Figure 1)]; Because of sharp edges, gloves are recommended for sleeve installation;
- Hammer drill;
- 5/8-inch (16mm) diameter hammer bit (hole must be 5/8-inch (16mm) diameter to ensure seal. It is recommended that you use the drill guide). (Hilti™ TE-YX 5/8" x 22" (400 mm) #00206514 or equivalent);
- 1½-inch (38mm) diameter hammer bit (Hilti™ TE-YX 1½" x 23" #00293032 or equivalent) for flush mount applications;
- ¾-inch (19mm) diameter bottle brush;
- Wet/Dry vacuum with HEPA filter (optional);
- VAPOR PIN® sampling device installation/extraction tool;

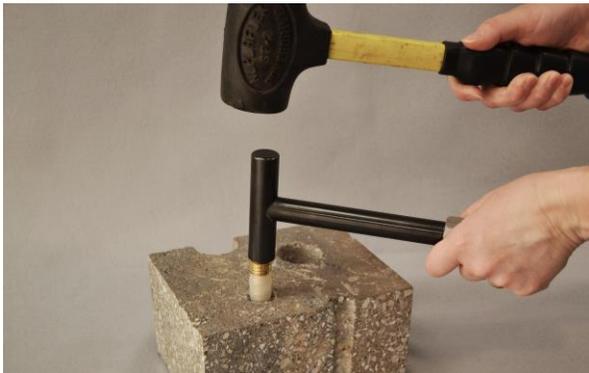
Figure 2. Installing the VAPOR PIN®

- 4) Drill a 5/8-inch (16mm) diameter hole through the slab and approximately 1-inch (25mm) into the underlying soil to form a void. Hole **must** be 5/8-inch (16mm) in diameter to ensure seal. It is recommended that you use the drill guide.
- 5) Remove the drill bit, brush the hole with the bottle brush, and remove the loose cuttings with the vacuum.
- 6) Place the lower end of VAPOR PIN® sampling device assembly into the drilled hole. Place the small hole located in the handle of the installation/extraction tool over the vapor pin to protect the barb fitting, and tap the vapor pin into place using a dead blow hammer (Figure 2). Make sure the installation/extraction tool is aligned parallel to the vapor pin to avoid damaging the barb fitting.

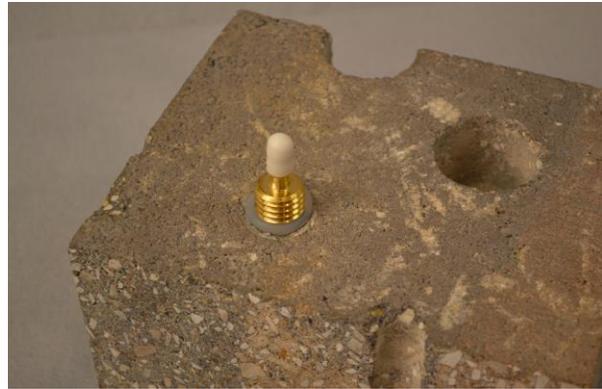
Figure 3. Installed VAPOR PIN® sampling device

During installation, the silicone sleeve will form a slight bulge between the slab and the VAPOR PIN® sampling device shoulder. Place the protective cap on VAPOR PIN® sampling device to prevent vapor loss prior to sampling (Figure 3).

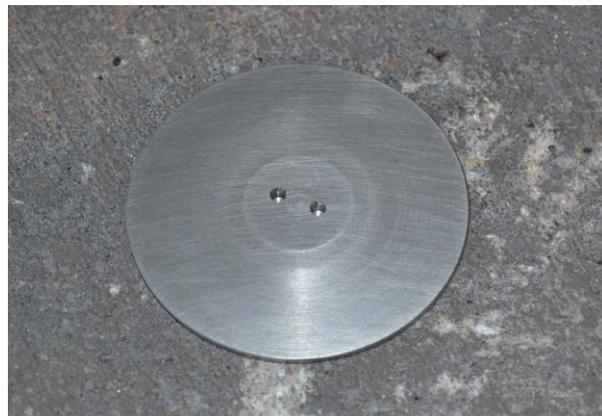
Figure 4. [Secure Cover](#) Installed

- 7) For flush mount installations, cover the vapor pin with a flush mount cover, using either the plastic cover or the optional stainless-steel Secure Cover (Figure 4).

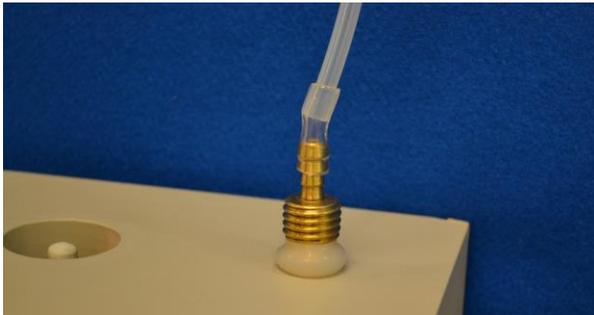
Figure 5. VAPOR PIN® sampling device sample connection

piece of Tygon™ tubing to join the VAPOR PIN® sampling device with the Nylaflow tubing (Figure 5). Put the Nylaflow tubing as close to the VAPOR PIN® sampling device as possible to minimize contact between soil gas and Tygon™ tubing.

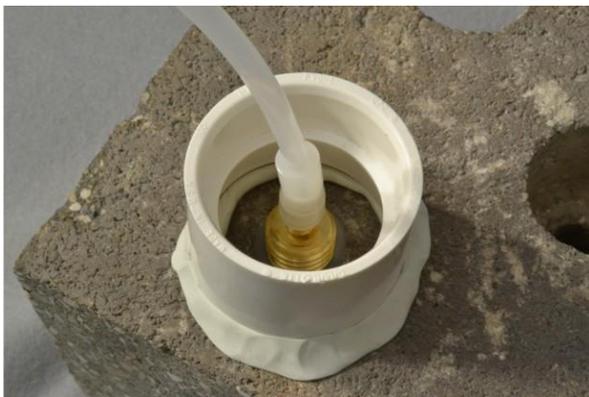
Figure 6. Water dam used for leak detection

10) Conduct leak tests in accordance with applicable guidance. If the method of leak testing is not specified, an alternative can be the use of a water dam and vacuum pump, as described in SOP Leak Testing the VAPOR PIN® sampling device via Mechanical Means (Figure 6). For flush-mount installations, distilled water can be poured directly into the 1 1/2 inch (38mm) hole.

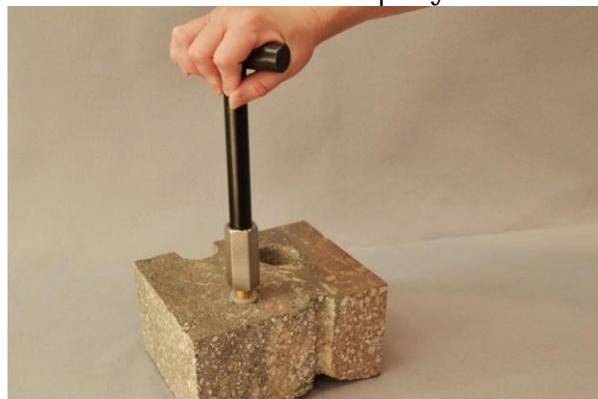
Figure 7. Removing the VAPOR PIN® sampling device

- 1) Remove the protective cap, and thread the installation/extraction tool onto the barrel of the VAPOR PIN® sampling device (Figure 7). Turn the tool clockwise continuously, don't stop turning, the VAPOR PIN® sampling device will feed into the bottom of the installation/extraction tool and will extract from the hole like a wine cork, DO NOT PULL.
- 2) Fill the void with hydraulic cement and smooth with a trowel or putty knife.

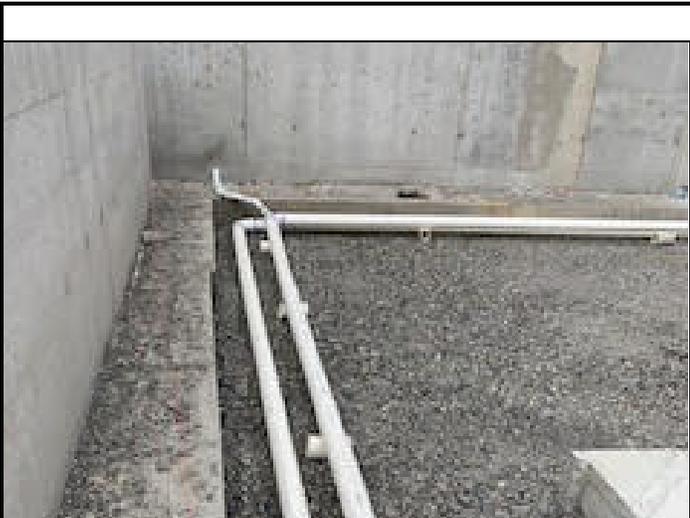
<p>Photo #1: View of Perforated PVC Installation</p>	<p>Photo #2: View of Aggregate Material underneath Geomembrane</p>

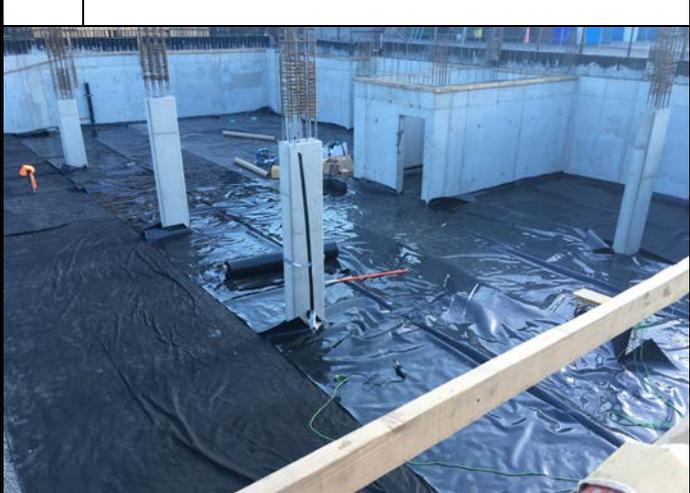
<p>Photo #3: View of Absolute Barrier® Installation</p>	<p>Photo #4: View of DemTech Wedge Welder</p>

Point Source observed the installation of the Absolute 40 mil Barrier. Point Source, with a representative from Raven Industries, confirmed the proper installation to manufacturer recommendations. On June 7, 2019, Nathan Williams, Professional Engineer (PE) with PBS performed smoke testing to detect any tears or holes in the barrier. No impairments to the barrier were noted during the smoke test. A copy of a memorandum prepared by PBS on the smoke testing results is included as **Appendix E**.

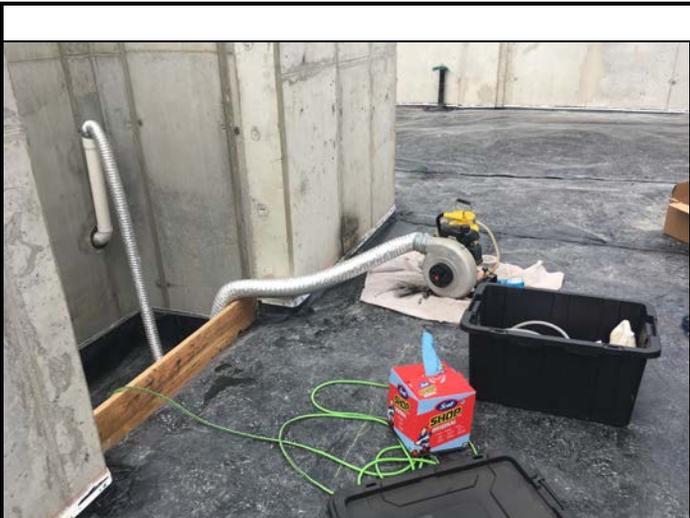
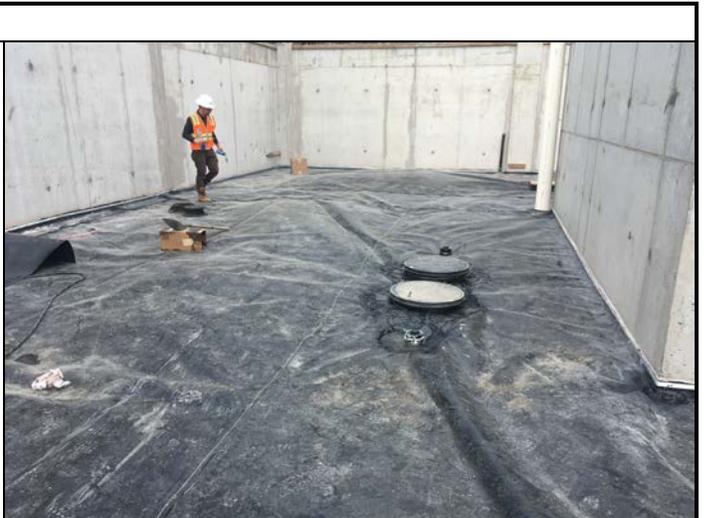
Photo #7:	View of Smoke Test Equipment	Photo #8:	View of PBS Engineer Inspecting Absolute Barrier® for Leaks

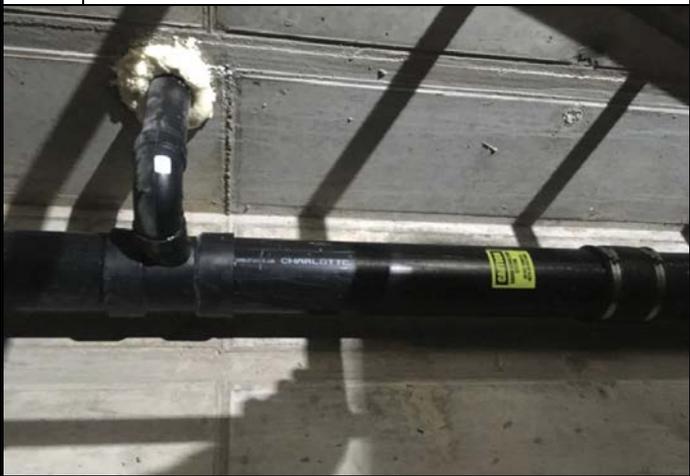
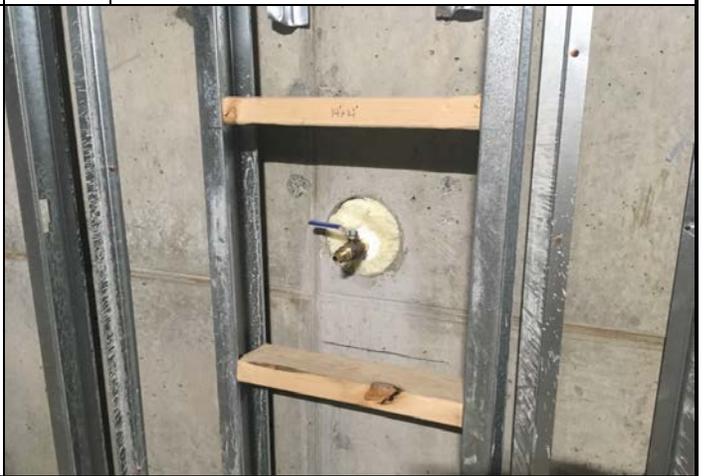
Photo #9:	View of Vent Riser to Sampling Port Connection through Elevator Shaft	Photo #10:	View of Vent Riser Sampling Port in Parking Garage (Enclosure not yet installed)

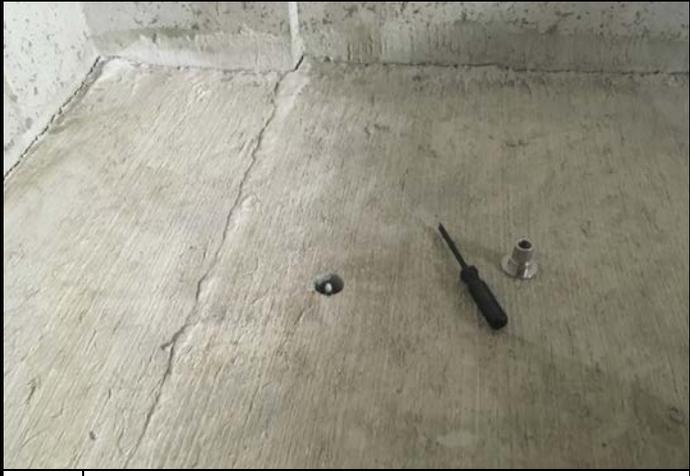
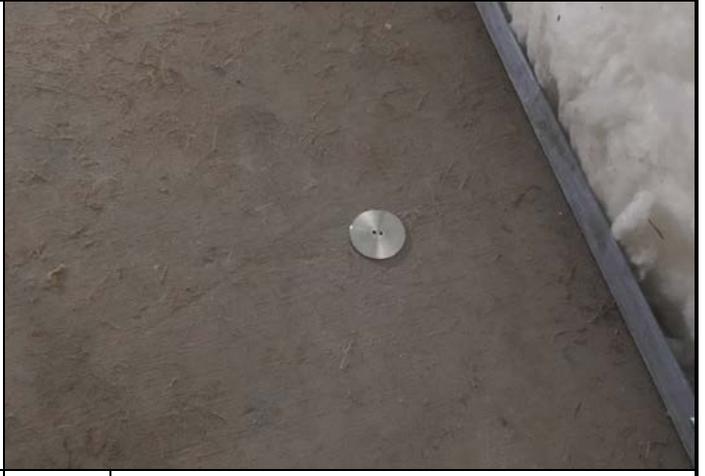
Photo #11:	View of Stainless Steel Vapor Pin®	Photo #12:	View of Vapor Pin® Secure Cover
