**Subject:** River Terrace Town Center Development, ECSI #6283; Staff Memorandum in support of a Conditional No Further Action determination

This document presents the basis for the Oregon Department of Environmental Quality's (DEQ's) recommended Conditional No Further Action (CNFA) determination for the River Terrace Town Center Development site in Tigard. As discussed in this report, contaminant concentrations in soils exceed acceptable risk levels for applicable exposure pathways. Consequently, the No Further Action determination will be conditioned upon adherence to restrictions in Easements & Equitable Servitudes recorded with the property.

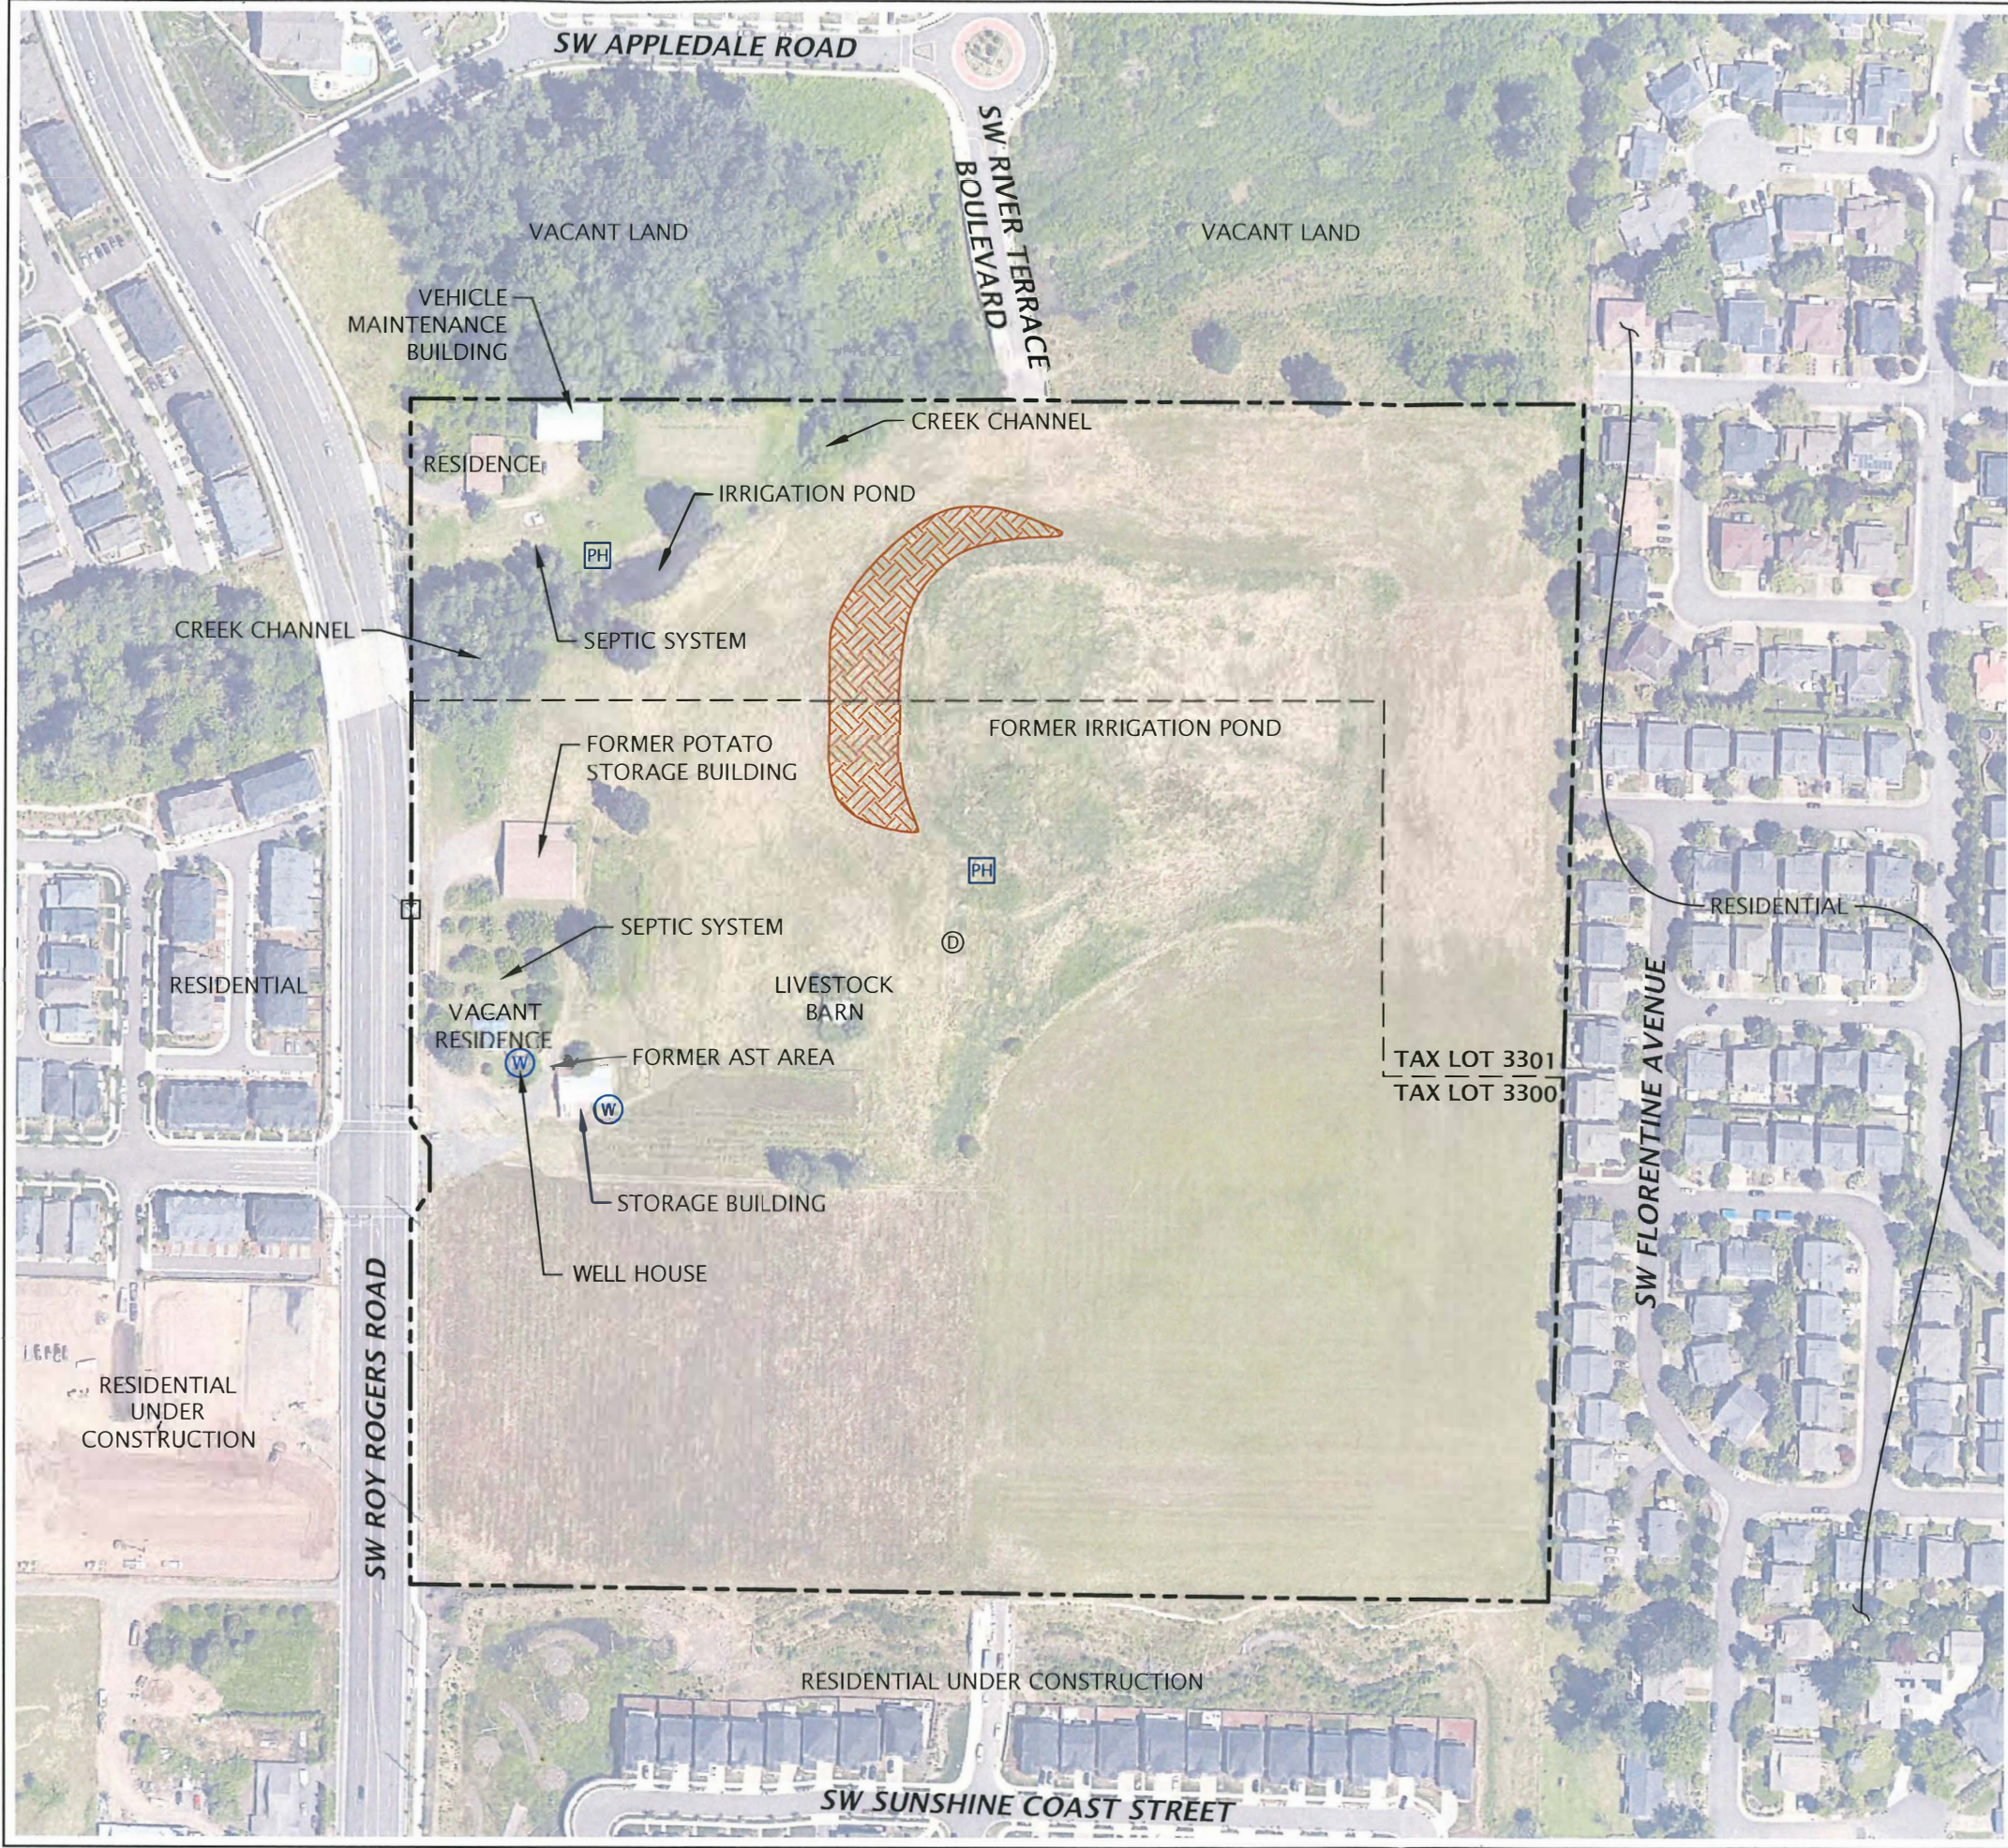
The 38.52-acre site covered two rural properties on the east side of Roy Rogers Road. See Attachment 1 for a topographic map of the area (circa 1977) and Attachment 2 for an aerial photo of the site (circa 2022). A residential neighborhood bordered the site to the east, and at the time the site entered the Voluntary Cleanup Program (circa 2018), residential neighborhoods were being planned to the north and south of the site. Residences were under construction to the west of the site, across Roy Rogers Road.

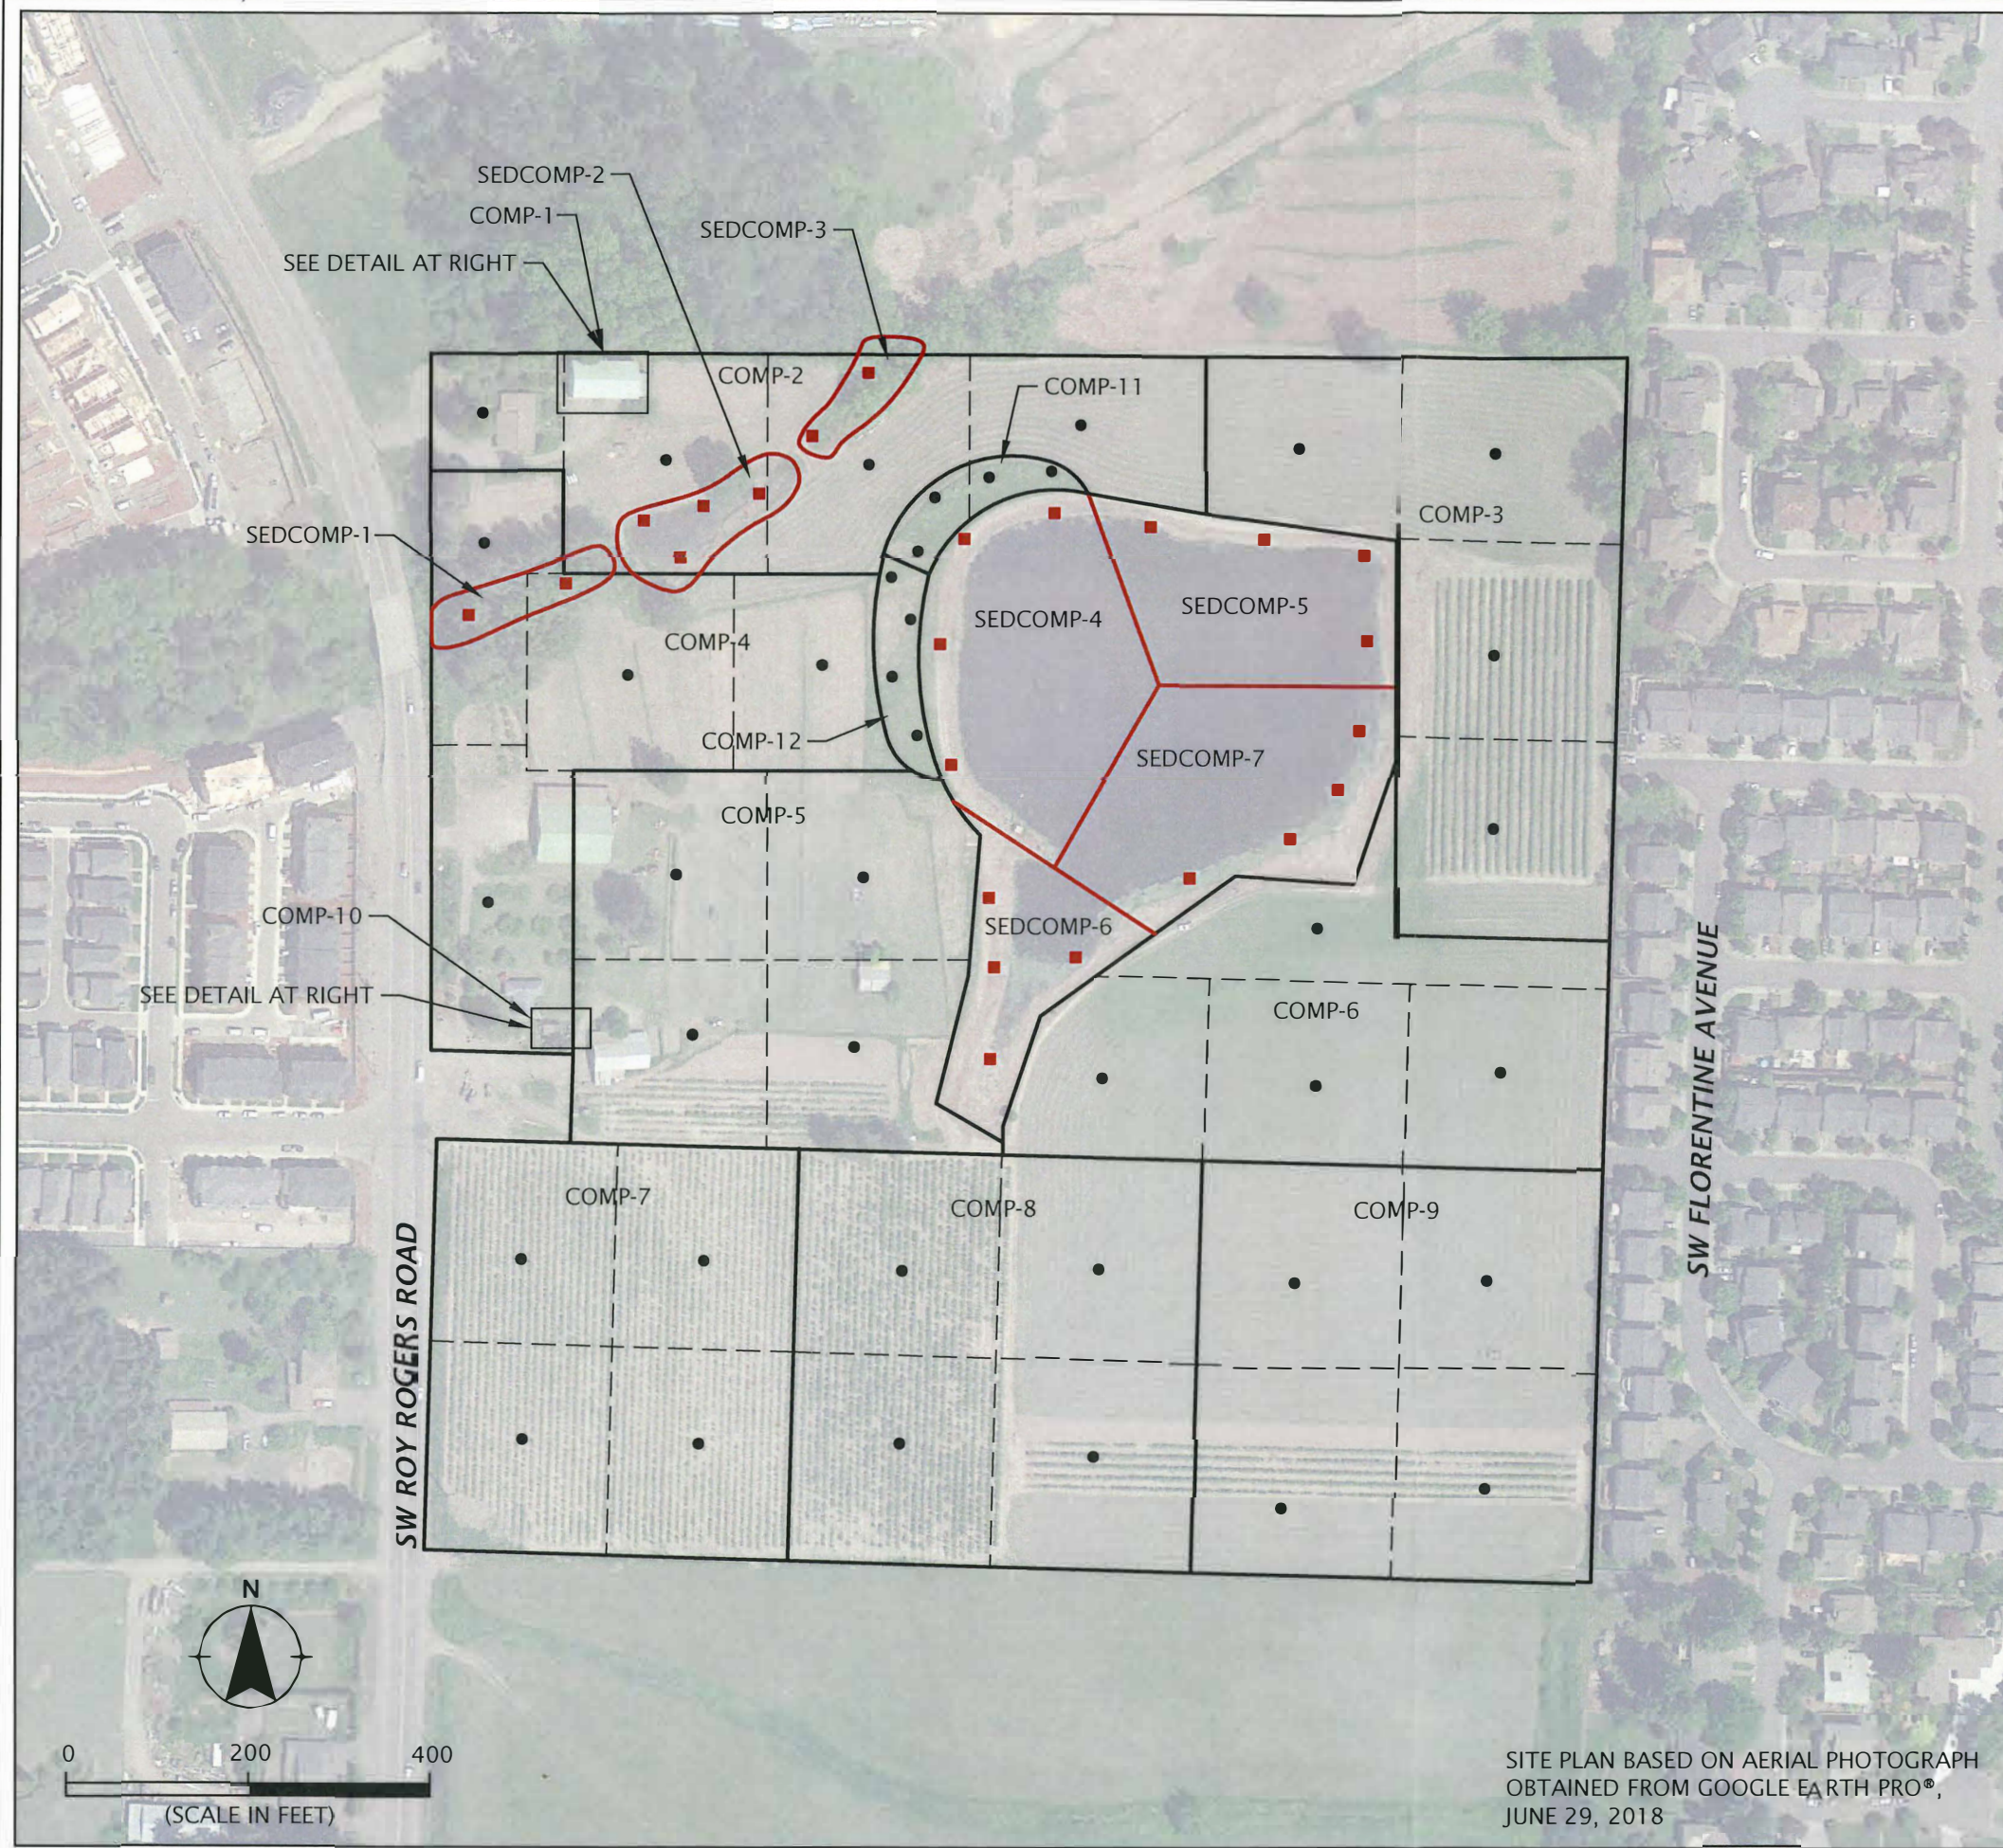
**Attachment 5**

A total of 14 composite soil samples were collected from eight decision units covering the agricultural areas of the site. The eight decision units are labeled COMP-2 through COMP-9 on Attachment 5. In each decision unit, four discrete soil samples were collected from 0-6 inches bgs and combined into a composite sample. In six of the decision units (all but COMP-2 and COMP-5), four additional discrete soil samples were collected from 1-1½ feet bgs and combined into a composite sample. The 14 composite soil samples were analyzed for organochlorine pesticides.

Three composite sediment samples were collected from the intermittent creek in the northwest corner of the site. The sample locations are labeled SEDCOMP-1 through SEDCOMP-3 on Attachment 5. The three composites, each consisting of 2-4 discrete samples collected from the upper six inches of sediments, were analyzed for organochlorine pesticides and total metals. The only pesticide detected was DDE, at a concentration of 0.00533 ppm. Metals included arsenic (10.6 ppm), barium (221 ppm), beryllium (0.645 ppm), chromium (25.8 ppm), cobalt (27.8 ppm), copper (23.4 ppm), lead (11.8 ppm), nickel (16.3 ppm), vanadium (81.9 ppm), and zinc (247 ppm).

Four composite sediment samples were collected from the shoreline of the irrigation pond. The sample locations are labeled SEDCOMP-4 through SEDCOMP-7 on Attachment 5. The four composites, each consisting of four discrete samples collected from the upper six inches of sediments, were analyzed for organochlorine pesticides and metals. DDE was detected in three of the composites, at concentrations up to 0.0151 ppm, and dieldrin was detected in one composite at a concentration of 0.0028 ppm. Metals included arsenic (3.54 ppm), barium (153 ppm), beryllium (0.532 ppm), cadmium (0.282 ppm), chromium (19.3 ppm), cobalt (14.2 ppm), copper (13.6 ppm), lead (45.1 ppm), nickel (11.0 ppm), vanadium (60.6 ppm), and zinc (47.9 ppm).

Two composite soil samples were collected from an earthen berm on the northwest side of the irrigation pond. The sample locations are labeled COMP-11 and COMP-12 on Attachment 5. The two composites, each consisting of four discrete samples collected from the upper three feet of the berm soils, were analyzed for petroleum hydrocarbons, metals, polycyclic aromatic hydrocarbons (PAHs), polychlorinated biphenyls (PCBs), and volatile organic compounds (VOCs).

A composite soil sample was collected beneath three aboveground storage tanks (ASTs) on the west end of the site. The sample location is labeled COMP-10 on Attachment 5. The composite, consisting of five discrete soil samples collected from 0-6 inches bgs, was analyzed for petroleum hydrocarbons, metals, PAHs, PCBs, and VOCs. Diesel (1,290 ppm) and heavy oils (195 ppm) were detected, along with low levels of PAHs including benzo[b]fluoranthene (0.0139 ppm), indeno[1,2,3-cd]pyrene (0.0123 ppm), naphthalene (0.183 ppm), and pyrene (0.125 ppm). One PCB (Aroclor 1260, at 0.0718 ppm) was also detected, along with elevated concentrations of cadmium (2.92 ppm) and lead (63.9 ppm).

Low concentrations of a variety of pesticides were detected in the eight near-surface (0-6 inch) composite samples, including chlordane at concentrations up to 0.482 parts per million (ppm). Other pesticides included alpha-Chlordane (0.0619 ppm), gamma-Chlordane (0.0387 ppm), DDD (0.0114 ppm), DDE (0.393 ppm), DDT (0.556 ppm), dieldrin (0.162 ppm), and heptachlor epoxide (0.0095 ppm). The six deeper composite samples (1-1½ feet bgs) identified beta-BHC (0.00528 ppm), delta-BHC (0.011 ppm), alpha-Chlordane (0.012 ppm), gamma-Chlordane (0.00883 ppm), DDE (0.178 ppm), DDT (0.192 ppm), dieldrin (0.0377 ppm), and heptachlor epoxide (0.00325 ppm). The eight near-surface composite samples were also analyzed for metals. Metals concentrations were consistent with naturally-occurring background levels.

The maximum concentrations of five pesticides exceeded DEQ's clean fill screening level values (SLVs): DDD, DDE, DDT, dieldrin, and heptachlor epoxide. The maximum dieldrin concentration (0.162 ppm) also exceeded DEQ's residential direct contact risk-based concentration (RBC) of 0.034 ppm.

Naphthalene was detected in the two composites at concentrations of 0.205 ppm and 0.211 ppm, respectively. Both concentrations exceeded the clean fill SLV of 0.077 ppm. Heavy oils were detected in COMP-12 at a concentration of 89.4 ppm. No clean fill SLVs have been established for heavy oils. Concentrations of metals were consistent with naturally-occurring background levels.

The diesel concentration exceeded the residential direct contact RBC of 1,100 ppm, and the concentrations of cadmium, lead, and naphthalene exceeded their clean fill SLVs.

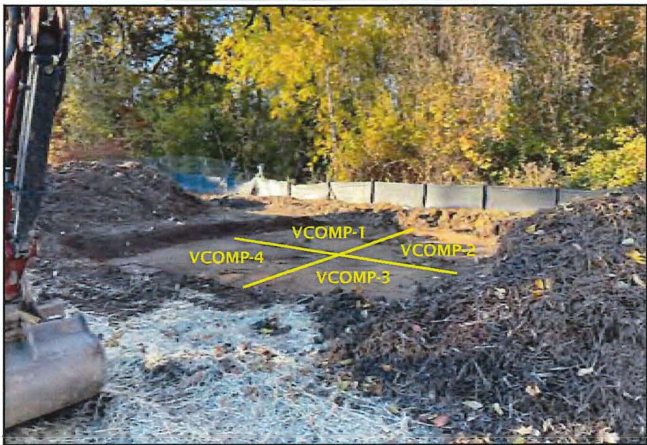
**DETAIL 1 (NOT TO SCALE)**

① PETROLEUM-IMPACTED SOIL FROM THE FORMER VEHICLE MAINTENANCE BUILDING HAS BEEN REMOVED AND DISPOSED OF OFF SITE
-

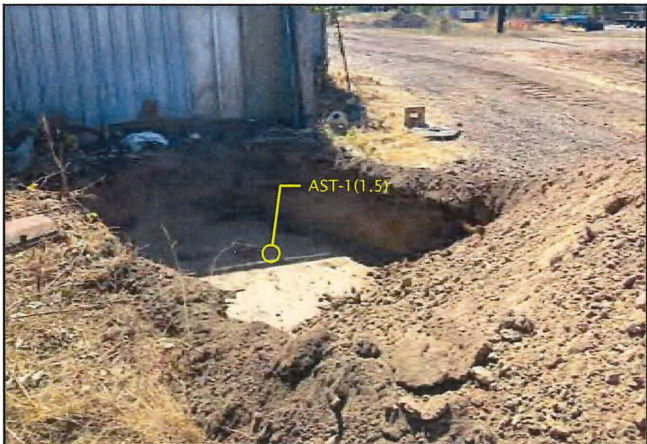
**DETAIL 2 (NOT TO SCALE)**

② PETROLEUM-IMPACTED SOIL FROM THE FORMER AST AREA HAS BEEN REMOVED AND DISPOSED OF OFF SITE

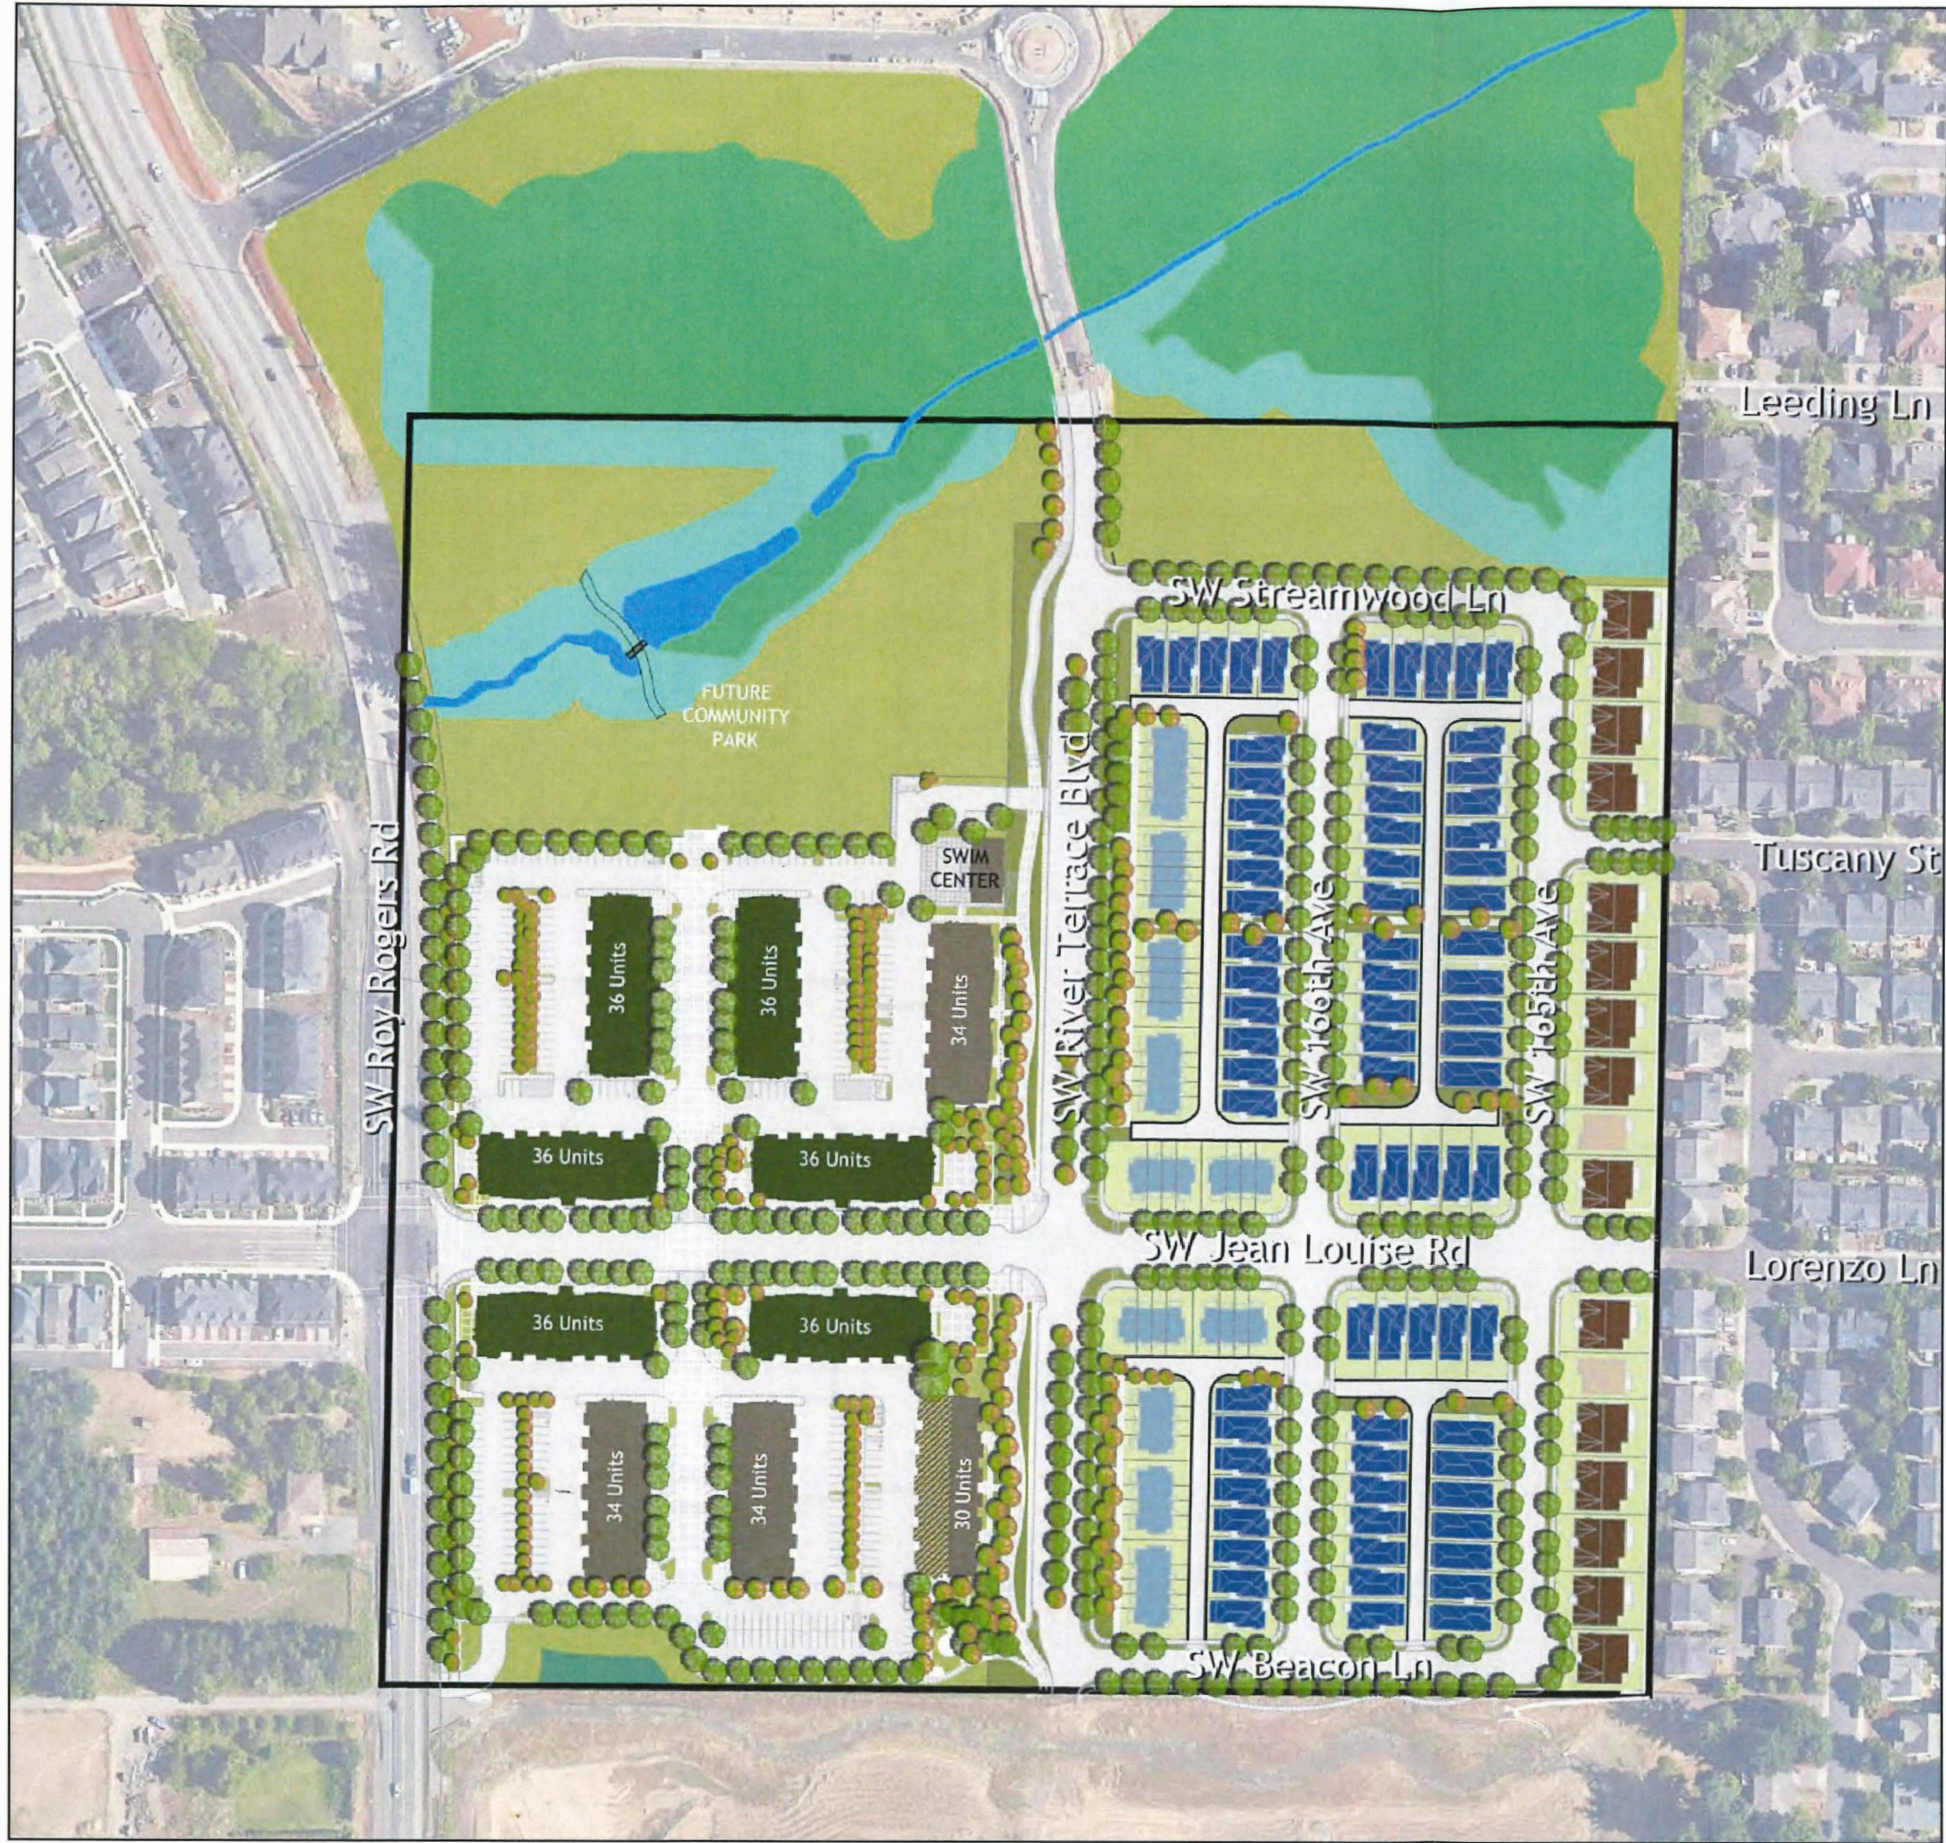
Attachment 7

The eastern half of the River Terrace Town Center site will be redeveloped with 93 detached, single-family houses and 50 rowhouses, as shown on Attachment 7. The western half of the site

will be redeveloped with 348 apartment units across 10 buildings, and a community park will be established around the intermittent creek in the northwest corner of the site.

A formal ecological risk assessment was not completed for this site. However, residual soil contamination at the site is minimal and is not expected to impact ecological receptors. Most of the site will be redeveloped as a residential and urban residential neighborhood, as shown on Attachment 7. The primary remaining ecological habitat will be the creek and community park in the northwest corner of the site.
