## **Source Control Evaluation Report**

Former Chevron Willbridge Asphalt Plant No.  
209293

5501 NW Front Avenue Portland, Oregon

May 2009

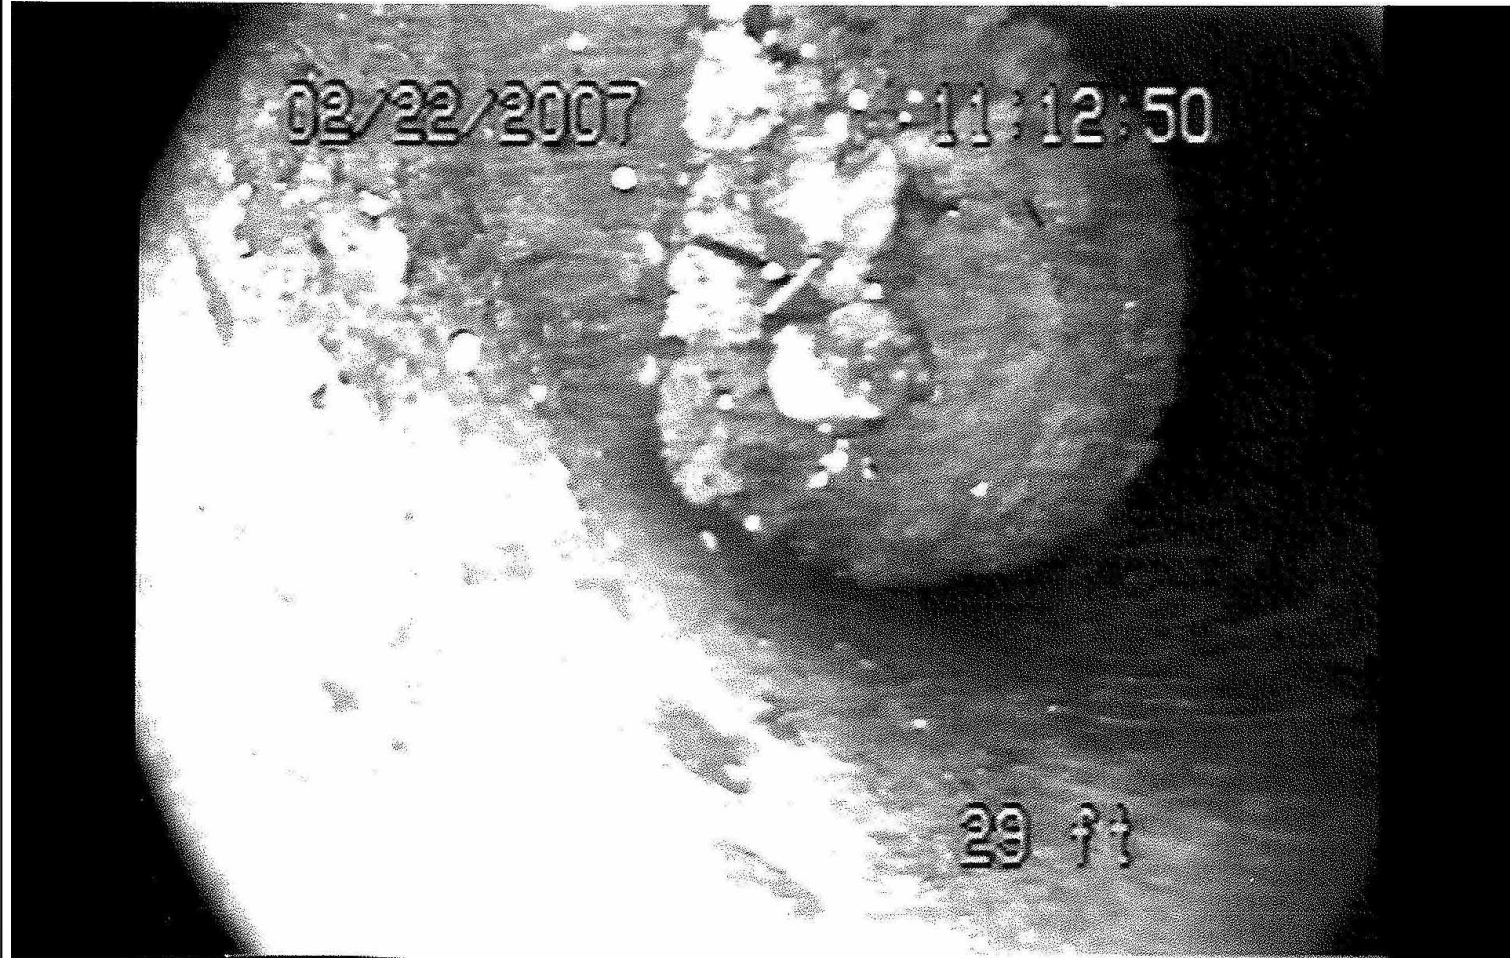
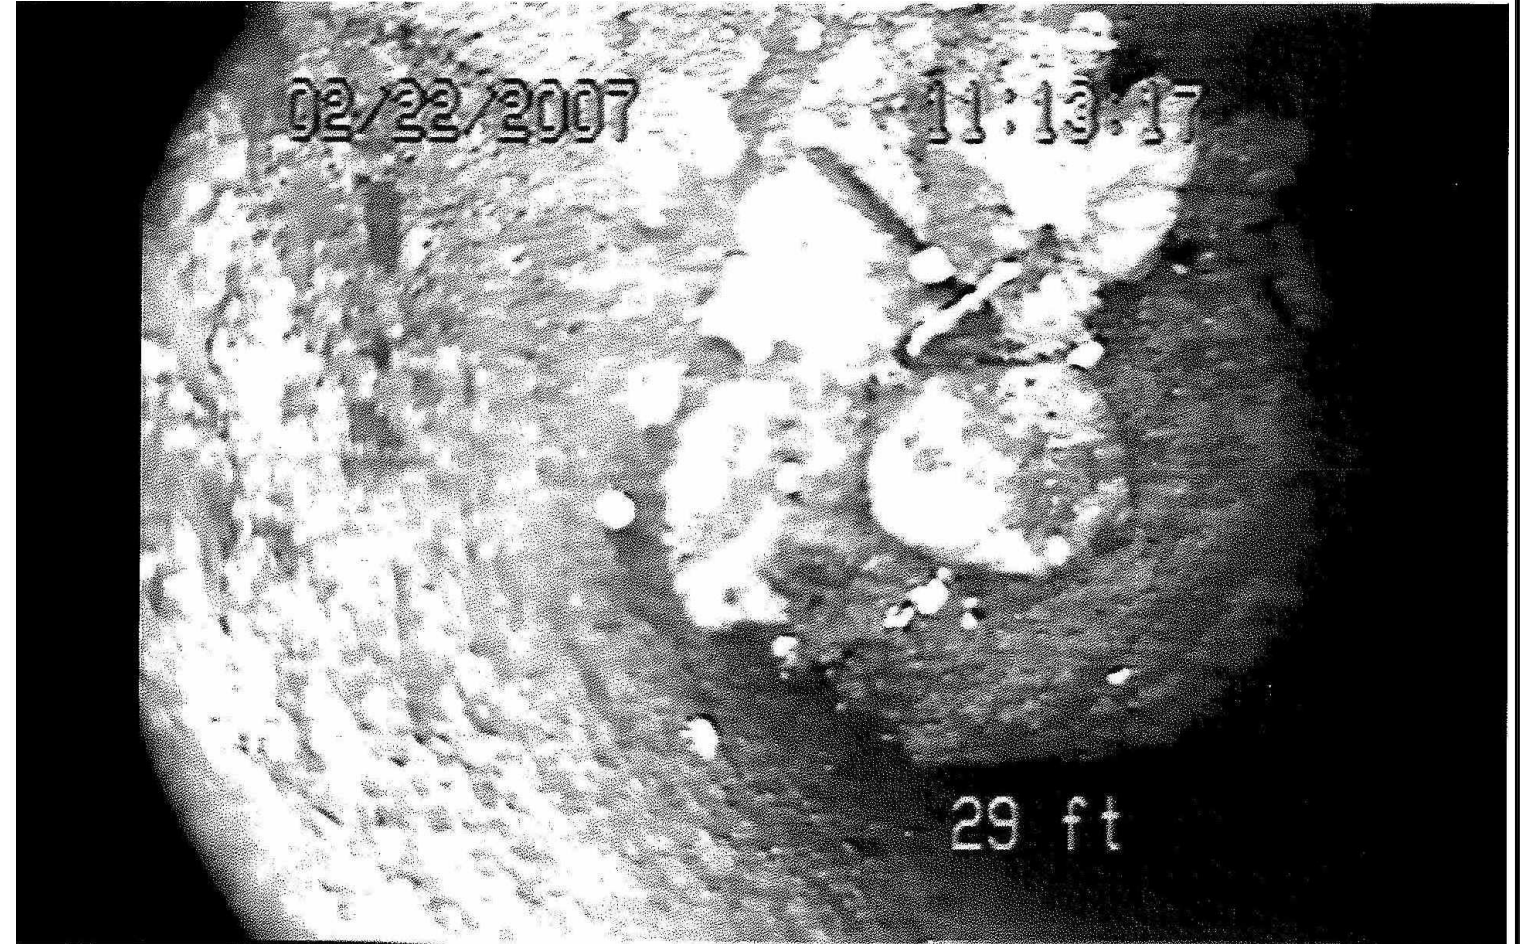
FIGURE  
11

**ABANDONED LINE SOUTH OF MH-AAM084**

A video survey was conducted from manhole AAM084 upstream to confirm that a historical connection to the site had been abandoned and capped off. This run is labeled Run 11 on Figure 8 and on Table 1. The video survey confirmed that this stormwater line is capped approximately 29 feet upstream of its junction with the COP stormwater line. A screen snapshot of the video survey showing the concrete cap is provided on Figure 11. The original video survey for this line was provided as an attachment to the Storm Water Sampling Plan (ARCADIS BBL 2007a). The line was observed to be dry, despite having heavy rain during the investigation. No flow or inline solids were observed in the line, and the nature of the cap confirmed that flow will not occur from this line in the future.

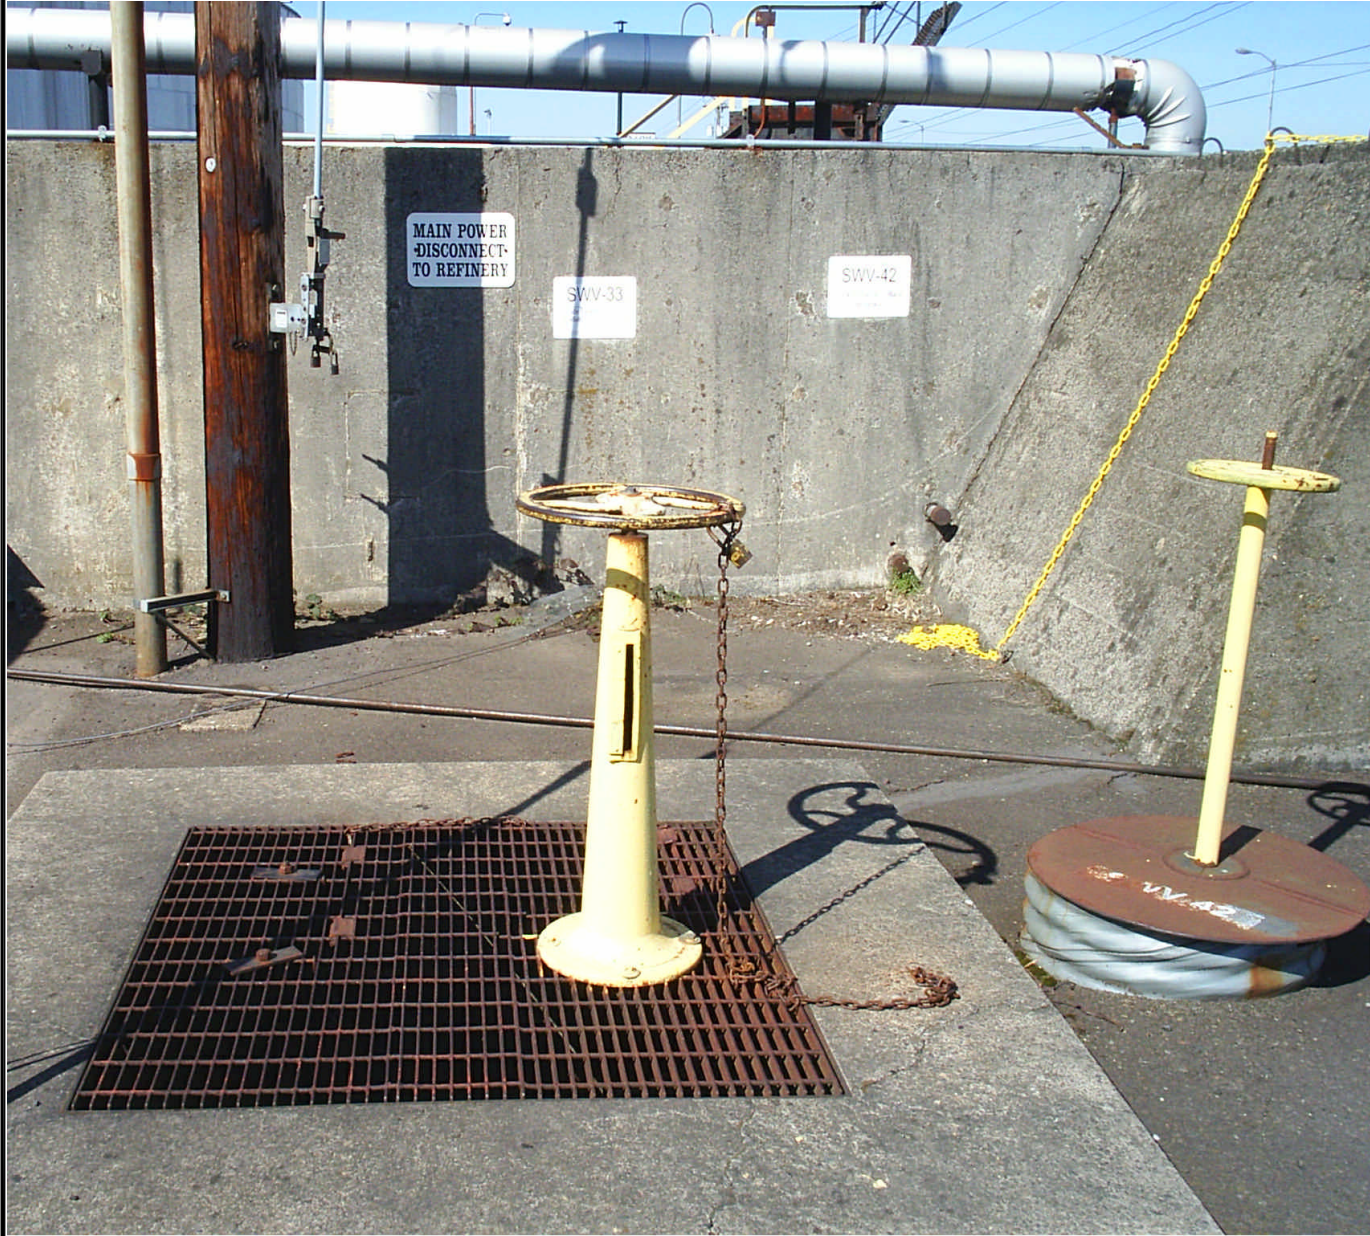
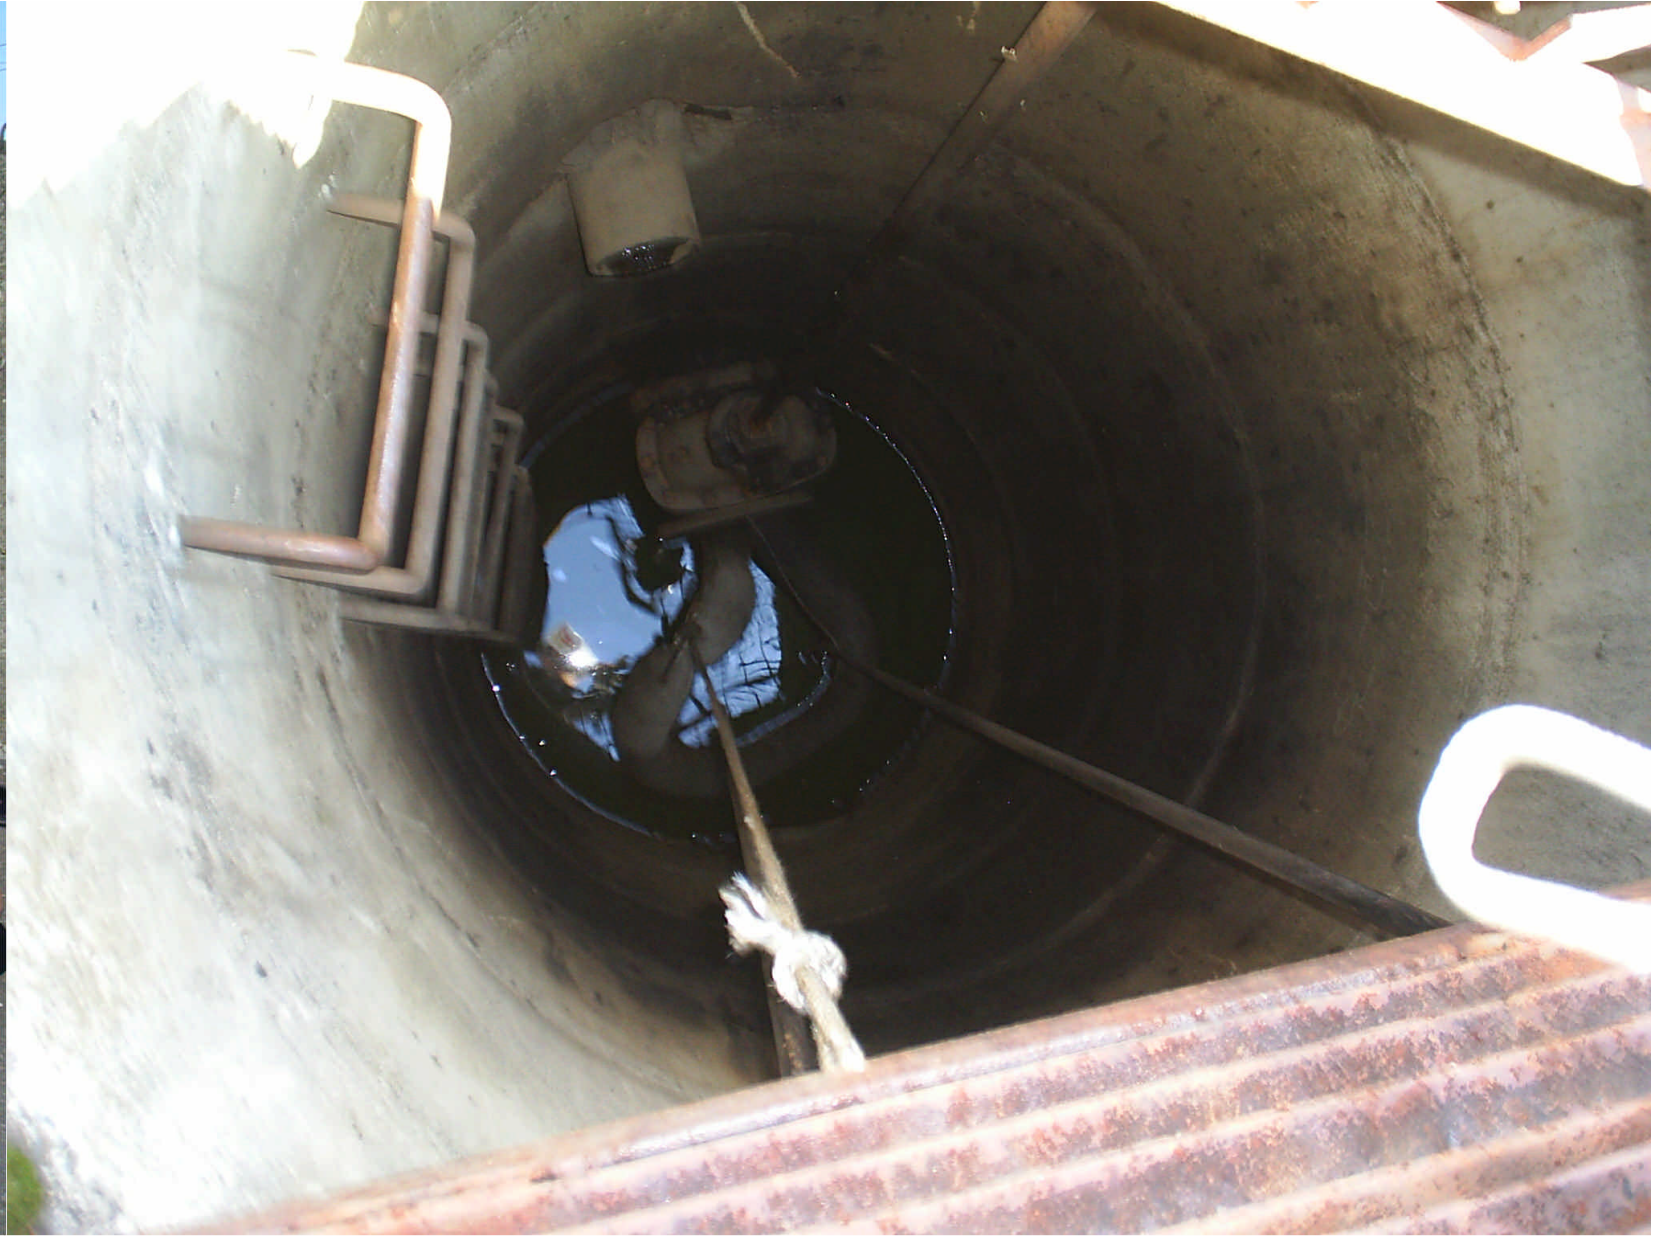
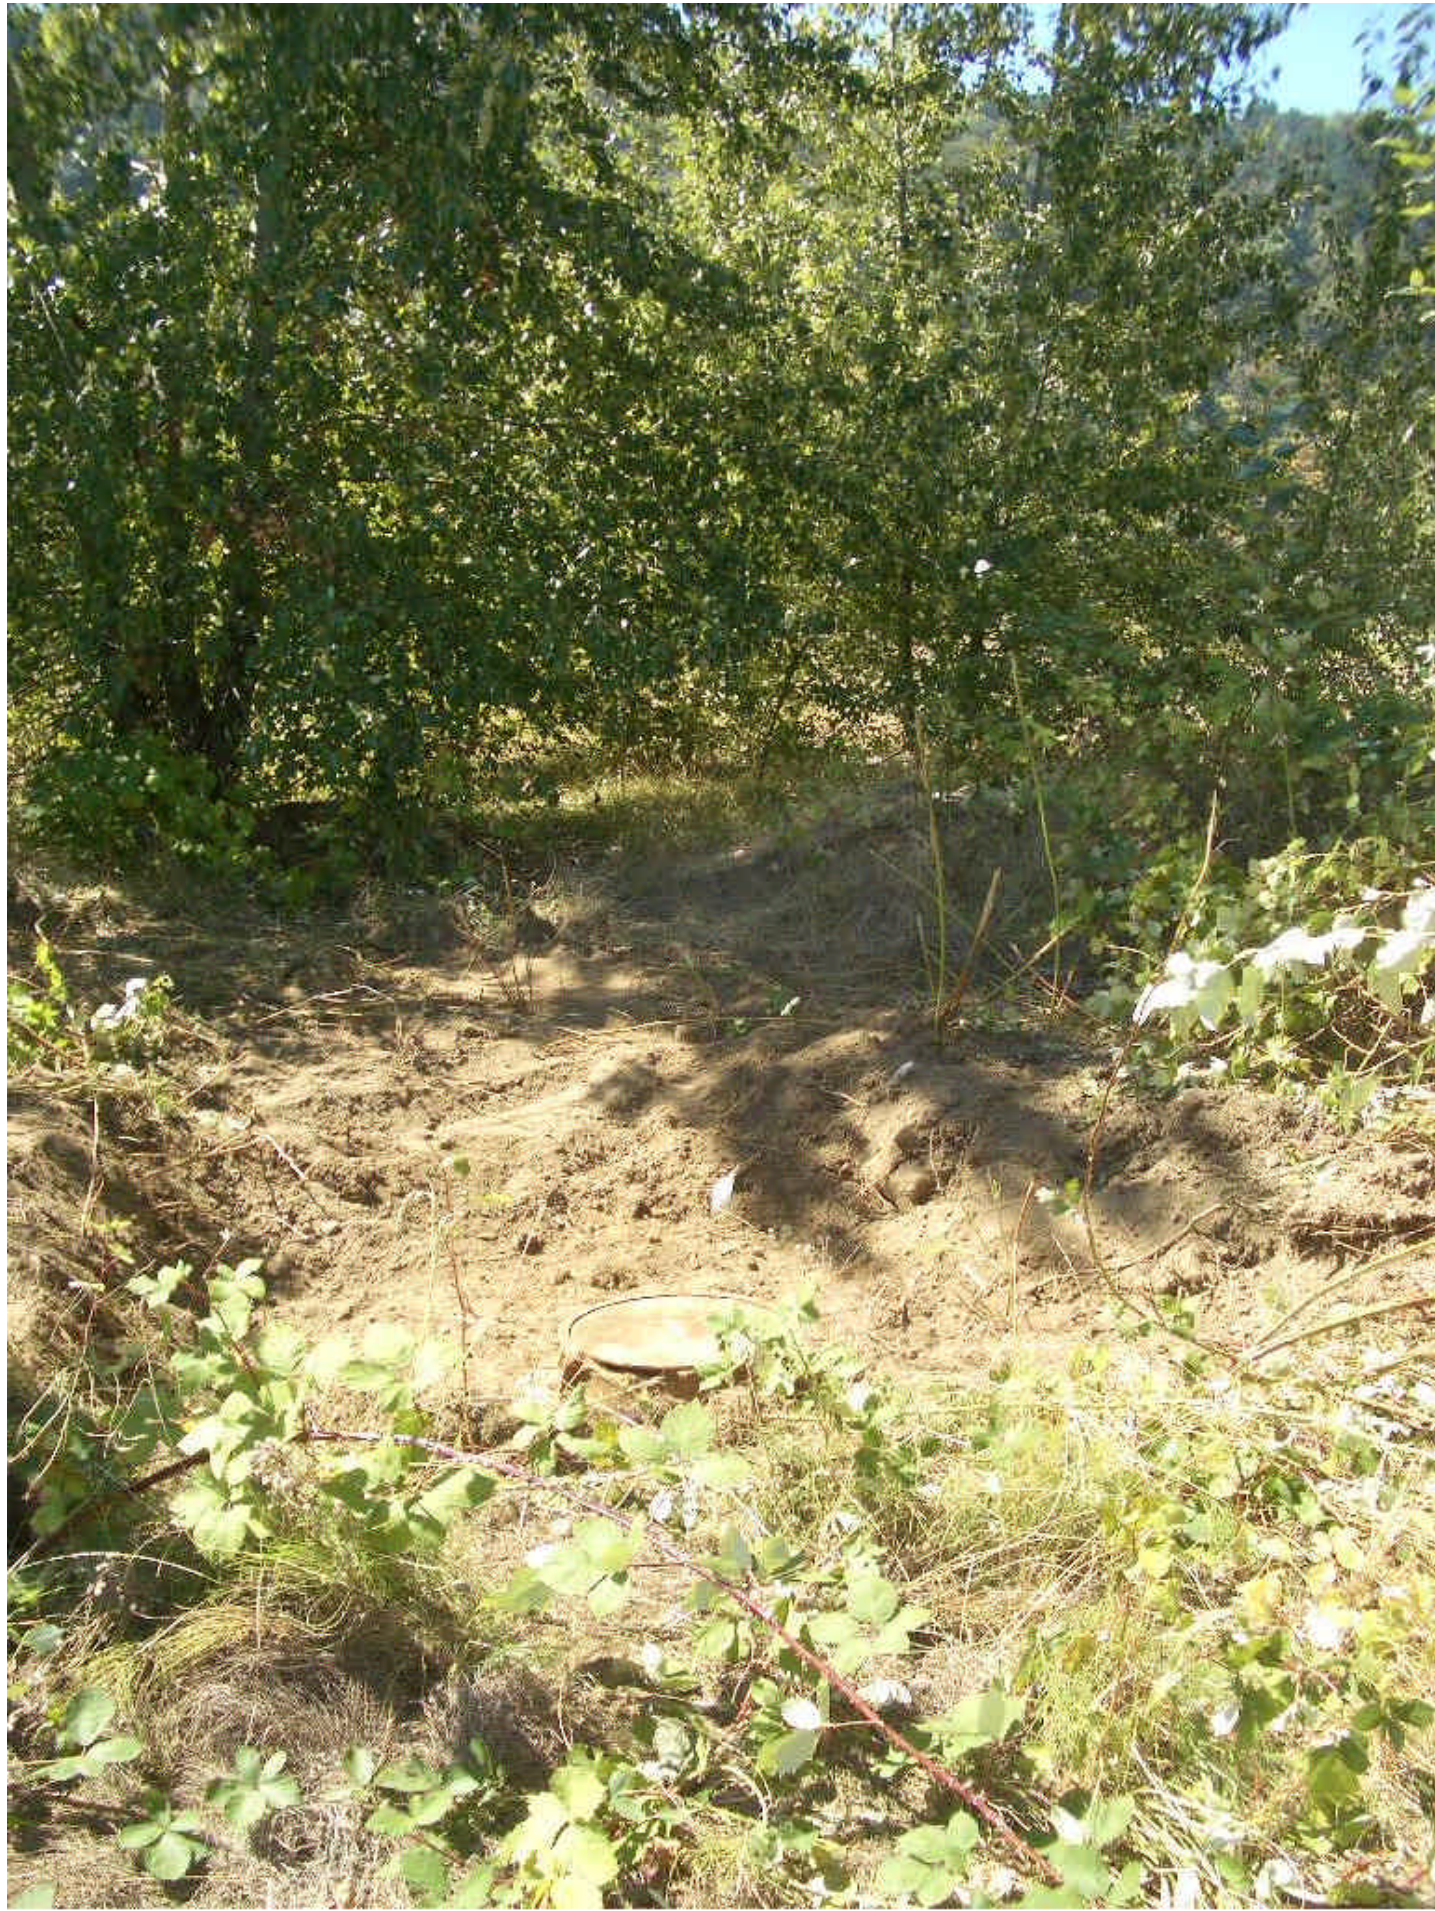
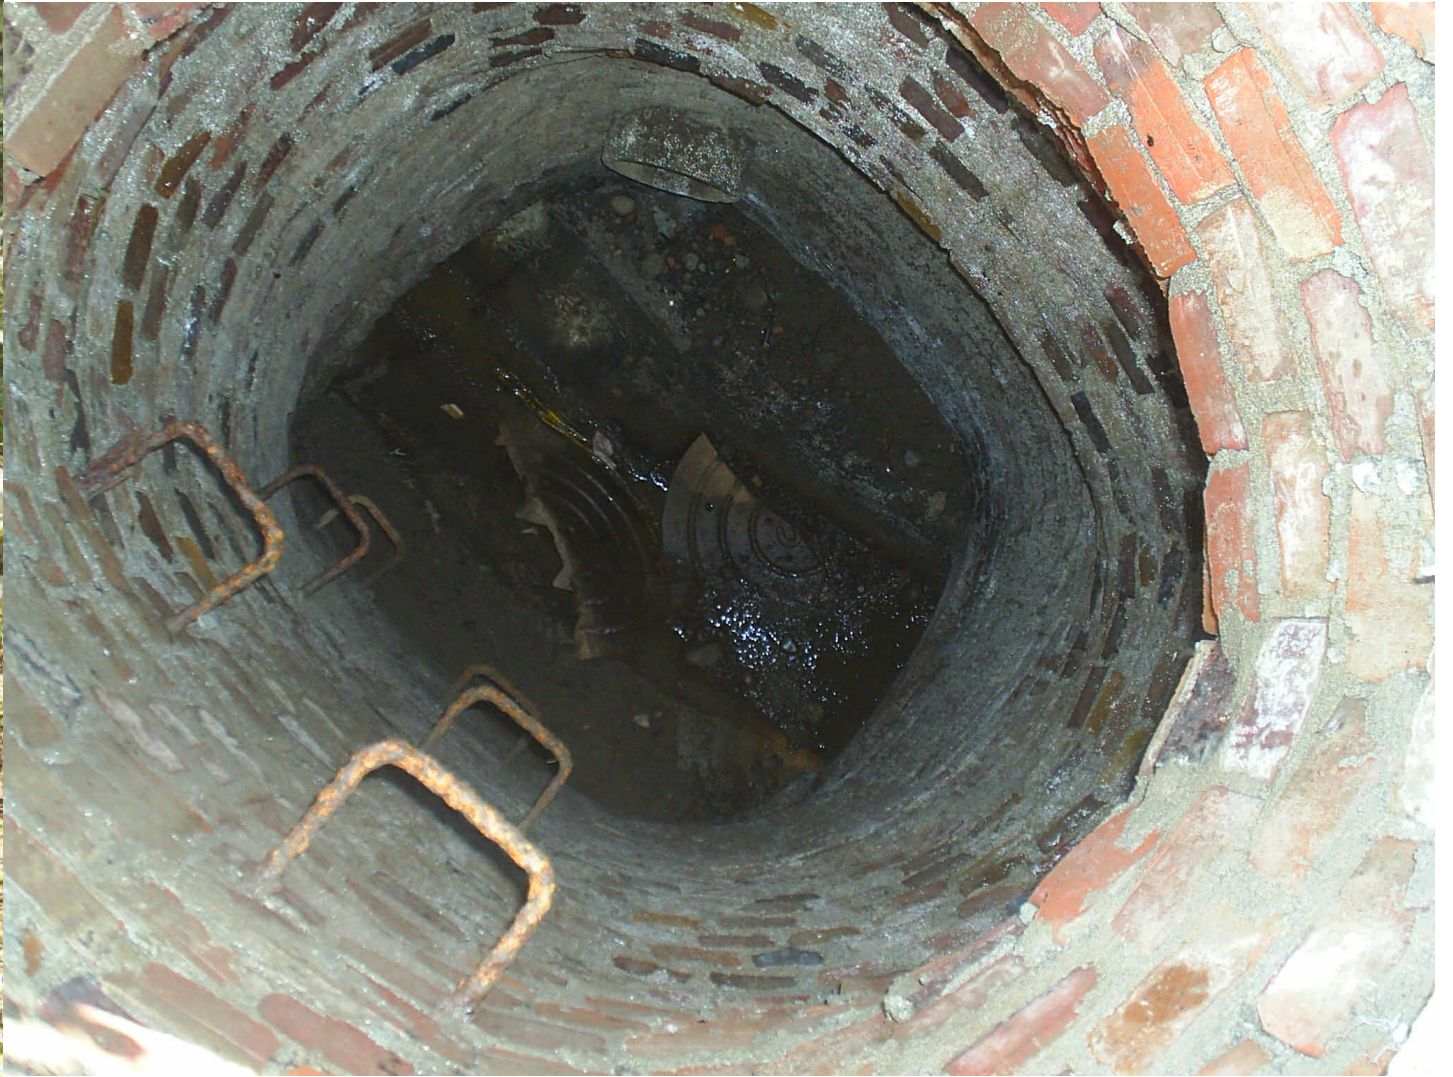
FIGURE  
**14**

**SAMPLE LOCATION AAP825/V39**

Four sampling events were conducted under the JSCS source control evaluation. Samples were collected from the stormwater valve at Outfall V33 and at manhole AAP825 downstream of the stormwater valve at Outfall V39 during each event. Stormwater manhole AND864 was also checked by sampling personnel during each sampling event to observe active stormwater flow in the line. Stormwater flow was not observed at that location during any of the four events. Photos of the stormwater sampling locations are provided on Figures 13, 14 and 15. Catch basin and storm line cleanouts were completed prior to stormwater sampling; therefore, the stormwater data is representative of the post-cleanout condition of the lines.

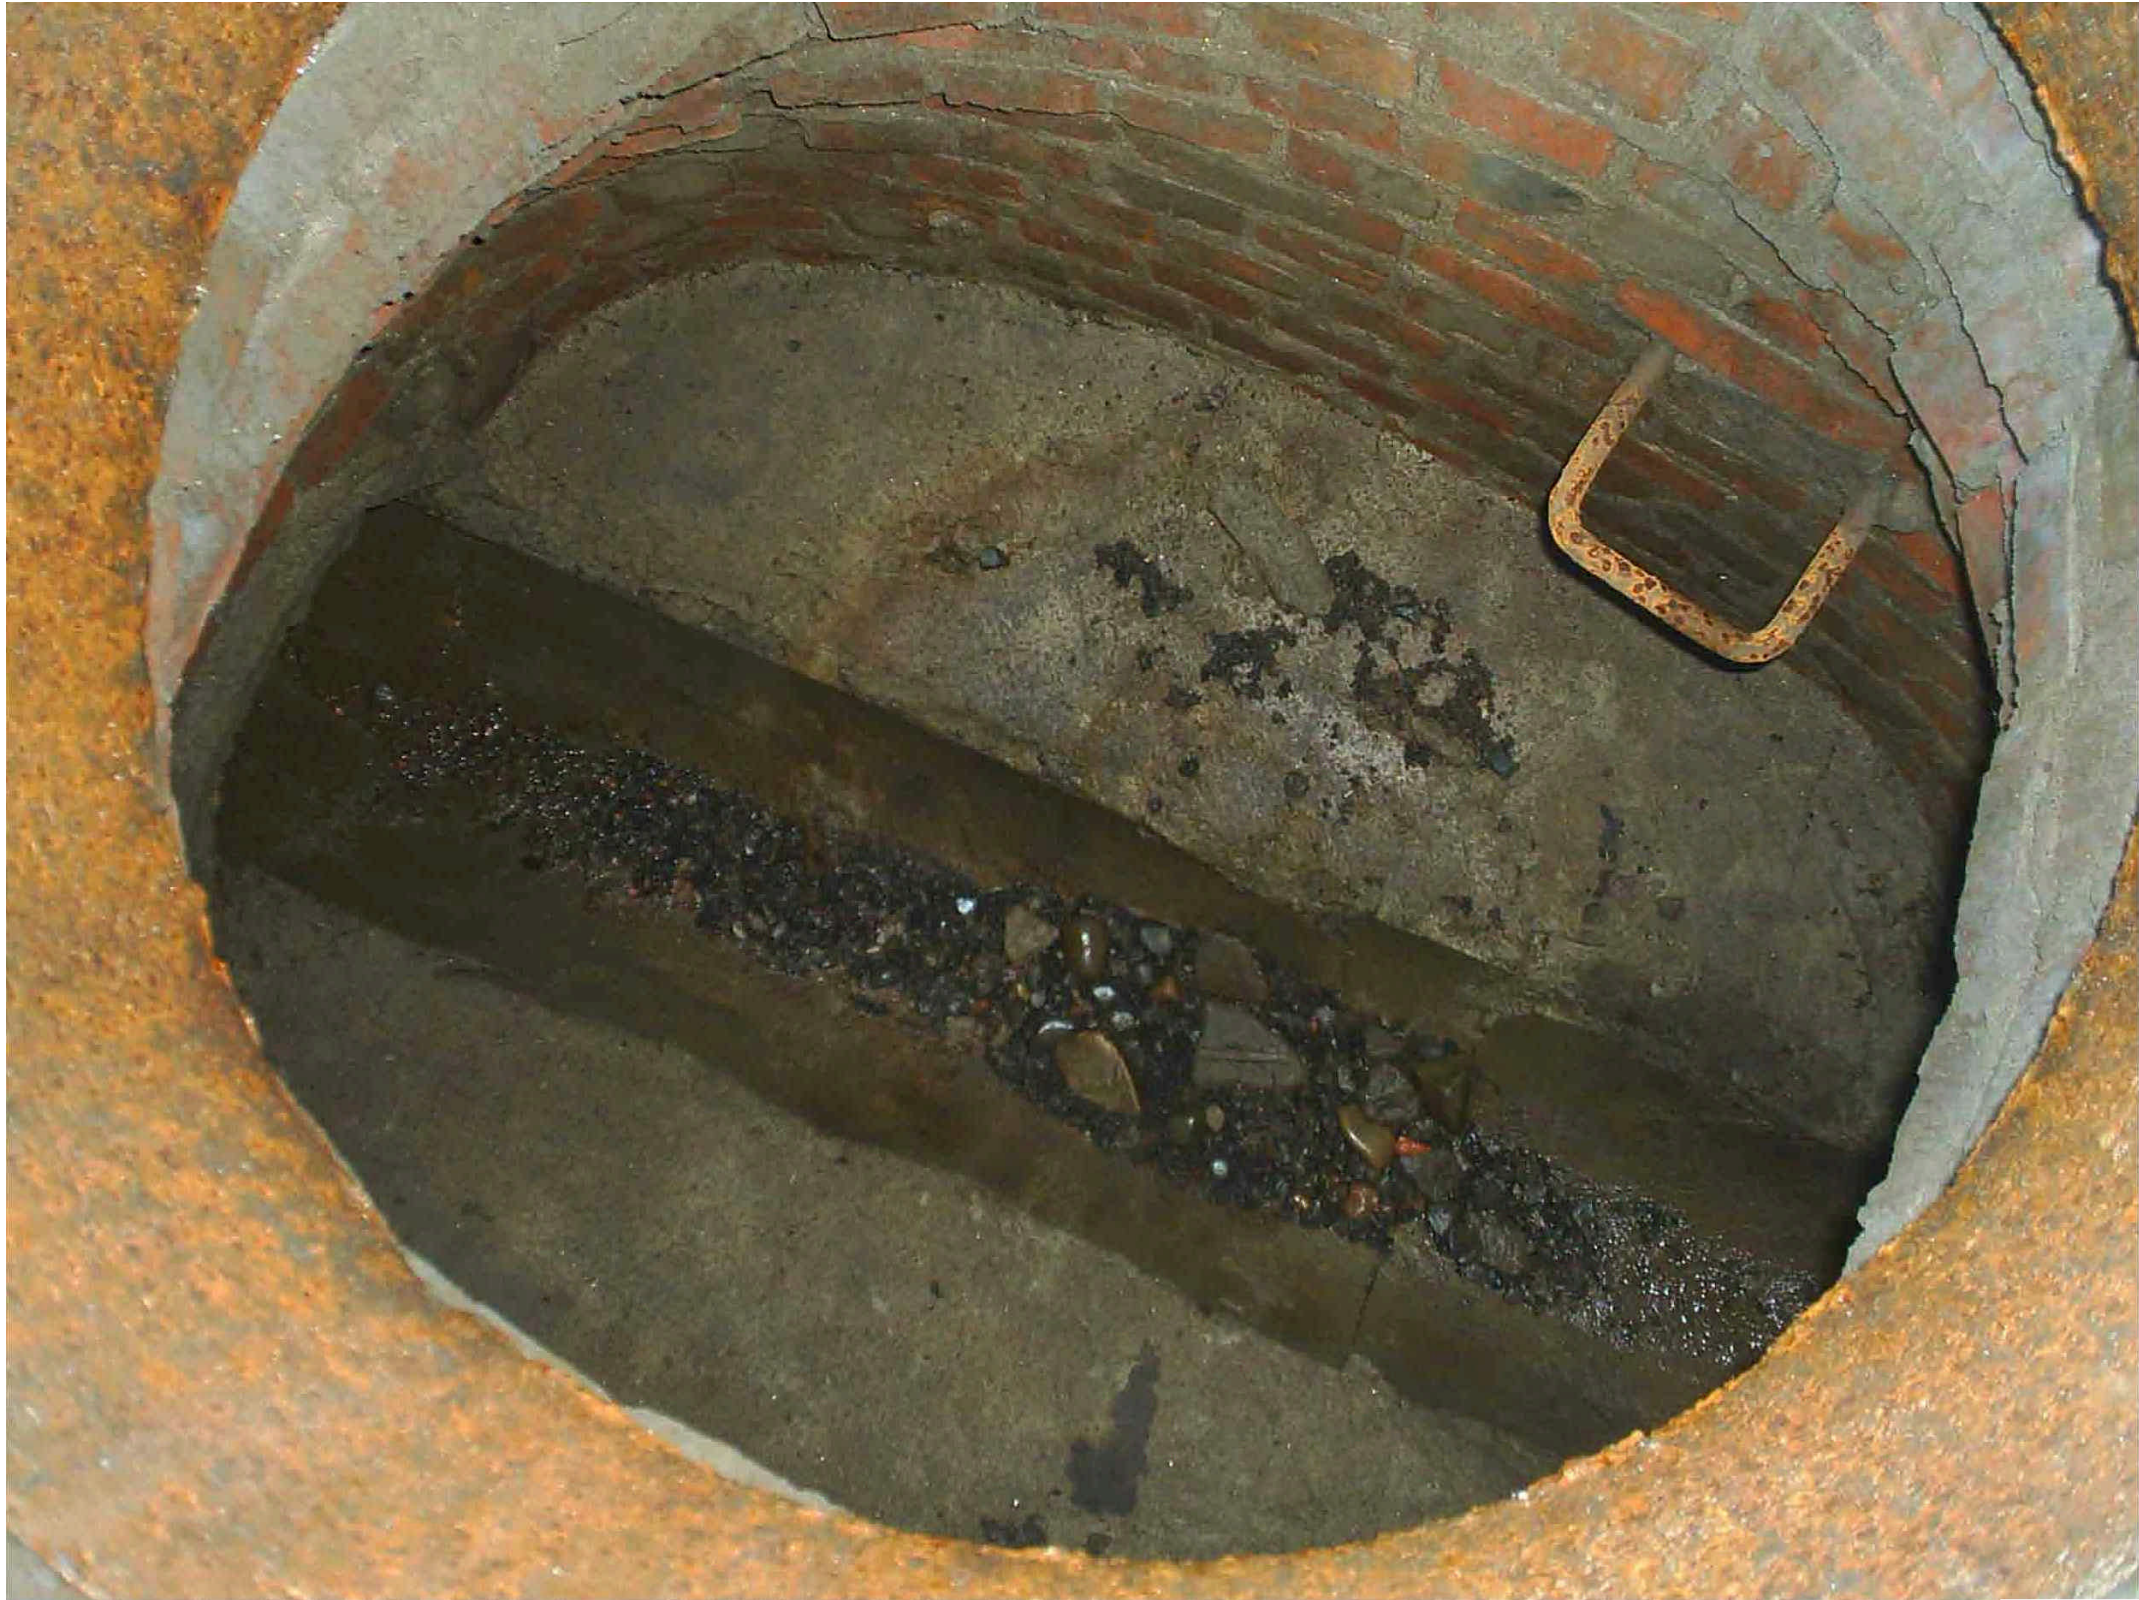
FIGURE  
**15**

**SAMPLE LOCATION AND864/AREA 5**
