**ADDENDUM 1  
METHANE MONITORING AND CONTINGENCY PLAN**

Former Durham Pit Landfill – North  
SW 72<sup>nd</sup> Avenue, SW Upper Boones Ferry Road, and SW Durham Road  
Tigard, Oregon  
ECSI No. 3870

For  
Washington County Facilities Management and PacTrust Realty, Inc.  
May 28, 2021

Project: WashCoLUT-3-04-04

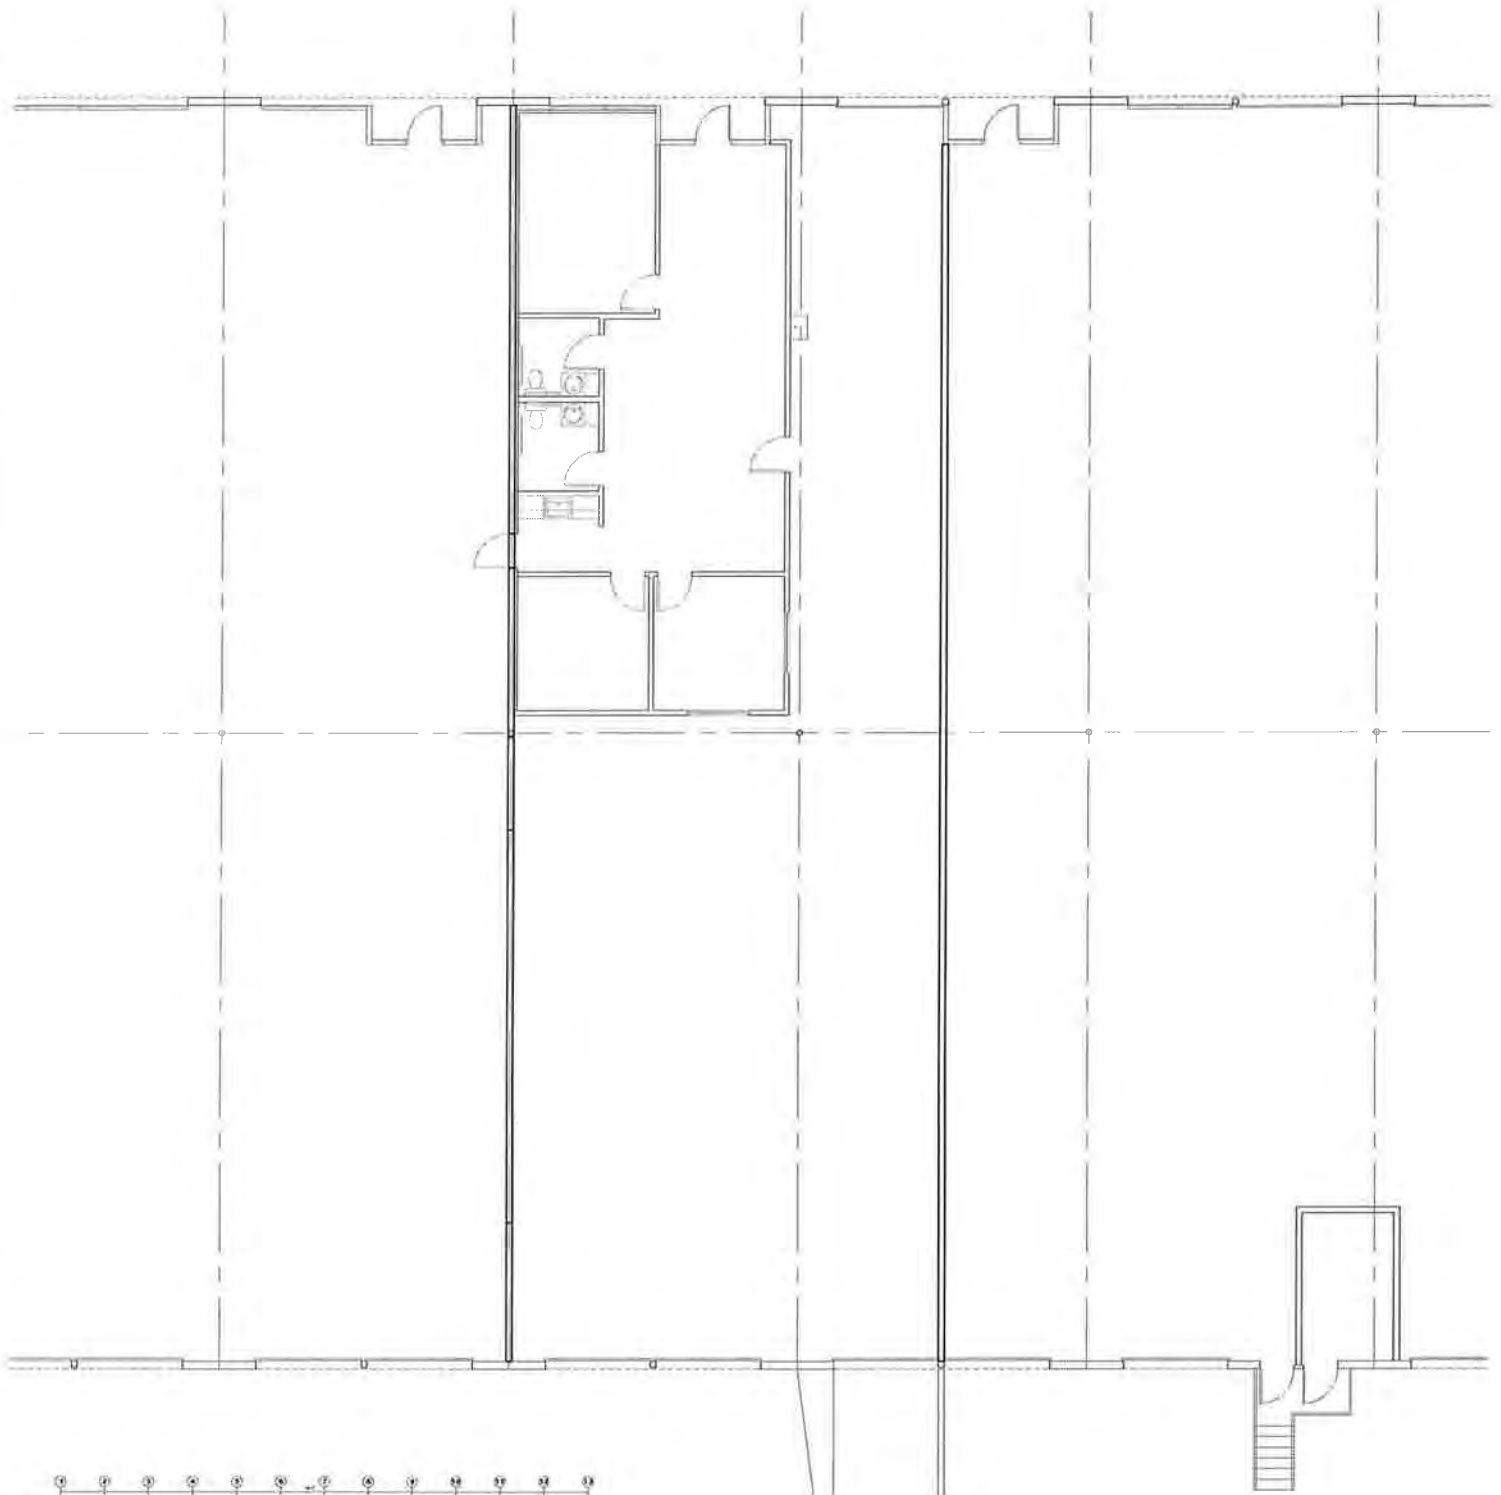
## ECONOLITE CONTROL PRODUCTS, INC.

Unventilated Occupiable Space	Location I.D. (see attached site plan)	Notes

1,220 SF Office

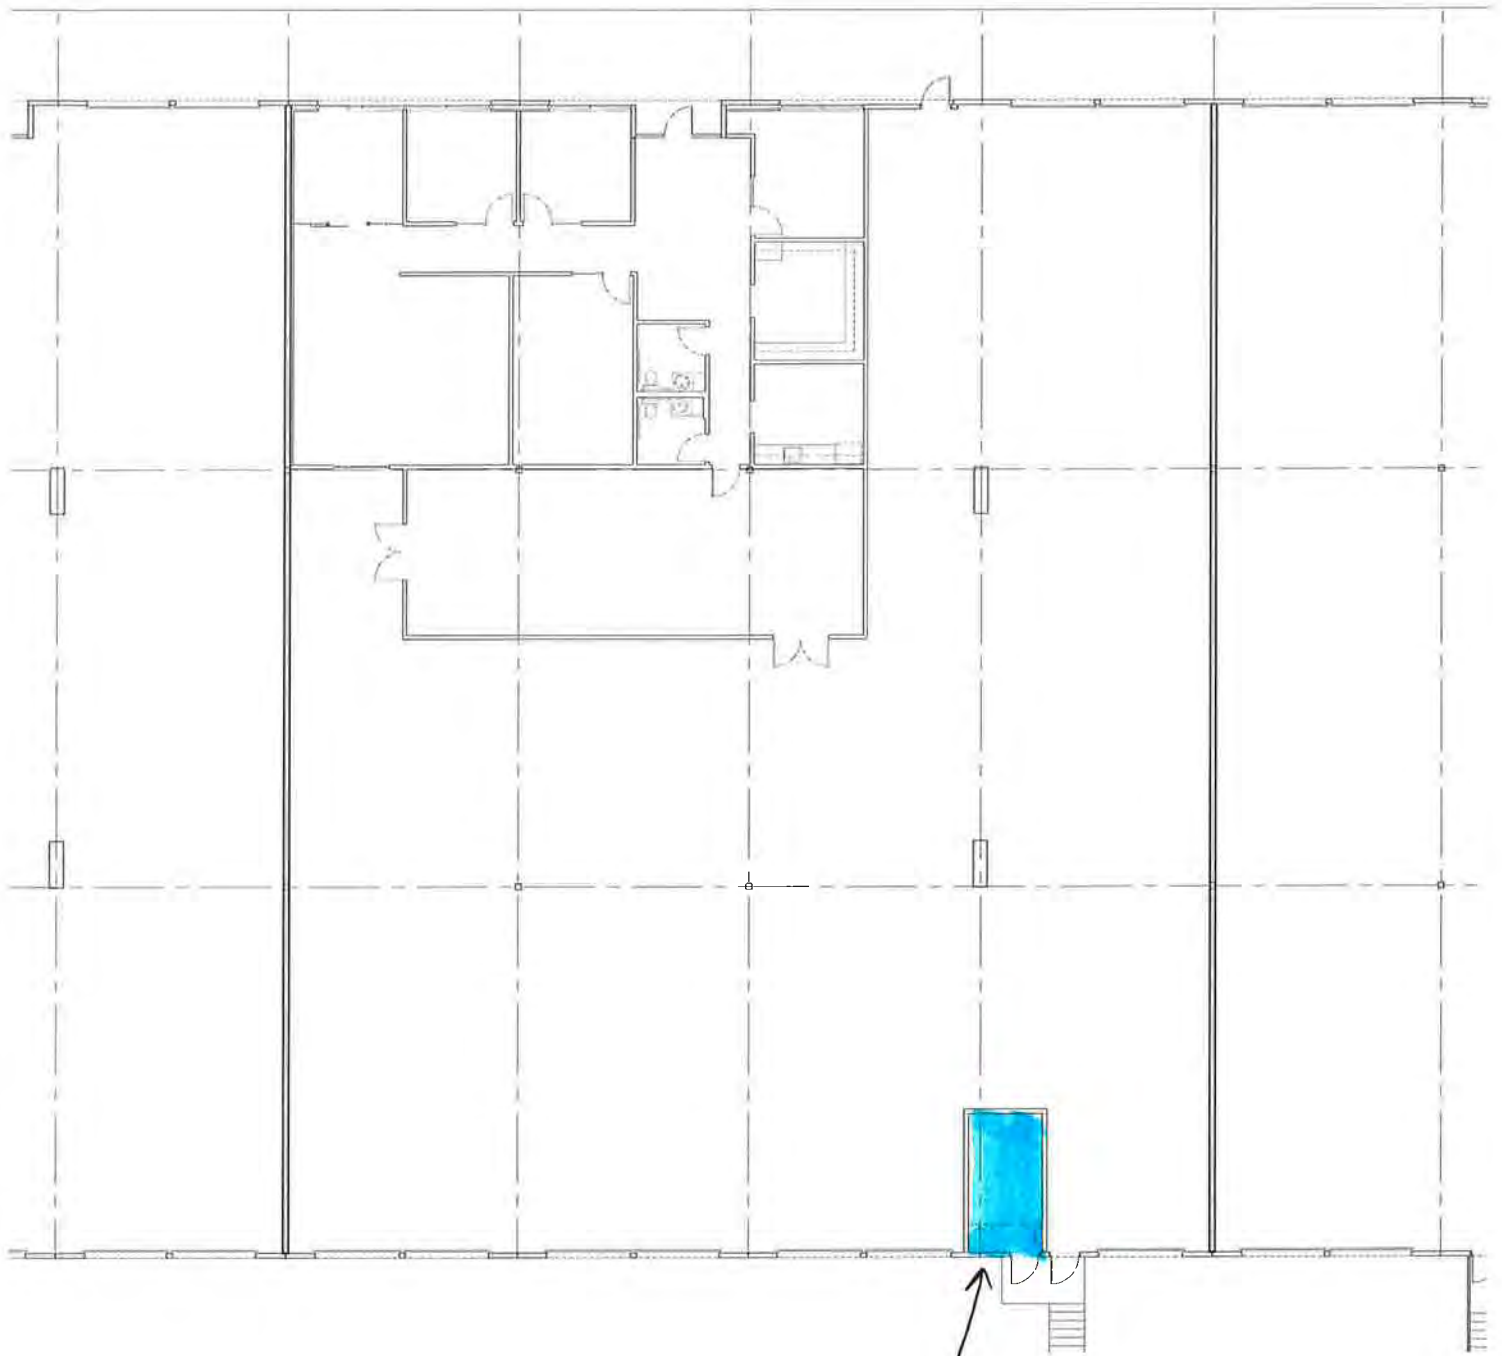
BUILDING ELECTRICAL  
Room

<i>Unventilated Occupiable Space</i>	<i>Location I.D. (see attached site plan)</i>	<i>Notes</i>
BUILDING ELECTRICAL ROOM	SOUTH-HIGHLIGHTED	STANDARD DOOR GRILLE AND ROOF VENT
