# CONTAMINATED MEDIA MANAGEMENT PLAN

## FORMER ESCO PLANT #1

**Point Source Solutions Project No: OR180913-6B**

**September 12, 2019**

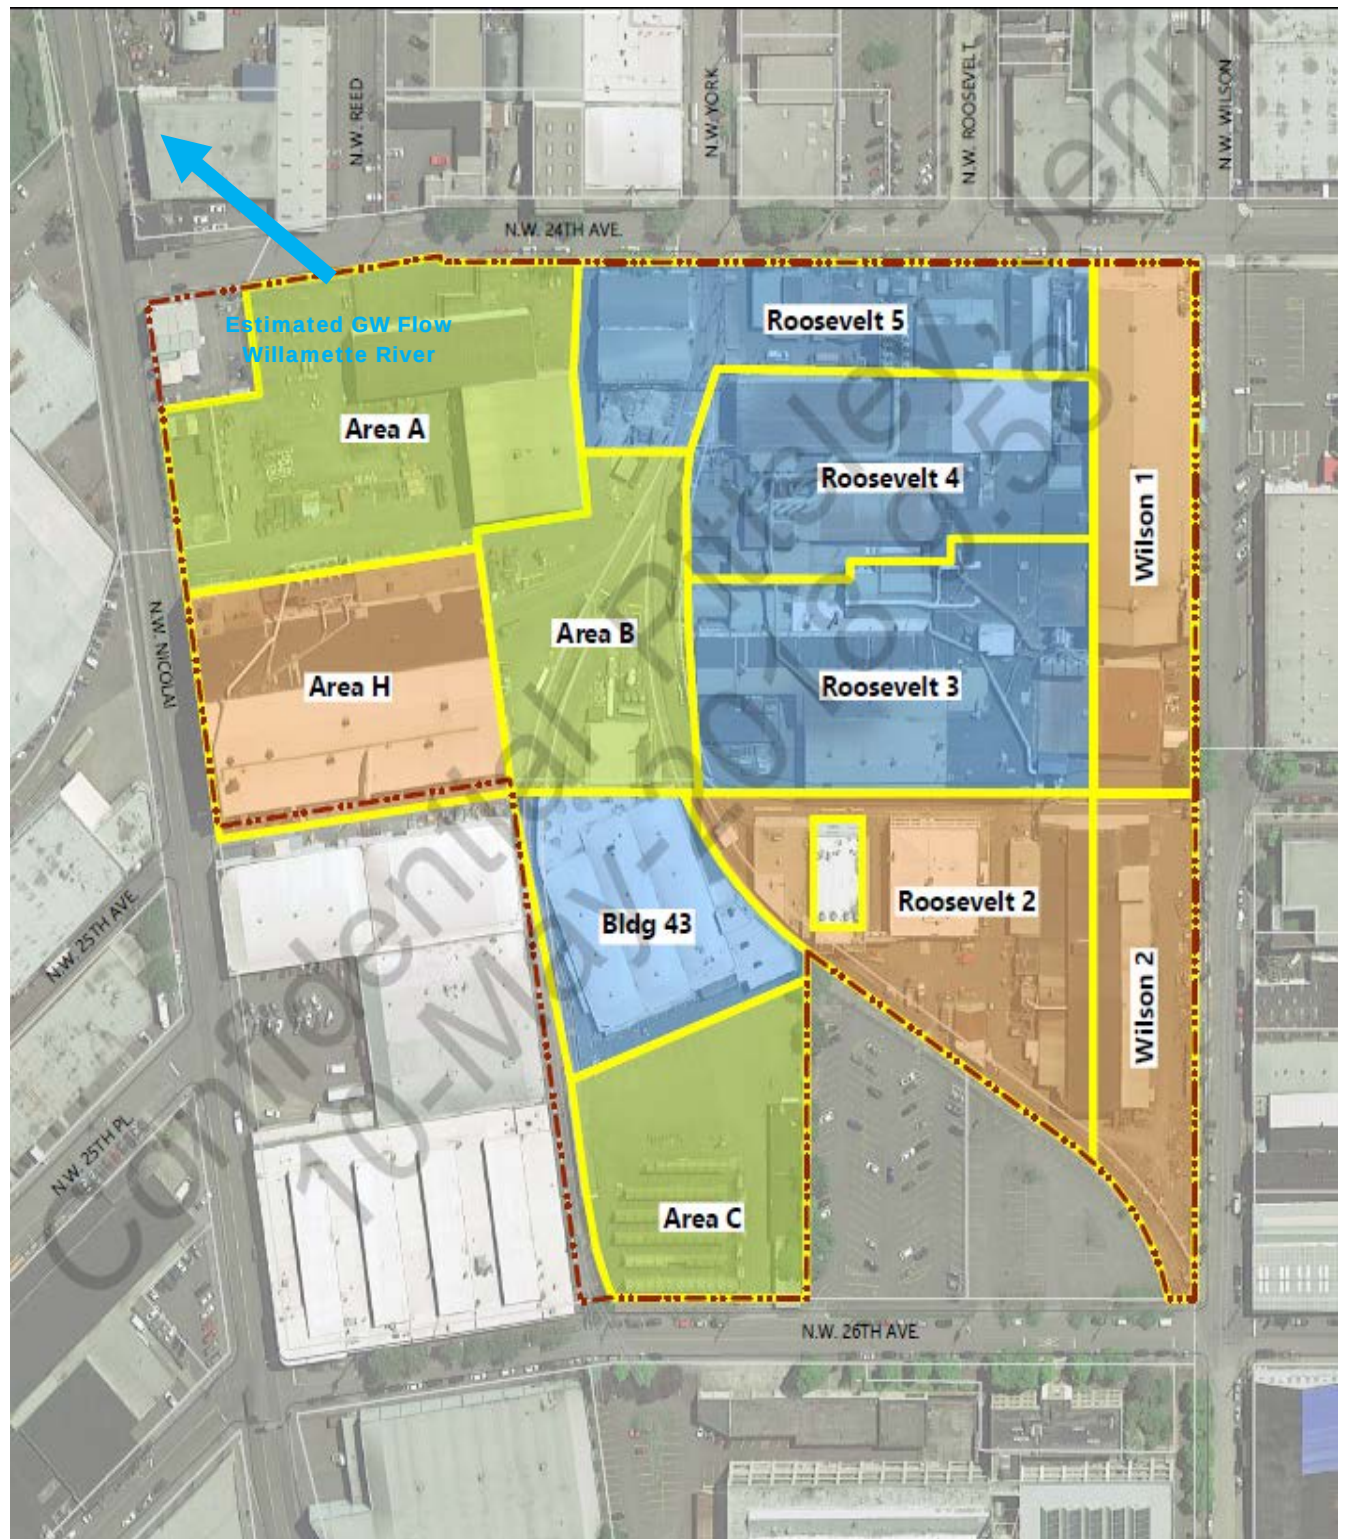
**FIGURE 3 - SITE PLAN**

The Site has been divided into distinct areas for site characterization activities. These specific management areas are depicted on Figure 3.

A Site Location Map is included as Figure 1; a Topographic Map is included as Figure 2; and a Site Plan is included as Figure 3.
