RE: 2024 Annual Cap Inspection  
Starlight (formerly Westwind) Apartments, 355 NW 6<sup>th</sup> Avenue, Portland, Oregon  
(ECSI 6492/5315)

# PHOTOGRAPHIC LOG

Starlight (Formerly Westwind) Apartments  
355 NW 6<sup>th</sup> Avenue  
Portland, Oregon

Project No.  
1017-21002-05

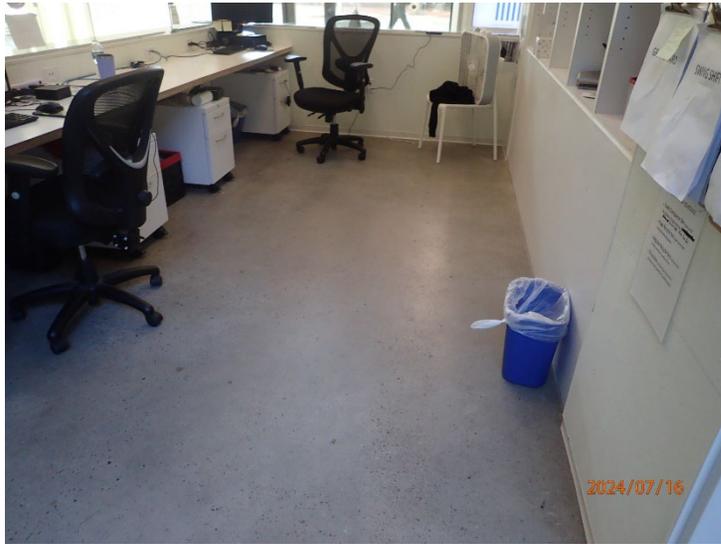
View of concrete floor within the front desk area. The condition of the concrete floor in this area is typical of resident and employee areas of the ground floor and is in good condition.

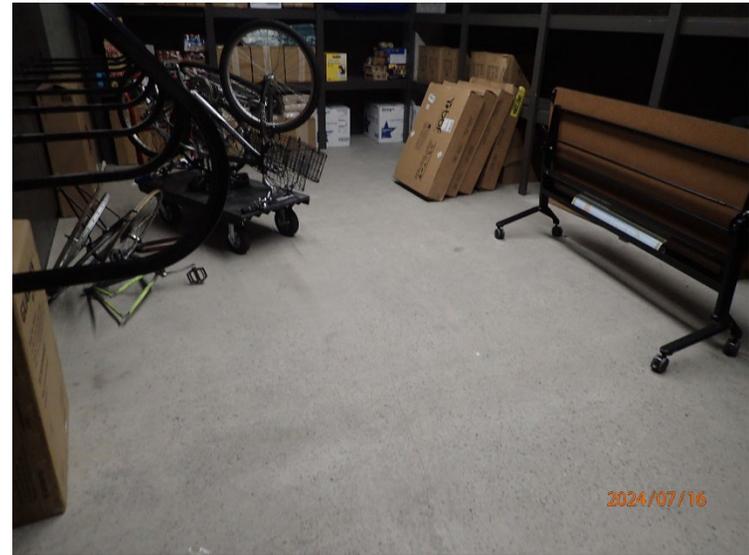
View of concrete floor within the employee bike and storage room. The condition of the concrete floor in this area is typical of utility rooms on the ground floor and is in good condition.

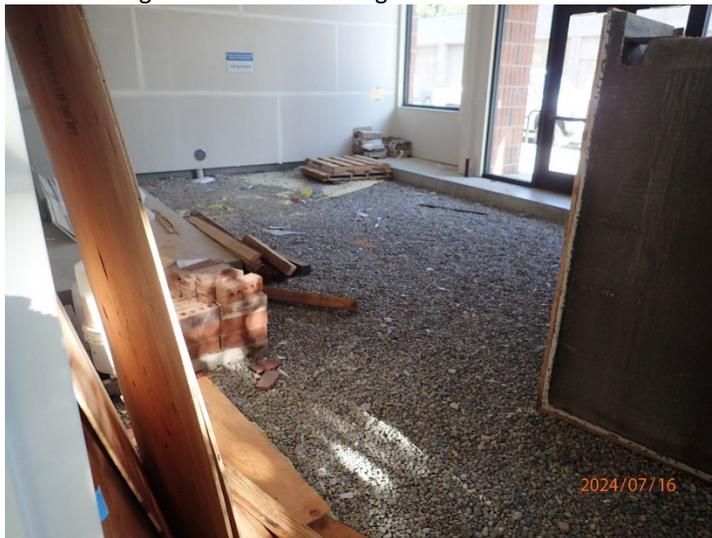
The floor of the unoccupied tenant space remains unfinished. However, the space is unused and base gravel covers the demarcation fabric preventing contact with underlying soils.

Commercial tenant space remains unoccupied and portions of the floor are unfinished. However, demarcation fabric is overlain by concrete and/or gravel in all areas.

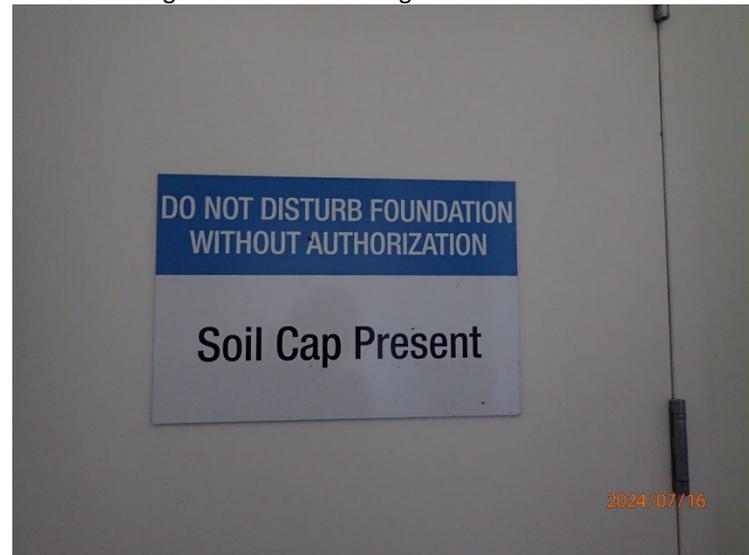
Signage posted warning of soil cap. Several signs are located throughout the ground floor.
