# MONITORING WELL ABANDONMENT REPORT

## MONITORING WELLS MW01 THROUGH MW05

### Former Meyers Container Site

10103 NE Marx Street  
Portland, Oregon

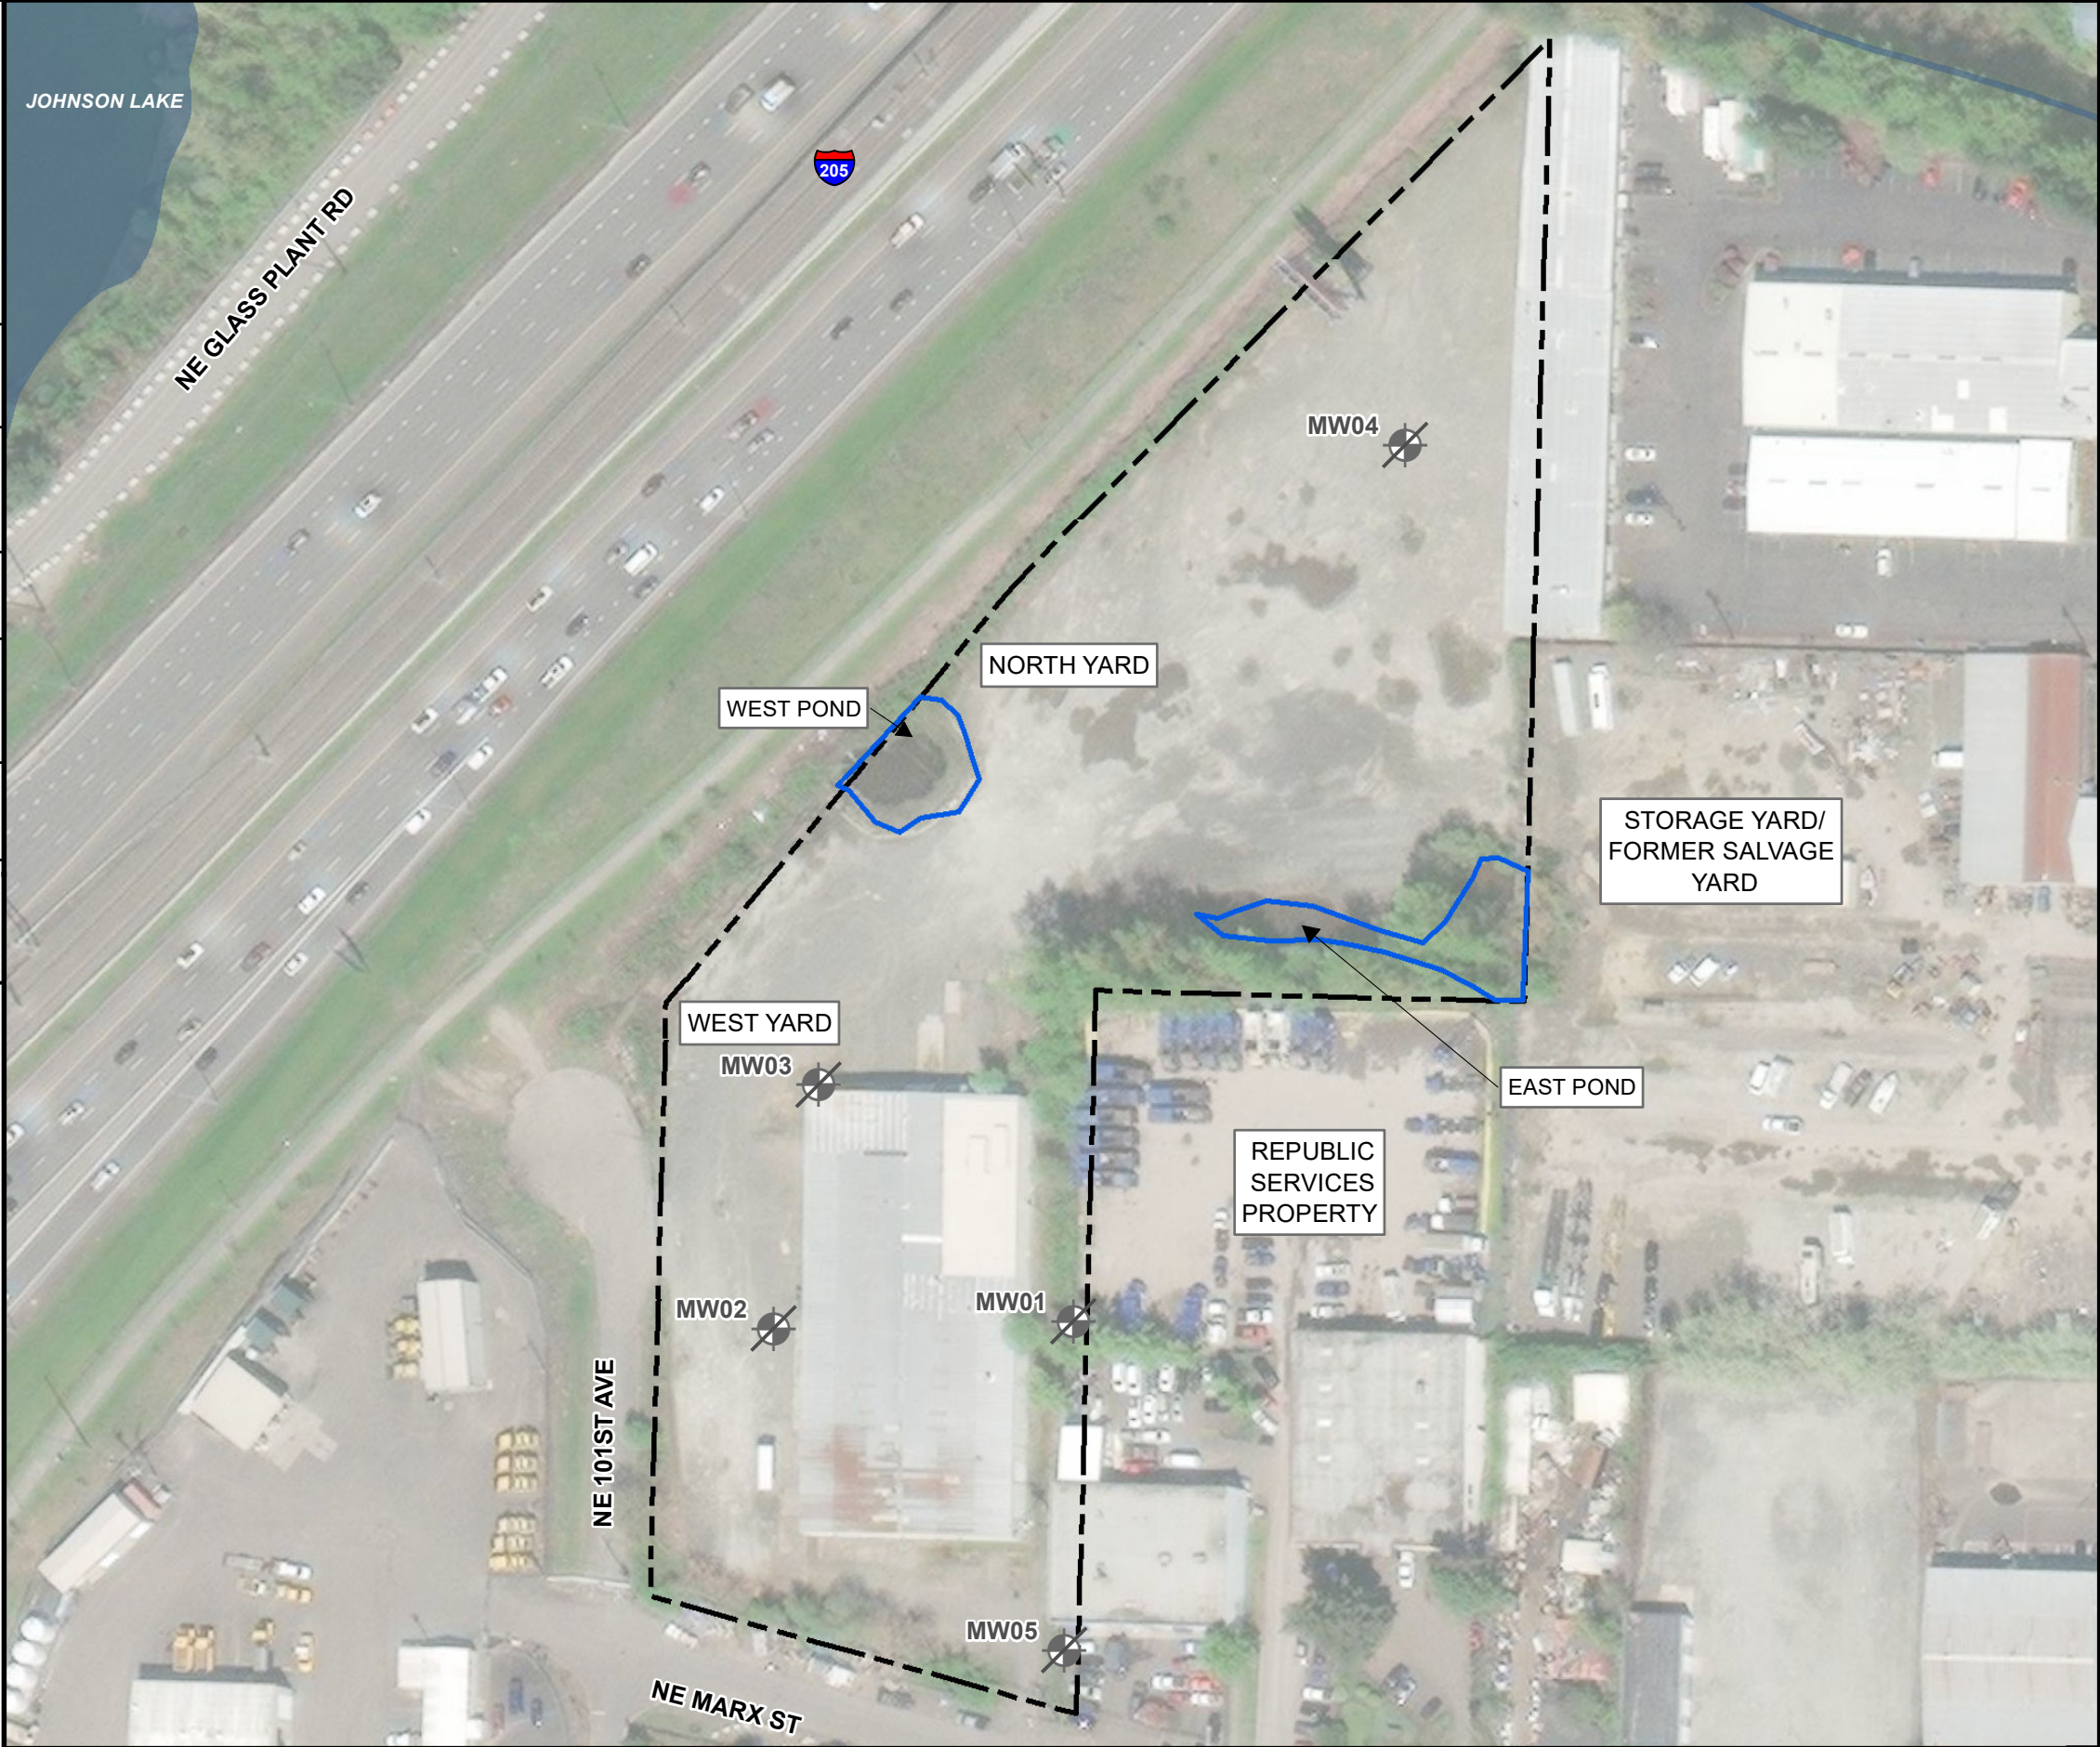
FIGURE 3

ABANDONED MONITORING WELL LOCATION

ABANDONED MONITORING WELL  
LOCATION DIAGRAM

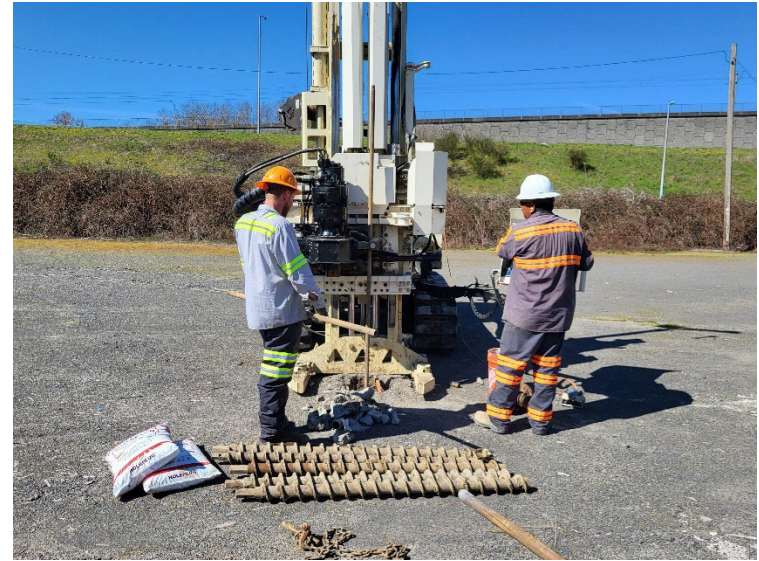
View of MW04 during over-drilling with auger tooling. Cuttings were contained in drums for appropriate disposal.

- The well was over-drilled to total depth using hollow-stem auger tooling sized to the diameter of the original boring. The filter pack and seals were recovered during the over-drilling process. Recovered well cuttings/materials were placed into Oregon Department of Transportation (ODOT)-approved drums pending disposal.

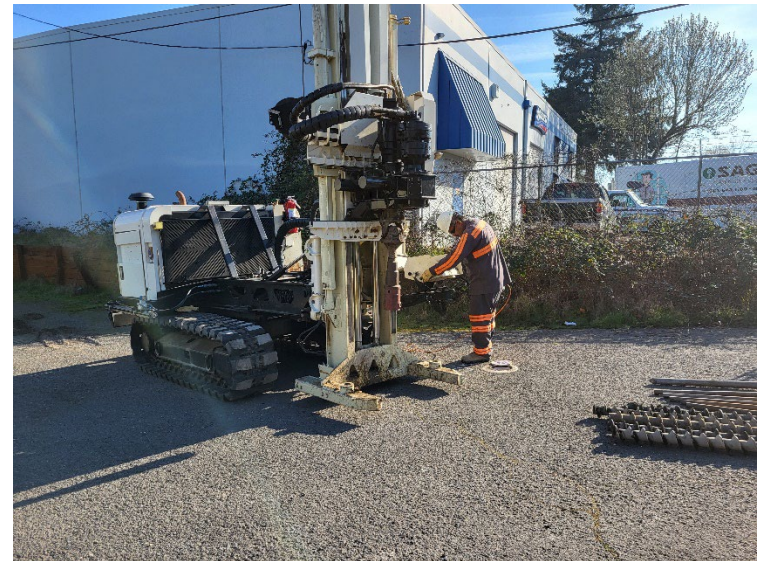
View of MW05 as the monument and casing / screen were removed.

- The flush-mount concrete collars and well monuments were removed using the percussive hammer and cabled crane on the drill rig. All resulting metal and concrete debris was removed from the site by Cascade.

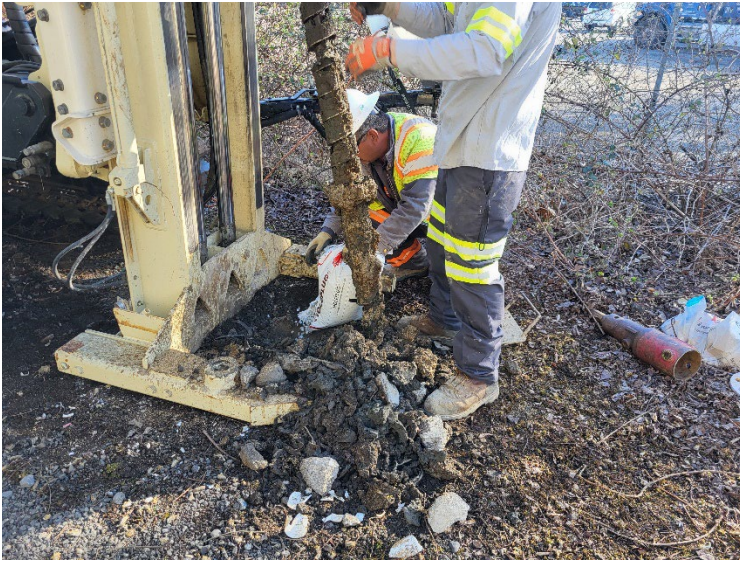
View of the sand pack and bentonite seal material caught on the auger flight while over drilling MW01.

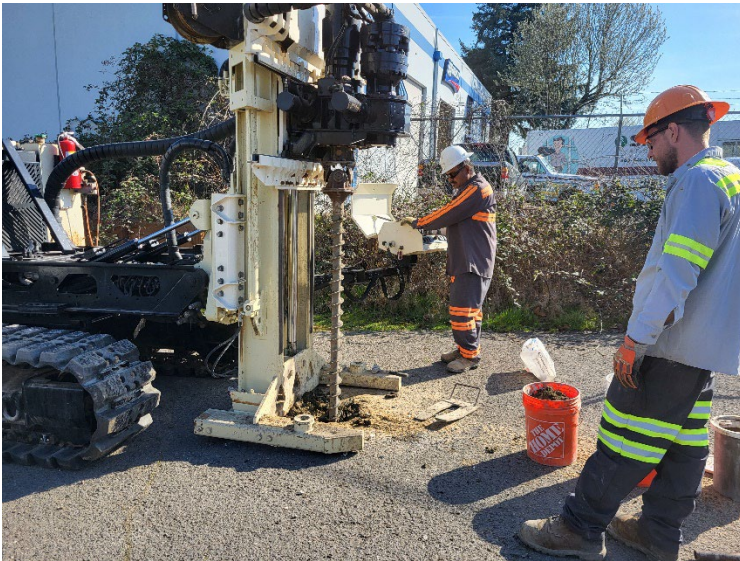
View of MW05 during over-drilling with auger tooling.

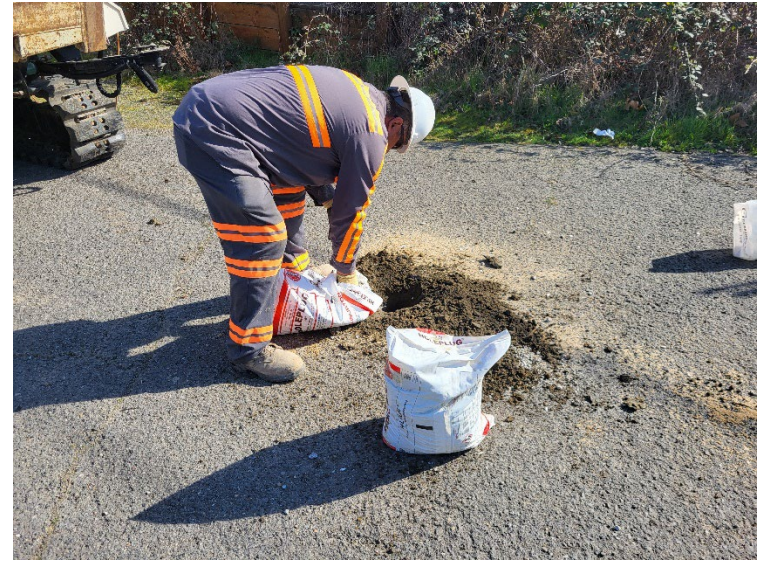
After over-drilling to total depth, all wells were abandoned using bentonite chips. View of MW05.

- Since wells were less than 50 feet deep and contained less than 25 feet of water column, Cascade backfilled each well with HolePlug® bentonite chips.

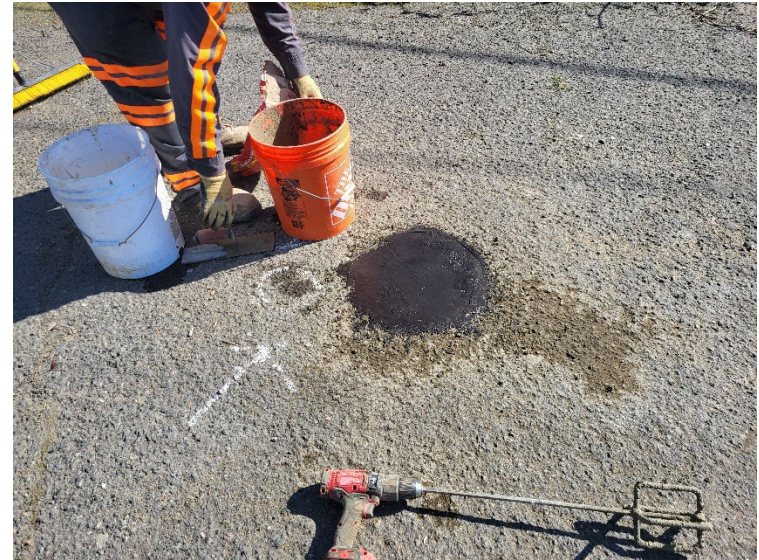
A concrete cap was installed over the bentonite chips at each well location.

- After backfilling, an approximate one (1)-foot plug or cap of Quikrete® cement was placed on top of the well bore. Onsite crushed rock / gravel was raked over the top of each abandoned well location to match surrounding areas.

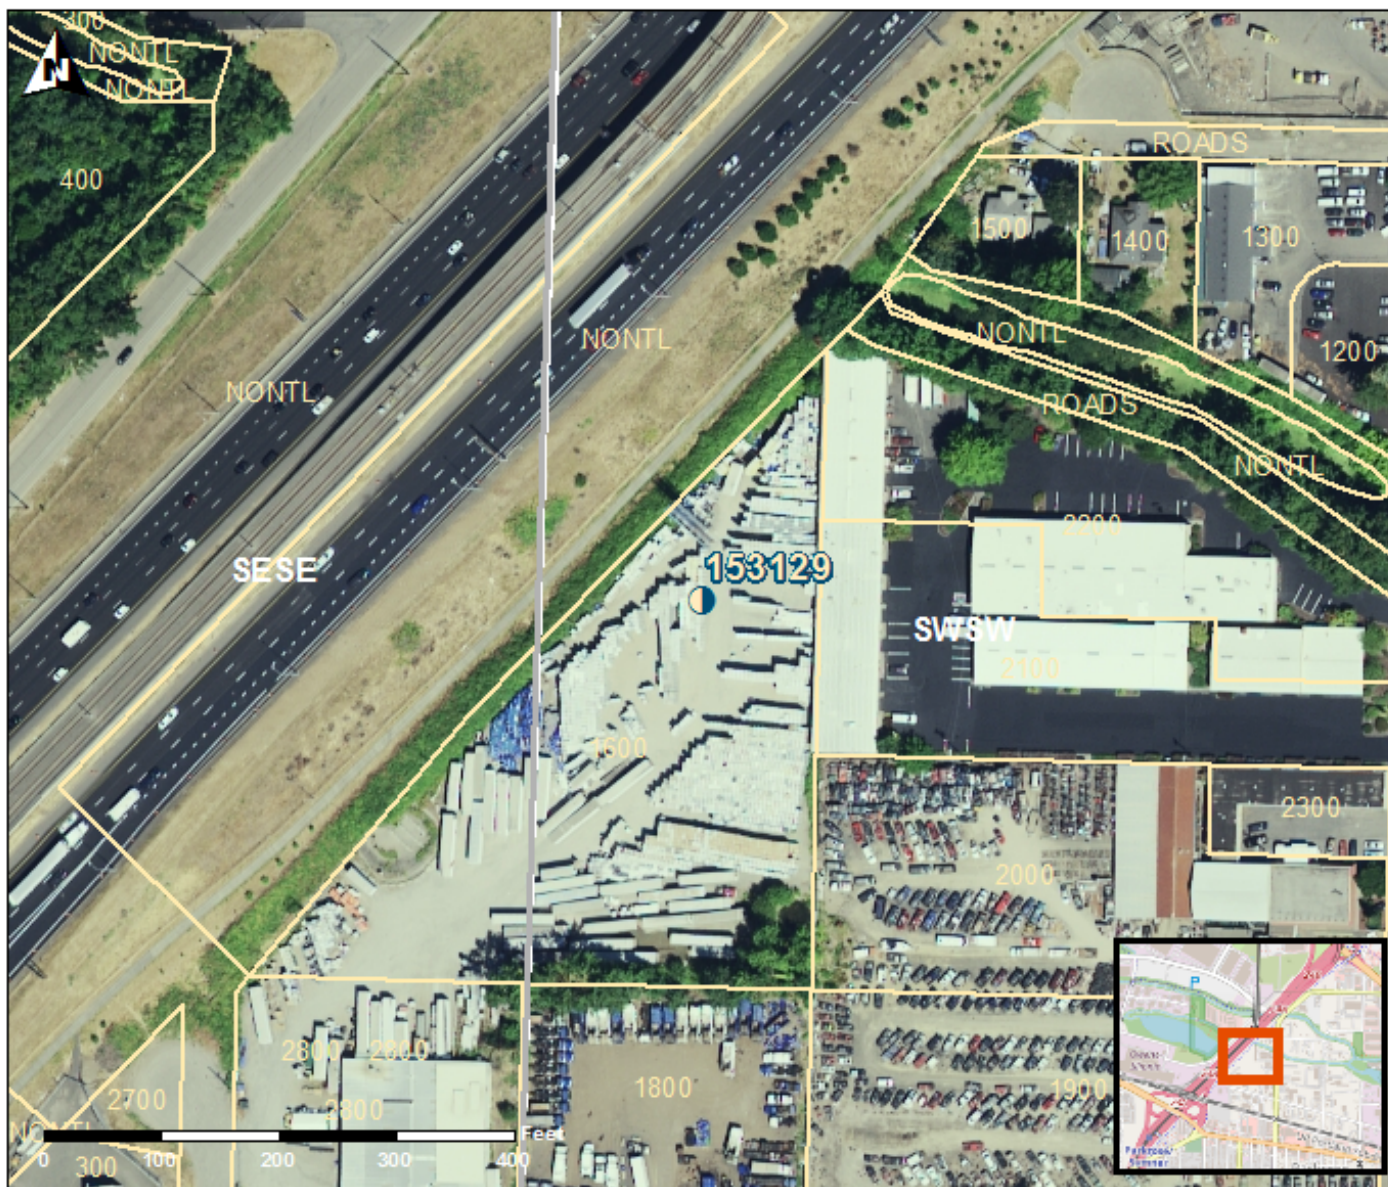
DISCLAIMER: This map is intended to represent the approximate location the well. It is not intended to be construed as survey accurate in any manner.

Provided by well constructor
