RISK ASSESSMENT  
WEST PROPERTY – TASS 2 SITE  
10505 NORTH PORTLAND ROAD  
PORTLAND, OREGON

by  
Haley & Aldrich, Inc.  
Portland, Oregon

for  
City of Portland, Bureau of Environmental Services, TASS Program, and  
Brownfield Program  
Portland, Oregon

File No. 0209772-002  
13 August 2024

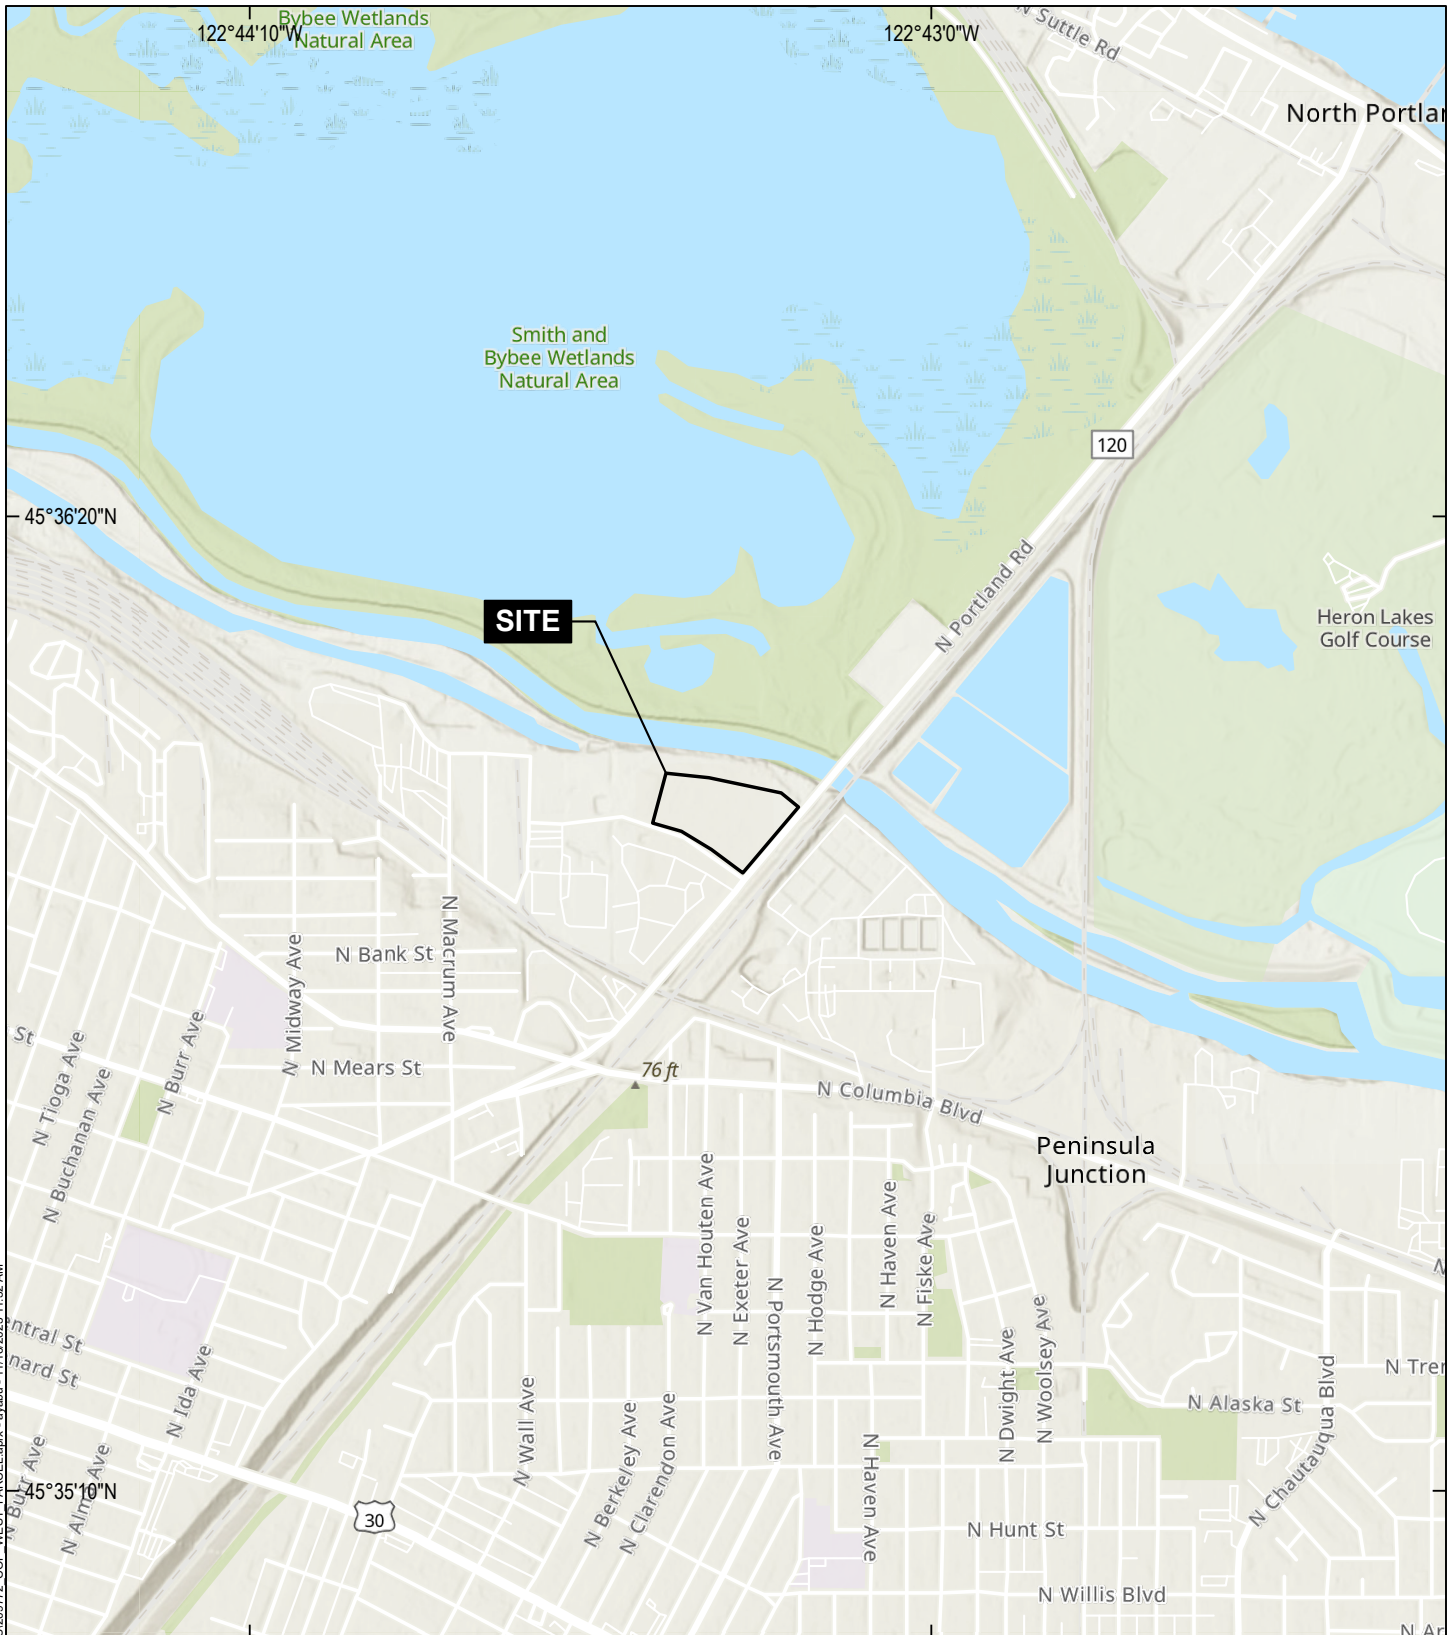
**FIGURE 1**

The site is located at 10505 North Portland Road in Portland, Oregon (Figure 1) and is located on tax lot 1000 of Multnomah County tax map 1N1E05B. The site was previously referred to as the North Larsen Property. The site is now referred to as the “West Property” within the BES CSA Program as the site is the planned western expansion of the Columbia Wastewater Treatment Plant. The site consists of 22.5 acres and is bordered by industrial properties to the west (Columbia Steel) and south (Truck Repair Enterprise), North Portland Road to the east, and the Columbia Slough to the north. A vicinity map is shown on Figure 1. A site plan is included in Attachment A (BES Figure 1).

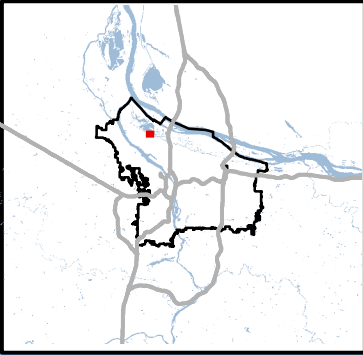
**Figure 1**  
Site Plan with  
Elevation Contours

West Property  
TASS 2 Site  
10505 N Portland Rd

The Former Diesel Engine Repair Shop is located within the northeastern portion of the TASS 2 footprint, as shown on BES Figure 1 (Attachment A).

The Former Materials Storage Yard covers the western half of the TASS 2 footprint, as shown on BES Figure 1 (Attachment A).

The Former Retention Pond Area is located outside the TASS 2 footprint with the exception of a small triangular wedge approximately 15 feet wide by 60 feet long overlapping the western border of TASS 2, as shown in BES Figure 1 (Attachment A).

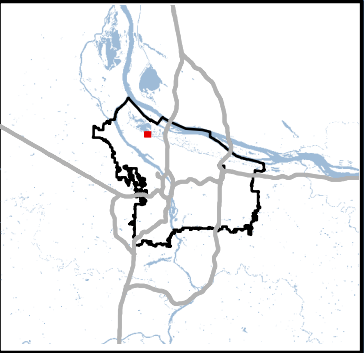
**Figure 12**  
Soil Vapor  
Sample Locations

West Property  
TASS 2 Site  
10505 N Portland Rd

Soil sample locations are shown on BES Figure 9 – Soil Sampling Location Map and groundwater sampling locations are shown on BES Figure 11 – Groundwater Data Map. Soil vapor sample location are shown on BES Figure 12. These figures are included in Attachment A.
