Re: Hamade Property
File No. 03-09-0775

The Department of Environmental Quality (DEQ) has completed its review of the information submitted to date regarding the underground storage tank (UST) decommissioning and cleanup conducted at 13625 SE McLoughlin Boulevard, south of Milwaukie, Oregon. DEQ has determined that the cleanup appears to have met the requirements of Oregon Administrative Rules (OAR) 340-122-0205 through 340-122-0360. No further action is required at this time subject to the conditions described below.

UST DECOMMISSIONING

EXTENT OF CONTAMINATION DEFINED

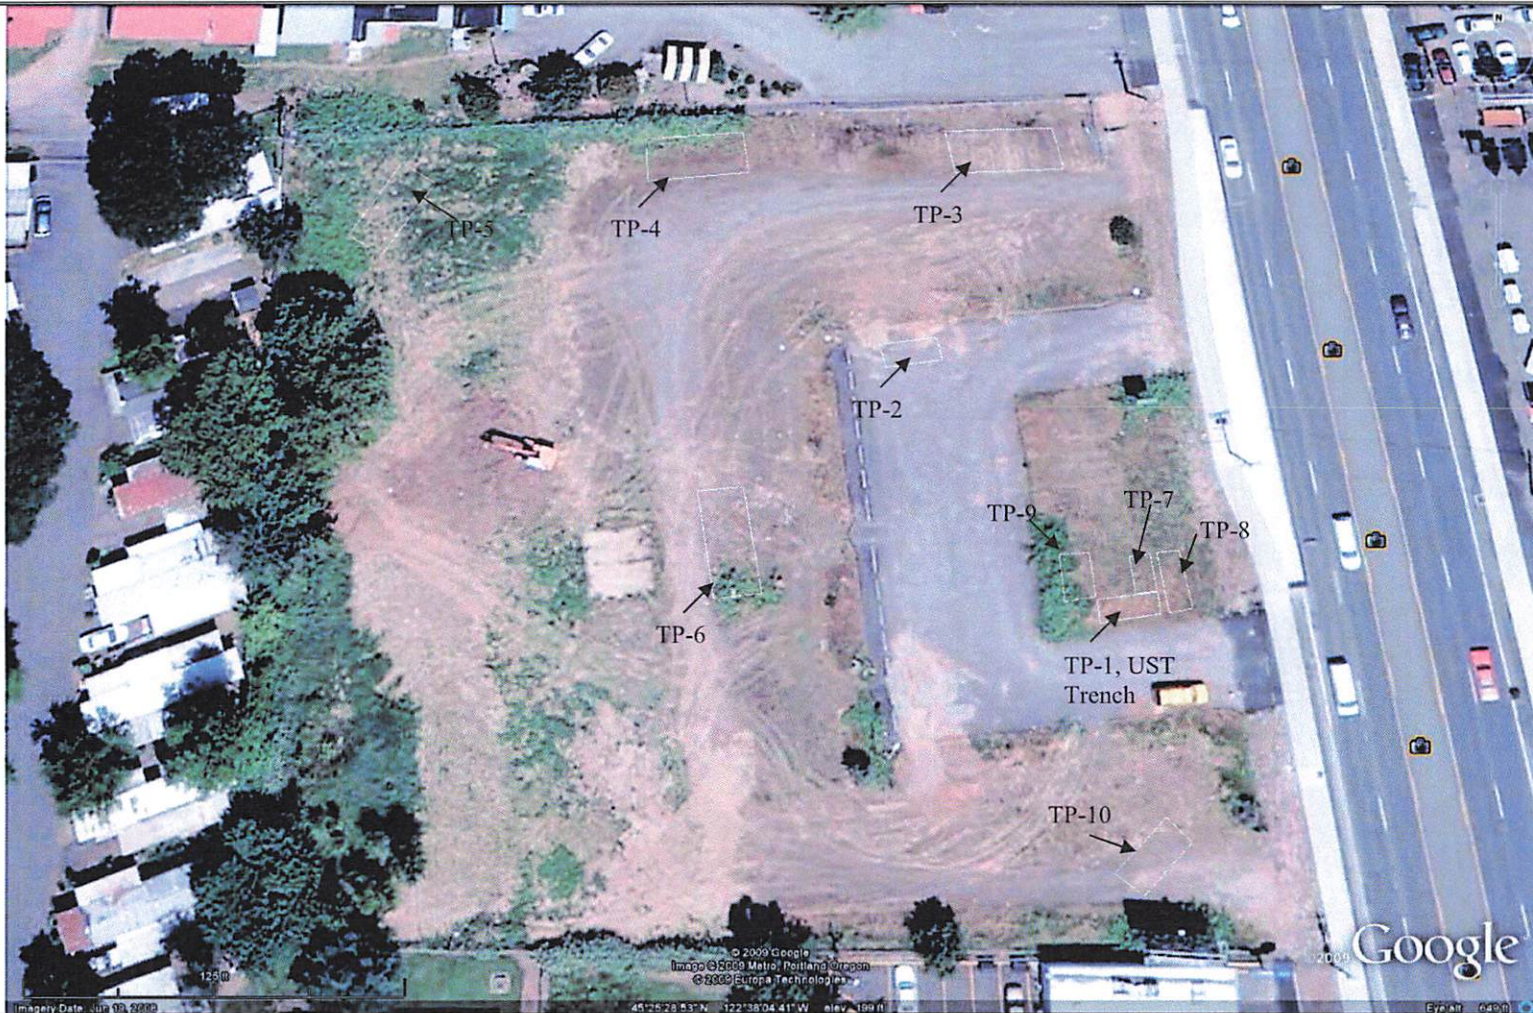
FIGURE 2 TEST PIT LOCATIONS

In general, the site is mantled with fill consisting of silty sand and gravel and concrete, asphalt, treated lumber, brick and metal fragments, and miscellaneous construction debris to depths ranging from about 2 to 5 ft BGS, underlain by silty and clayey organic soils over decomposed basalt bedrock. Slowly seeping groundwater was observed in two of the test pits at a depth of about 6 ft BGS. Two USTs and ancillary piping were encountered in test pits TP-1 (USTs and piping), TP-7 (USTs and piping), and TP-9 (piping). Generalized test pit and soils ample locations are shown on Figure 2.

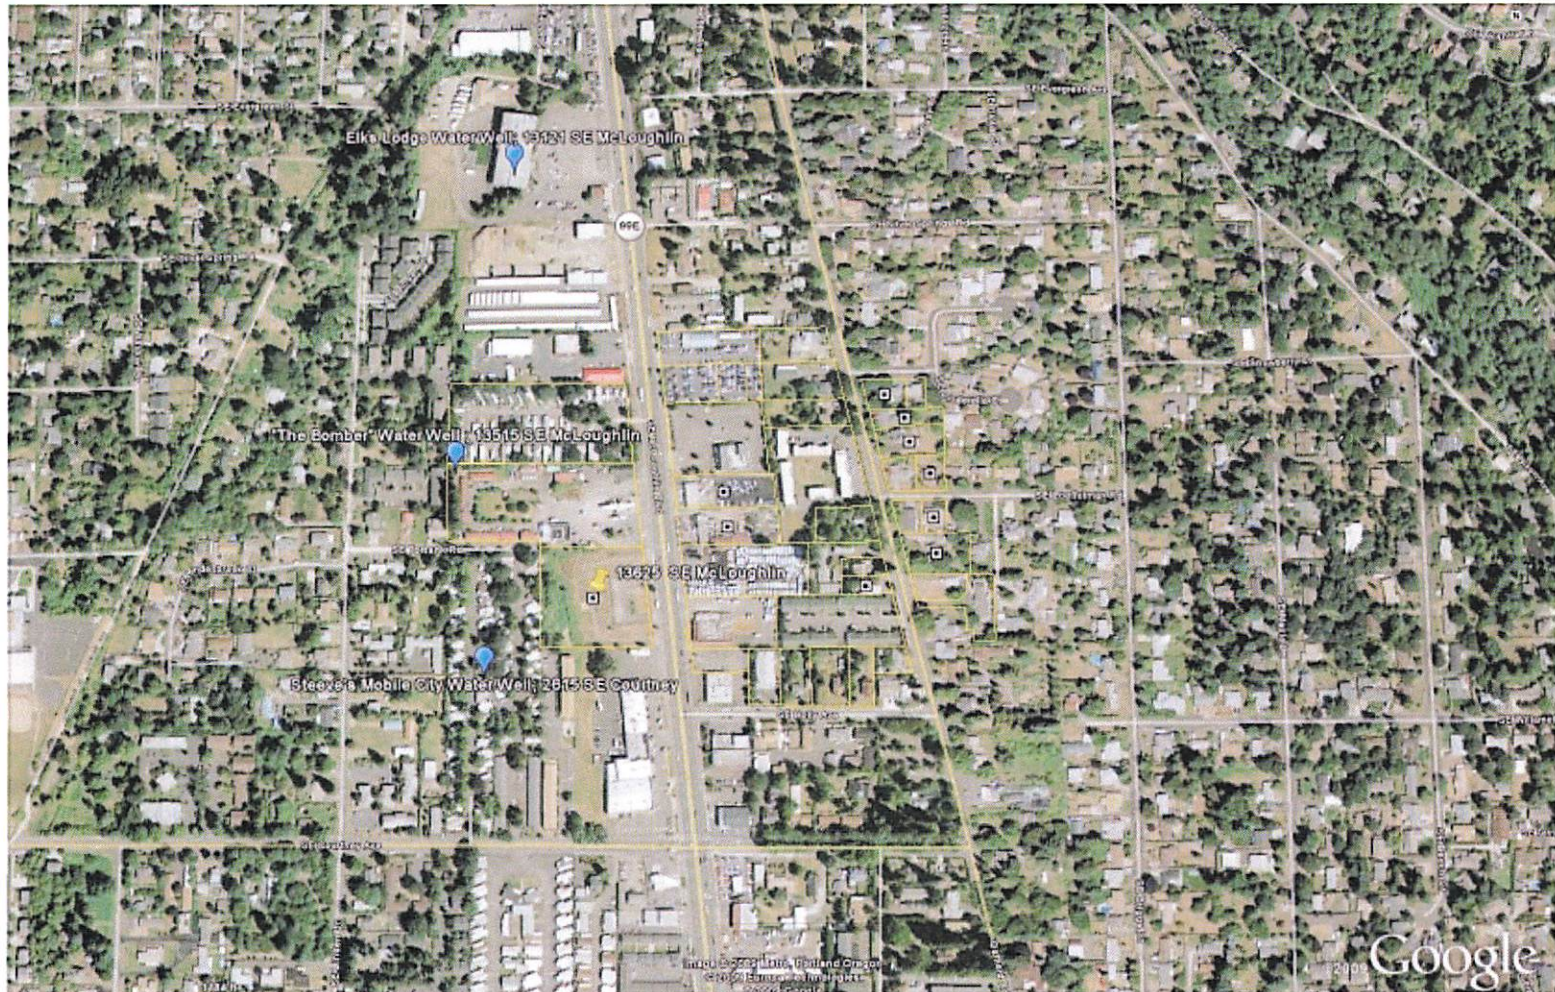
FIGURE 1 SITE VICINITY MAP

The 2.6 acre site is currently undeveloped and heavily vegetated with the exception of a "C-shaped" asphalt parking area with a grassy center, and an outer gravel drive encircling the parking area, as shown on Figures 1 and 2; Site Vicinity Map and Site Plan.

Water well logs were obtained from the Oregon Water Resources Department online GRID database system for information regarding groundwater users in the region. The Facility is located within SE¼, NW¼, Section 1, Township 2 South, Range 1 East (Willamette Meridian). The well log database showed thirteen water well logs in Section 1, Township 2 South, Range 1 East (see Appendix A). At least three of the wells are located within 1/4 of a mile of the LOF. The locations of the wells are plotted on Figure 1. The remaining ten wells are not located by address.
