Work Plan
Supplemental Limited Site Investigation
Former Automatic Vending Company
5001 North Lagoon Avenue
Portland, Oregon
ECSI No. 1430
GeoDesign Project: BCSAmerica-1-01-03

INTRODUCTION

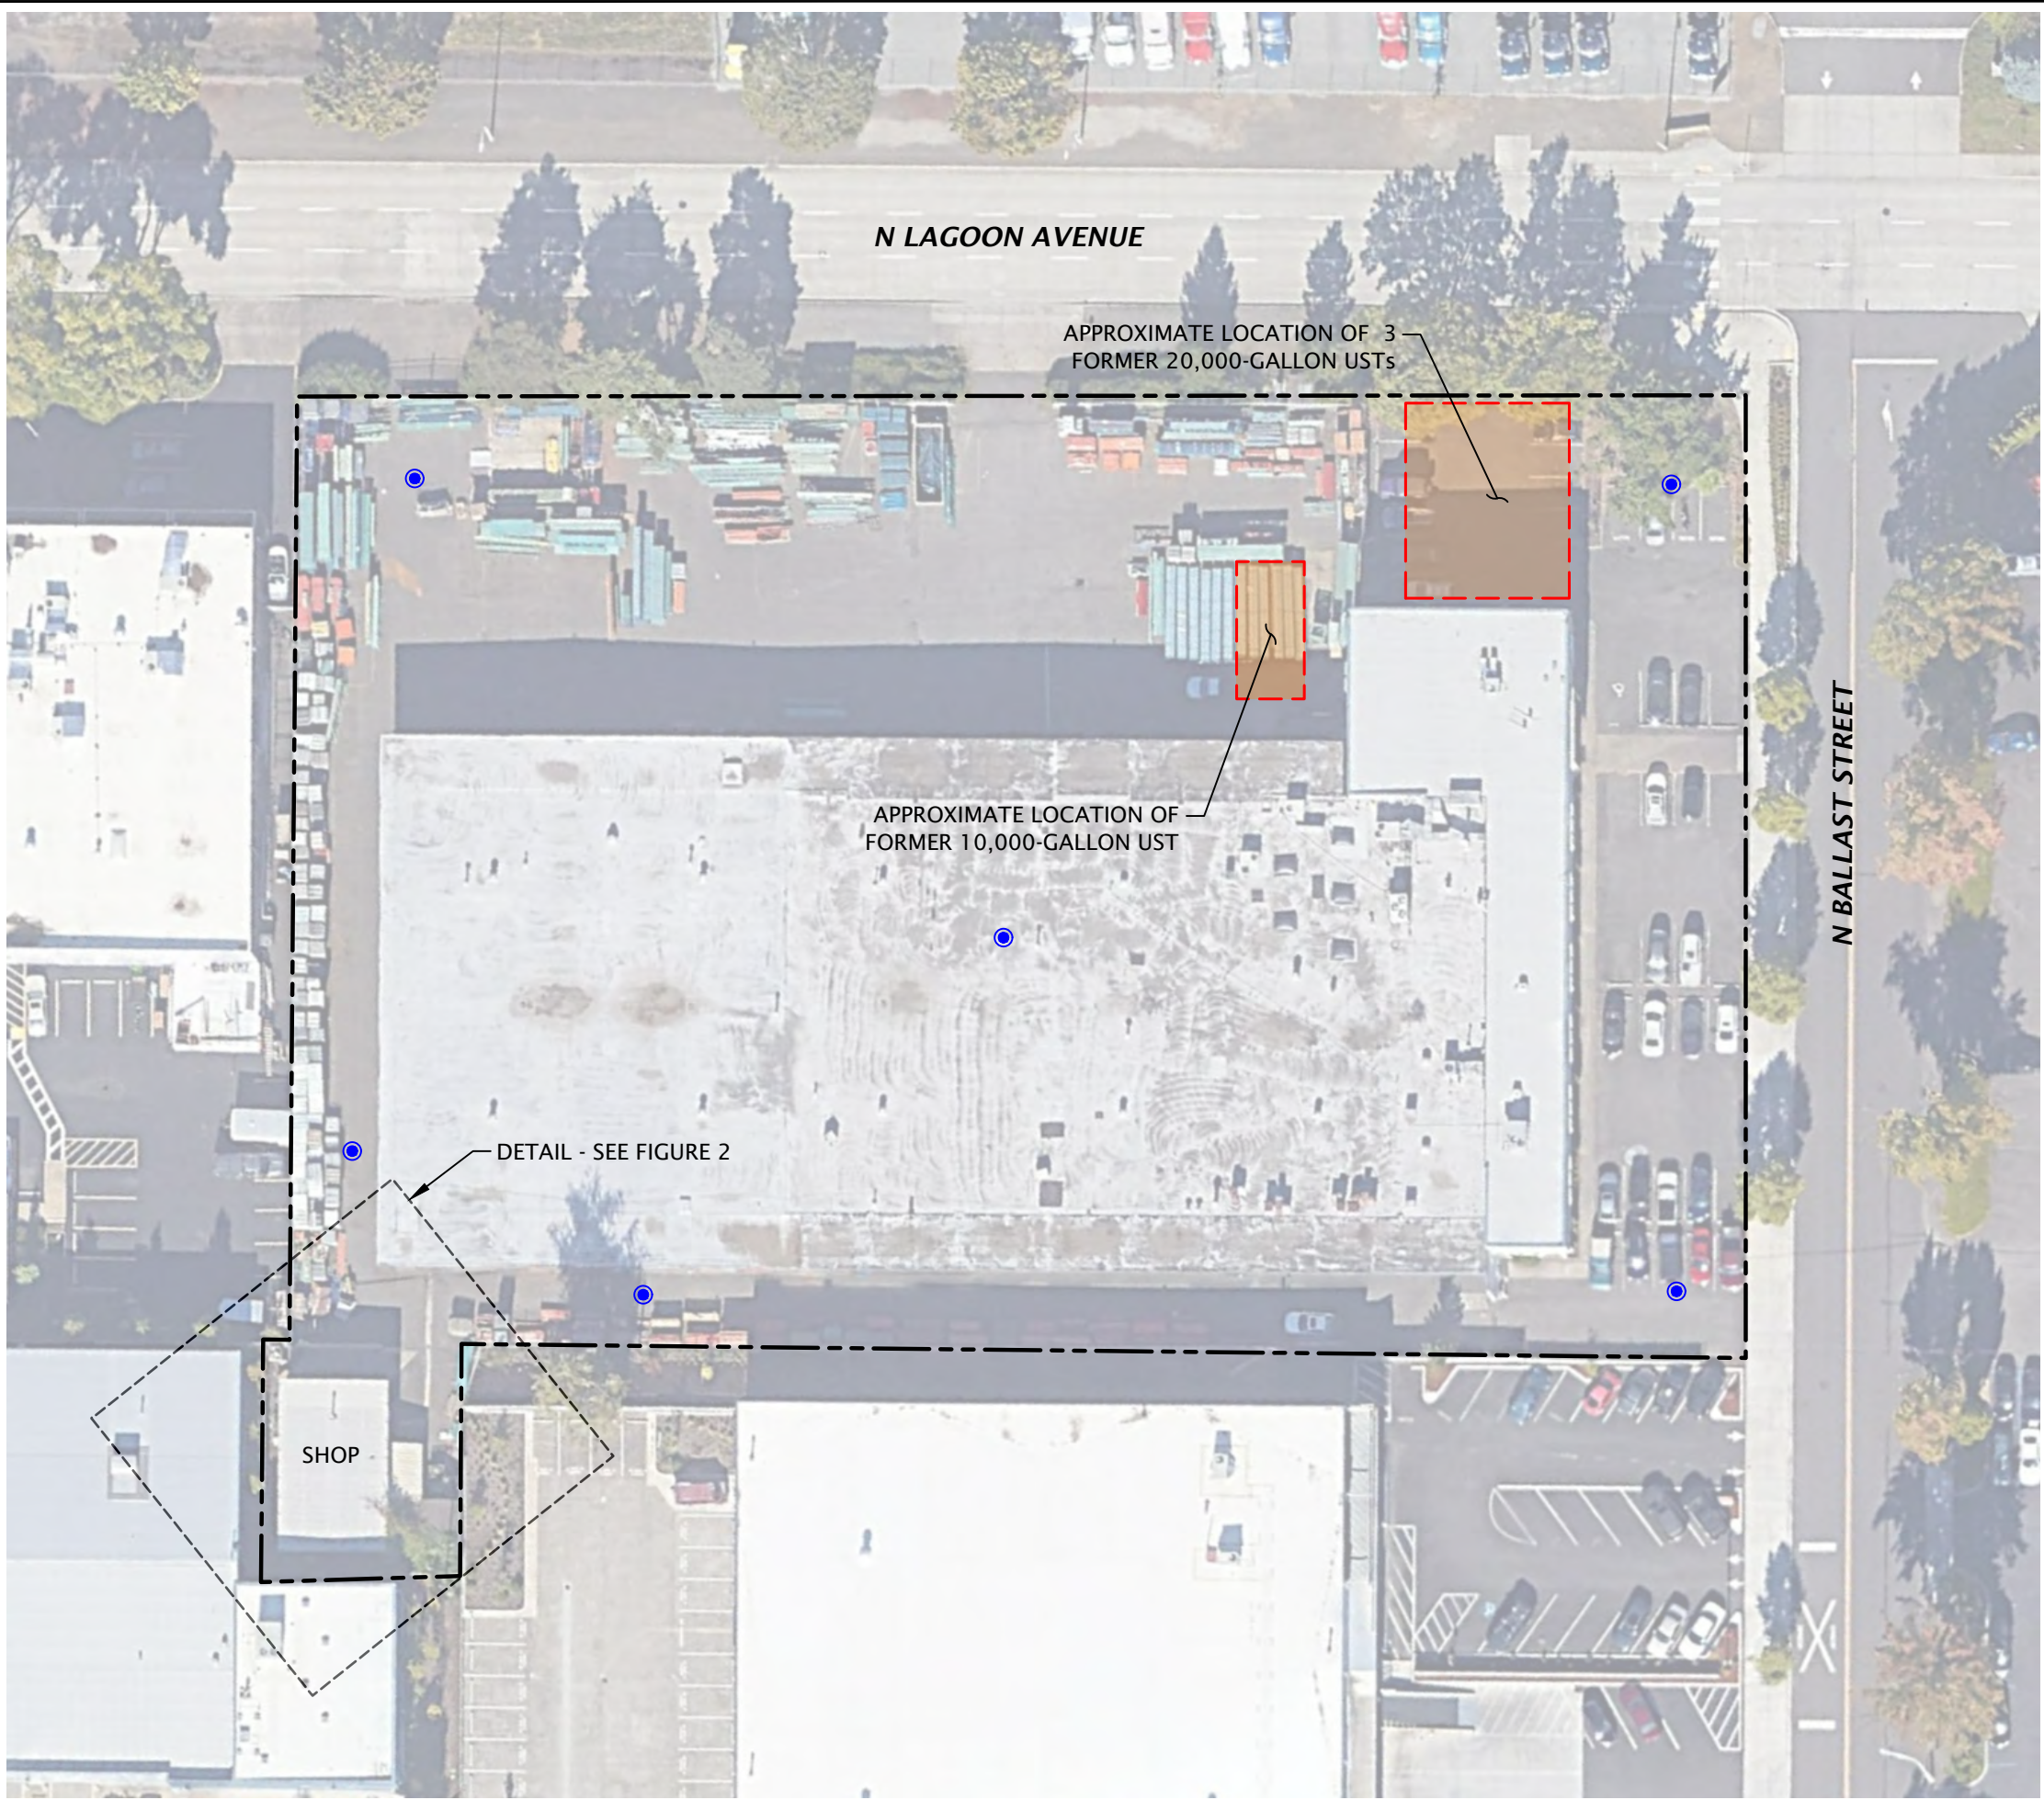
SITE PLAN	
	BCSAMERICA-1-01-03	FIGURE 1
FORMER AUTOMATIC VENDING COMPANY PORTLAND, OR		
MAY 2020

GeoDesign, Inc. is pleased to submit this work plan to conduct a supplemental limited site investigation (LSI) at the Former Automatic Vending Company site located at 5001 North Lagoon Avenue in Portland, Oregon (project site). The project site is in the upland portion of the Portland Harbor Superfund area on Swan Island. The project site is located on Tax Lot 700 of Multnomah County Tax Map 1N1E20A and is occupied by a 47,460-square-foot warehouse and an approximately 1,200-square-foot shop formerly used as a truck repair shop and most recently used for general storage. The project site layout is shown on Figures 1 and 2.

- Advance six direct-push soil borings at the project site approximately 10 feet into groundwater or refusal, whichever comes first. The proposed boring locations are intended to provide a spatial distribution of data across the entire project site and further evaluate impacts detected in the area of the shop. The proposed boring locations are shown on Figure 1. GeoDesign proposes advancing two borings approximately 50 feet northeast and 50 feet southeast of the shop to further evaluate the extent of impacts observed during the previous LSI. GeoDesign also proposes advancing one boring in the center of the project site and three borings in the northeast, northwest, and southeast corners of the project site to evaluate if the fill material is present across the entire project site and to evaluate groundwater conditions on the boundaries of the project site and the potential for on-site migration of contaminants.

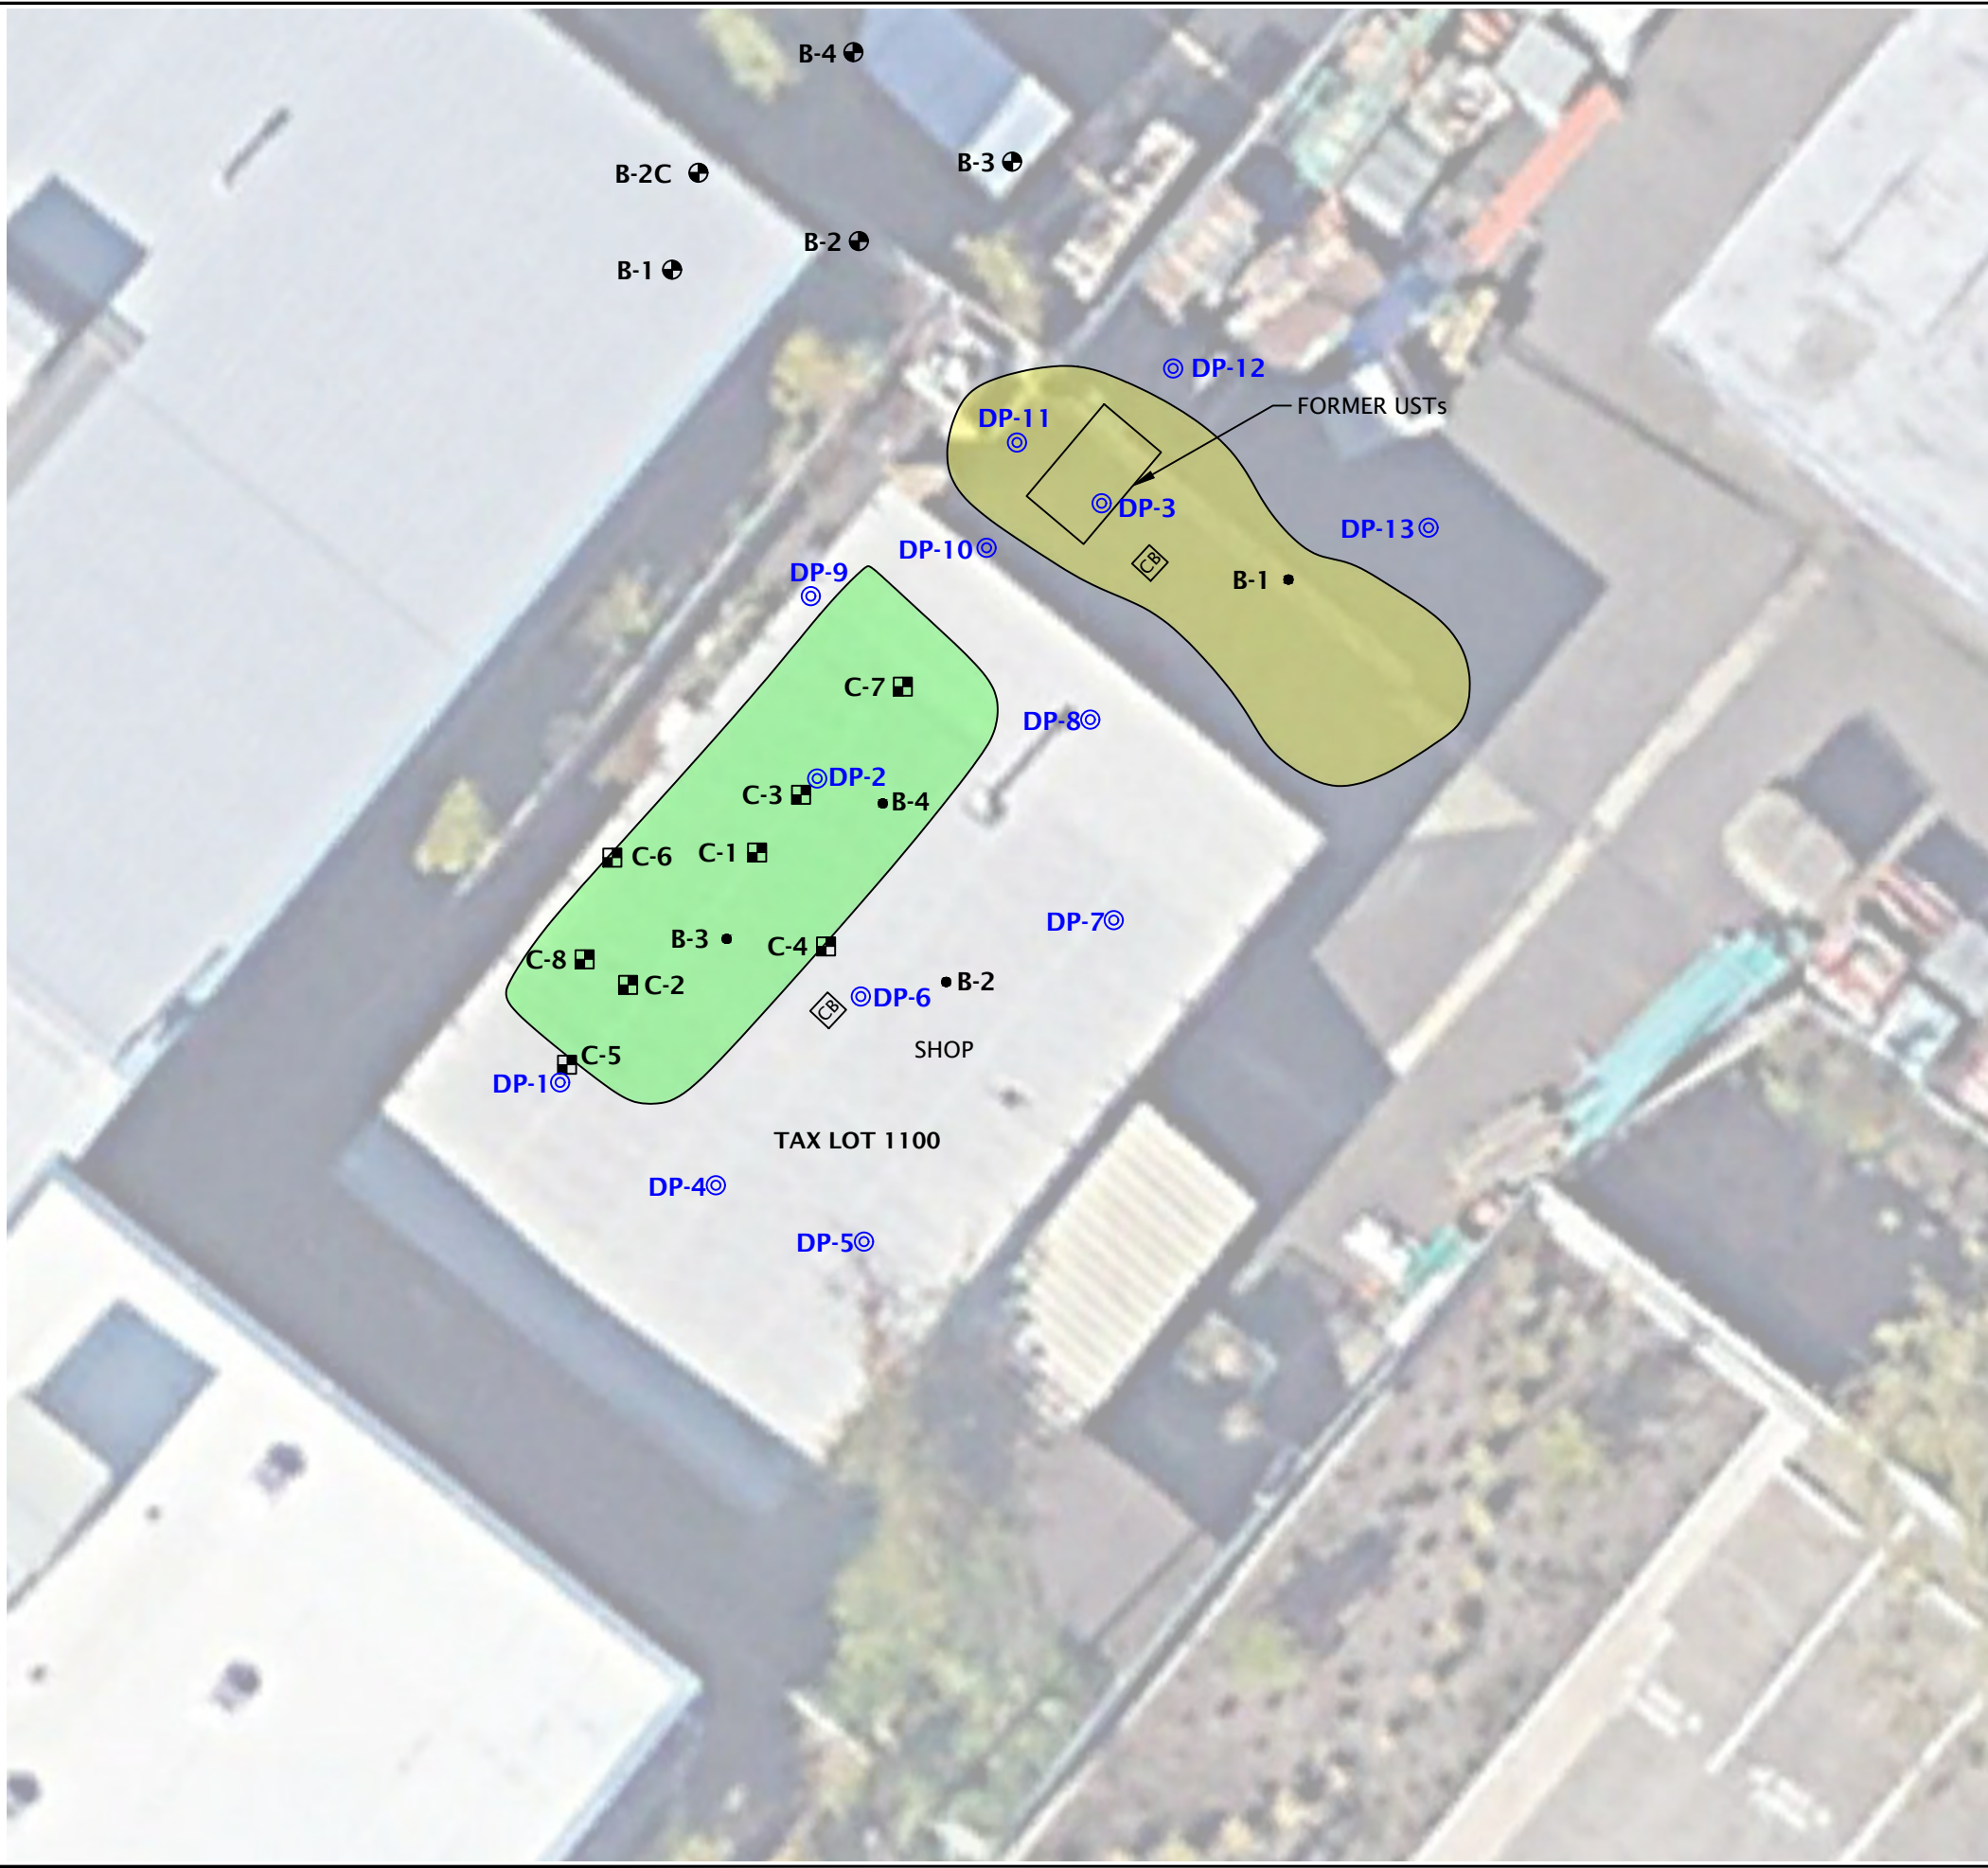
Printed By: mmiller | Print Date: 5/19/2020 1:45:20 PM
File Name: J:\A-D\BCSAmerica\BCSAmerica-1-01-03-Supp LSI\Figures\CAD\BCSAmerica-1-01-03-SP01.dwg | Layout: FIGURE 2

It appears the project site formerly contained six underground storage tanks (USTs) that included one 10,000-gallon and three 20,000-gallon gasoline USTs, one 550-gallon motor oil UST, and one 1,000-gallon waste oil UST. These six USTs were decommissioned by removal in the 1990s from the locations shown on Figures 1 and 2. A release was not observed during decommissioning of the four gasoline USTs. Oil-impacted soil was observed during decommissioning of the motor oil and waste oil USTs formerly located on the project site. Approximately 134 tons of petroleum-impacted soil were excavated from the motor oil and waste oil UST pit and disposed of off site. The approximate limits of the excavation associated with decommissioning of the oil USTs are shown on Figure 2.

Subsequently, PEMCO advanced four borings (B-1 through B-4) west of the remedial excavation (outside of the project site boundary) to delineate the extent of impacted soil left in place. The locations of the PEMCO borings are shown on Figure 2. Chemical analytical results of the soil samples collected from the borings indicated that heavy oil was detected in fill material at concentrations of up to 2,000 milligrams per kilogram (mg/kg) collected from boring B-3. PEMCO and the Oregon Department of Environmental Quality (DEQ) concluded that detection of heavy oil appeared to be associated with fill material and was not related to the UST release. DEQ issued a No Further Action (NFA) determination in May 1997 for Leaking Underground Storage Tank File No. 26-91-0415, which was associated with these USTs. However, DEQ listed the project site as DEQ Environmental Cleanup Site Information (ECSI) No. 1430 due to detections of oil in the undocumented fill material.

Subsequently, K&S conducted a subsurface investigation by advancing four borings (shown on Figure 2) at the project site to evaluate potential soil impacts to the subsurface from the hydraulic hoists and catch basins. The maximum detected concentrations of diesel- and oil-range hydrocarbons, tetrachloroethene (PCE), and polychlorinated biphenyls (PCBs) were detected in soil samples from boring B-3 (at approximately 7 feet below ground surface [BGS]) at concentrations of 25,800 mg/kg, 17,000 mg/kg, 10.3 mg/kg, and 0.109 mg/kg, respectively.
