**UNDERGROUND STORAGE TANK DECOMMISSIONING
CHECKLIST AND SITE ASSESSMENT REPORT**

DEQ FACILITY NUMBER:	3111	
FACILITY NAME:	Former Emerald Chrysler Products	
FACILITY ADDRESS:	2300 West 7th Avenue Eugene, Oregon 97402	
PERMITTEE PHONE:	541-912-1320	DATE: 8/8/2024

UST DECOMMISSIONING NARRATIVE

Former Emerald Chrysler Products (Facility ID# 3111)
2300 West 7th Avenue
Eugene, Oregon 97402

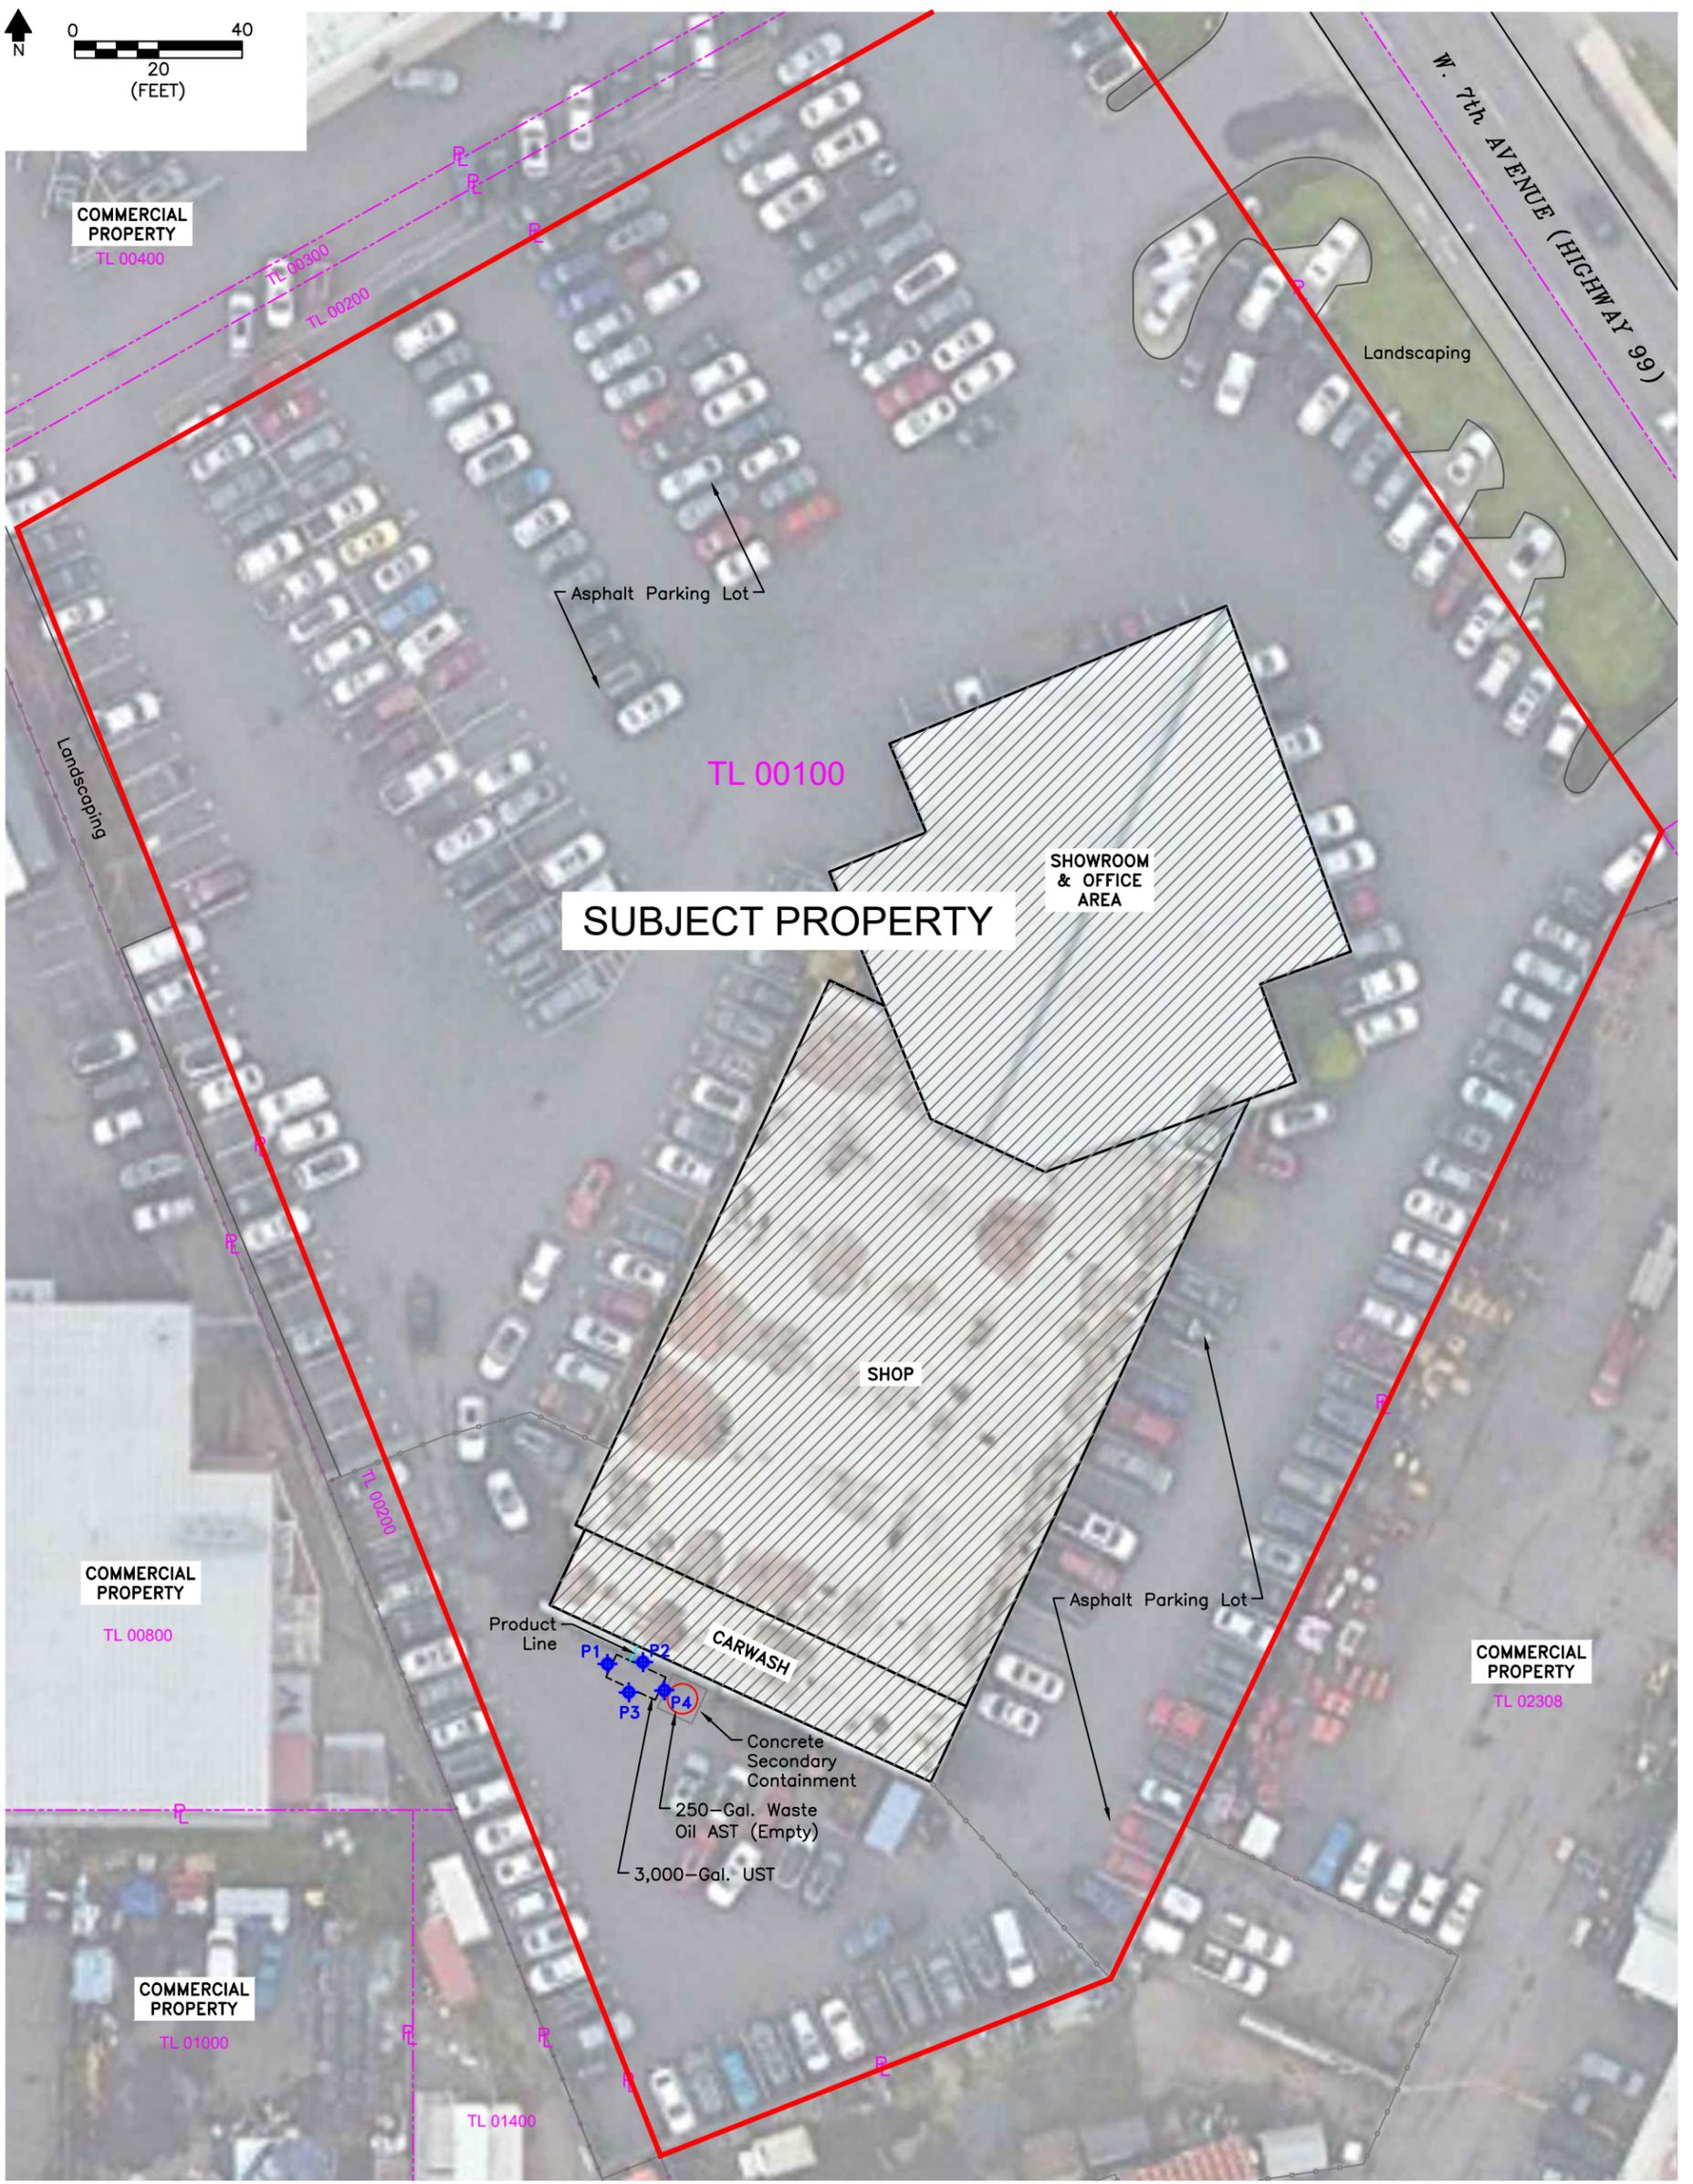
FIGURE #:
3

**SITE PLAN SHOWING PROPOSED PUSH PROBE LOCATIONS
COMMERCIAL PROPERTY
2300 WEST 7th AVENUE, EUGENE, OREGON**

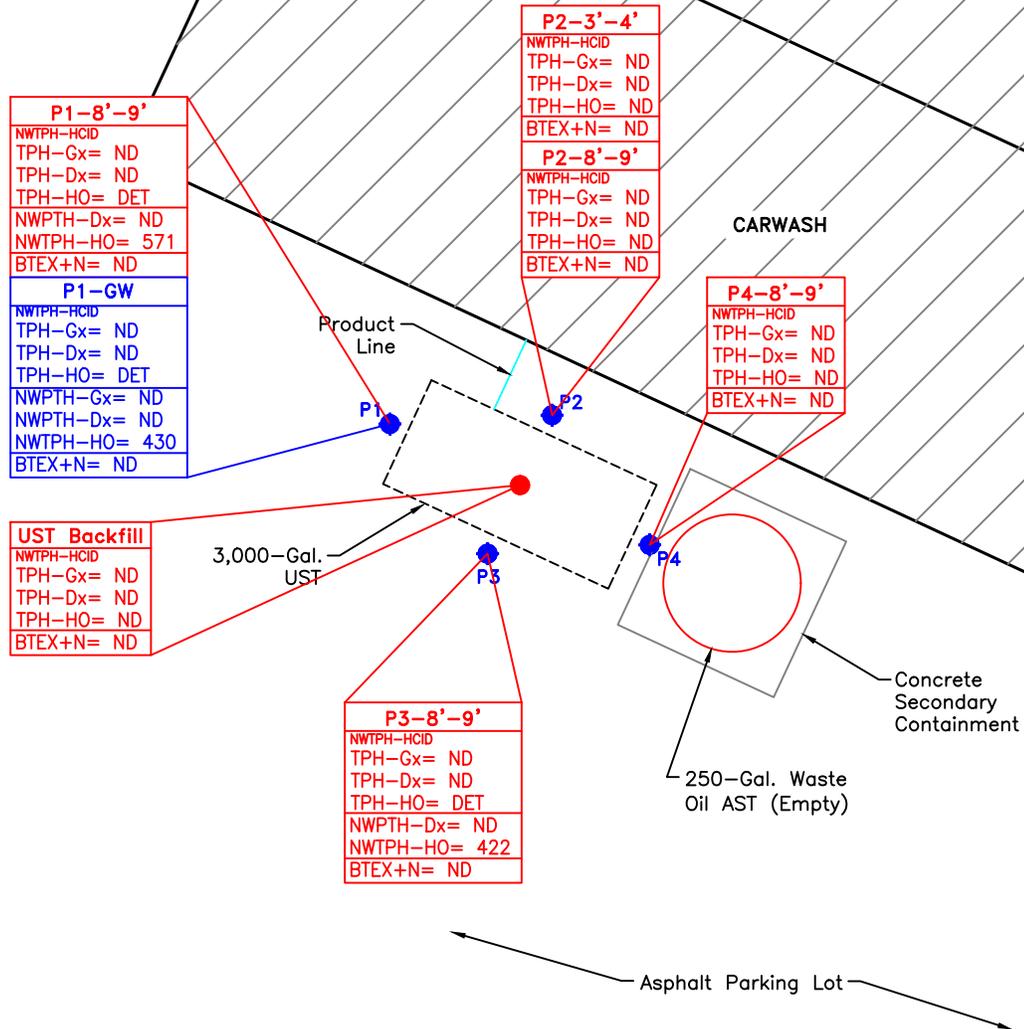
DETAILED SITE PLAN
COMMERCIAL PROPERTY
2300 WEST 7th AVENUE, EUGENE, OREGON

P1-8'-9'
NWTPH-HCID
TPH-Gx= ND
TPH-Dx= ND
TPH-HO= DET
NWPTH-Dx= ND
NWTPH-HO= 571
BTEX+N= ND
P1-GW
NWTPH-HCID
TPH-Gx= ND
TPH-Dx= ND
TPH-HO= DET
NWPTH-Gx= ND
NWPTH-Dx= ND
NWTPH-HO= 430
BTEX+N= ND

P2-3'-4'
NWTPH-HCID
TPH-Gx= ND
TPH-Dx= ND
TPH-HO= ND
BTEX+N= ND
P2-8'-9'
NWTPH-HCID
TPH-Gx= ND
TPH-Dx= ND
TPH-HO= ND
BTEX+N= ND

P4-8'-9'
NWTPH-HCID
TPH-Gx= ND
TPH-Dx= ND
TPH-HO= ND
BTEX+N= ND

UST Backfill
NWTPH-HCID
TPH-Gx= ND
TPH-Dx= ND
TPH-HO= ND
BTEX+N= ND

P3-8'-9'
NWTPH-HCID
TPH-Gx= ND
TPH-Dx= ND
TPH-HO= DET
NWPTH-Dx= ND
NWTPH-HO= 422
BTEX+N= ND

Oregon DEQ does not have an established risk-based concentration (RBC) for oil-range TPH; however, the detected concentrations in soil samples P1-8'-9' and P3-8'-9' are below all RBCs for diesel-range TPH. The *Soil Ingestion, Dermal Contact & Inhalation* RBC is deemed to be incomplete as contamination soil occurs at depths of approximately eight (8) feet BLS. The soil sample analytical results are summarized in **Table 1** and shown on **Figure 4**.

Oregon DEQ does not have an established RBC for oil-range TPH; however, the detected concentrations in the groundwater sample are at or below all RBCs for diesel-range TPH. The *Ingestion & Inhalation from Tapwater* RBC is deemed to be incomplete as shallow groundwater is not utilized as a potable resource on or near the *subject property*, and city water is available. The groundwater sample analytical results are summarized in **Table 2** and shown on **Figure 4**.

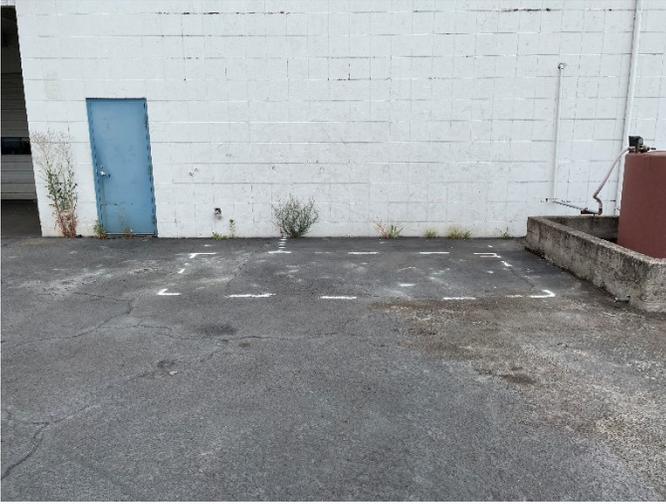
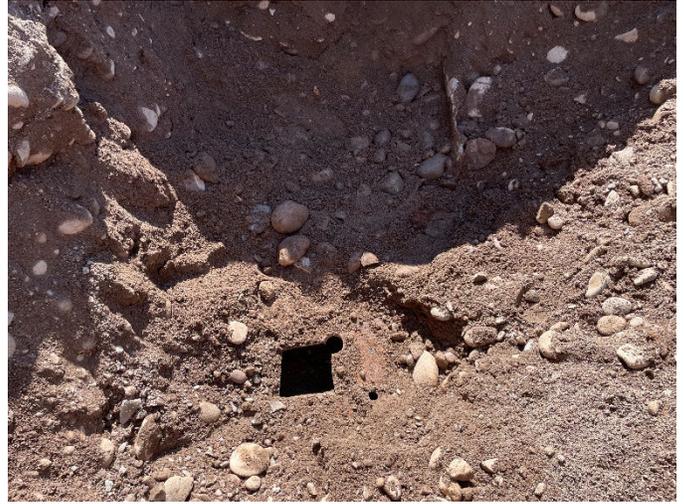
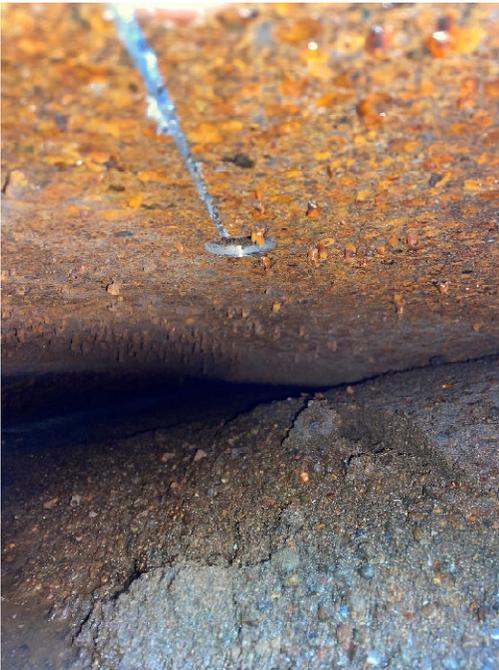
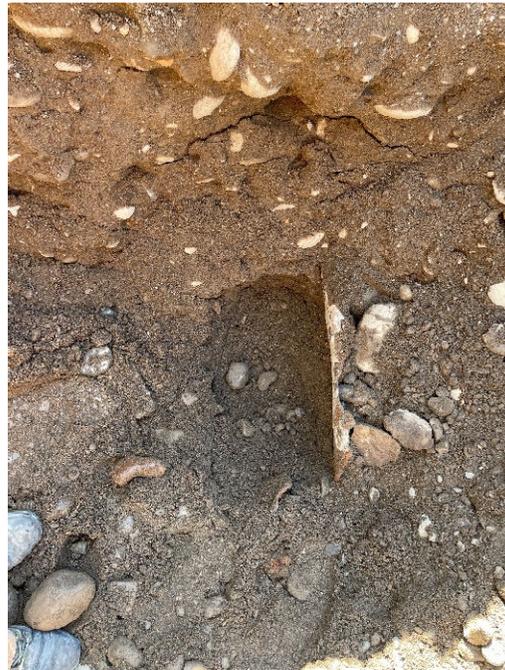
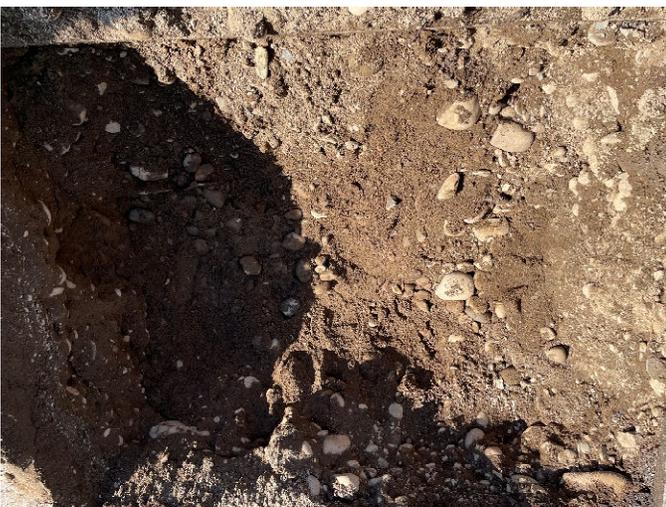
Attachment B – Photo Log

Top Left Photo taken facing northwest showing the location of the UST. Top Right Photo taken facing south showing the hole cut by BB&A in the top of the UST. Middle Left Photo taken facing southeast showing the inside of the UST had been previously filled with sand at an earlier date. Middle Right Photo taken facing southeast showing the larger hole in the top of the UST, presumed to be cut when the UST was previously filled with sand. Bottom left photo taken facing northwest showing the UST filled to capacity with sand.

On July 18, 2024, BB&A was onsite at the *subject property* to decommission the UST in-place. The UST is approximately six (6) feet in diameter by 14 feet in length (approximately 3,000 gallons) and buried approximately three (3) feet below land surface (BLS). The asphalt above the UST was cut to allow for excavation and removal of soils to expose the top of the UST. Upon uncovering the top of the UST, one (1) approximately two (2) inch diameter hole was discovered presumably where the former fill pipe had been historically cut. The hole was enlarged, and BB&A confirmed the inside of the UST was filled with sand to approximately two (2) to three (3) inches of the top of the UST (photos included in **Attachment B**).

Additional excavation was conducted and a second approximately one (1) foot by two (2) foot hole, presumably utilized for the historical filling of the UST with sand, was discovered. The sand in this portion of the UST was compacted, indicating the UST was filled to capacity with sand. The smaller hole was further enlarged, and the remaining void within the UST was filled with sand and compacted to capacity.
