# FOCUSED PHASE II ENVIRONMENTAL SITE ASSESSMENT

## Scouters Mountain Burrigut Development

Tax Lots 200, 201, 401, 491, 900, 1100,  
1801, 1802  
Happy Valley, Oregon 97086

Project No. THG-2021.3 / 351-21016-03

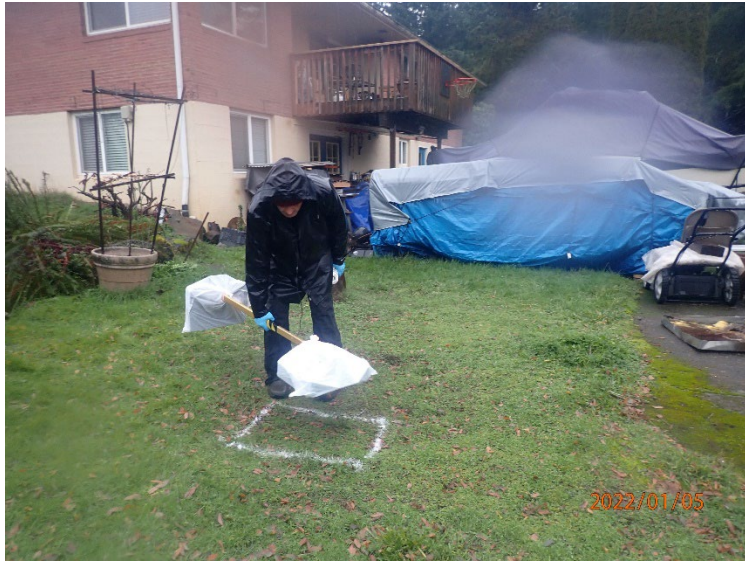
Geophysical survey of south residence (10400 SE Vradenburg) located a possible old septic tank (MA01).

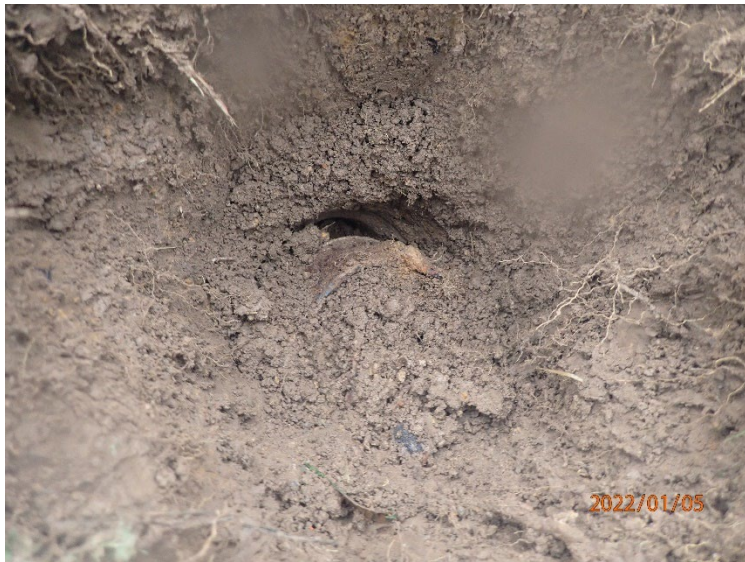
- **MA01 (possible septic).** 2' x 2' anomaly northeast of the north residence. Hand-excavated a broken 4-inch cast iron pipe, which based on its proximity to the north residence, is possibly associated with an old septic system. Reinforced concrete found nearby may be where the septic tank is located. Septic tanks and drain fields used under normal domestic use generally do not pose an environmental concern.

Hand excavation of MA01 revealed a broken 4-inch cast iron pipe possibly associated with a septic tank.

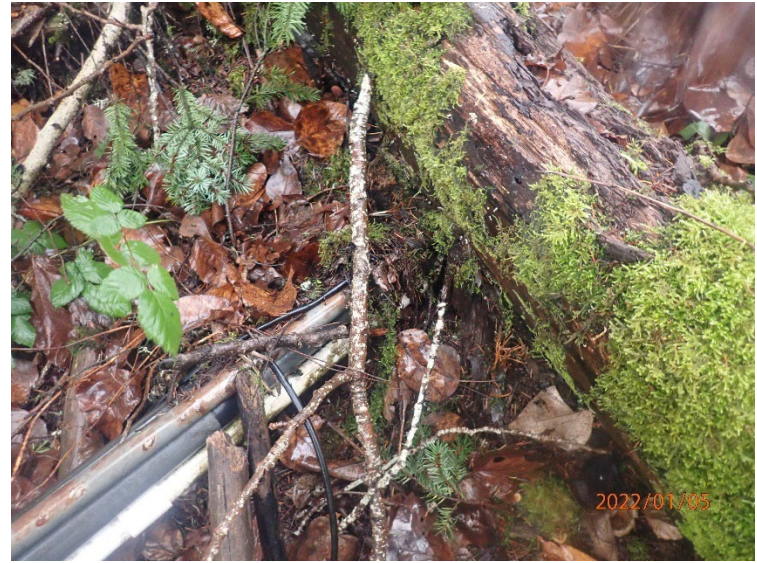
- **MA02 (chicken wire).** A metallic object between the shed and former airplane hangar, which when excavated revealed a piece of chicken wire.
- **MA03 (buried vent line).** A metal pipe believed to be a former vent line located southwest of the former airplane hangar. The vent pipe may be associated with a nearby metal rack (Comp01), which is believed to have been a support for a former AST, no longer present. No UST-like anomalies were found in the vicinity of the former hangar and shed.
- **MA04 (buried metallic debris).** Buried metallic debris found in a ditch west of the north residence.
- **MA05 (buried propane tank).** 6' x 6' anomaly determined to be a large, buried propane tank located northeast of the guest house associated with the south residence. The propane tank appeared to be in current use.

Vent line with other misc. conduits (MA03).

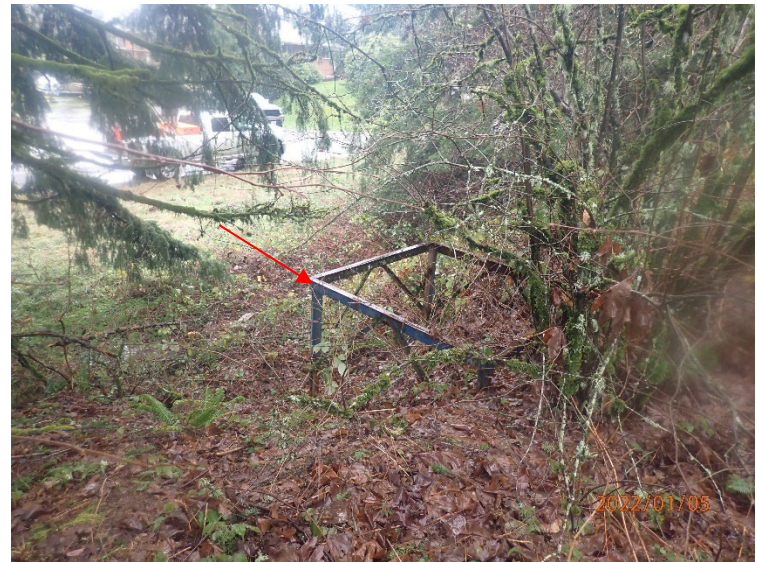
- Comp01 - a 36-square foot (sf) area beneath the footprint of a steel frame believed to formerly support an AST on the northern part of the site. Data objectives were intended to assess for potential impacts beneath this AST stand.
- Comp02 – from several burn piles northwest to northeast of the east residence.

Using a decontaminated stainless-steel hand auger, a 6-point composite was collected within the 36-sf footprint underlying the AST. A 10-point composite was collected beneath burned debris at several locations northwest to northeast of the east residence. Each subsample was collected at a depth of 0.5 feet.

A rectangular metal structure believed to be a support for a former above-ground storage tank, where Comp01 was collected.

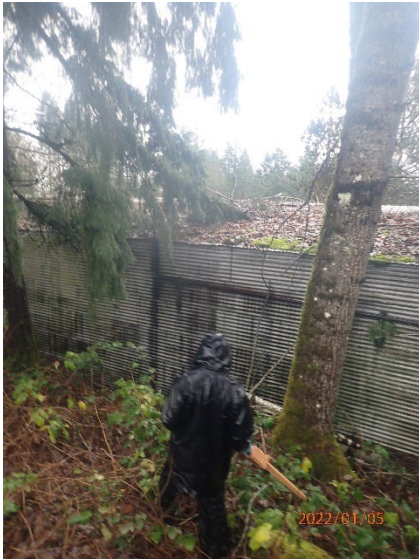
Using a magnetic locator west of the former airplane hangar where DU04 is located.

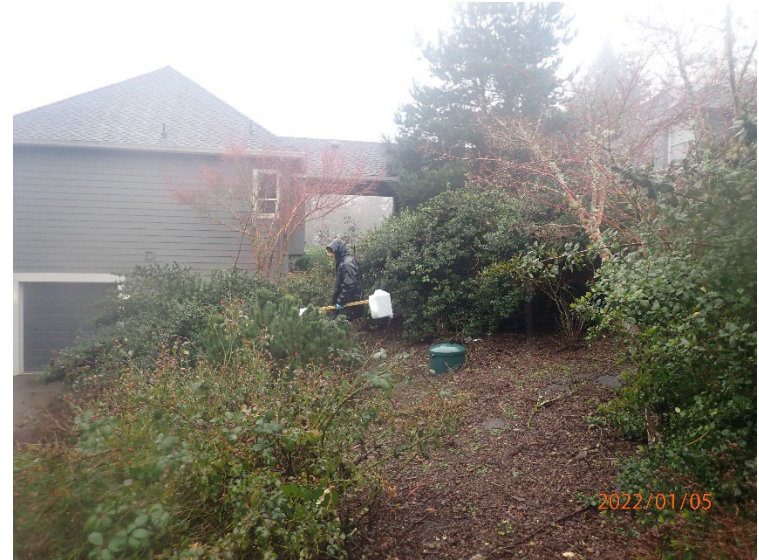
Large, buried propane tank (MA05) was located north of the guest house associated with the south residence.

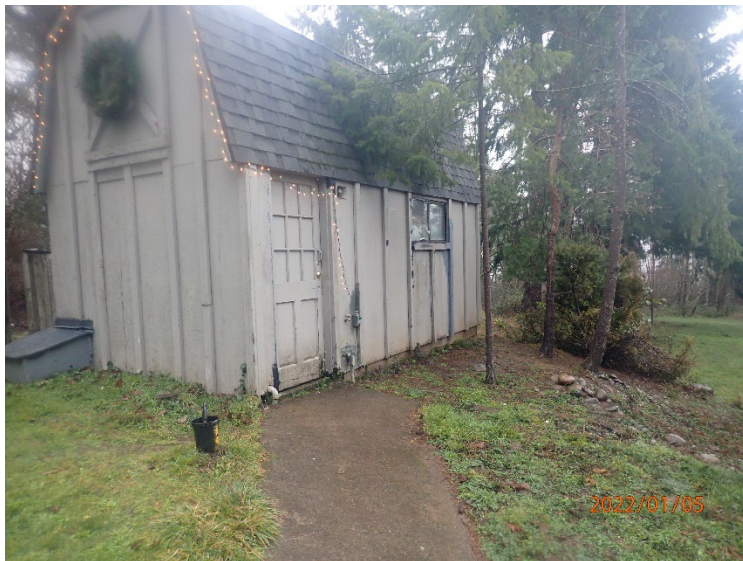
The east residence was scanned, also including the area of the burn pile east of the shed (Comp02).

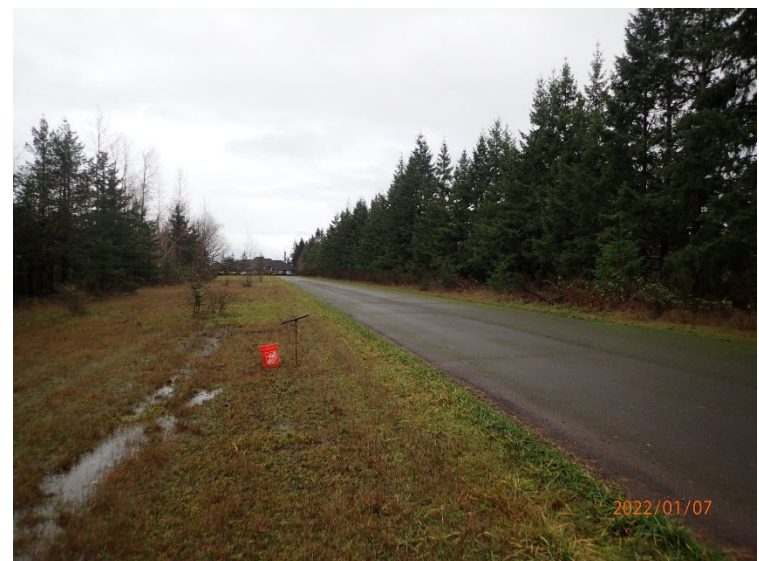
A decontaminated stainless-steel hand auger was used to collect ISM sample increments in the part of DU02 east of SE 162<sup>nd</sup> Avenue.

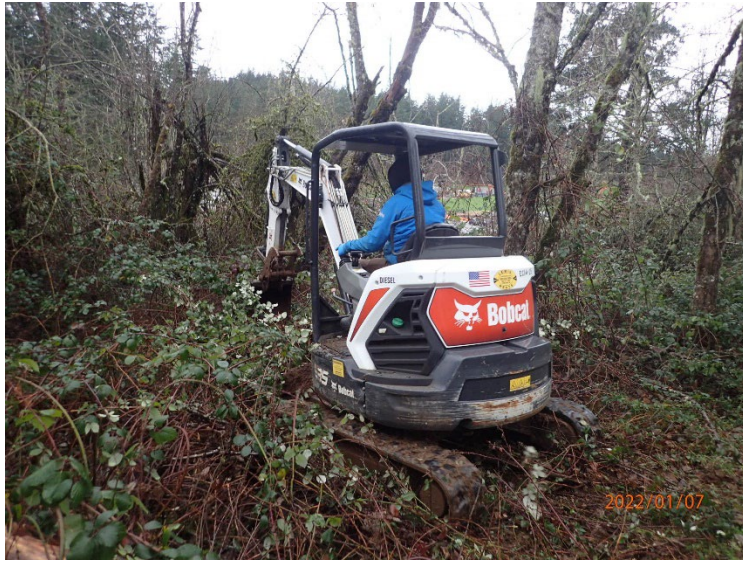
A mini excavator assisted with the collection of ISM subsamples by clearing a pathway into heavily vegetated areas of DU01.

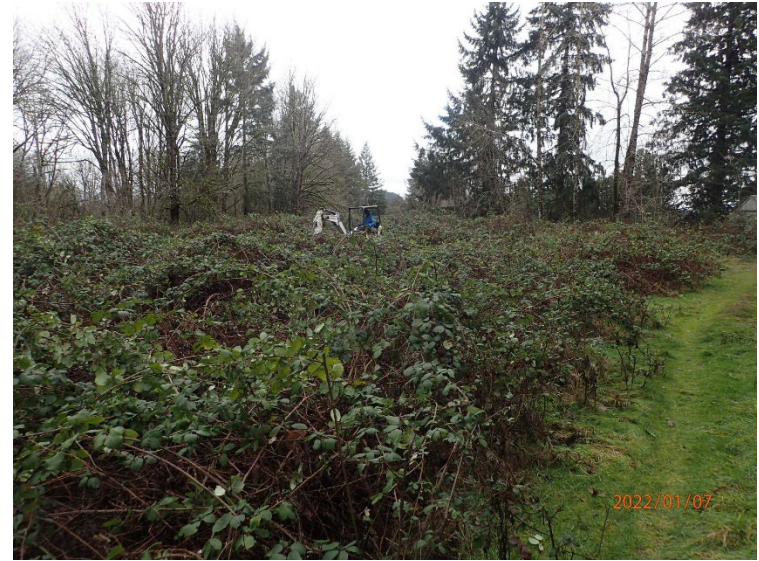
Clearing brambles to facilitate ISM sampling in DU04.

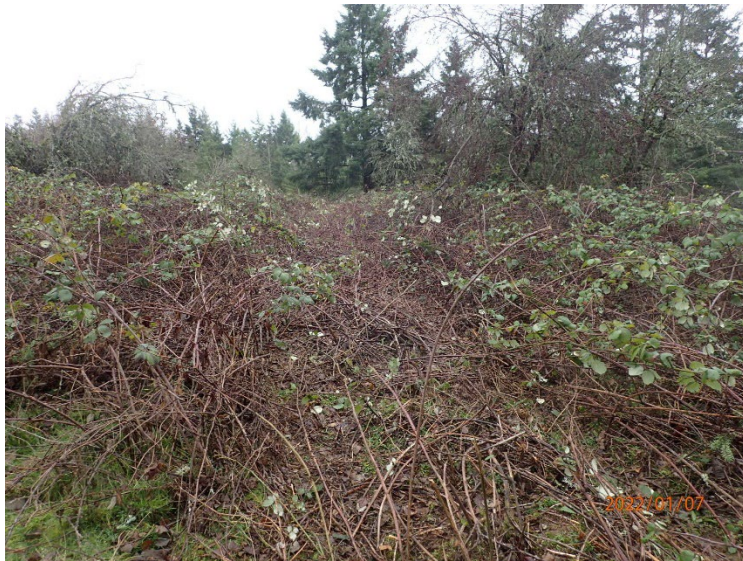
Former row crop fields are currently covered with blackberry brambles, e.g., DU01.
