OFFSITE CAP SOIL SOURCE SURFACE SOIL ASSESSMENT

Troh Legacy Landfill Property

10010 SE Vradenburg Road
Happy Valley, Oregon 97086

Project No. THG-2016.1/351-14002-07

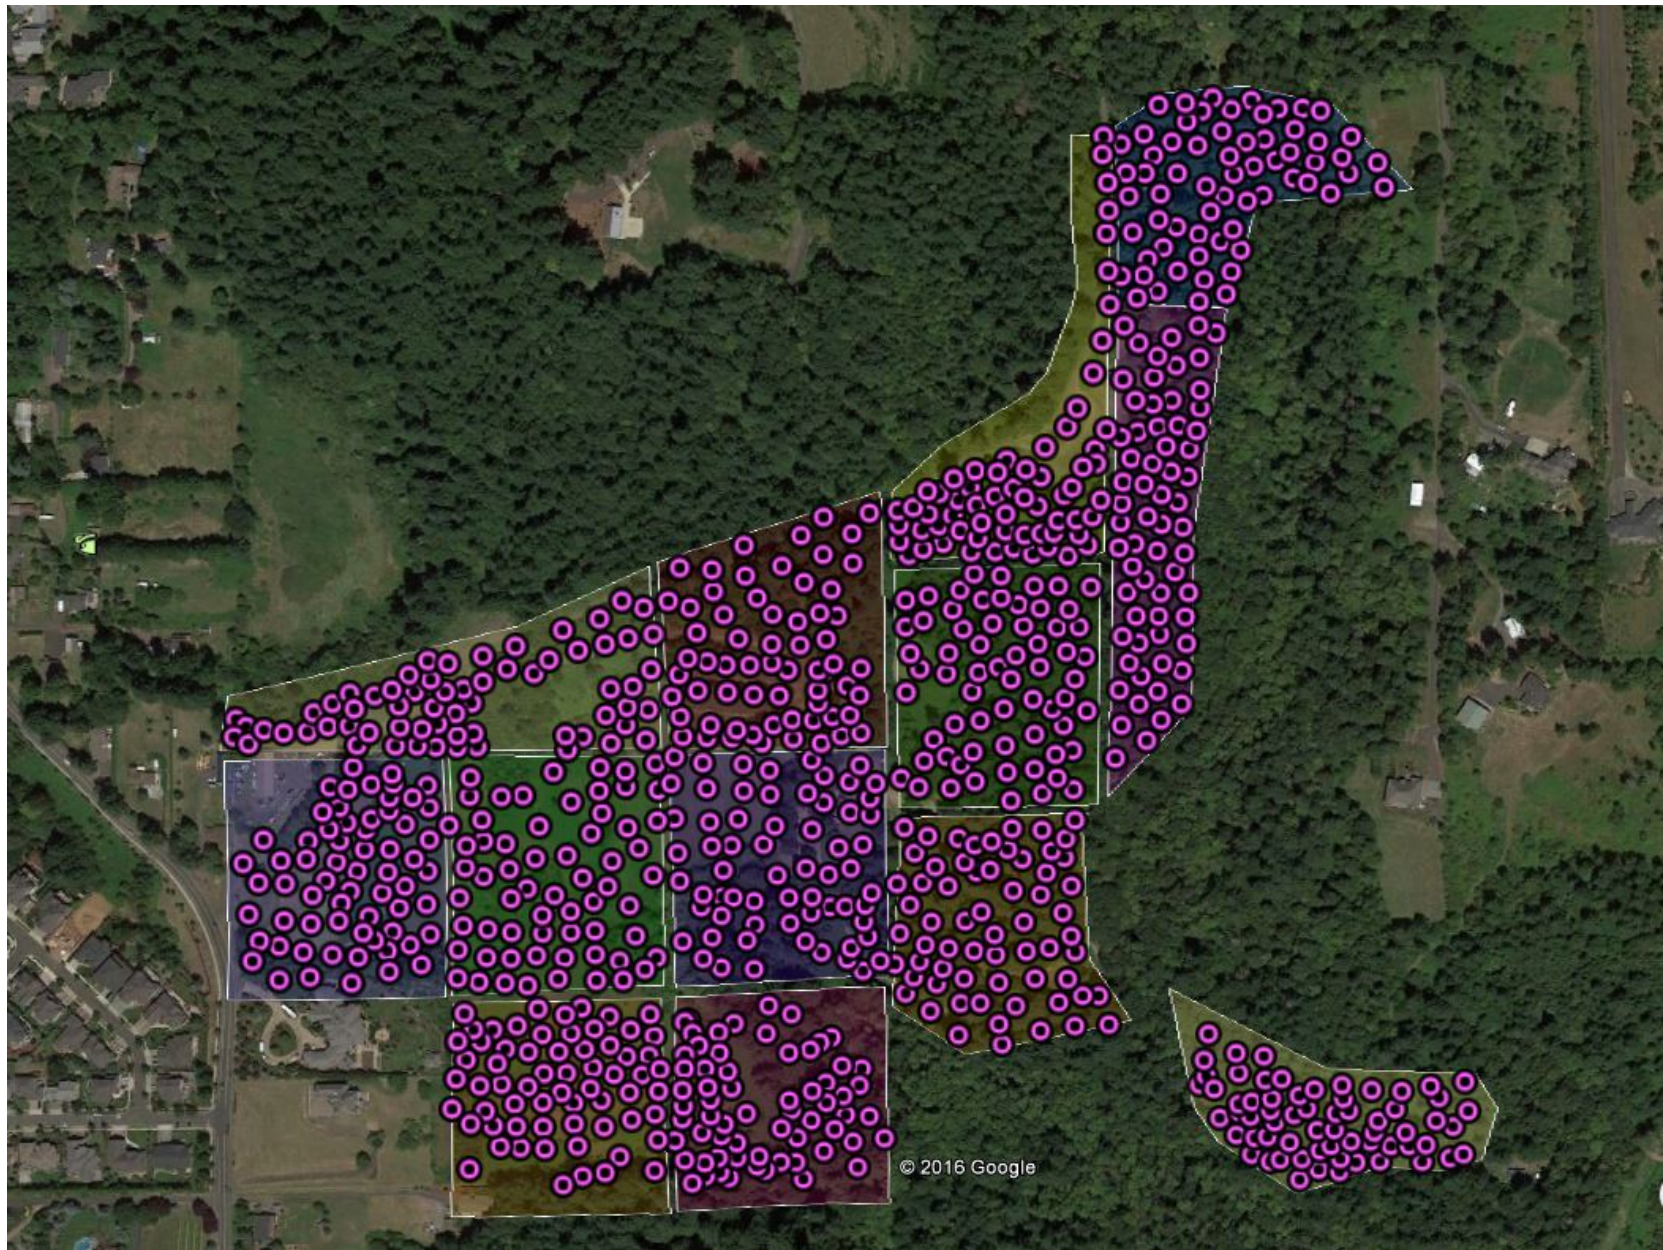
APPENDIX A INCREMENTAL SAMPLE LOCATION MAP

View of the individual sub samples collected in each of the 13 DUs. Areas not covered included those heavily vegetated (blackberries and dense forest) or covered in buildings and pavement (DU01 and DU02) or DU boundaries that did not line up with a property boundary. In particular, the northern boundary of DU 08 was a road and on the far side of the road was a natural area owned by Metro that was not to be disturbed.

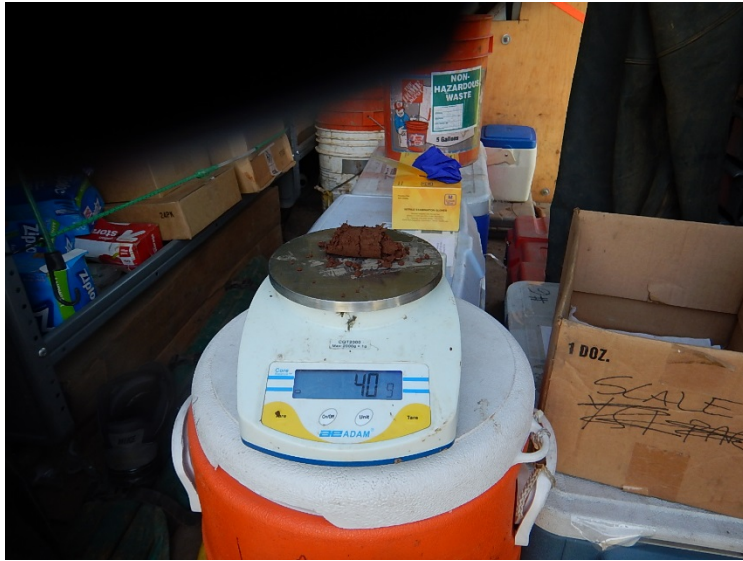
An approximate 40-gram core is obtained from each subsample location. These are collected in a dedicated 1-gallon jar and submitted to the lab for processing.

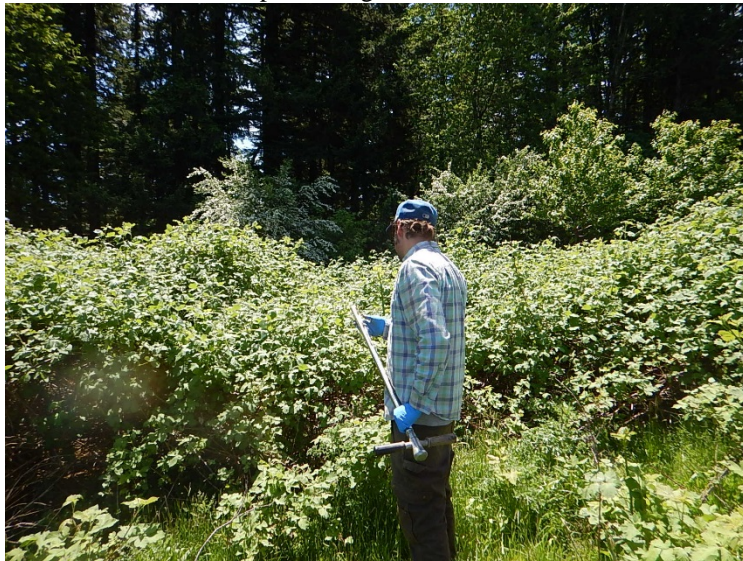
Soil samples were obtained using a stainless-steel probe, advanced approximately 6-inches BGS, with the lower 3 to 4 inches sampled.

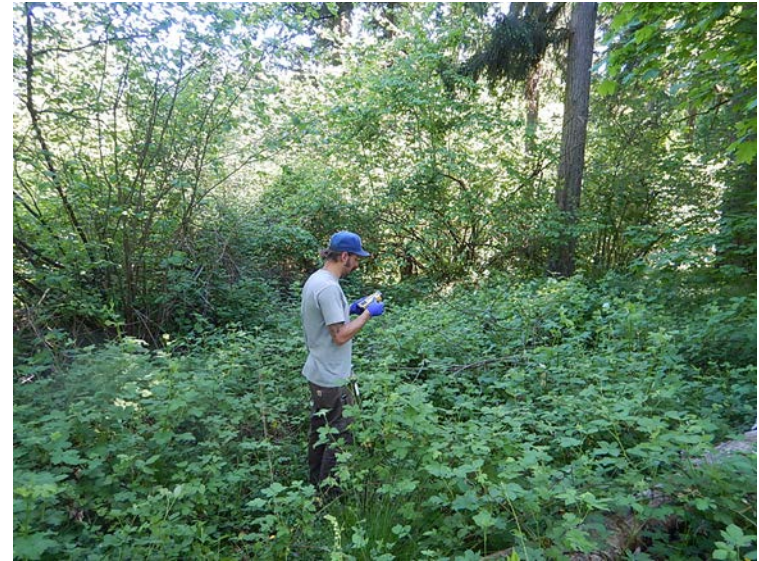
Each subsample location was recorded using a handheld GPS unit. This assured obtaining 64 subsamples across the site with appropriate coverage.

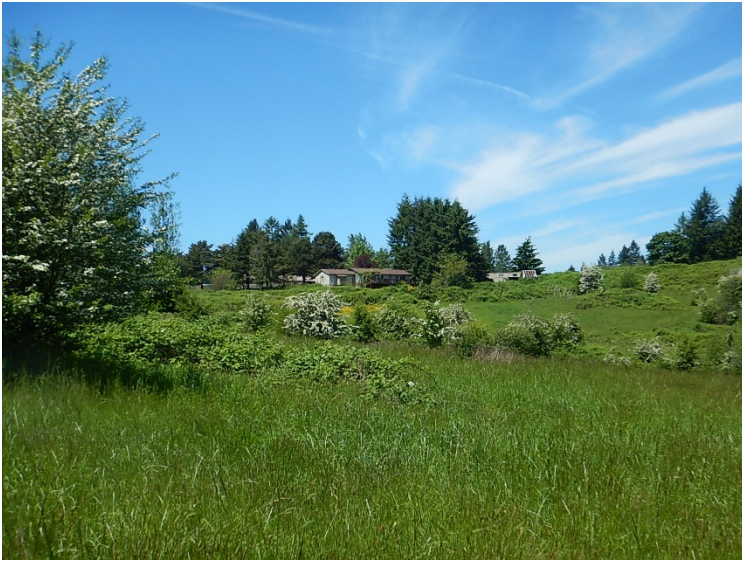
View looking north from DU04 at the back side of the former ranger's house, located in the northeast corner of the DU02. There are thick blackberries that border the back side of the residence.

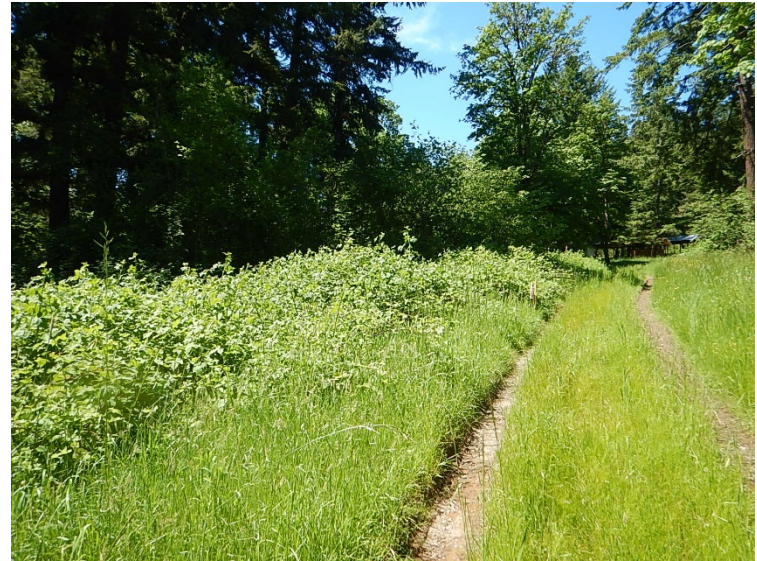
View looking northeast along an access road within DU06. Note the thick blackberries on the left side of the road that hampered access.

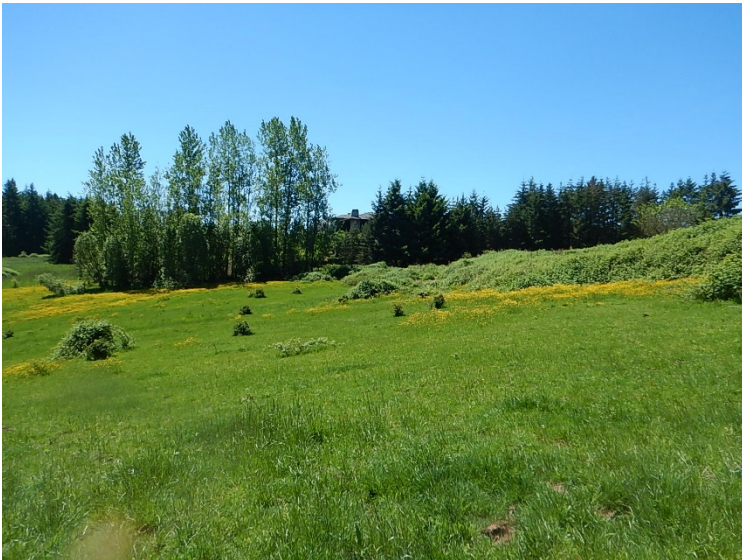
View looking west along the south end of DU02. Note the stand of blackberries on the right that limited access in the west central area of this DU.

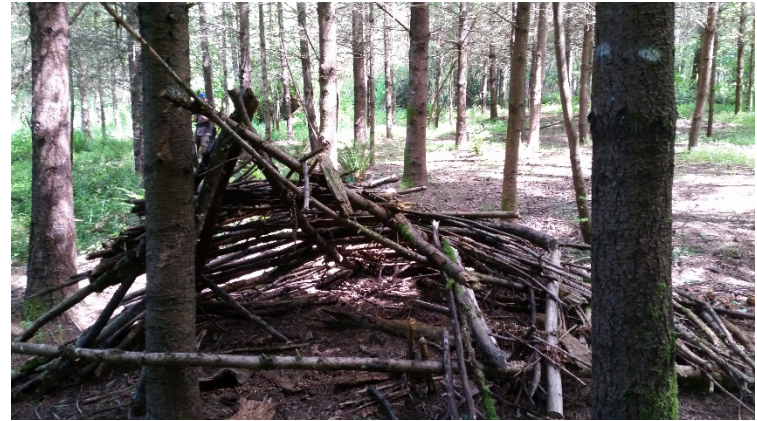
View of a disturbed area within DU09. Primitive shelters were observed throughout this area, created out of tree limbs.

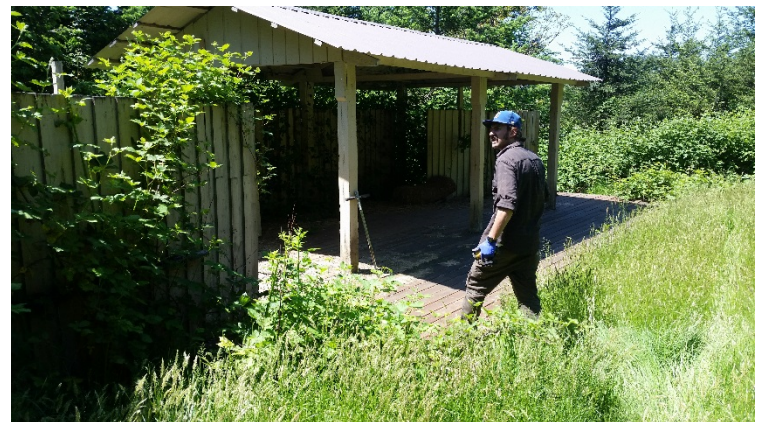
A basic stage was found within thick blackberries and tall grass in DU09. It was built out of wood with a steel roof. Basic bench seats were noted in the field in front of the stage, most removed and stacked off to the side.

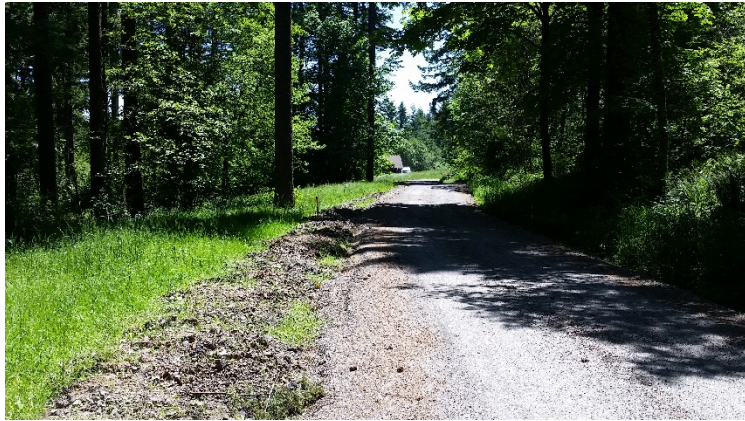
View looking south along the access road that bordered DU08 along the western side. Further west (right side of the photo) was Metro property under protection due to reforestation. Sampling included the area on the left side of the photo.

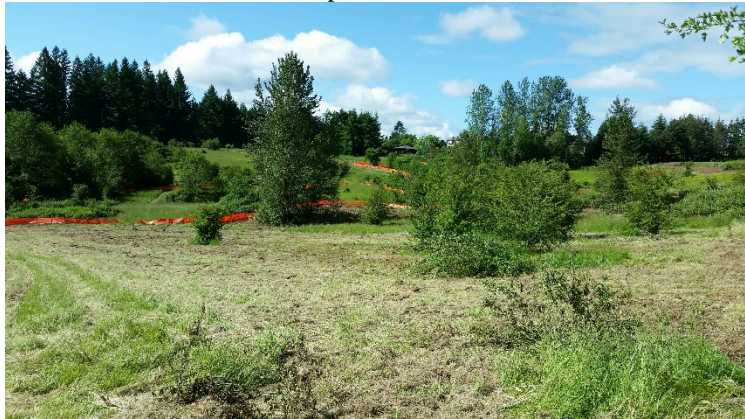
View looking south and east across DU03 and DU06 on June 2, 2017. Work to set up erosion control was beginning and areas had been mown and silt fencing was being erected.

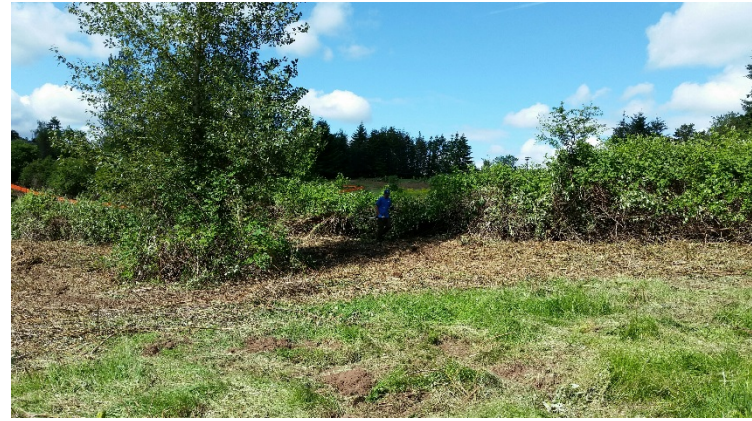
View looking north during sampling of DU01, following some clearing in preparation for erosion control installation.
