### FINAL REMEDIAL DESIGN/REMEDIAL ACTION (RD/RA) IMPLEMENTATION REPORT

#### **Troh Legacy Landfill**

10010 SE Vrandenburg Road  
Happy Valley, Oregon

January 7, 2020 (revised April 2, 2020)

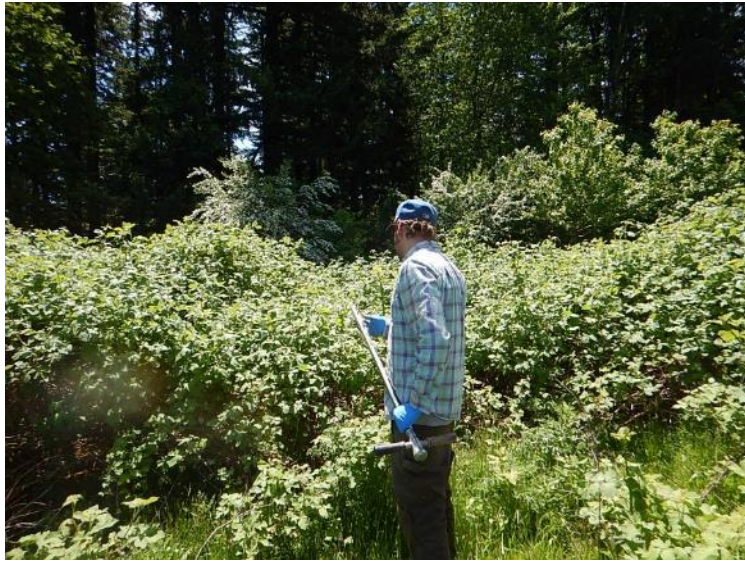
Import Soil Characterization - soil samples were obtained to ensure imported soil for the landfill cap was not impacted. Sample location on nearby parcels that were not part of the landfill area.

In May and June 2017, Creekside-ENW characterized surface soils<sup>6</sup> at Scouters Mountain Phase I residential subdivision marked for excavation and placement as cap materials on the nearby Troh Legacy Landfill. Scouters Mountain Phase I was divided into thirteen decision units (DUs), and representative surface soil samples were collected from each DU using Incremental Sampling Methodology (ISM). Thirteen surface soil samples and two replicate samples were analyzed for Resource Conservation and Recovery Act (RCRA) 8 Metals. All metals analyzed in 13 ISM samples and two replicate samples were either not detected or were below Oregon Department of Environmental Quality's (ODEQ's) Clean Fill Screening Levels (CFSLs). Based on these findings, surface soils at Scouters Mountain Phase I met or

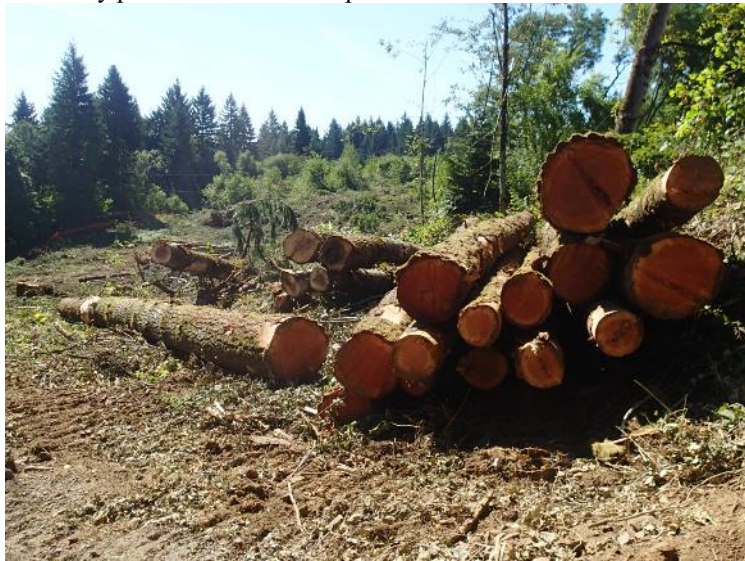
Surface of Troh Legacy Landfill was logged and cleared of brush – view south (August 16, 2017).

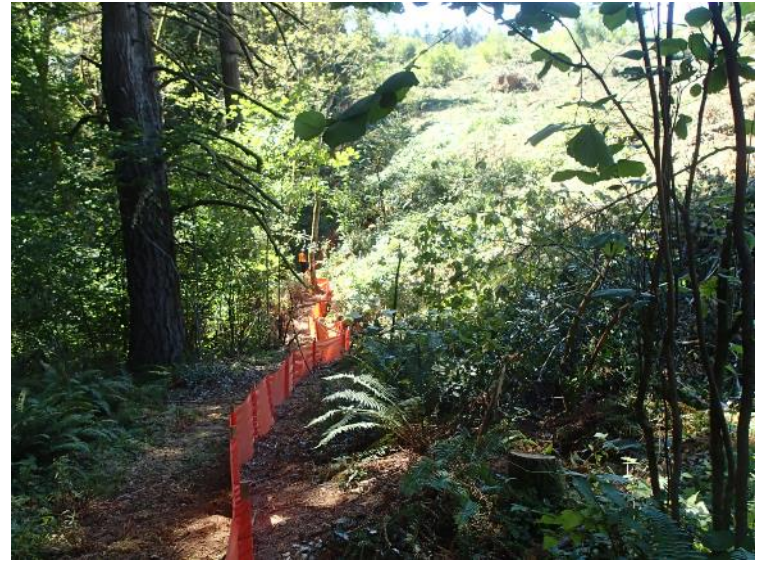
A silt fence was installed around the perimeter of the disturbed area – view of east boundary looking south (August 16, 2017).

By August 2017, erosion control measures were installed around the perimeter of the subject area (see Clearing and Demolition, below), and construction fence was installed on the bluff overlooking the landfill to restrict access to this area. In addition, two construction entrances bedded with pit run rock and gravel were constructed along the western boundary of the disturbed area. These construction entrances connected to haul routes for dump trucks and other heavy equipment transporting materials to and from the Subject Area.

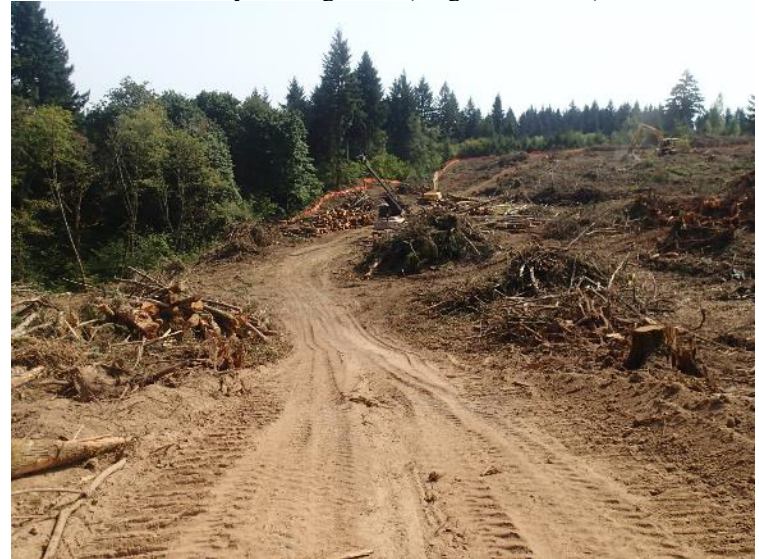
View south of cleared landfill surface with brush piles (August 22, 2017).

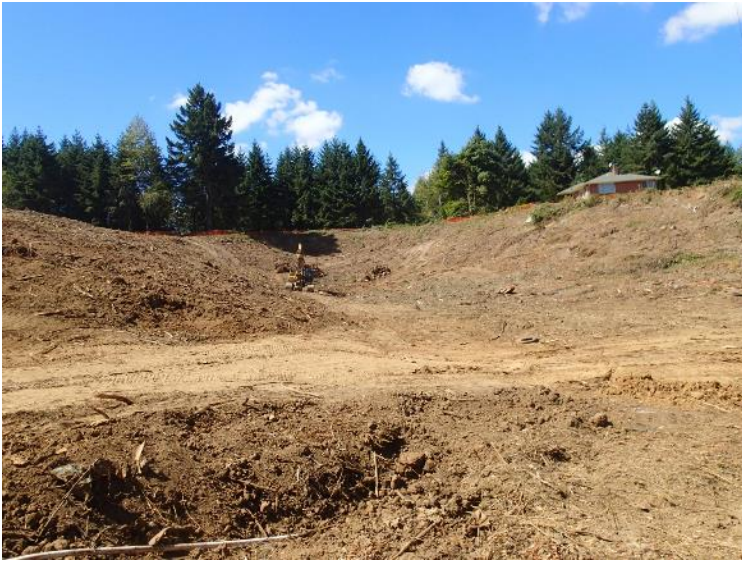
View looking west showing the de-vegetated landfill cap (August 31, 2017).

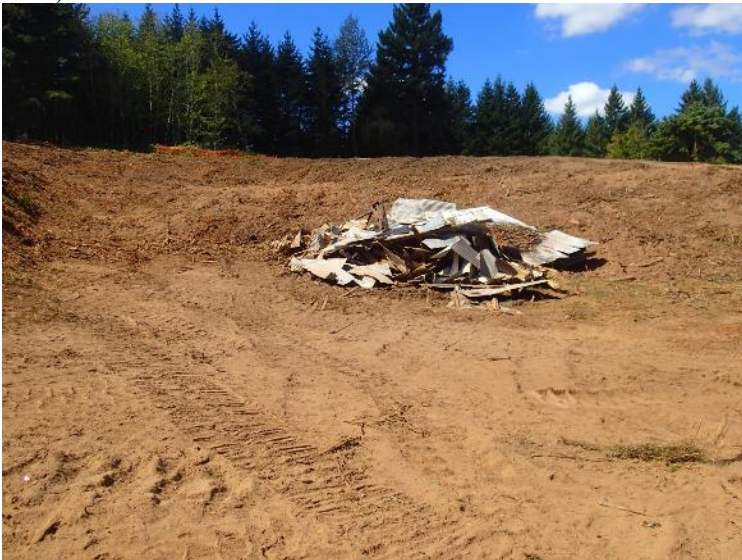
Near surface debris was gathered and disposed of or recycled (August 31, 2017).

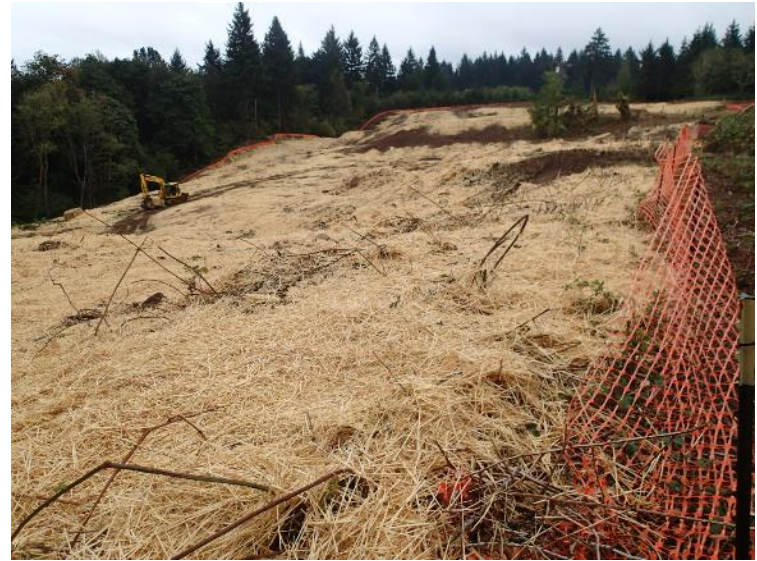
Straw was placed over the soil surface for erosion control purposes – view south (September 29, 2017).

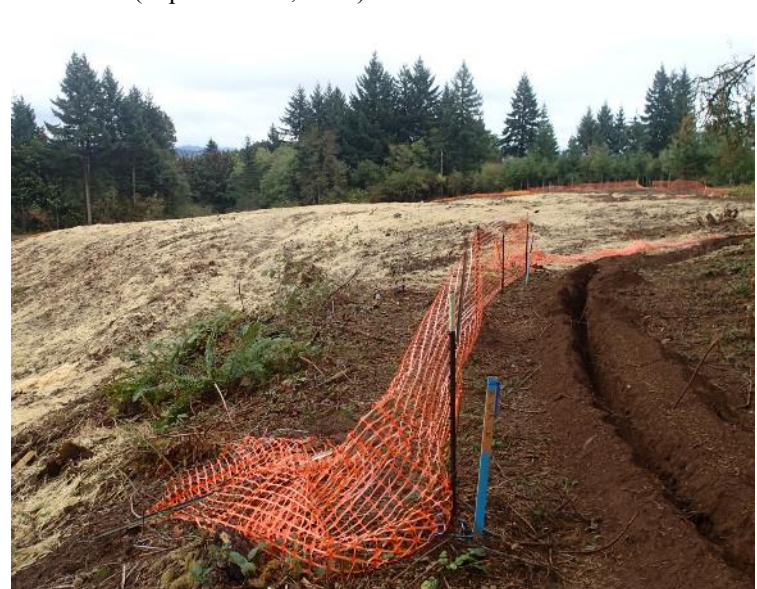
Water line to an east-adjacent residence was diverted around the landfill (October 13, 2017).

An overhead utility pole that crossed the landfill area was removed. A domestic water line that passed through the landfill area was re-routed around the perimeter of the landfill.

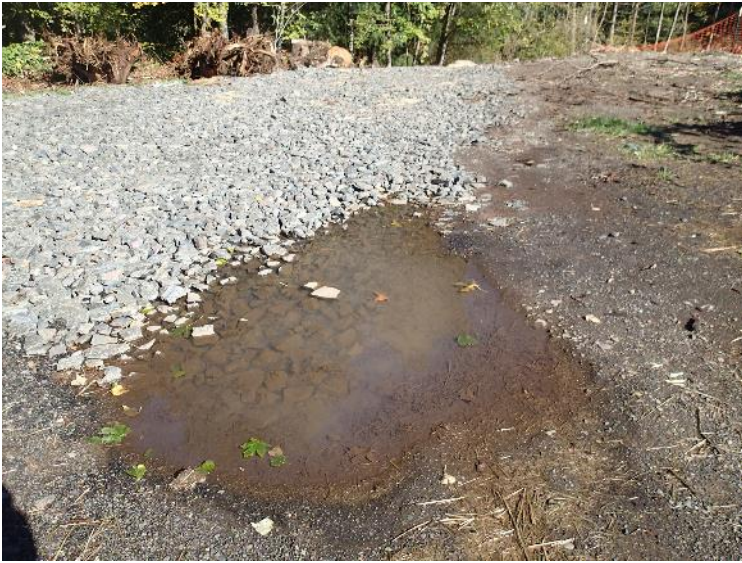
Rock was placed over the haul routes on the upslope west side of the landfill (October 13, 2017).

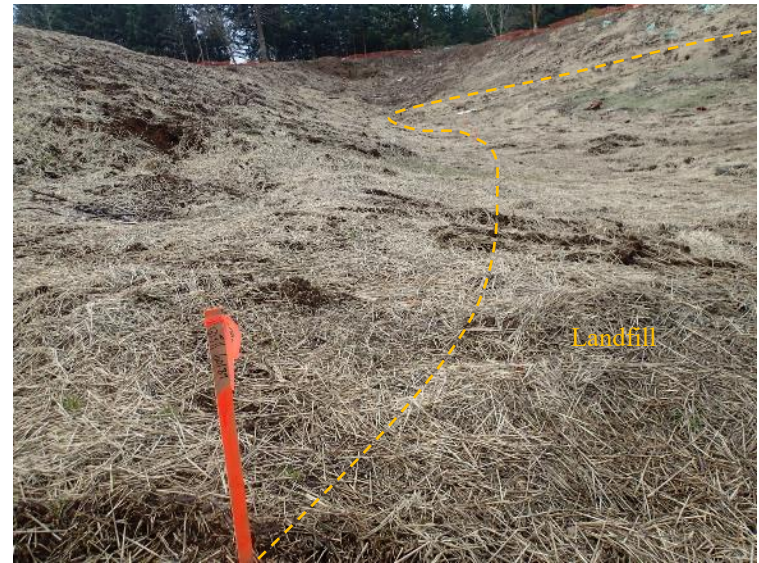
Surveyed landfill boundary (south) – looking west (January 2, 2018).

By January 2018, AKS surveyed and placed stakes around the perimeter of the landfill. This surveyed area provided a visual boundary for demarcation grid placement, as well as pre-grading reference surface elevations for fill placement.

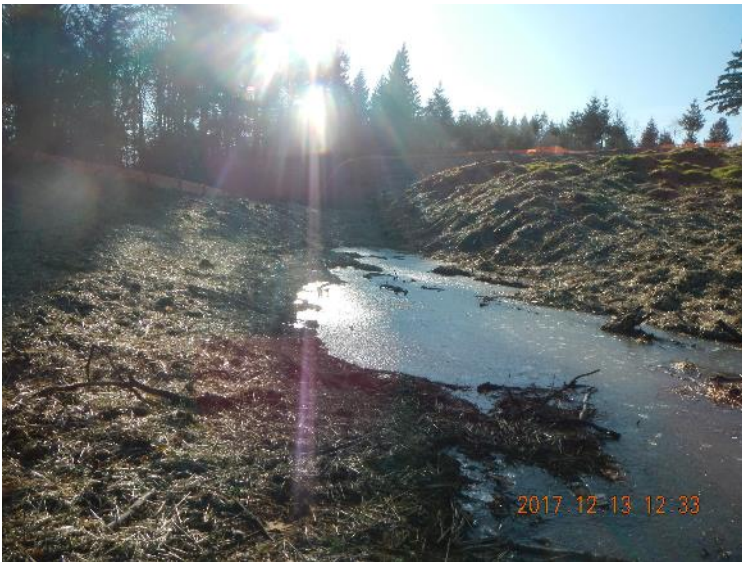
Ponded water on the south side of the landfill at the base of the ravine – view south (December 13, 2017).

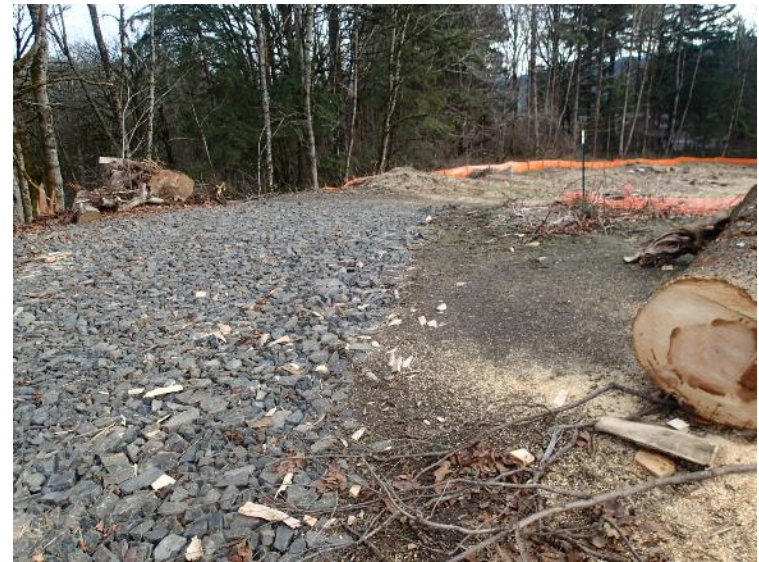
Northwest graveled haul road (January 2, 2018).

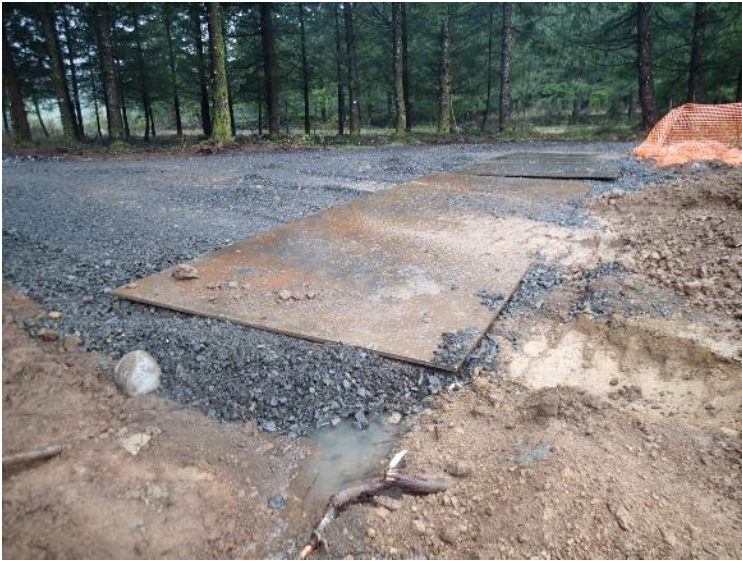
Steel plates positioned at unloading platform at the west margin of the landfill (January 18, 2018).

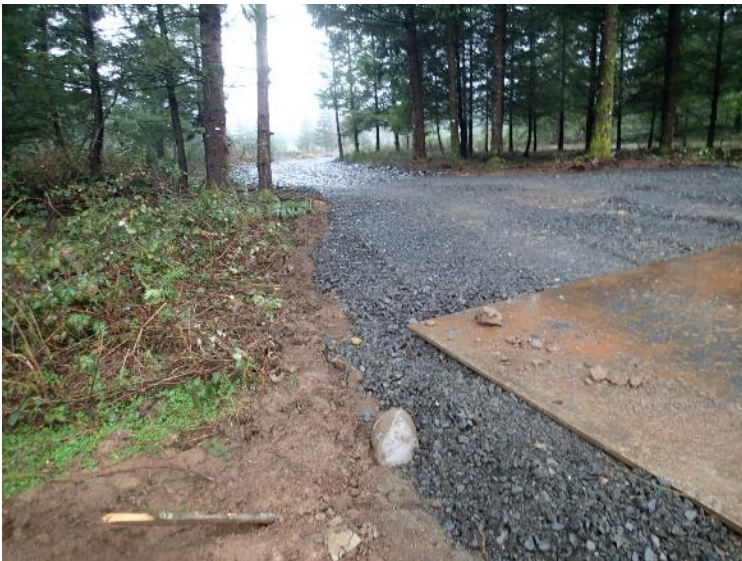
Graveled haul road west of the landfill (January 18, 2018).

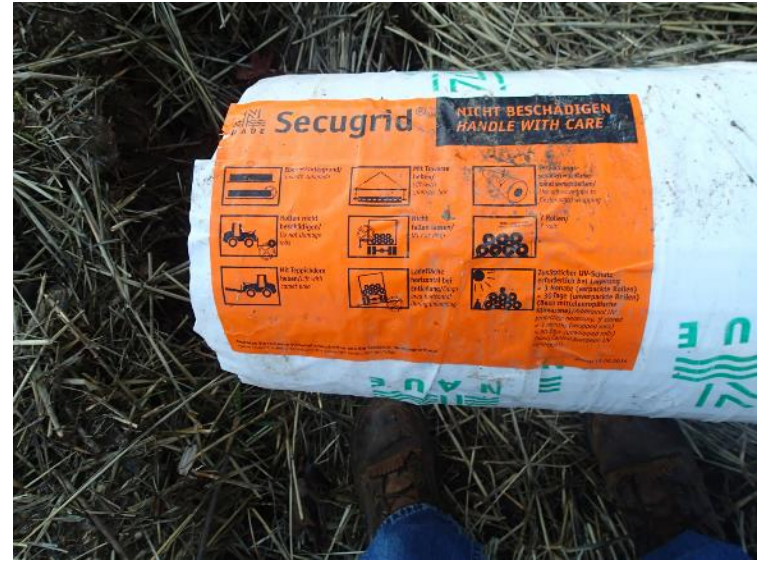
A roll of demarcation grid (geotextile) to be placed over the landfill footprint prior to installing cap (February 12, 2013).

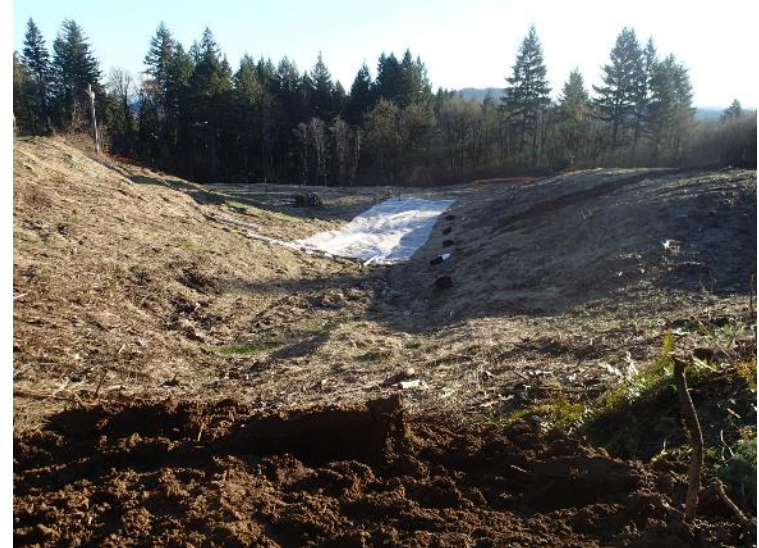
A portion of the demarcation layer rolled out over the landfill – view east (February 12, 2018).

In middle February 2018, White Securgrid® demarcation geotextile began to be installed in the ravine over the southern part of the landfill. The demarcation grid overlapped the surveyed landfill boundary by at least a few feet. The 20-foot-wide rolls were overlapped a foot or more, taking care to thoroughly cover the entire surveyed Troh Legacy Landfill area. Demarcation grid installation continued through the end of May 2018, at the north end of the landfill, covering the entire former landfill area.

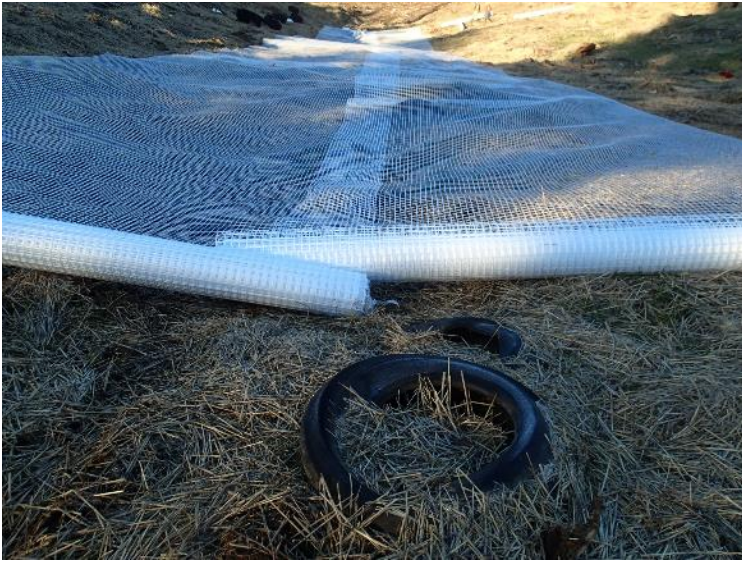
Close-up photo showing the overlapped demarcation grid – view west (February 12, 2018).

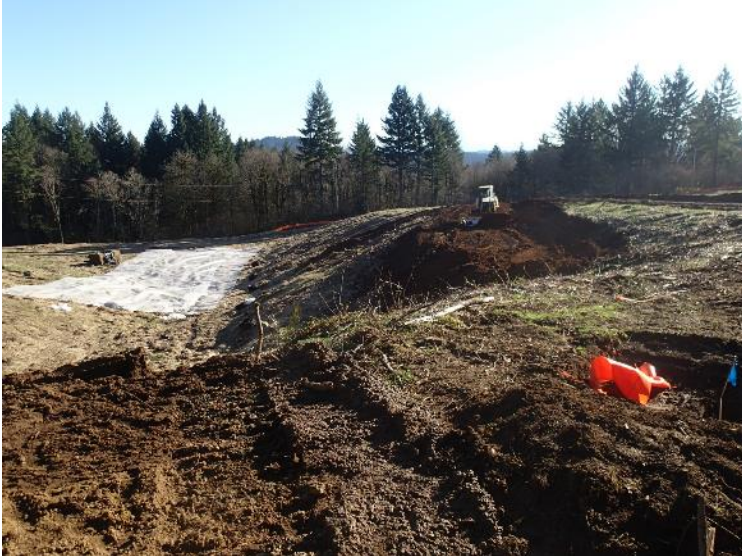
Construction of the buttress fill south of the landfill (right side of the demarcation represents the southernmost extent of the landfill) – view southeast (February 12, 2018).

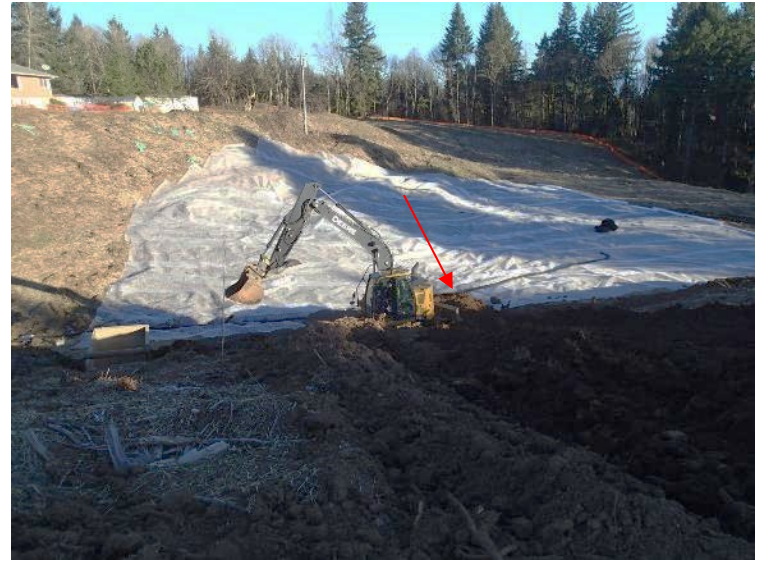
Demarcation placed over southwest corner of landfill. Note drain pipe placed along centerline of ravine – view north (February 13, 2018).

Four (4)-inch perforated flexible ABS drain pipe was installed along the centerline of the south ravine, the buttress fill structural keyways. These subdrains were bedded in and covered with drain rock and discharge along the eastern boundary of the Subject Area.

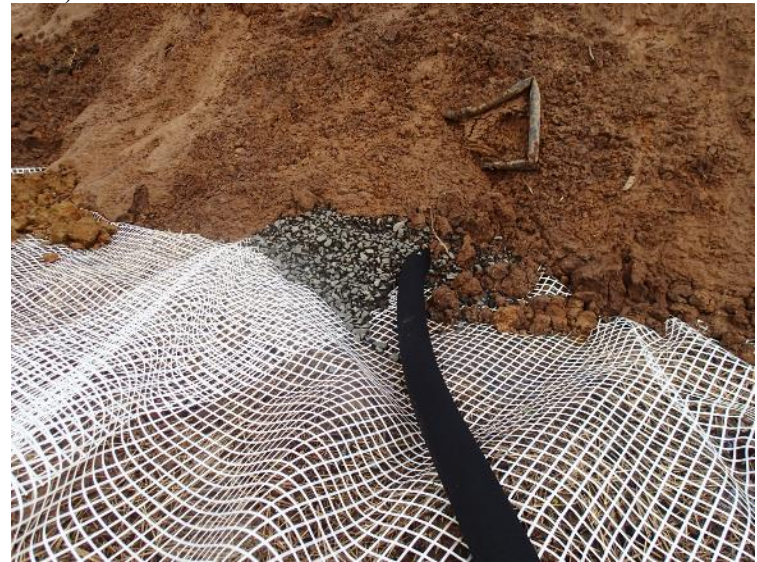
Drain pipe were bedded and covered with gravel prior to placing the soil cap (March 2, 2018).

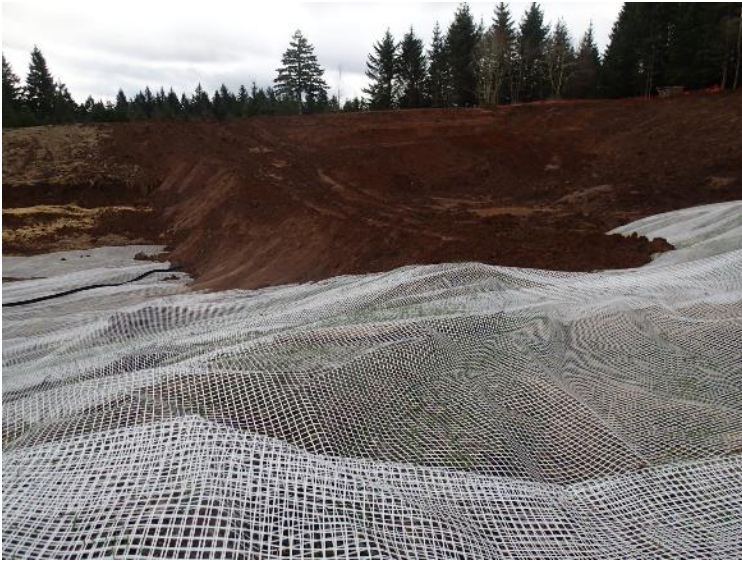
View south of buttress fill and soil cap beginning to be installed above the demarcation grid (March 2, 2018).

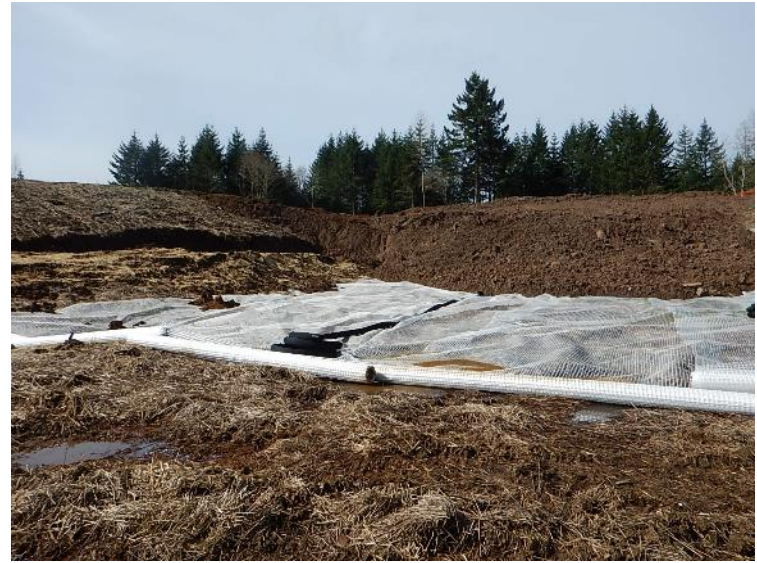
View west showing the buttress fill (left) and demarcation grid and cap (right). Note cap is substantially > 3 feet thick (March 29, 2018).

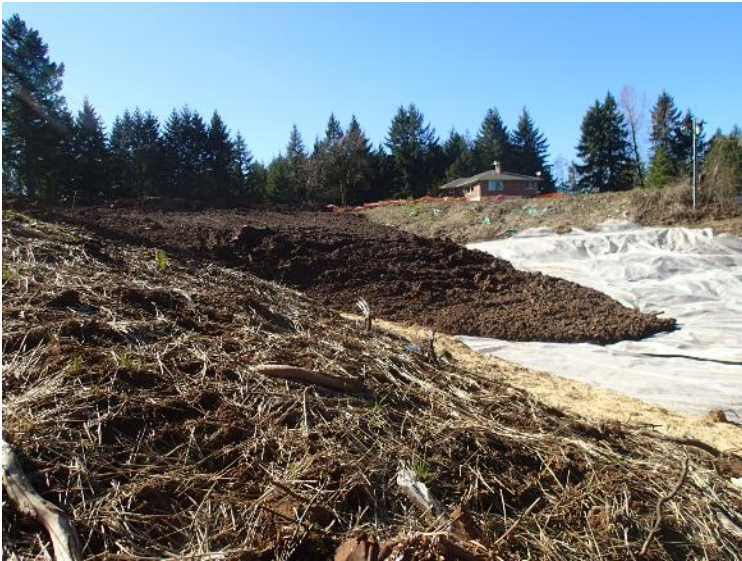
Continued cap installation over the demarcation grid on the southwest part of the landfill – view northwest (March 3, 2018).

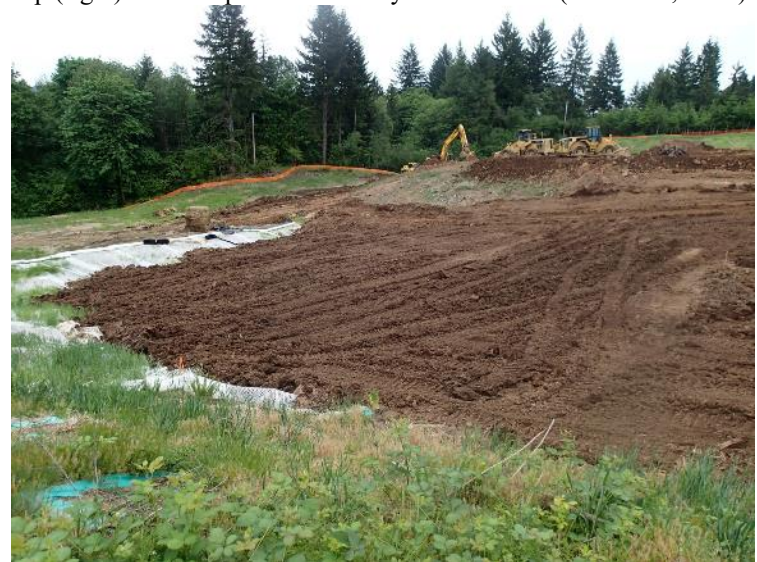
Landfill cap as it appears on May 17, 2018 – view southeast. Heavy equipment is sitting on the south buttress fill.

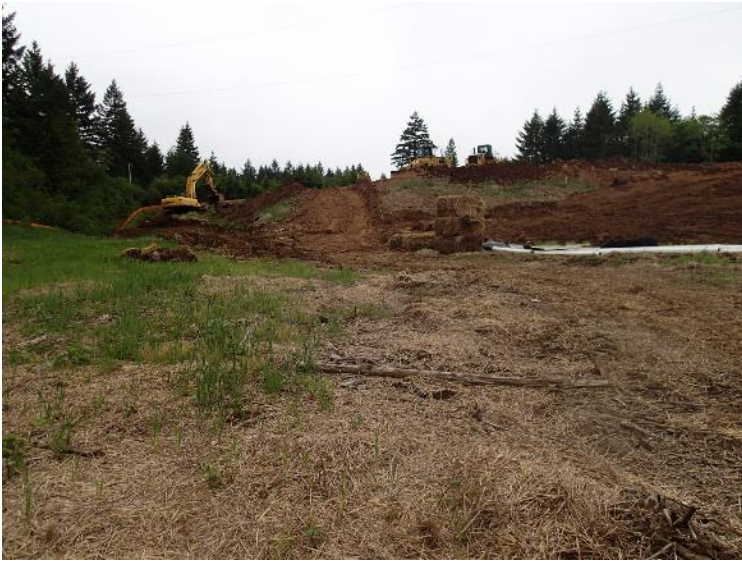
Keyway excavation of south buttress (May 17, 2018).

Earthwork began on the south buttress fill and landfill cap in early February 2018 and concluded in late August 2018. A structural keyway was excavated along the north and east sides of the buttress, and a subdrain was installed in this keyway. Imported soil transported to the south buttress and south part of the landfill was delivered to the east end of the haul route located near the southwest corner of the disturbed area, where it was unloaded. From there, bulldozers pushed the soil to the south buttress fill area and south ravine of the landfill after the demarcation and subdrain were installed. The buttress fill was compacted using a sheeps-foot roller. The majority of fill ended up being placed in the south buttress area.

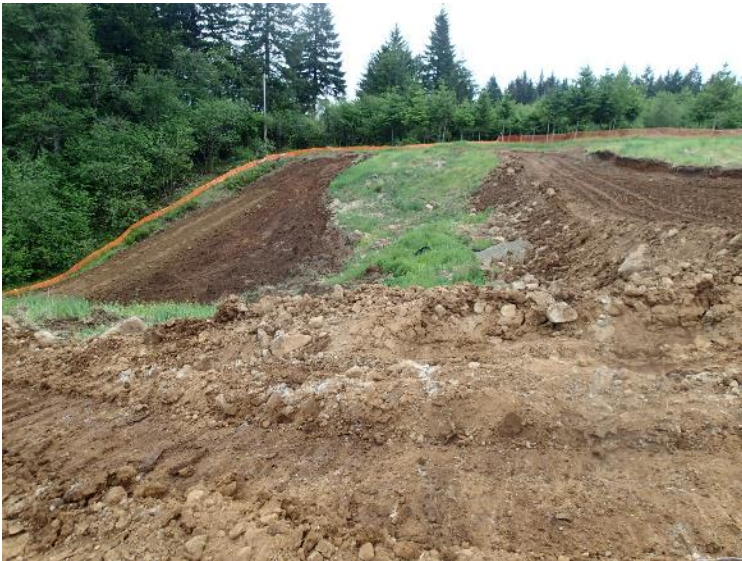
South buttress keyway (left) and bench (right) as seen on May 17, 2018).

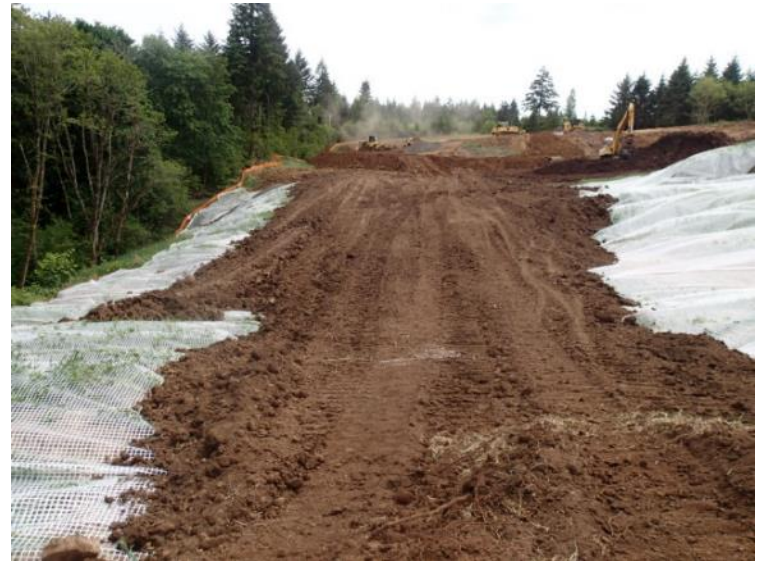
Soil cap being installed over the demarcation grid at the east-central part of the landfill – view south (May 30, 2018).

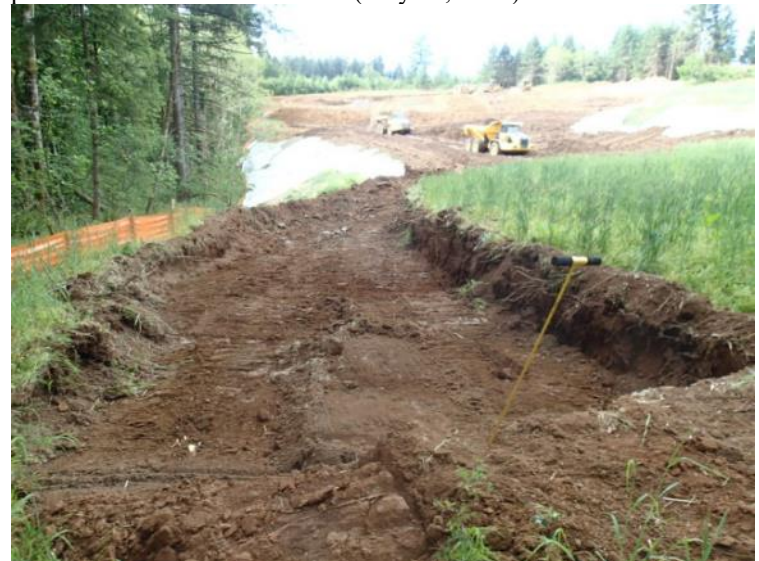
Keyway excavation along the east side of the north buttress fill - view south (June 1, 2018).

Earthwork began on the north buttress fill and landfill cap in the first of June 2018 and continued through the end of August 2018. A structural keyway was excavated along the south and east sides of the buttress, and a subdrain was placed along the keyway. Imported soil transported to the north buttress and northern parts of the landfill was delivered to the southeast end of the haul road located near the northwest corner of the disturbed area, where it was unloaded. Bulldozers pushed the soil to the north buttress fill area and north part of the landfill after the demarcation grid was installed.

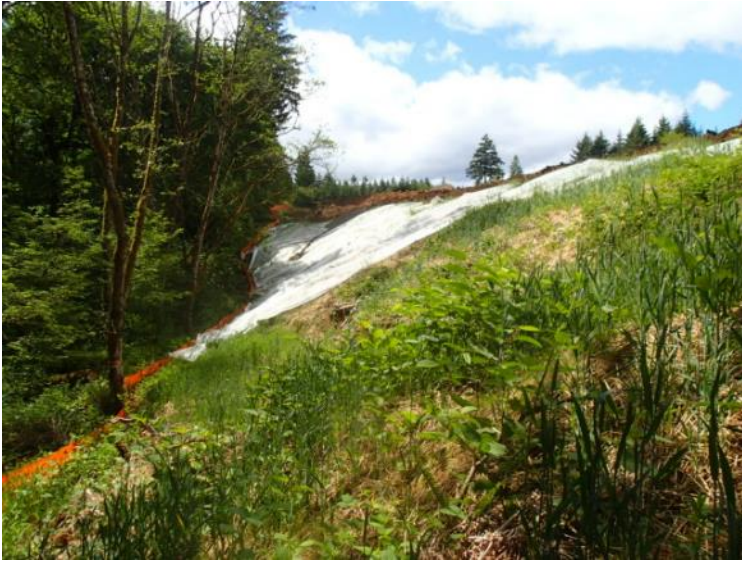
Demarcation grid installation along the east-central edge of the landfill - view south (June 1, 2018).

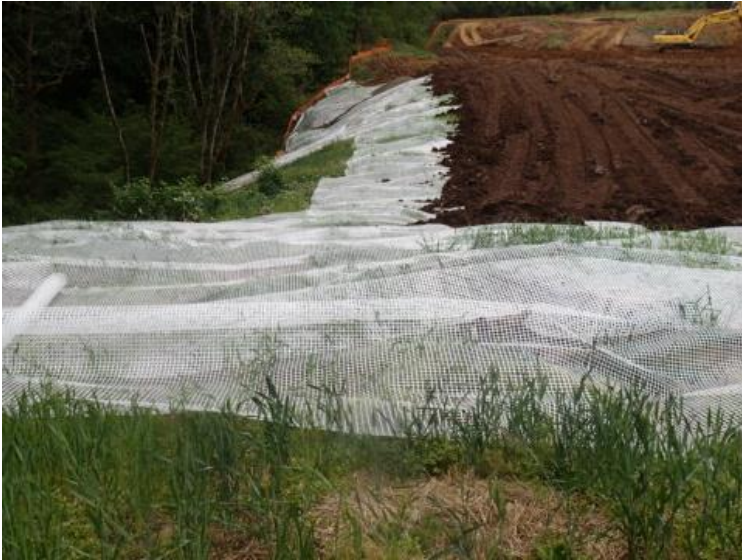
Cap installation at the north end of the landfill – view south (June 1, 2018).

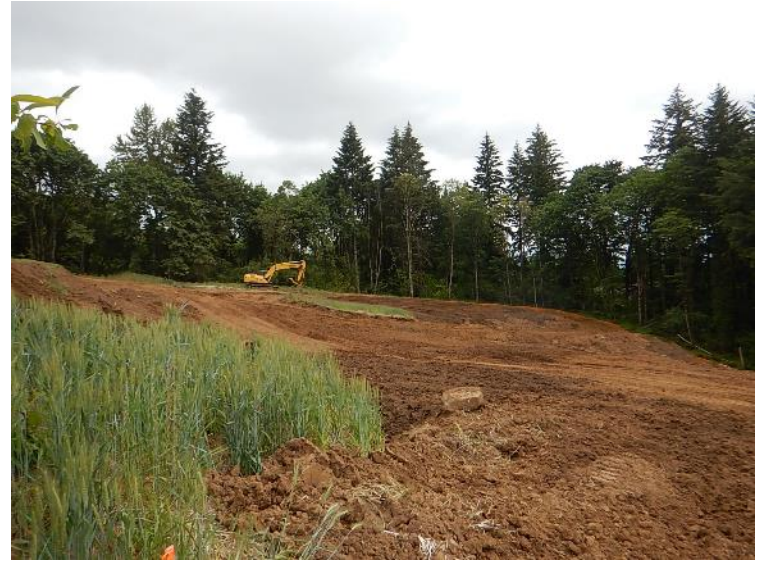
View north of cap at the north end of the landfill (June 7, 2018).

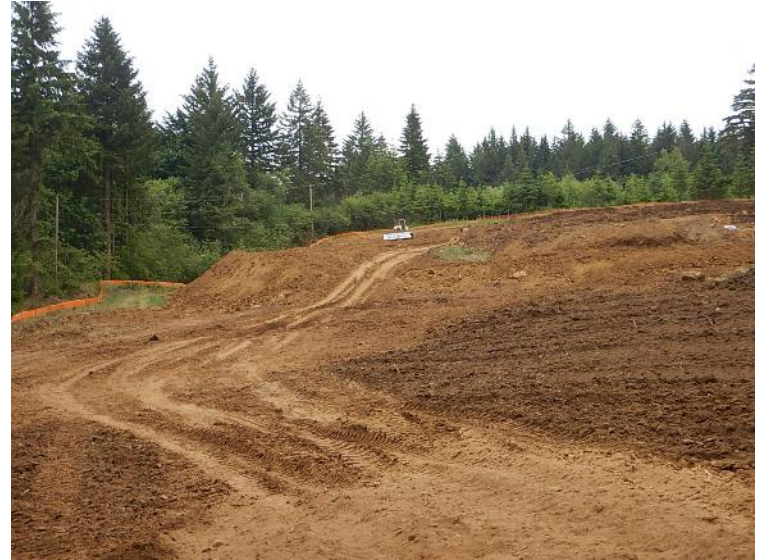
South buttress fill (June 7, 2018).

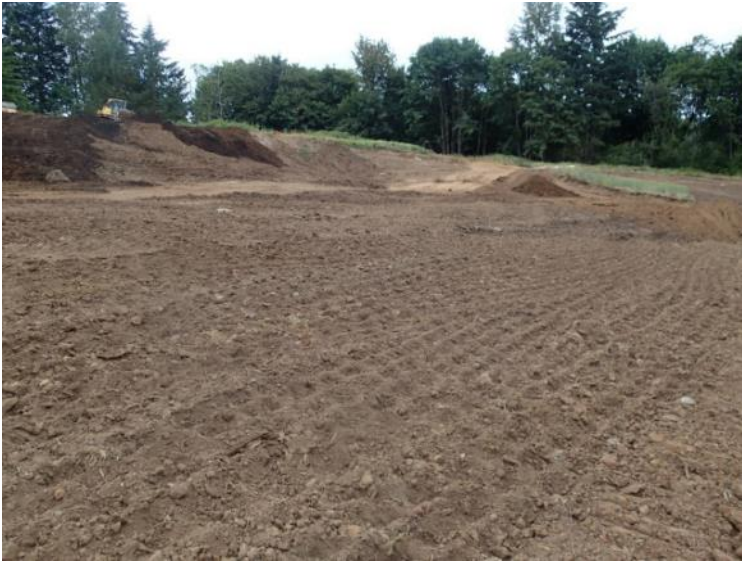
Cap surface was tracked and compacted with a sheepsfoot roller perpendicular to slope (June 25, 2018).

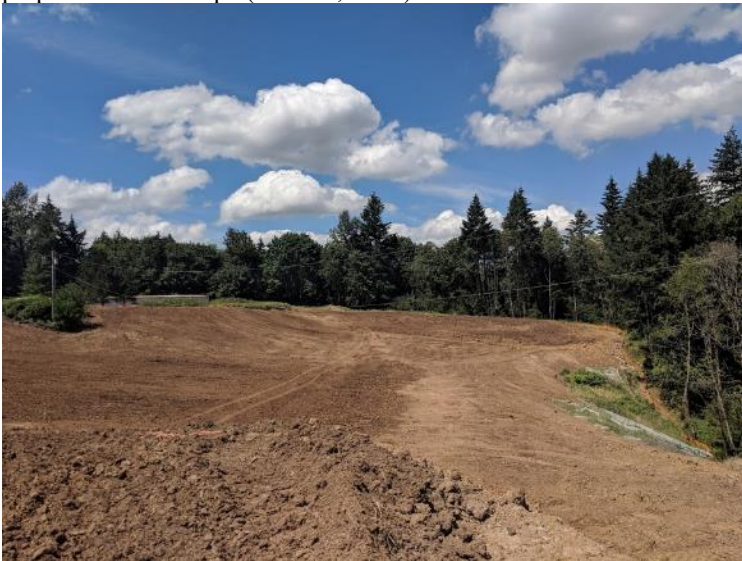
View north of the capped landfill from the vantage of the south buttress fill (July 6, 2018).

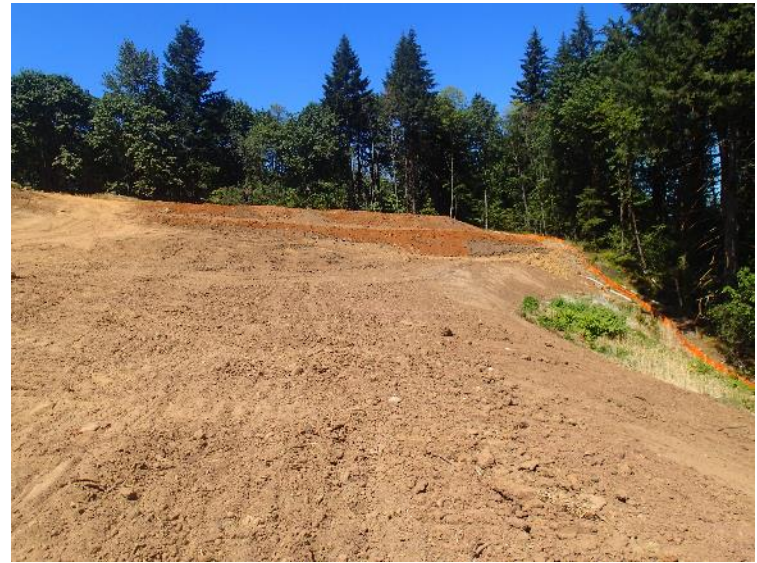
North buttress fill (July 24, 2018).

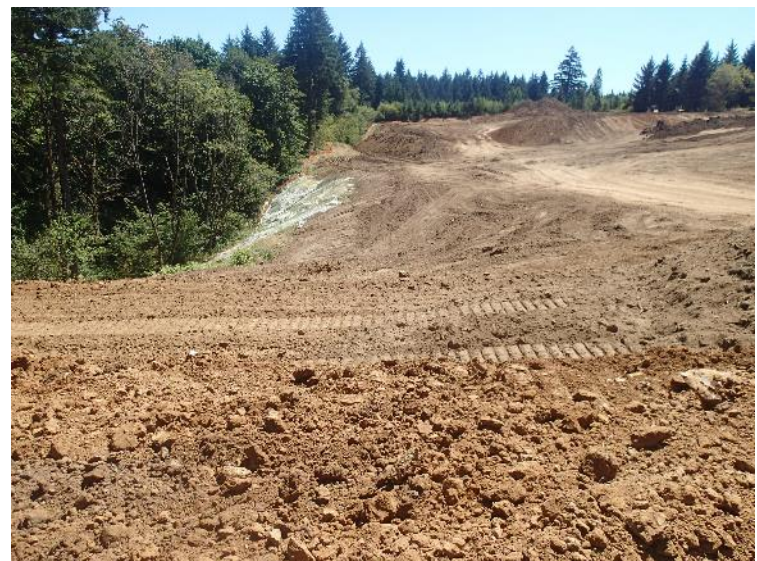
South buttress fill (under construction) from the perspective of the north buttress (July 24, 2018).

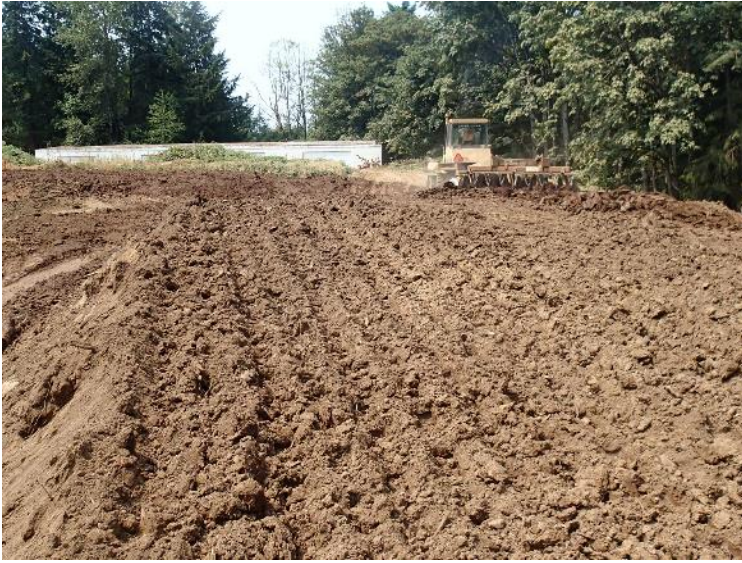
North end of landfill cap being prepared for seeding.

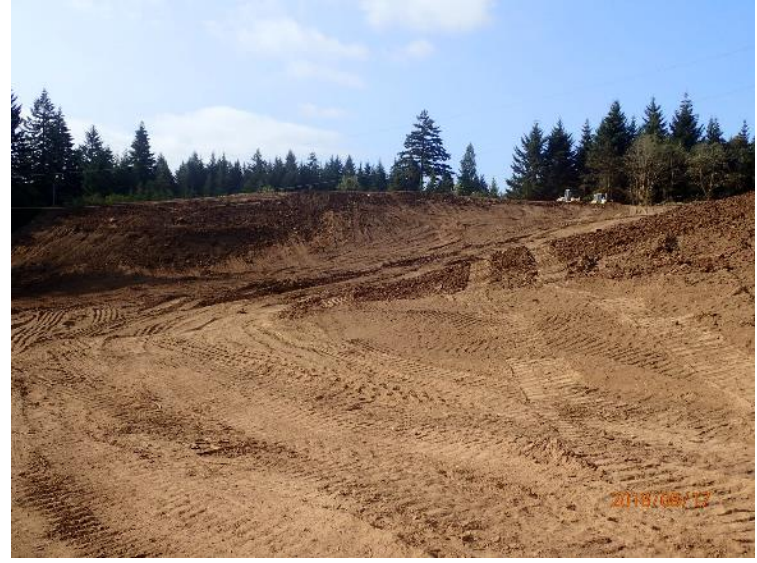
South buttress fill on August 17, 2018.

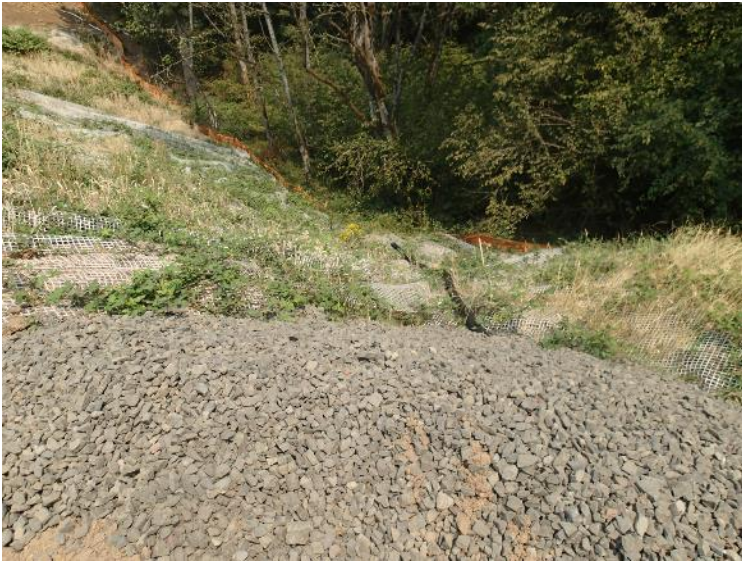
Drain rock was placed over the ravine drain line. Drain pipe exits at the eastern landfill boundary, which has not yet been capped as of this date (August 8, 2018).

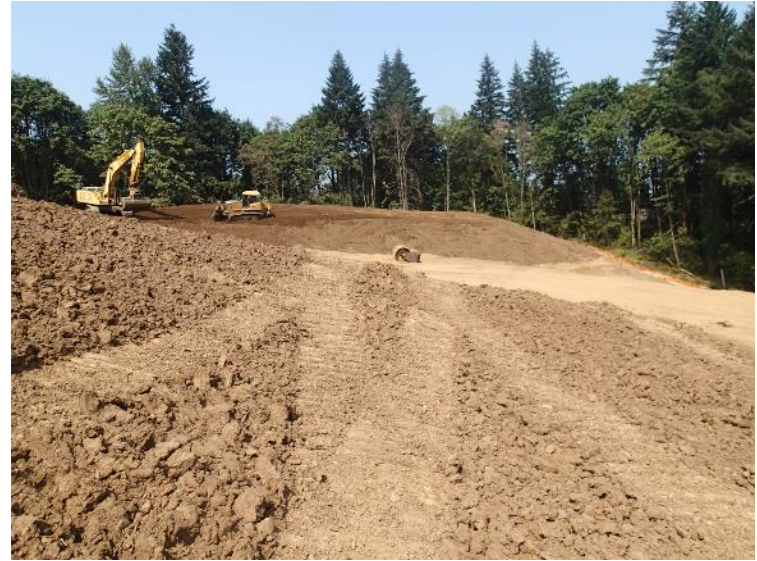
North buttress fill on August 22, 2018.

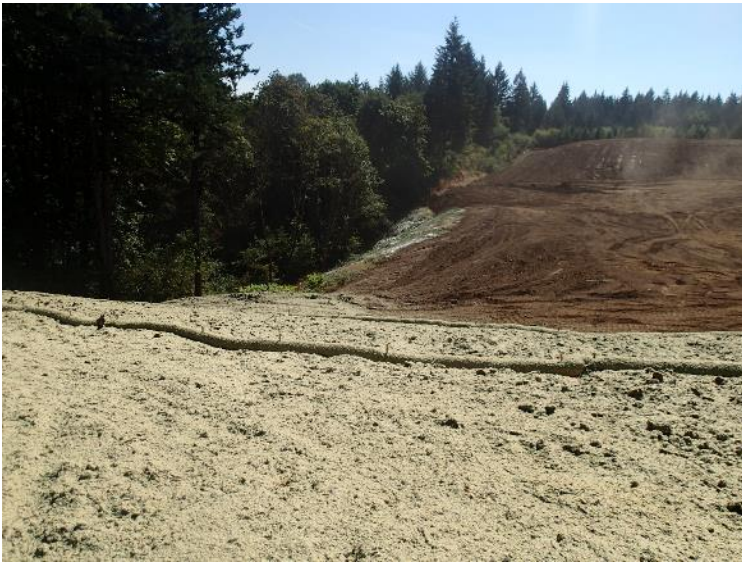
North buttress fill was hydroseeded and straw wattles placed according to erosion and sediment control plan (August 29, 2018).

At the end of August 2018, the north buttress fill was hydroseeded and straw wattles placed according to the Erosion and Sediment Control Plan. In early October 2019, straw wattles were placed on the remaining portions of the landfill and the south buttress fill, and the surface was hydroseeded. A disc was used to prepare the buttress fills and landfill cap surfaces for seeding. By November 2018, the grass seed had taken root and covered the buttress fills and landfill cap with a lush, green grass cover. Evidence of minor soil erosion was observed beyond the limits of the planned soil cap during Creekside/ENW's site inspections in November 30, 2019. The two areas were immediately stabilized with diversion of a drainage pipe and regrading of the sloped area.

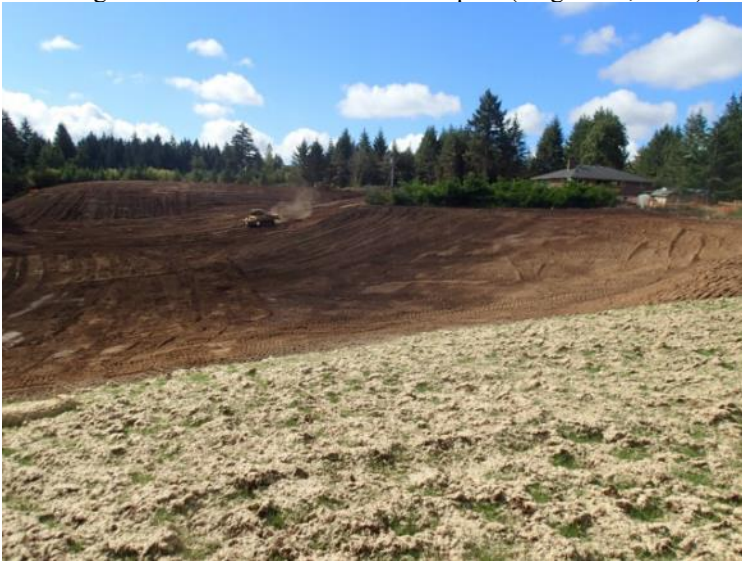
Grass has taken root on the north buttress fill, and the remainder of the landfill is being prepared for hydroseeding (September 14, 2018).

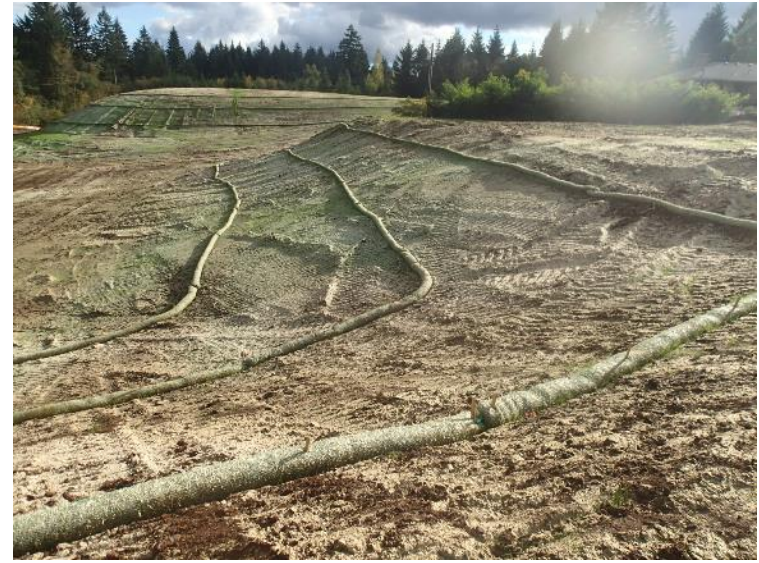
Straw wattles were placed on the remaining portions of the landfill, after which the ground surface was hydroseeded– view south (October 9, 2018).

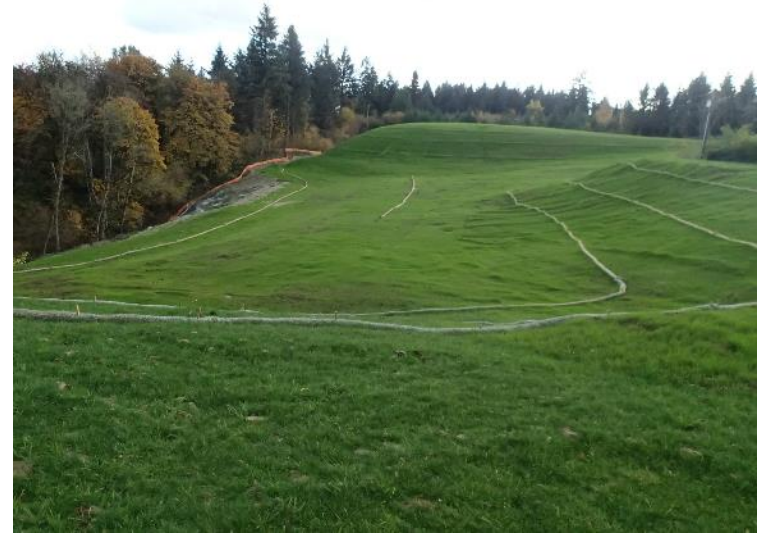
Grass has taken root over the capped landfill and buttress fills – view south (November 6, 2018).

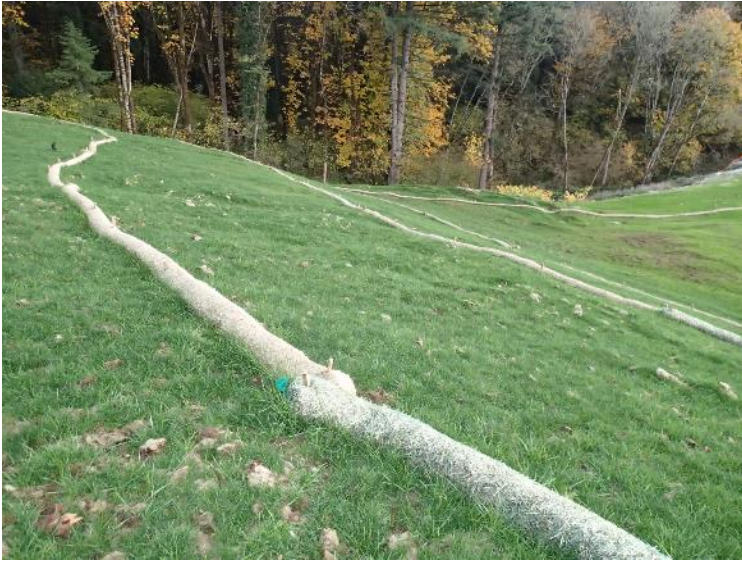
North buttress fill – view east (November 6, 2018).

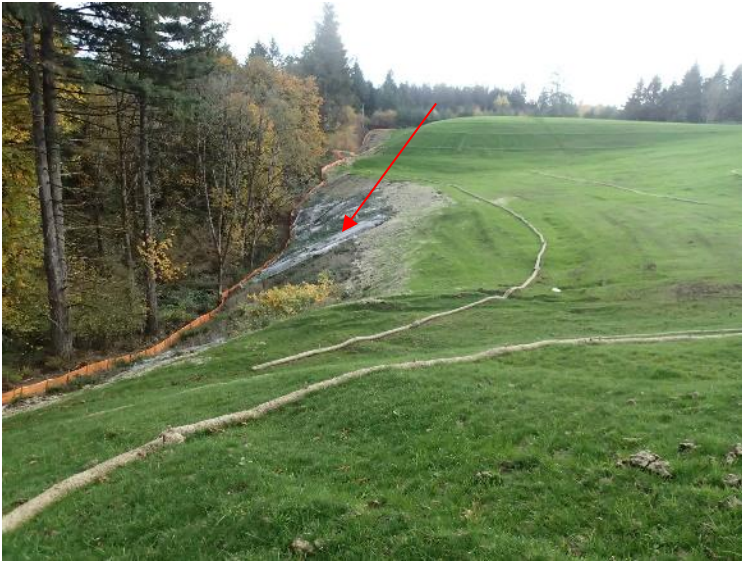
Area where rip-rap was proposed to cap the steep, eastern margin of the landfill where the demarcation grid is still visible.

Due to steep terrain, soil placed over the uncapped portion of the steep, eastern edge of the landfill was deemed impracticable to compact and stabilize. Stabilizing the eastward sloping terrain is important in protecting the forested area further downslope of the landfill. Accordingly, Creekside/ENW and AKS Engineering proposed an alternative protective cover.

2. Placement of 1-foot thick layer of rip-rap.

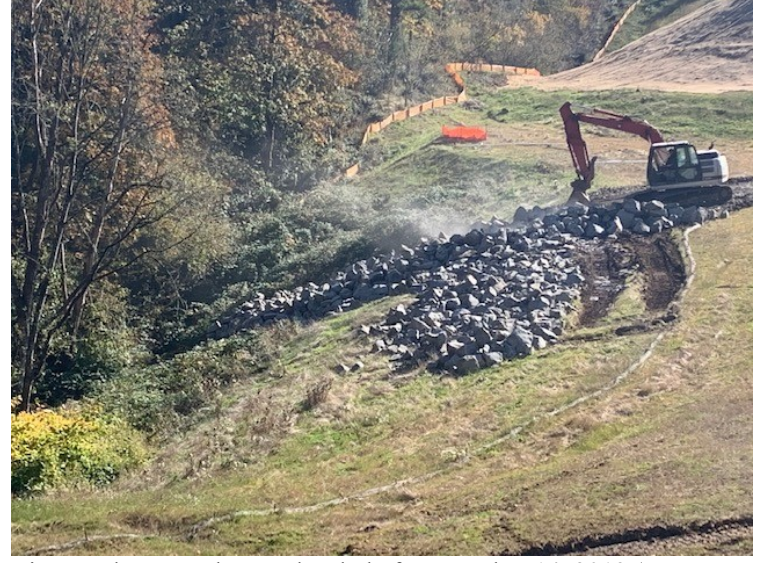
Rip-rap placement began shortly before October 14, 2019 (note, demarcation barrier is present beneath area where rip-rap was placed, however is obscured by growing grass).

Kerr Contractors installed the additional cap in October 2019 according to plan. A road was constructed to provide access from the haul route at the south entrance, down the south ravine to the placement site. A track hoe unloaded the rip-rap directly from the trucks and pushed it downslope from the top of the east margin bank. Logs were placed at the toe of the embankment to contain the new rip-rap and preventing it from entering the downslope forested area. After the rip-rap cover was installed, the work site was stabilized with hay cover for erosion control. Drawings in Attachment B includes a final topo survey showing where the soil versus rip-rap were placed, the minimum design thickness required in these areas, and as-built cross sections.
