### FINAL REMEDIAL DESIGN/REMEDIAL ACTION (RD/RA) IMPLEMENTATION REPORT

#### **Troh Legacy Landfill**

10010 SE Vrandenburg Road  
Happy Valley, Oregon

January 7, 2020 (revised April 2, 2020)

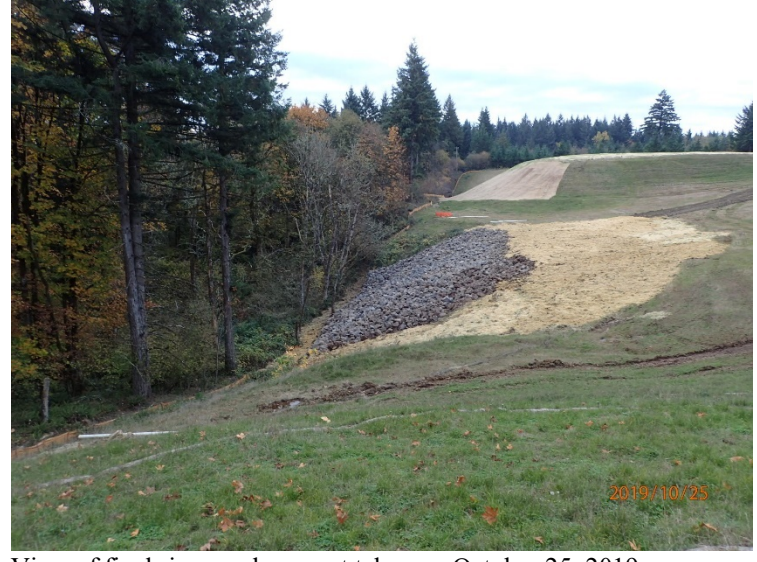
View of final rip-rap placement taken on October 25, 2019.

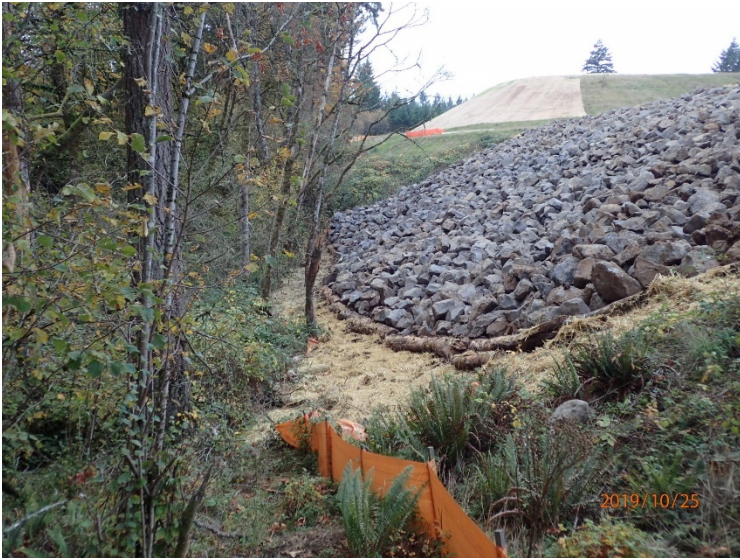
The toe of the rip-rap extended to the east margin of the landfill covering all remaining demarcation fabric.

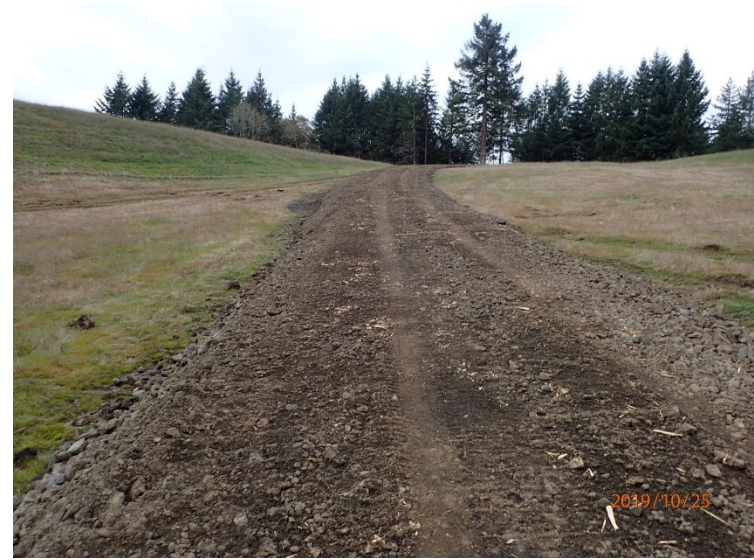
View of access road used to facilitate access for loading equipment while installing the rip-rap.

Kerr Contractors installed the additional cap in October 2019 according to plan. A road was constructed to provide access from the haul route at the south entrance, down the south ravine to the placement site. A track hoe unloaded the rip-rap directly from the trucks and pushed it downslope from the top of the east margin bank. Logs were placed at the toe of the embankment to contain the new rip-rap and preventing it from entering the downslope forested area. After the rip-rap cover was installed, the work site was stabilized with hay cover for erosion control. Drawings in Attachment B includes a final topo survey showing where the soil versus rip-rap were placed, the minimum design thickness required in these areas, and as-built cross sections.

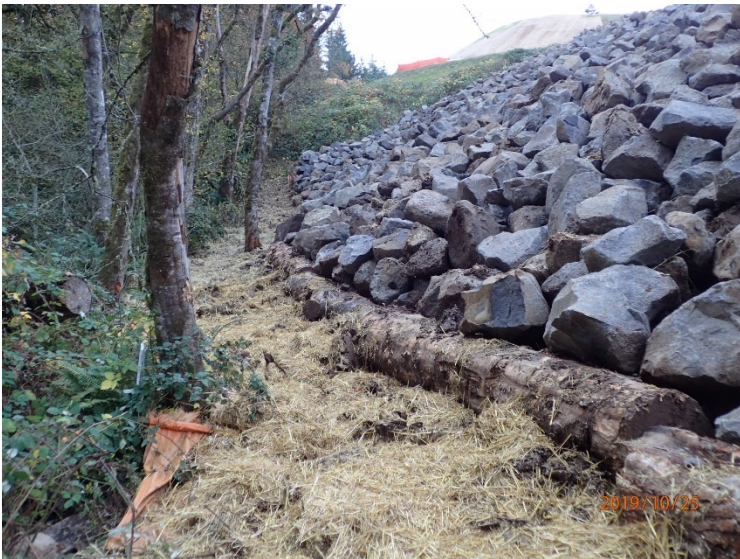
Logs secure and stabilize the downslope margin of rip-rap.

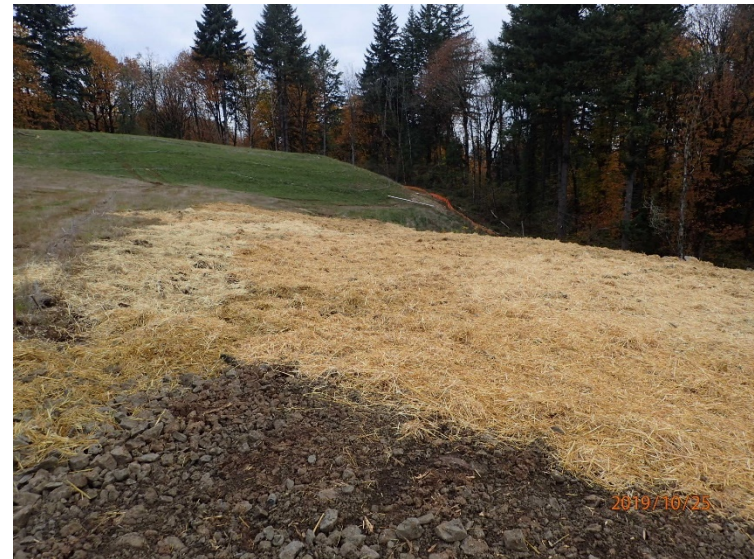
The construction area was stabilized and reseeded following installation of the rip-rap cover.
