RE: RD/RA Installation Progress Report
Troh Legacy Landfill (ECSI No. 5257)

Creekside Environmental Consulting (Creekside) has collaborated with EVREN Northwest, Inc. (ENW) on this Remedial Design/Remedial Action (RD/RA) Installation Summary Report / Annual Report for the subject site located at 10010 SE Vradenburg Road, in the City of Happy Valley¹. Upon completion of the RD/RA, i.e., completion of the Managed Soil Cap remedial action alternative, Creekside-ENW will submit a Final RD/RA Installation Report pursuant to Creekside-ENW's RD/RA Work Plan. This progress report outlines the components of the Managed Soil Cap remedial action alternative that have been completed to date as well as those components that remain to be accomplished.

FIGURE 3
MANAGED CAP AND BUTTRESS FILL MAP
 FORMER TROH LEGACY LANDFILL PROPERTY
 10010 SE VRADENBURG ROAD
 HAPPY VALLEY, CLACKAMAS COUNTY, OREGON

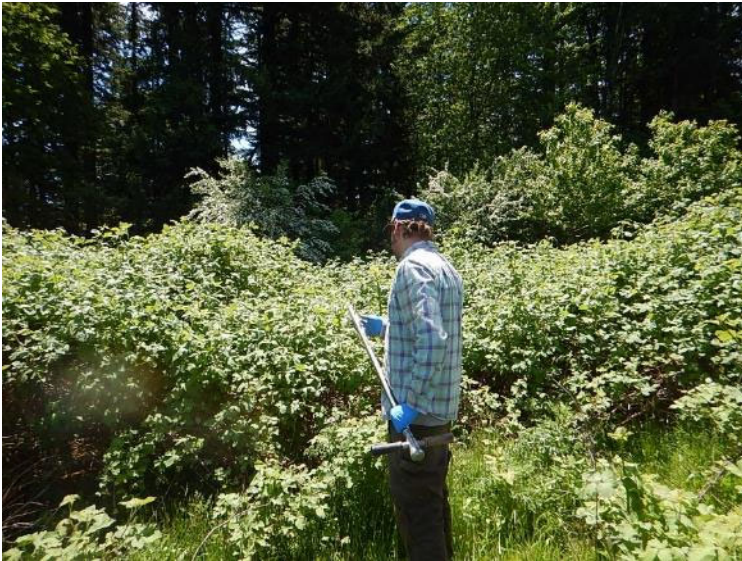
Import Soil Characterization - soil samples were obtained using a stainless-steel probe, advanced approximately 6-inches bgs, with the lower 3 to 4 inches retained.

Import Fill Characterization – In May and June 2017, Creekside-ENW characterized surface soils⁵ at Scouters Mountain Phase I residential subdivision marked for excavation and placement as cap materials on the nearby Troh Legacy Landfill. Scouters Mountain Phase I was divided into thirteen decision units (DUs), and representative surface soil samples were collected from each DU using Incremental Sampling Methodology (ISM). Thirteen surface soil samples and two replicate samples were analyzed for RCRA 8 Metals. All metals analyzed in 13 ISM samples and two replicate samples were either not detected or were below ODEQ's Clean Fill Screening Levels (CFSLS). Based on these findings, surface soils at Scouters

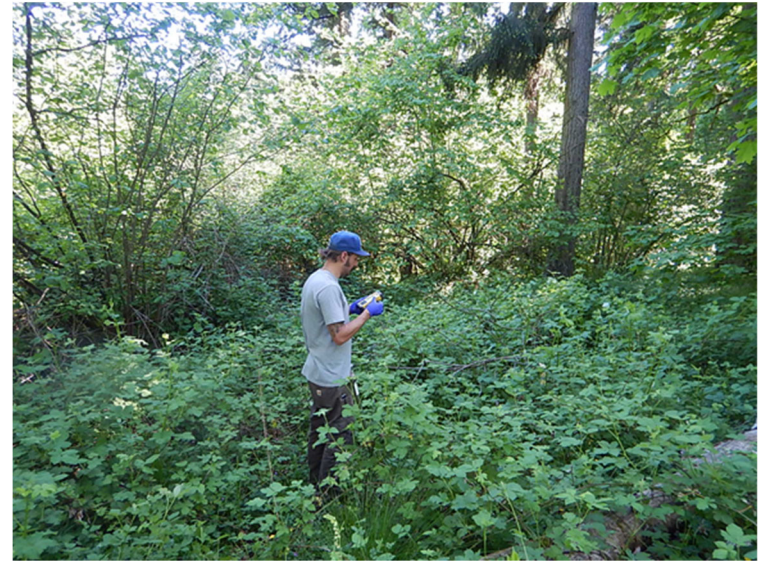
Import Soil Characterization - each subsample location was recorded using a handheld GPS unit. This assured obtaining 64 subsamples across the site with appropriate coverage.

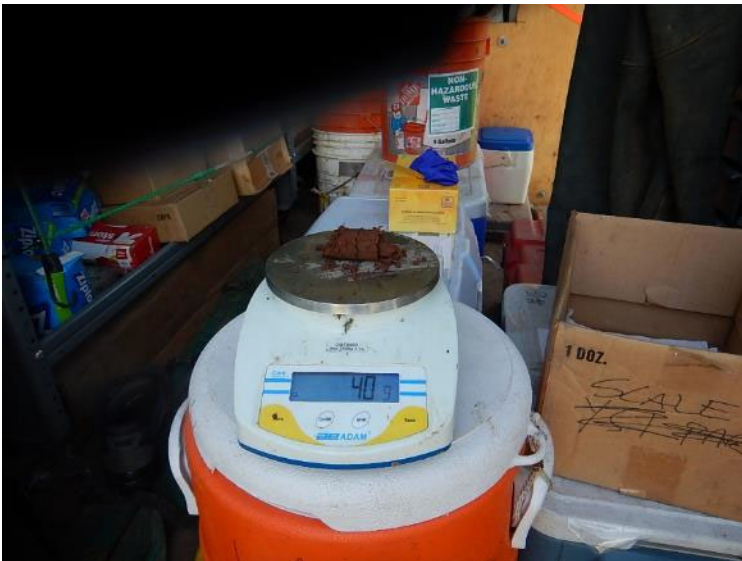
Import Soil Characterization - 64 subsamples (approx. 40-grams each) were combined into an incremental sample for analysis.

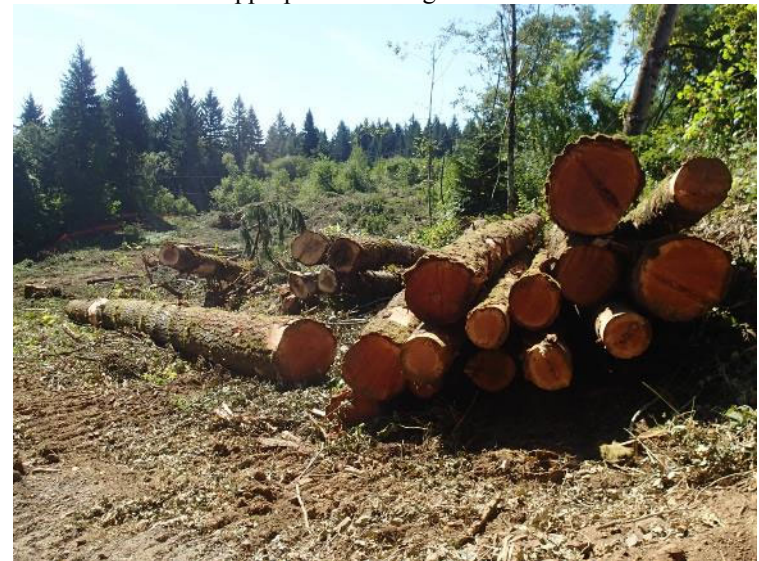
Surface of Troh Legacy Landfill was logged and cleared of brush - view south (August 16, 2017).

Clearing and Demolition – In August 2017, trees were felled, brush cleared, and grasses/weeds grubbed from the surface of the entire disturbed area. Logs, brush, root masses, brush and grass were hauled off-site for disposal. A shed was demolished, and demolition debris and metal were removed from the site for disposal and recycling. Straw was placed over the entire disturbed area of the site for erosion and sediment control purposes.

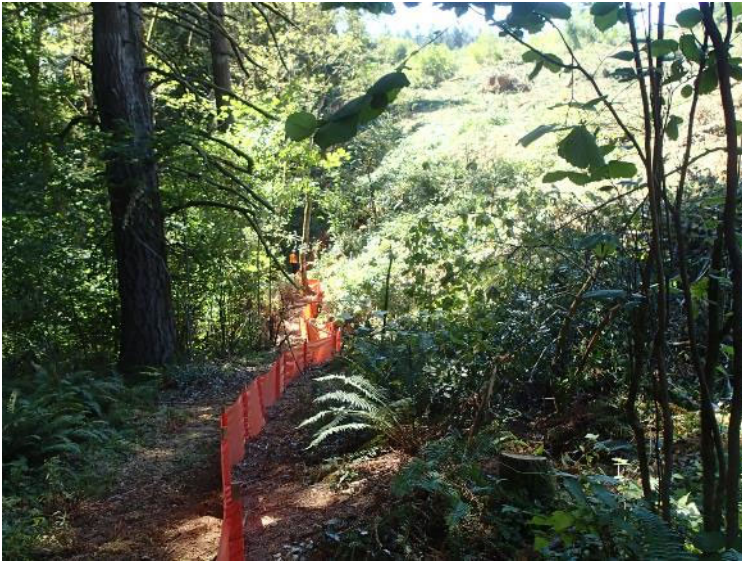
A silt fence was installed around the perimeter of the disturbed area – view of east boundary looking south (August 16, 2017).

Erosion and Sediment Controls – By August 2017, silt fence was installed around the perimeter of the disturbed area, and construction fence was installed on the bluff overlooking the landfill. In addition, two construction entrances bedded with pit run rock and gravel were constructed along the western boundary of the disturbed area (Figure 3). These construction entrances connected to haul routes for dump trucks and other heavy equipment transporting materials to and from the disturbed area.

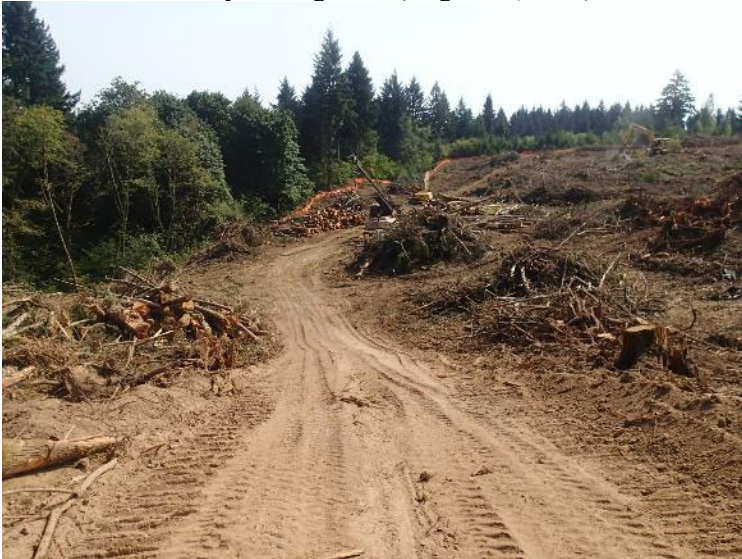
View south of cleared landfill surface with brush piles (August 22, 2017).

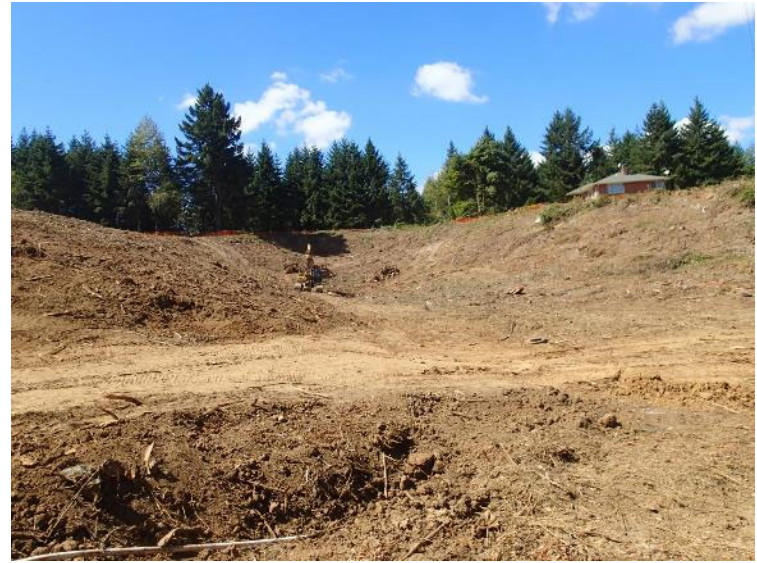
View looking west showing the de-vegetated landfill cap (August 31, 2017).

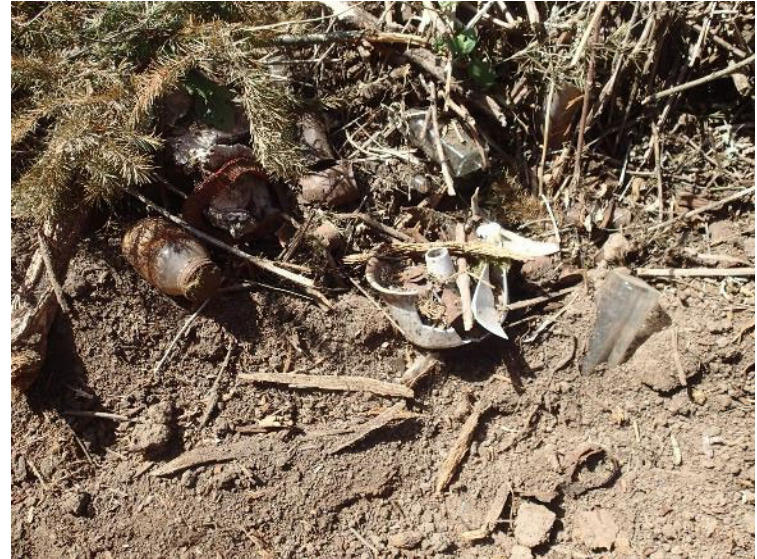
De minimis quantities of solid waste exposed at the ground surface were not removed since the entire landfill would be capped with 3 feet of soil.

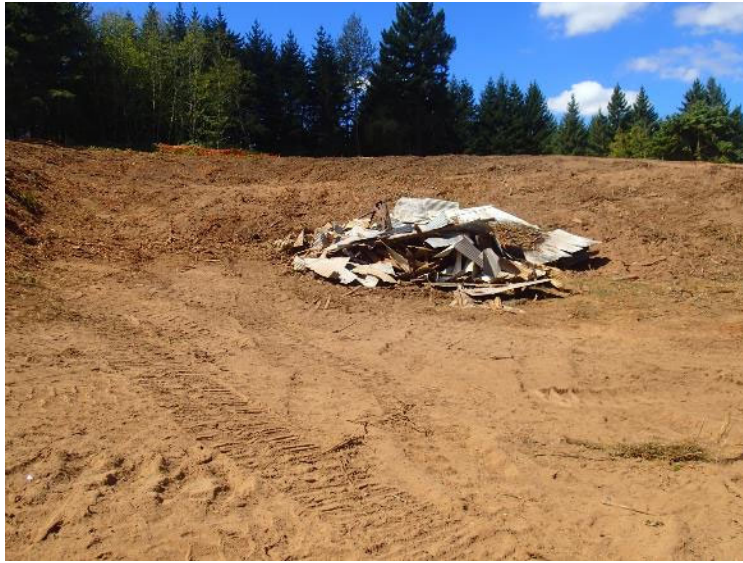
Demolition debris was gathered and disposed of or recycled (August 31, 2017).

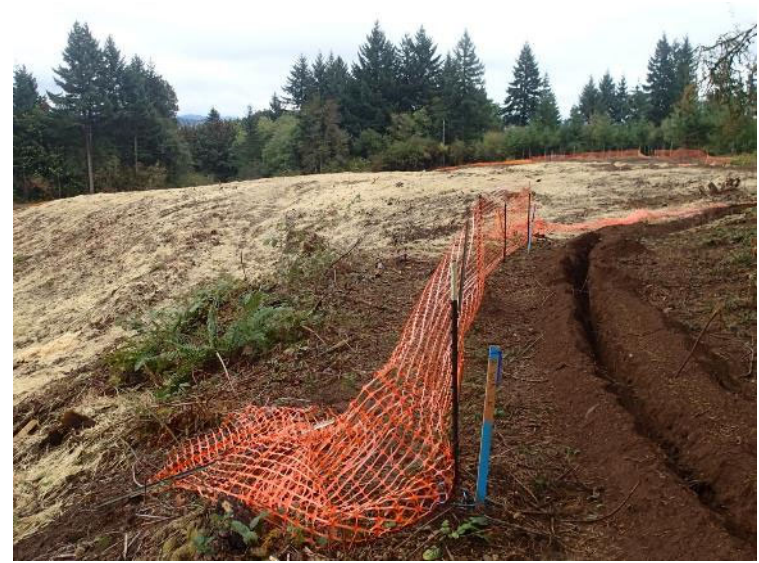
Water line to an east-adjacent residence was diverted around the landfill (October 13, 2017).

Utilities – An overhead utility pole that crossed the landfill area was removed. A domestic water line that passed through the landfill area was re-routed around the perimeter of the landfill.

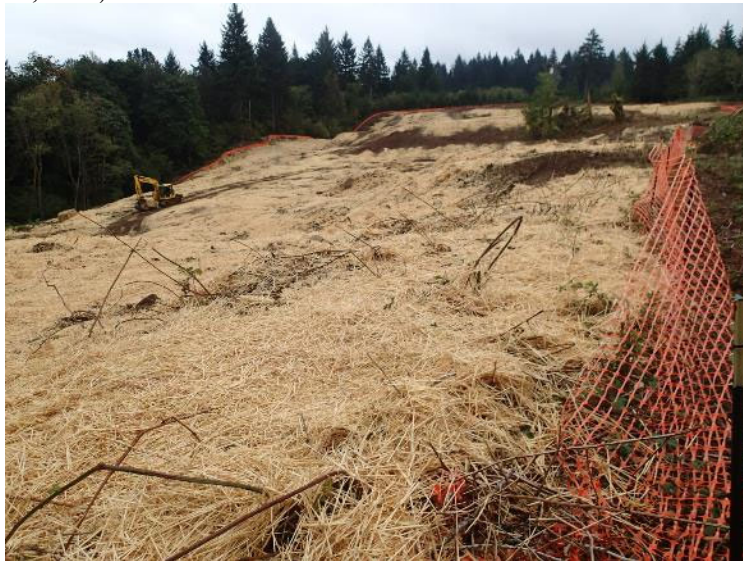
Straw was placed over the soil surface for erosion control purposes – view south (September 29, 2017).

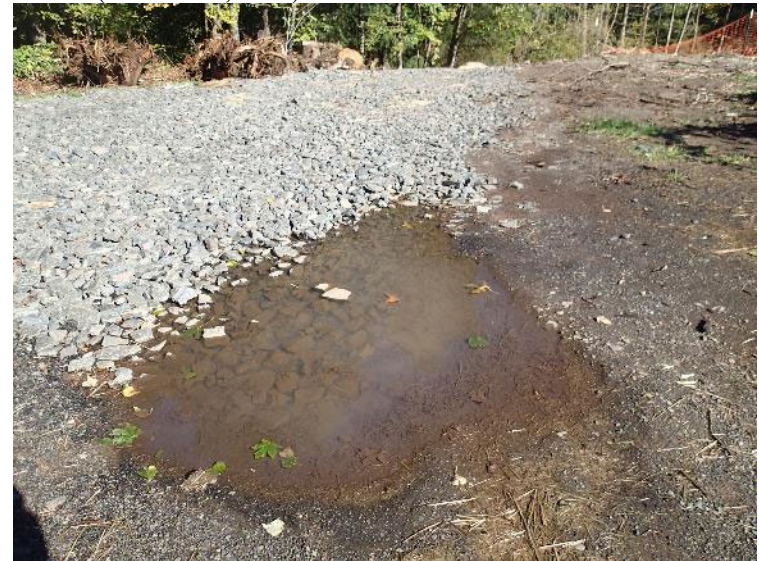
Rock was placed over the haul routes on the upslope west side of the landfill (October 13, 2017).

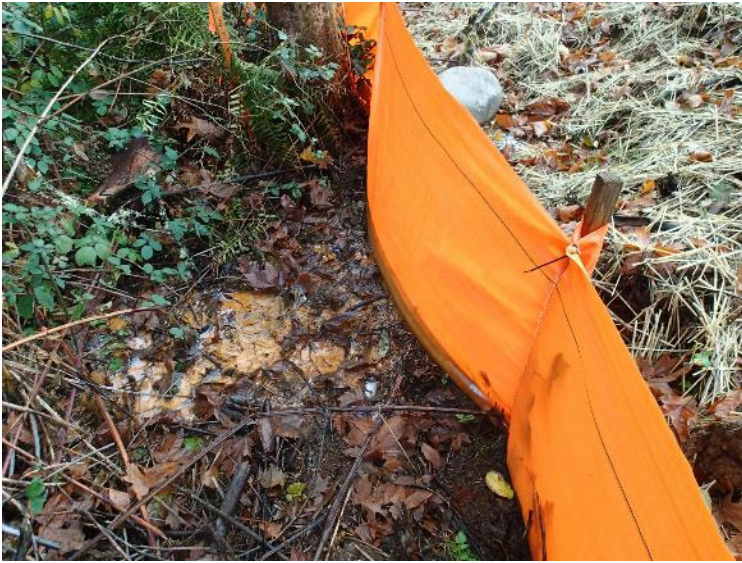
Seeps formed at the landfill toe (east) outside of the disturbed area (November 17, 2017).

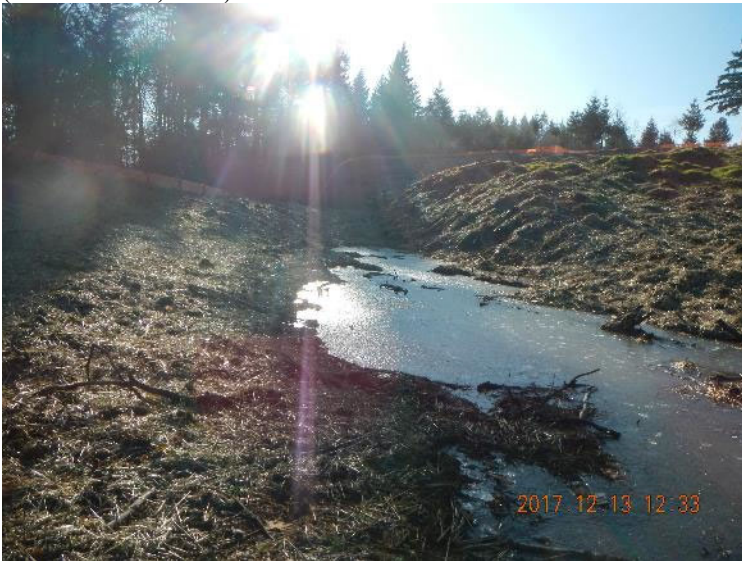
Ponded water on the south side of the landfill at the base of the ravine – view south (December 13, 2017).

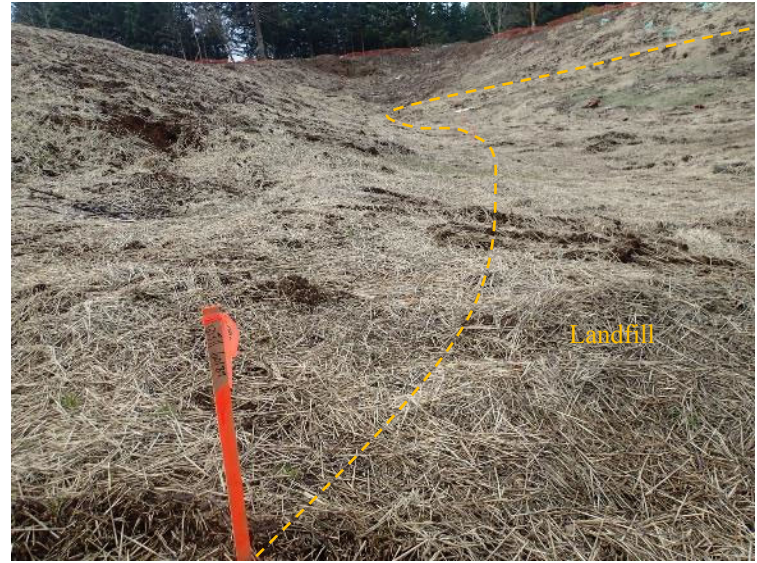
Surveyed landfill boundary (south) – looking west (January 2, 2018).

Surveying the landfill – By January 2018, AKS surveyed and placed stakes around the perimeter of the landfill. This surveyed area provided a visual boundary for demarcation grid placement, as well as pre-grading reference surface elevations for fill placement. Later AKS conducted a post-grading survey of the landfill area. The difference between pre-grading and post-grading elevations will be used to document that a minimum 3-foot clean soil cap was placed over the entire landfill area. These survey and cap thickness data will be presented in the Final RD/RA Installation Plan.

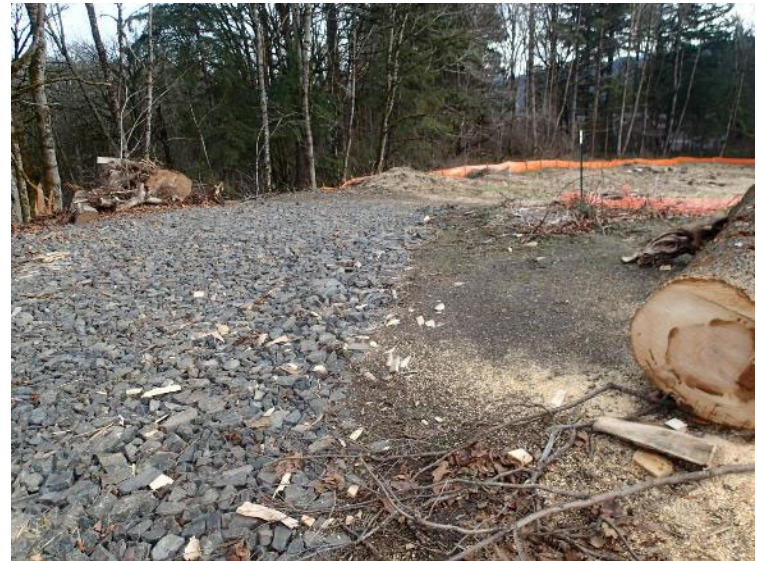
Northwest graveled haul road (January 2, 2018).

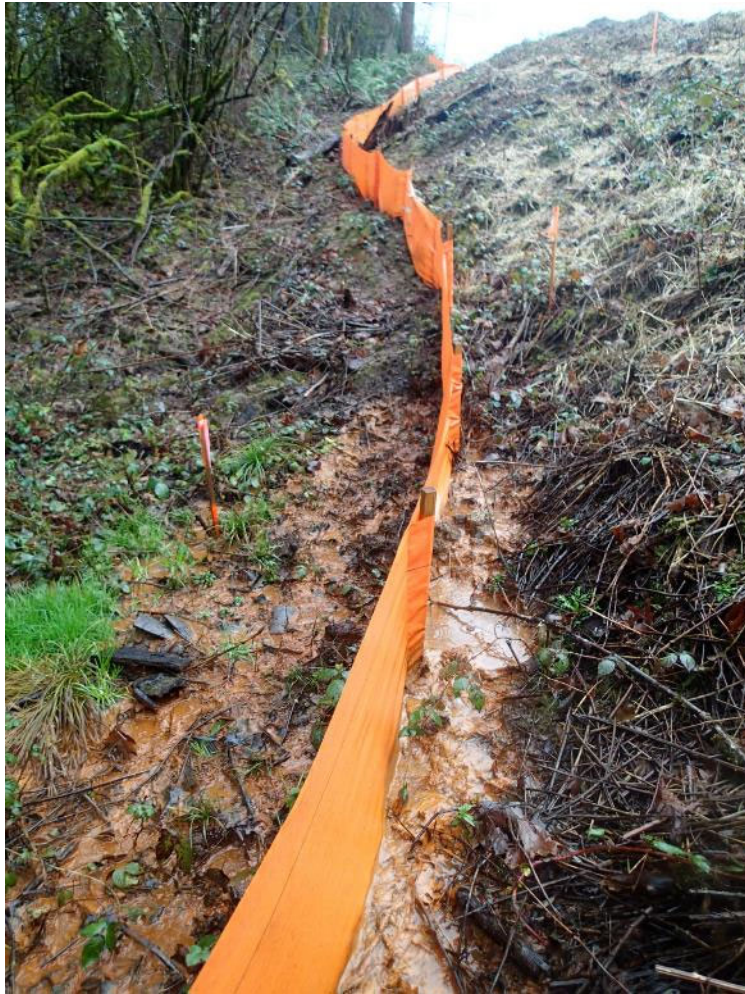
Seep at the landfill toe (January 18, 2018).

Erosion and Sediment Controls – At the end of August 2018, the north buttress fill was hydroseeded and straw wattles placed according to the Erosion and Sediment Control Plan. In early October 2019, straw wattles were placed on the remaining portions of the landfill and the south buttress fill, and the surface was hydroseeded. A disc was used to prepare the buttress fills and landfill cap surfaces for seeding. By November 2018, the grass seed has taken root and covered the buttress fills and landfill cap with a lush, green grass cover. No evidence of soil erosion has been observed during Creekside/ENW's site inspections. Since placement and compaction of the soil cap, there has been no evidence of landfill seeps previously observed at the toe of the landfill near its eastern margin.

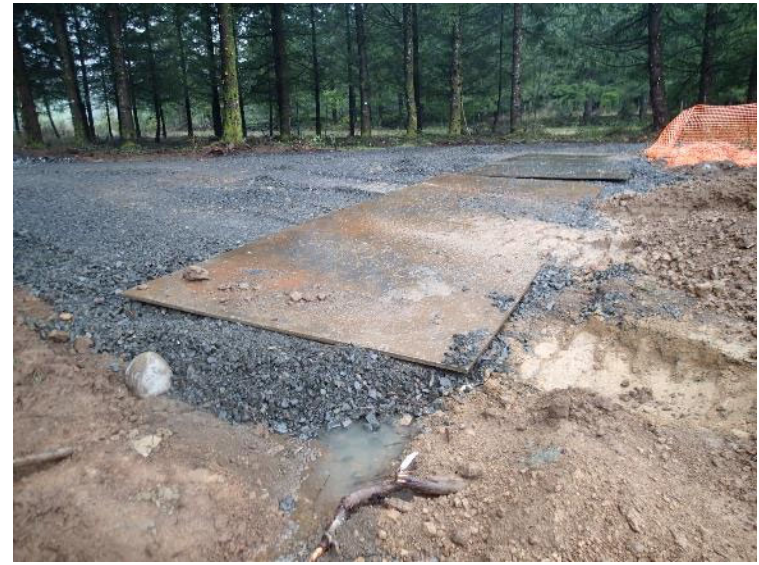
Steel plates positioned at unloading platform at the west margin of the landfill (January 18, 2018).

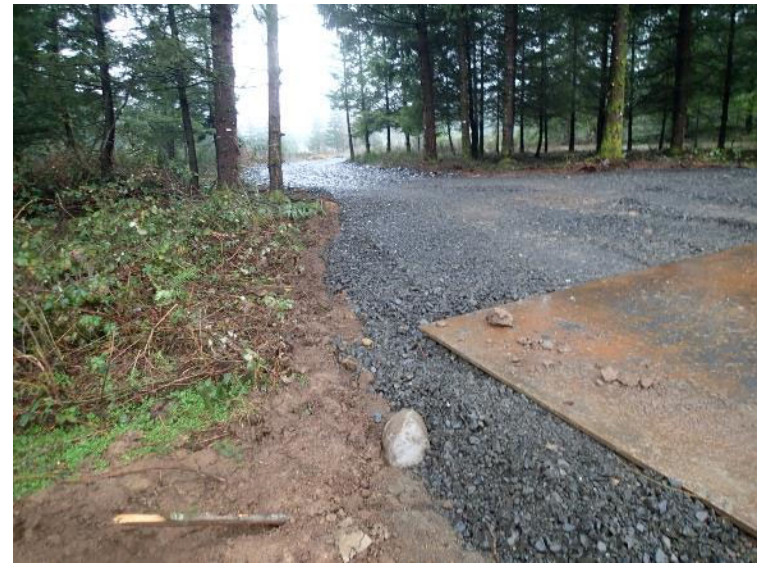
Gravelled haul road west of the landfill (January 18, 2018).

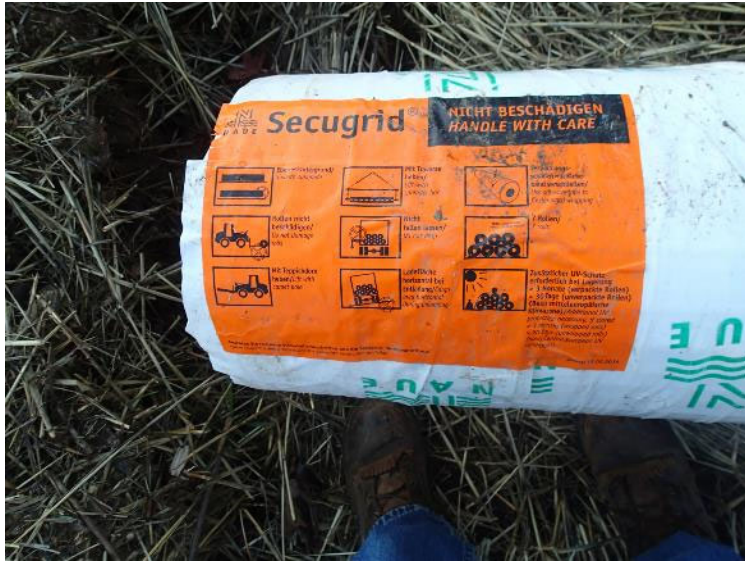
A roll of demarcation grid (geotextile) to be placed over the landfill footprint prior to installing cap (February 12, 2013).

Demarcation Layer – In middle February 2018, White Securgrid® demarcation geotextile began to be installed in the ravine over the southern part of the landfill. The demarcation grid overlapped the surveyed landfill boundary at least a few feet. The 20-foot-wide rolls were overlapped a foot or more, taking care to thoroughly cover the entire surveyed Troh Legacy Landfill area. Demarcation grid installation continued through the end of May 2018, at the north end of the landfill.

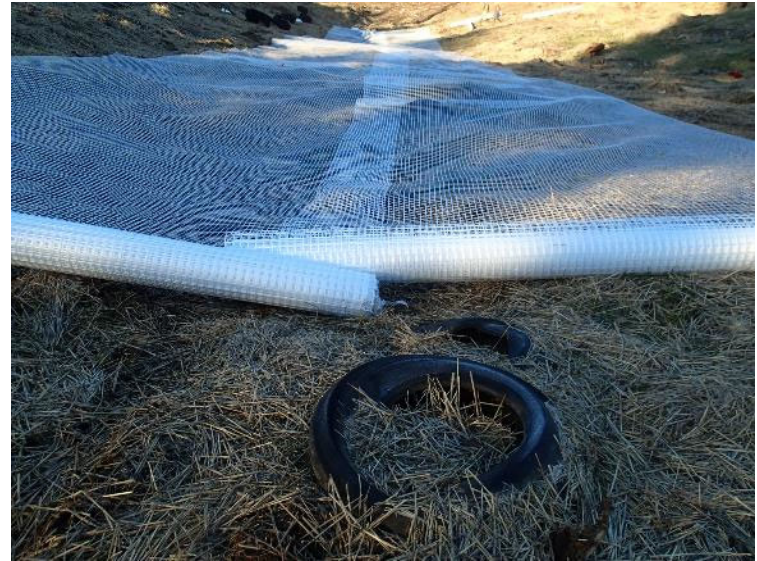
Close-up photo showing the overlapped demarcation grid – view west (February 12, 2018).

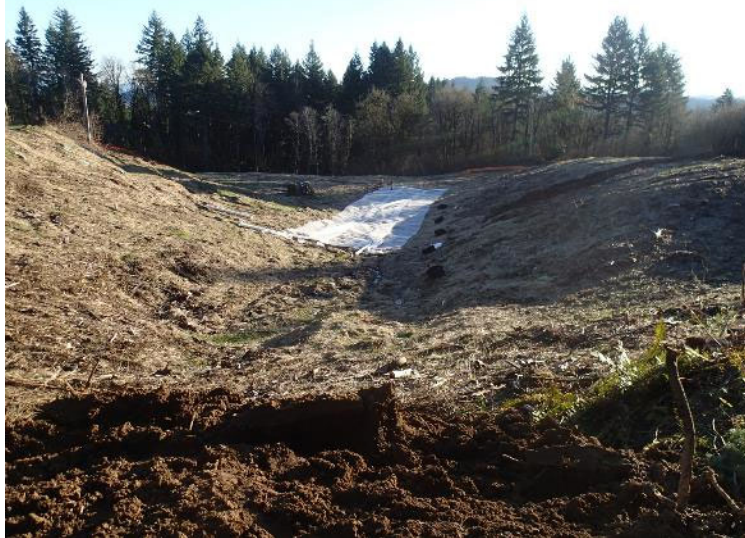
A portion of the demarcation layer rolled out over the landfill – view east (February 12, 2018).

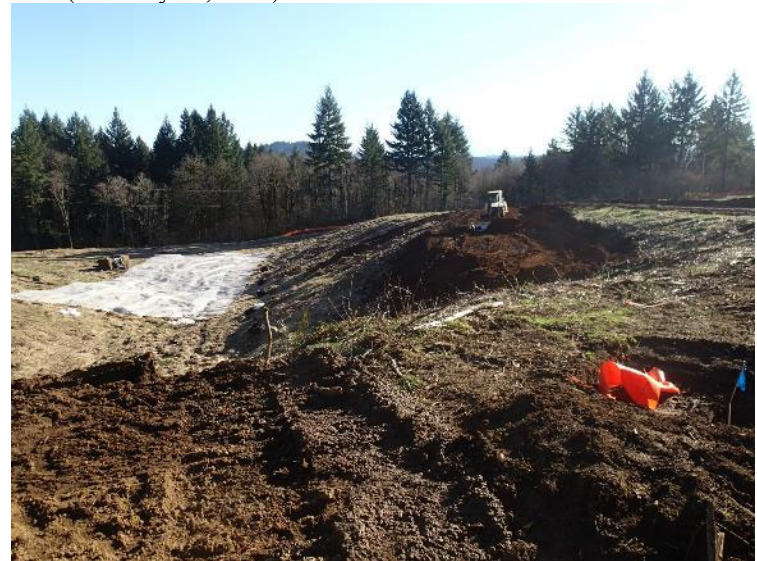
Construction of the buttress fill south of the landfill (right side of the demarcation represents the southernmost extent of the landfill) – view southeast (February 12, 2018).

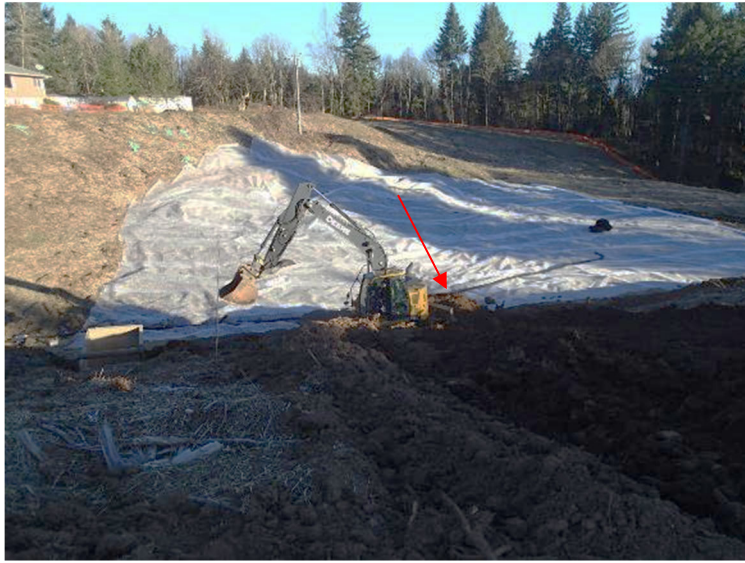
Demarcation placed over southwest corner of landfill. Note drain pipe placed along centerline of ravine – view north (February 13, 2018).

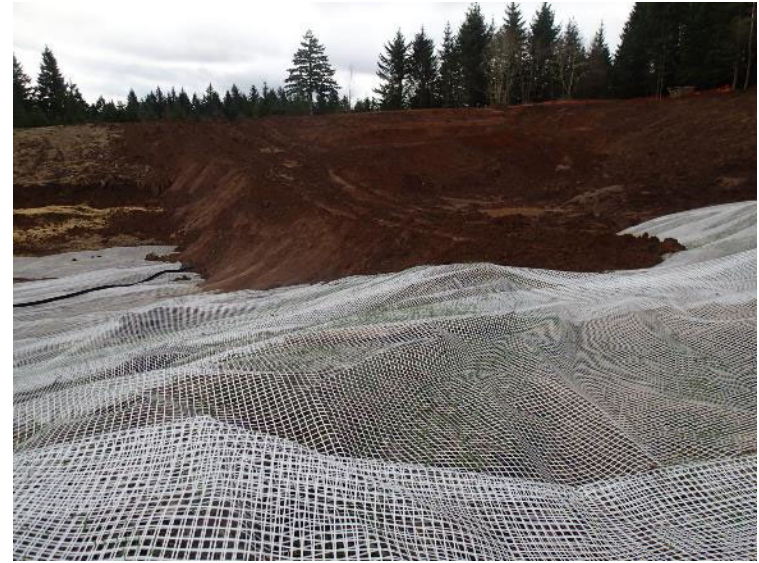
View south of buttress fill and soil cap beginning to be installed above the demarcation grid (March 2, 2018).

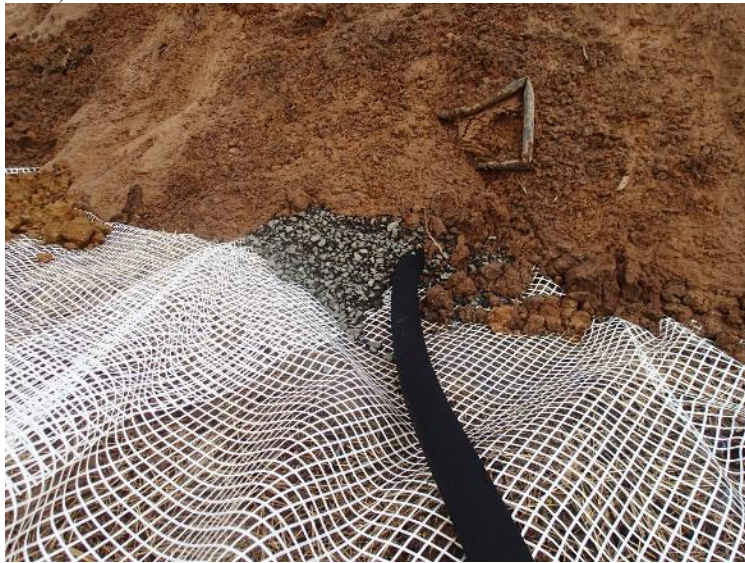
Drain pipe were bedded and covered with gravel prior to placing the soil cap (March 2, 2018).

Subdrains – 4-inch perforated flexible ABS drain pipe was installed along the centerline of the south ravine, the buttress fill structural keyways and other locations shown on the attached Figure. These subdrains were bedded in and covered with drain rock. These subdrains discharge along the eastern boundary of the disturbed area.

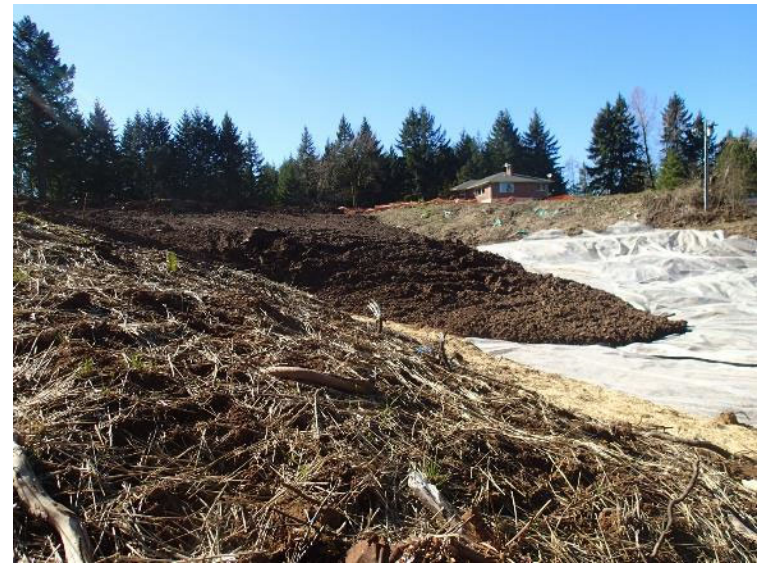
Continued cap installation over the demarcation grid on the southwest part of the landfill – view northwest (March 3, 2018).

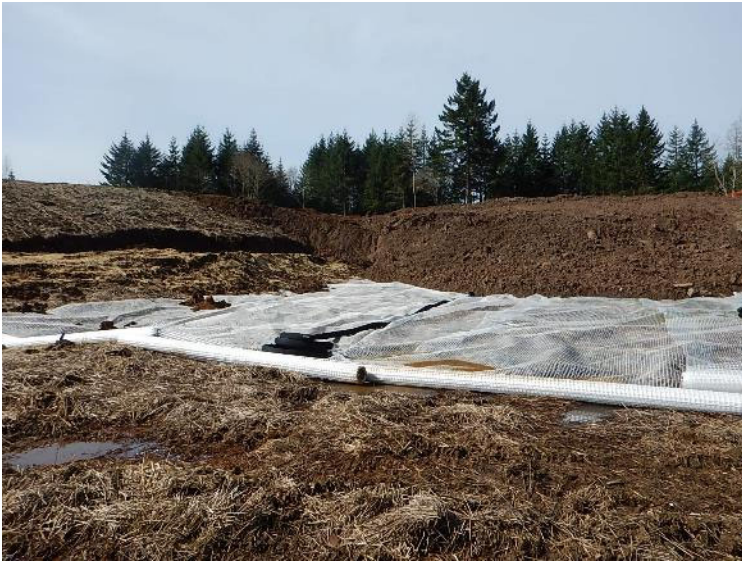
View west showing the buttress fill (left) and demarcation grid and cap (right). Note cap is substantially > 3 feet thick (March 29, 2018).

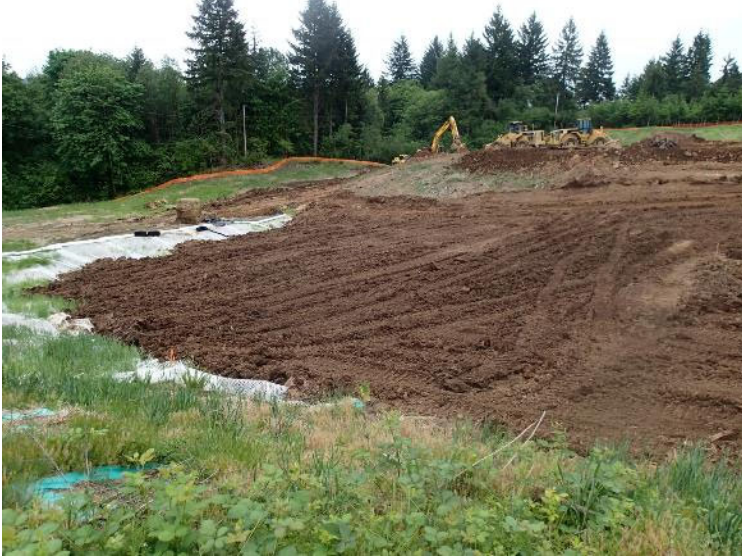
Landfill cap as it appears on May 17, 2018 – view southeast. Heavy equipment is sitting on the south buttress fill.

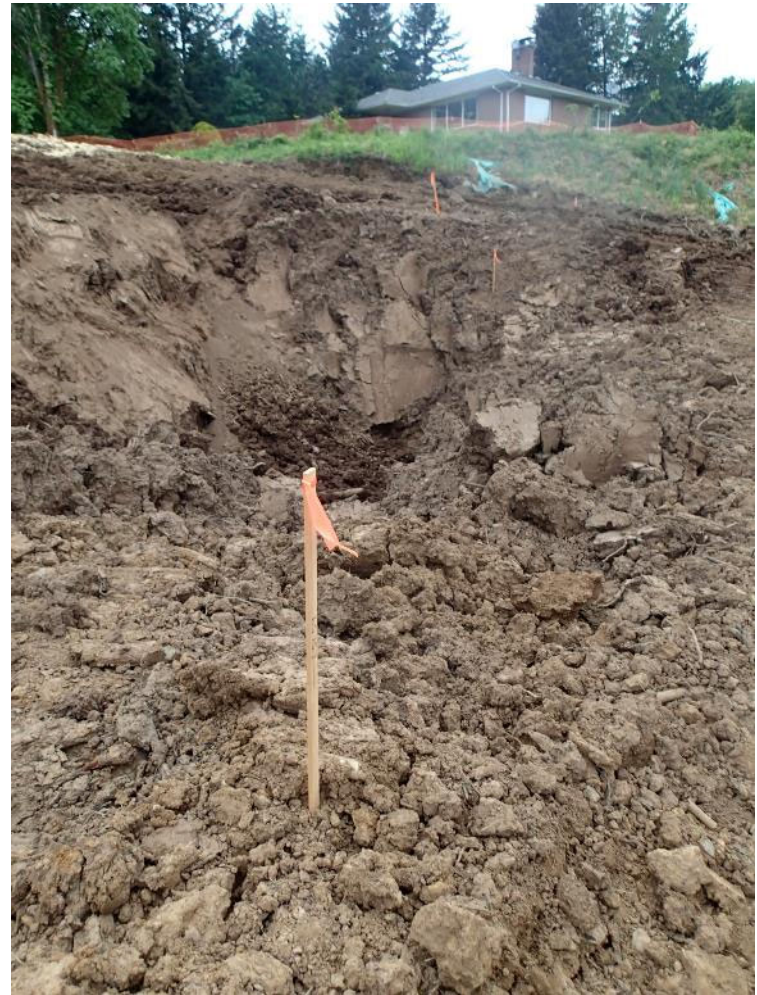
Close-up showing 3-foot-minum soil cap along western landfill boundary (May 17, 2018).

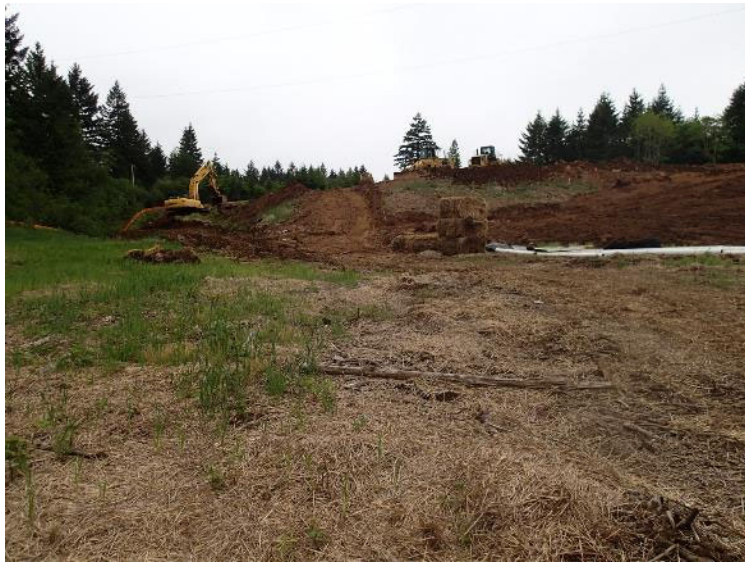
Keyway excavation of south buttress (May 17, 2018).

Buttress Fill and Landfill Cap – Earthwork began on the south buttress fill and landfill cap in early February 2018 and concluded in late August 2018. A structural keyway was excavated along the north and east sides of the buttress, and a subdrain was installed in this keyway. Imported soil transported to the south buttress and south part of the landfill was delivered to the east end of the haul route located near the

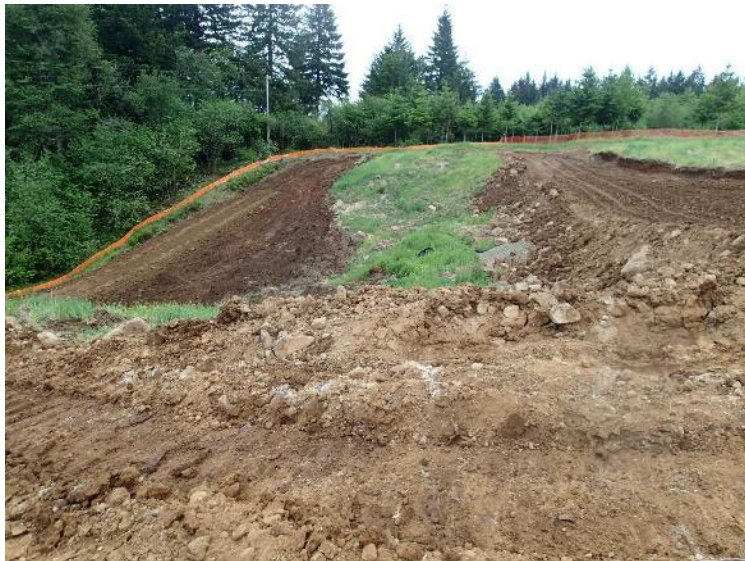
South buttress keyway (left) and bench (right) as seen on May 17, 2018).

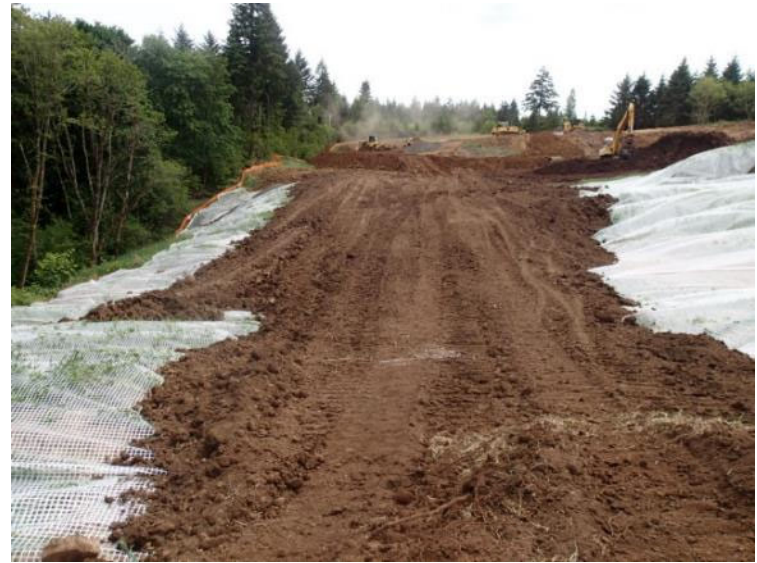
Soil cap being installed over the demarcation grid at the east-central part of the landfill – view south (May 30, 2018).

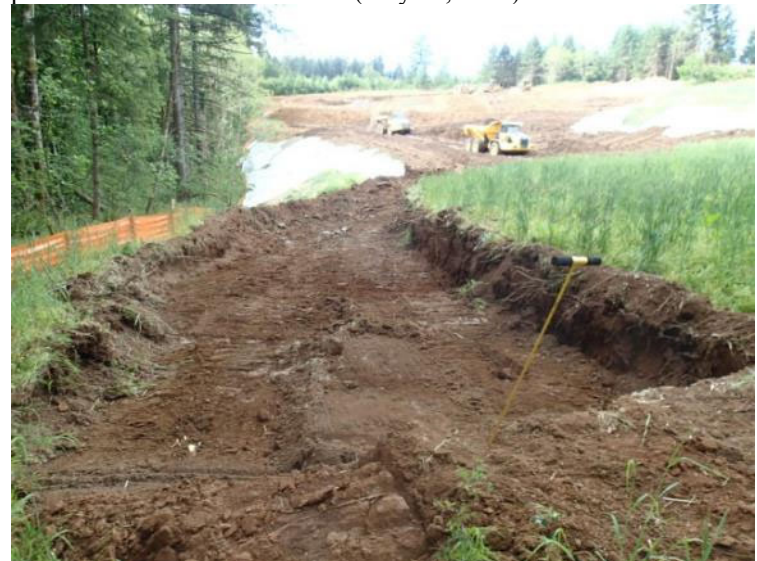
Keyway excavation along the east side of the north buttress fill - view south (June 1, 2018).

Earthwork began on the north buttress the first of June 2018 and continued through the end of August 2018. A structural keyway was excavated along the south and east sides of the buttress, and a subdrain was placed along the keyway. Imported soil transported to the north buttress and north part of the landfill was delivered to the southeast end of the haul road located near the northwest corner of the disturbed area, where it was unloaded. Bulldozers pushed the soil to the north buttress fill area and north part of the landfill after the demarcation grid was installed.

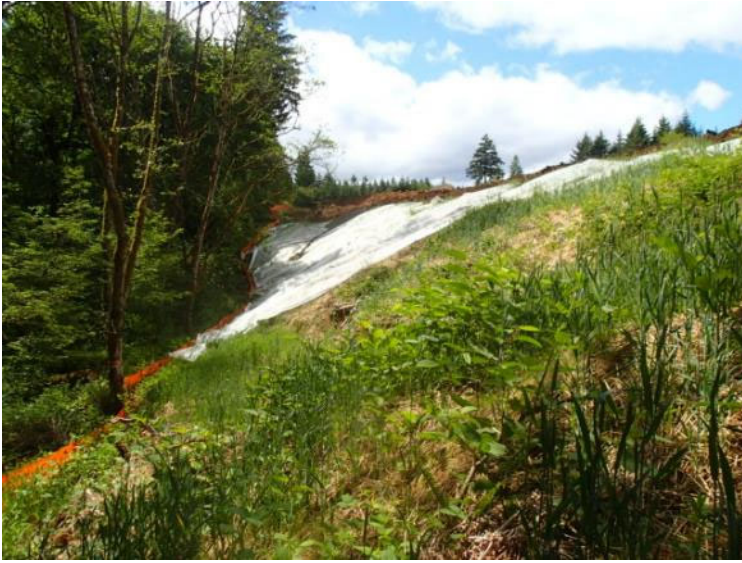
Demarcation grid installation along the east-central edge of the landfill - view south (June 1, 2018).

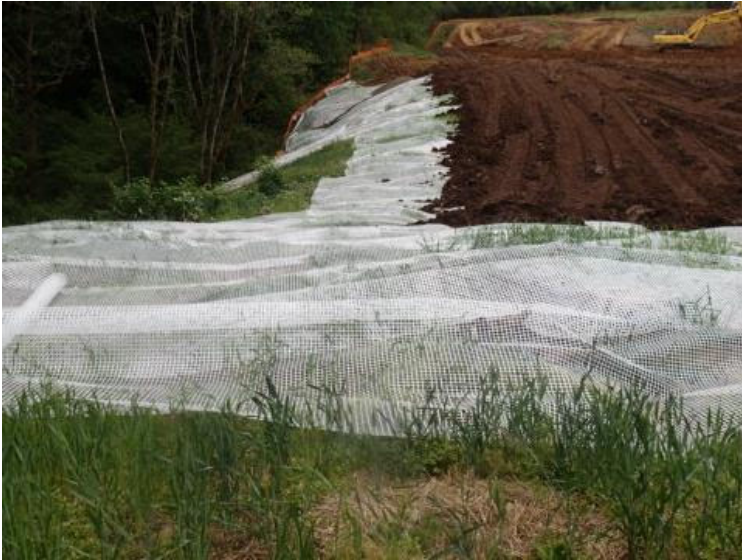
Cap installation at the north end of the landfill – view south (June 1, 2018).

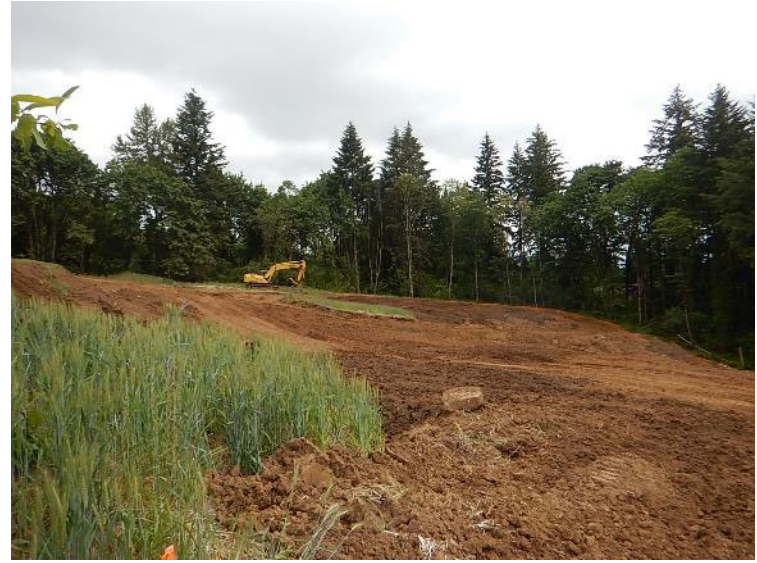
View north of cap at the north end of the landfill (June 7, 2018).

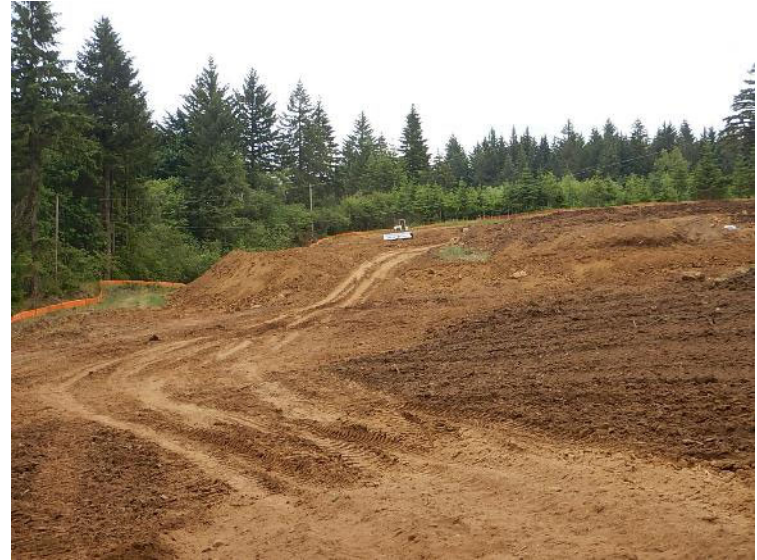
South buttress fill (June 7, 2018).

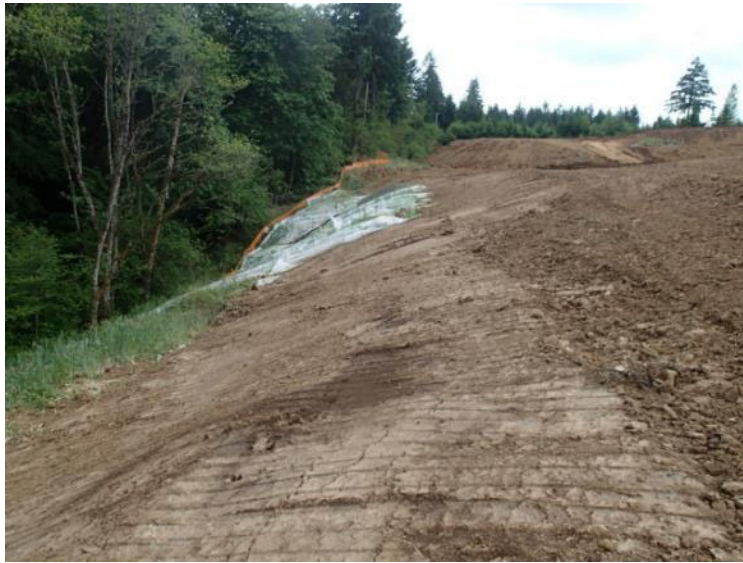
Cap along the east edge of landfill still needs to be completed where demarcation grid is visible (June 14, 2018).

The remainder of the landfill was capped by pushing imported soil north from the south ravine area and south from the north buttress fill area, until all be the steep eastern edge of the landfill was capped with a minimum of three feet of clean imported soil. Due to steep terrain, a small area at the eastern margin of the former landfill site has been covered by demarcation fabric; however, has not yet received a protective cap. Based on Creekside test pit log for TP17, this area of the landfill has been covered with approximately one to two feet of pre-existing inert soil cap materials, which overlie the construction and demolition debris. The demarcation fabric and natural vegetation is anticipated to secure this uncapped area until it will be capped in the Summer of 2019.

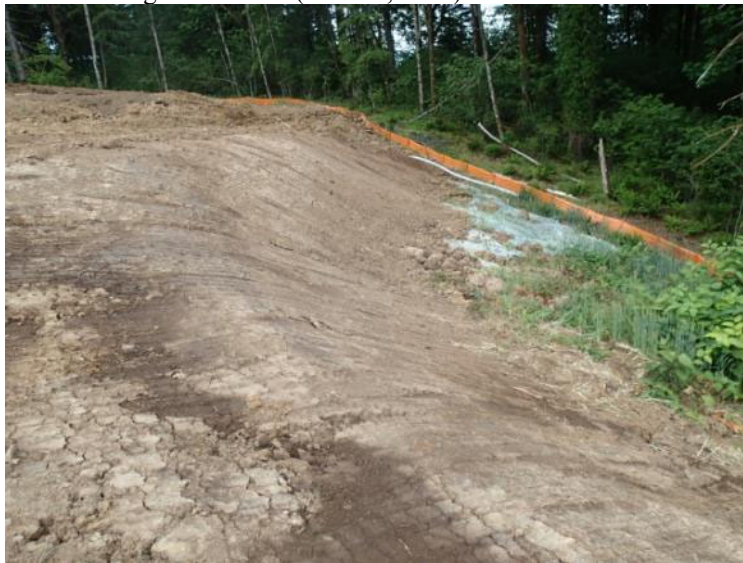
Cap over the eastern landfill boundary – view north (June 14, 2018).

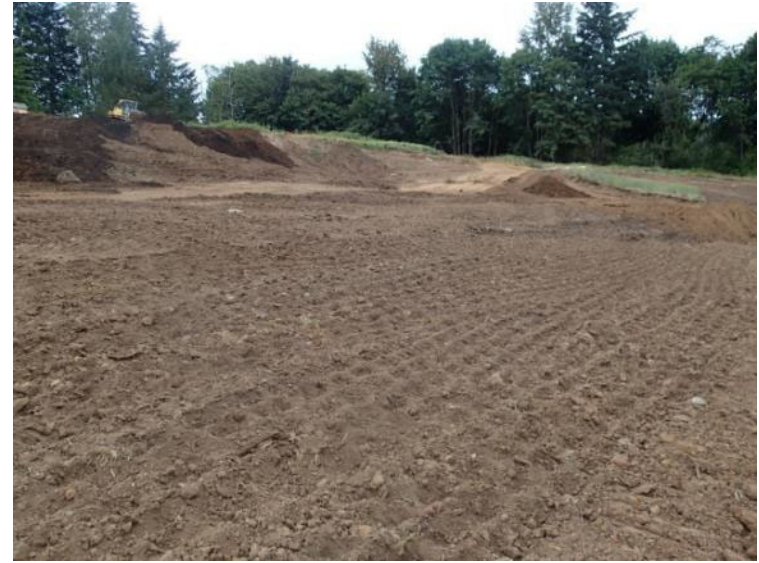
Cap surface was tracked and compacted with a sheepfoot roller perpendicular to slope (June 25, 2018).

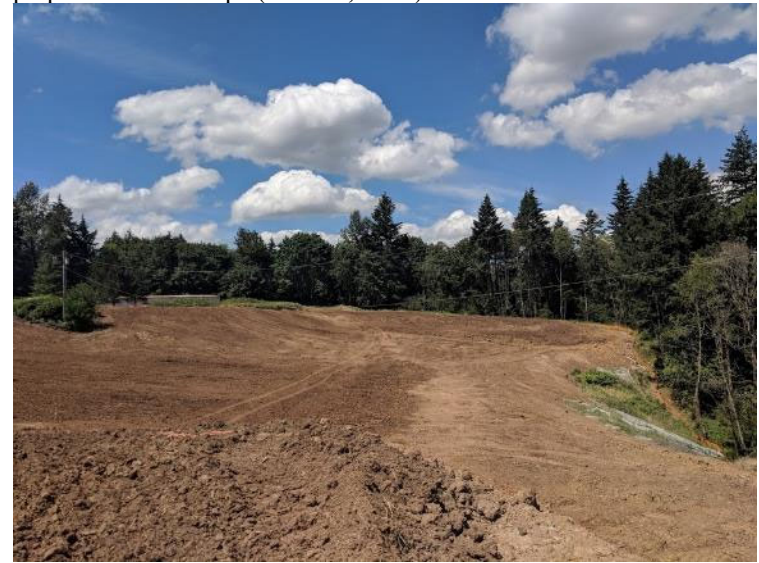
View north of the capped landfill from the vantage of the south buttress fill (July 6, 2018).

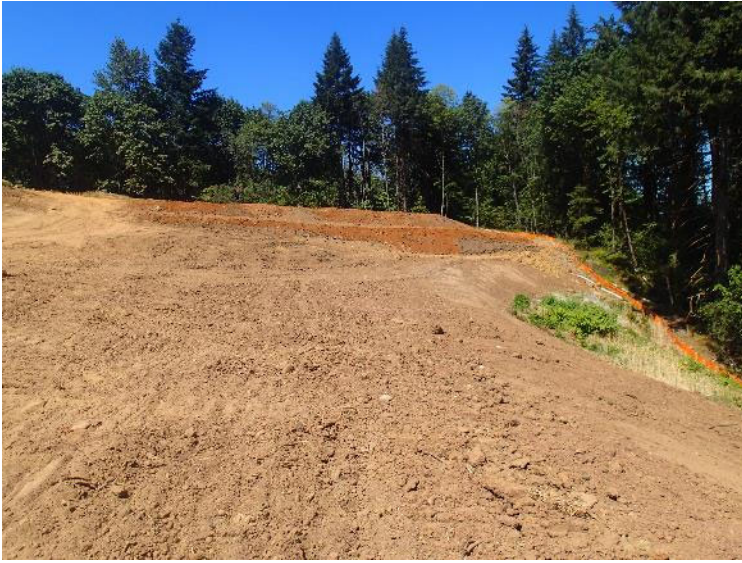
North buttress fill (July 24, 2018).

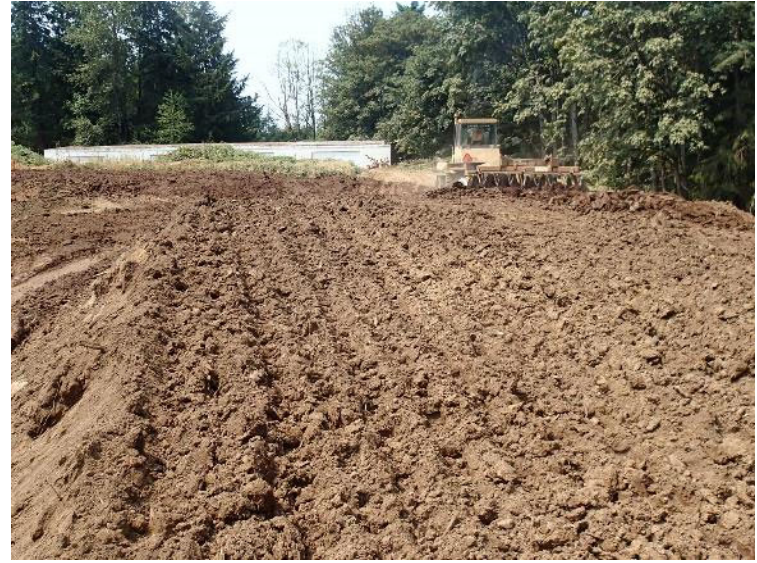
North end of landfill cap being prepared for seeding.

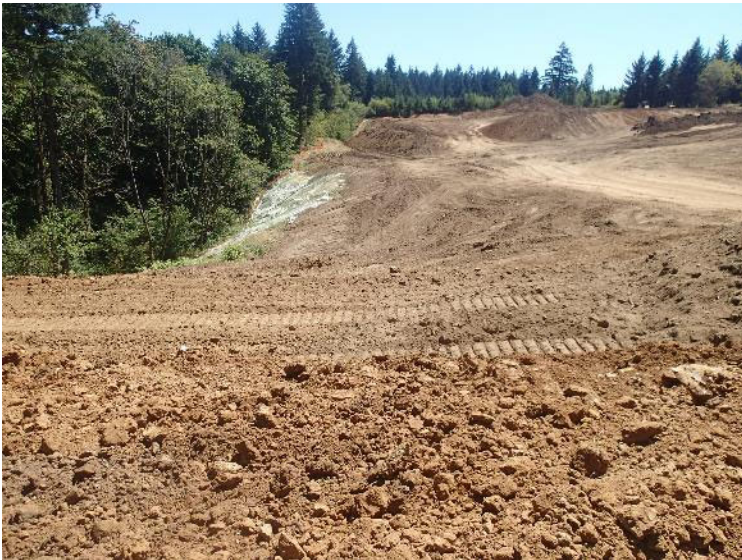
South buttress fill (under construction) from the perspective of the north buttress (July 24, 2018).
