RE: RD/RA Installation Progress Report
Troh Legacy Landfill (ECSI No. 5257)

Creekside Environmental Consulting (Creekside) has collaborated with EVREN Northwest, Inc. (ENW) on this Remedial Design/Remedial Action (RD/RA) Installation Summary Report / Annual Report for the subject site located at 10010 SE Vradenburg Road, in the City of Happy Valley¹. Upon completion of the RD/RA, i.e., completion of the Managed Soil Cap remedial action alternative, Creekside-ENW will submit a Final RD/RA Installation Report pursuant to Creekside-ENW's RD/RA Work Plan. This progress report outlines the components of the Managed Soil Cap remedial action alternative that have been completed to date as well as those components that remain to be accomplished.

FIGURE 3
MANAGED CAP AND BUTTRESS FILL MAP
 FORMER TROH LEGACY LANDFILL PROPERTY
 10010 SE VRADENBURG ROAD
 HAPPY VALLEY, CLACKAMAS COUNTY, OREGON

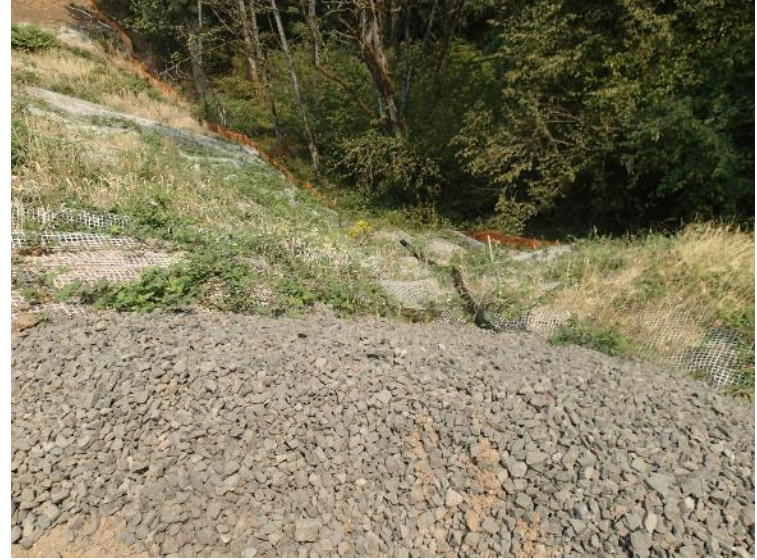
Drain rock was placed over the ravine drain line. Drain pipe exits at the eastern landfill boundary, which has not yet been capped as of this date (August 8, 2018).

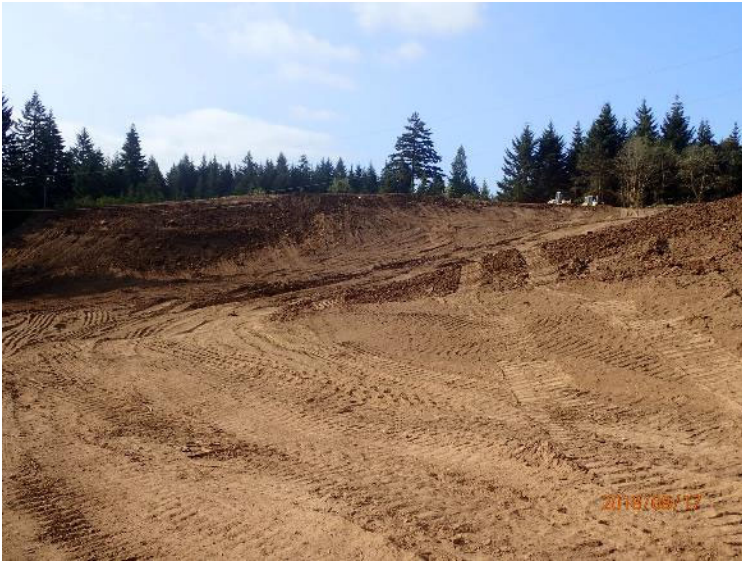
South buttress fill on August 17, 2018.

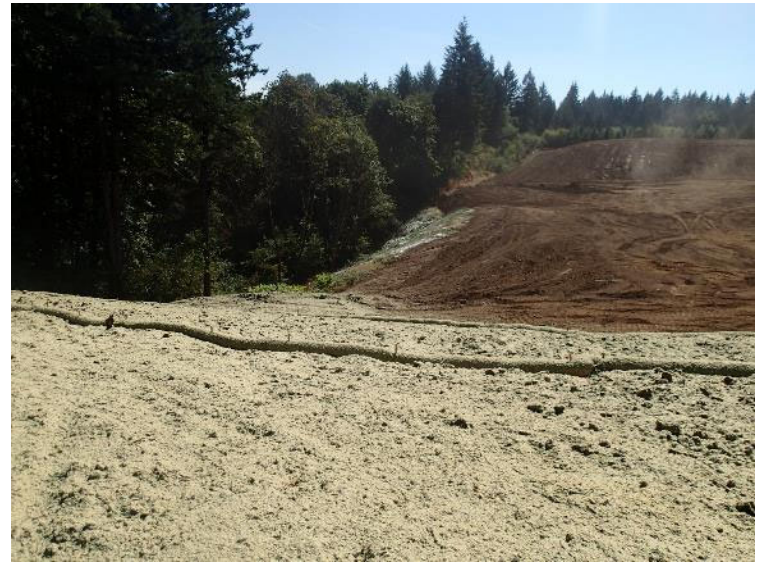
North buttress fill was hydroseeded and straw wattles placed according to erosion and sediment control plan (August 29, 2018).

Erosion and Sediment Controls – At the end of August 2018, the north buttress fill was hydroseeded and straw wattles placed according to the Erosion and Sediment Control Plan. In early October 2019, straw wattles were placed on the remaining portions of the landfill and the south buttress fill, and the surface was hydroseeded. A disc was used to prepare the buttress fills and landfill cap surfaces for seeding. By November 2018, the grass seed has taken root and covered the buttress fills and landfill cap with a lush, green grass cover. No evidence of soil erosion has been observed during Creekside/ENW's site inspections. Since placement and compaction of the soil cap, there has been no evidence of landfill seeps previously observed at the toe of the landfill near its eastern margin.

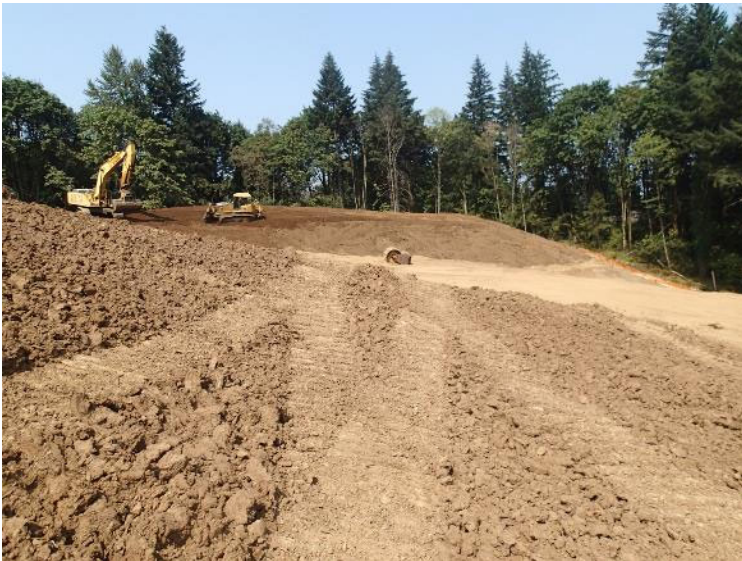
North buttress fill on August 22, 2018.

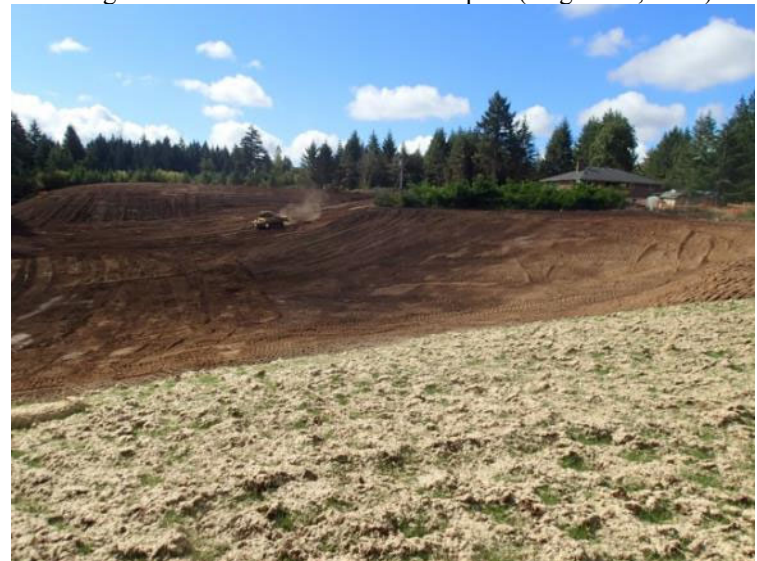
Grass has taken root on the north buttress fill, and the remainder of the landfill is being prepared for hydroseeding (September 14, 2018).

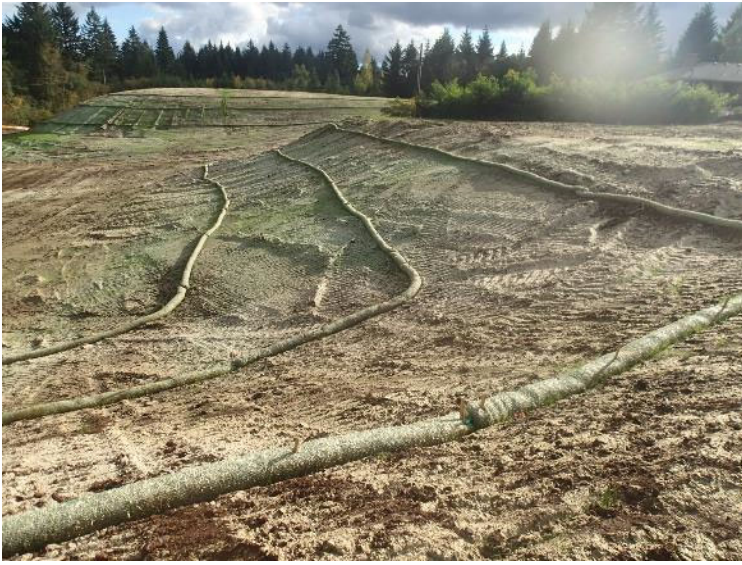
Straw wattles were placed on the remaining portions of the landfill, after which the ground surface was hydroseeded— view south (October 9, 2018).

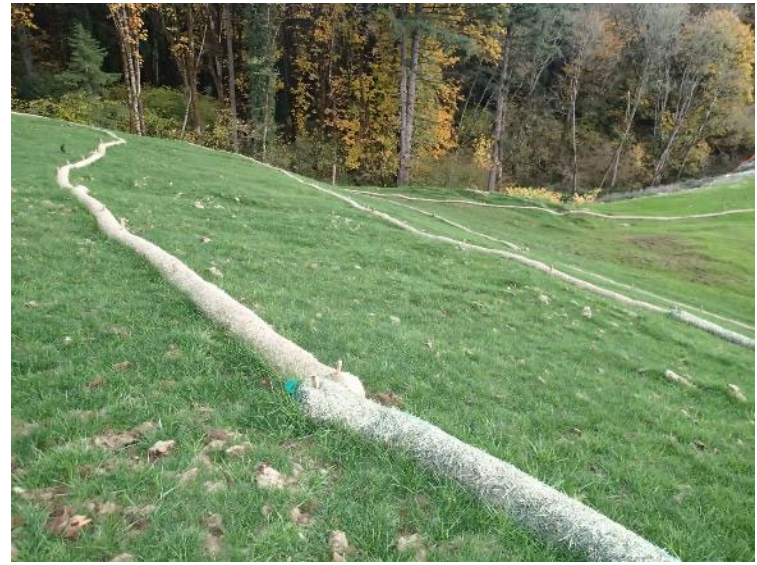
North buttress fill – view east (November 6, 2018).

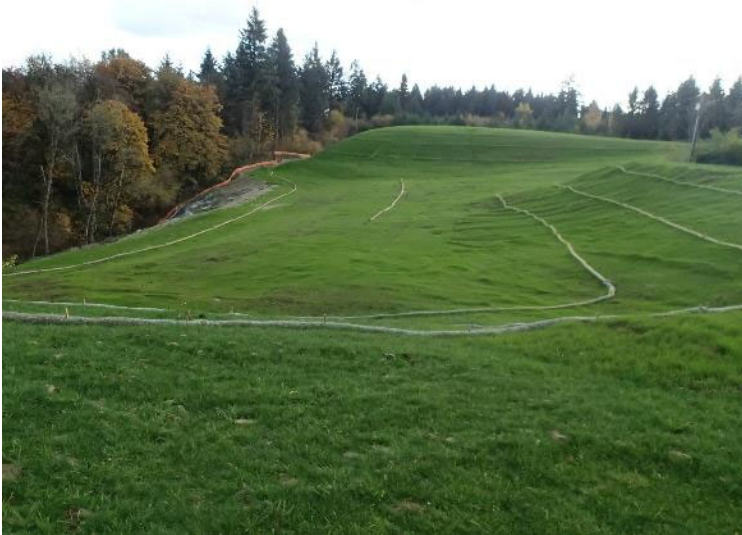
Grass has taken root over the capped landfill and buttress fills – view south (November 6, 2018).

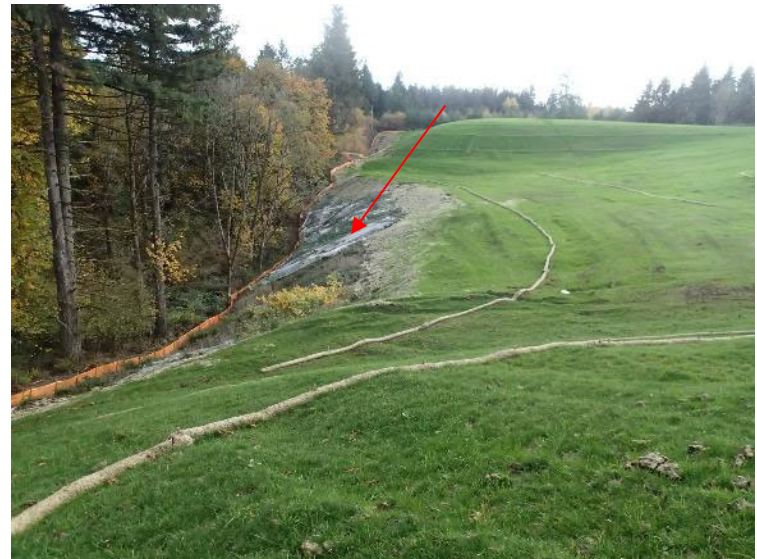
Rip-rap is being considered to cap the steep, eastern margin of the landfill where the demarcation grid is still visible.

Remaining Cap Installation - Due to steep terrain, any soil eventually placed over the uncapped portion of the steep, eastern edge of the landfill will be difficult to compact and stabilize. Stabilizing the eastward sloping terrain is important in protecting the forested area to the east. Accordingly, Creekside/ENW and AKS Engineering have proposed using a combination of soil and other means to act as the protective cover.

1. An additional 0.6 feet of soil in the TP17 cap area.
2. Placement of 1-foot thick layer of rip-rap.
