# **Risk-Based Assessment Report**

801 SW Harvey Milk Street  
Portland, Oregon 97205  
DEQ LUST File No. 26-22-0048  
UST Facility ID 9365

Prepared for:  
Multnomah County  
401 N Dixon Street  
Portland, Oregon 97227

September 2023  
PBS Project 15194.889

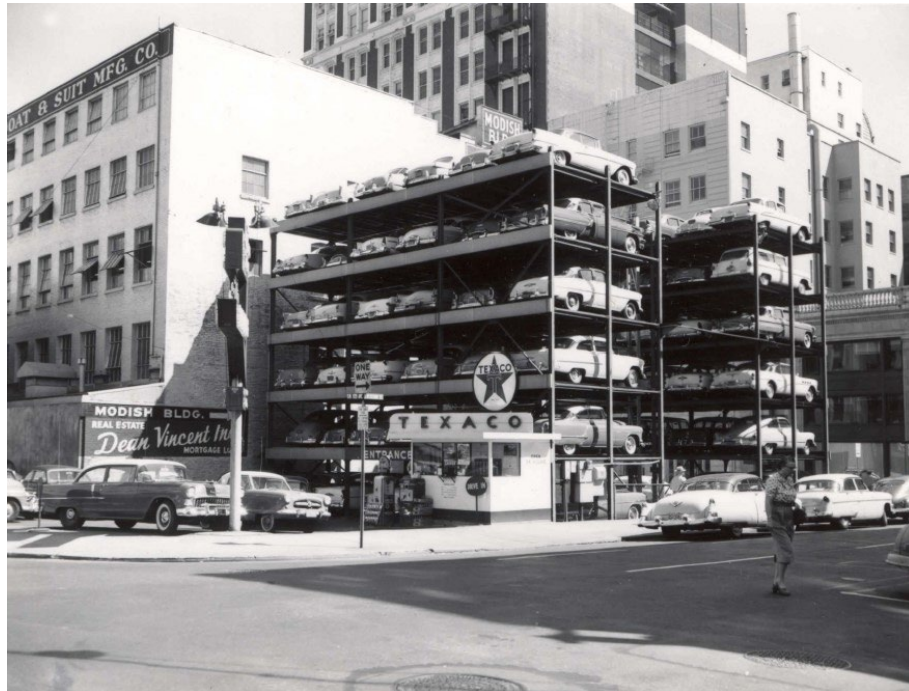
Photo 1. Looking northeast at the Site from the corner of SW Stark (Harvey Milk) Avenue and SW 9th Avenue. The Texaco gas station and "pigeon-hole" parking can be seen in the photo. Photo taken in 1955.

- A smaller subtle soil disturbance containing piping was noted adjacent to a construction trailer, approximately 11 feet north of the SW Harvey Milk Street sidewalk. Access to this area at the time of the investigation was poor and obstructed by the construction trailer and a storage cabinet related to ongoing construction at the 333 SW Park Avenue building. This disturbance was noted to be consistent with the location of the former fuel dispensers as indicated by a historic photograph of the Site from 1955 (Appendix C).

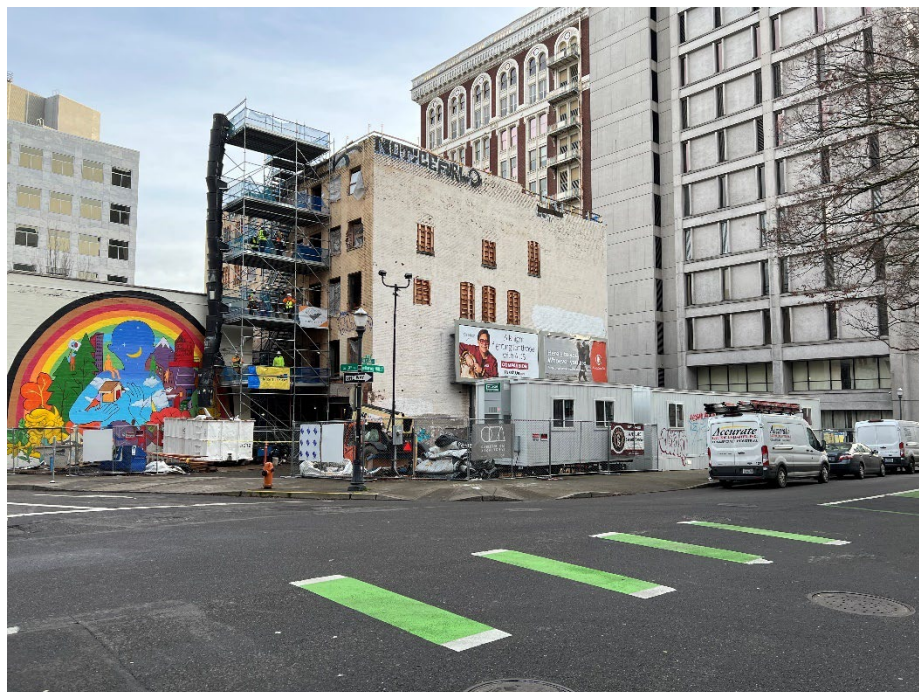
Photo 2. The same view of the Site from January 2022. The Site is being used as a staging area and construction site for a renovation project in the adjacent 333 SW Park Avenue building.

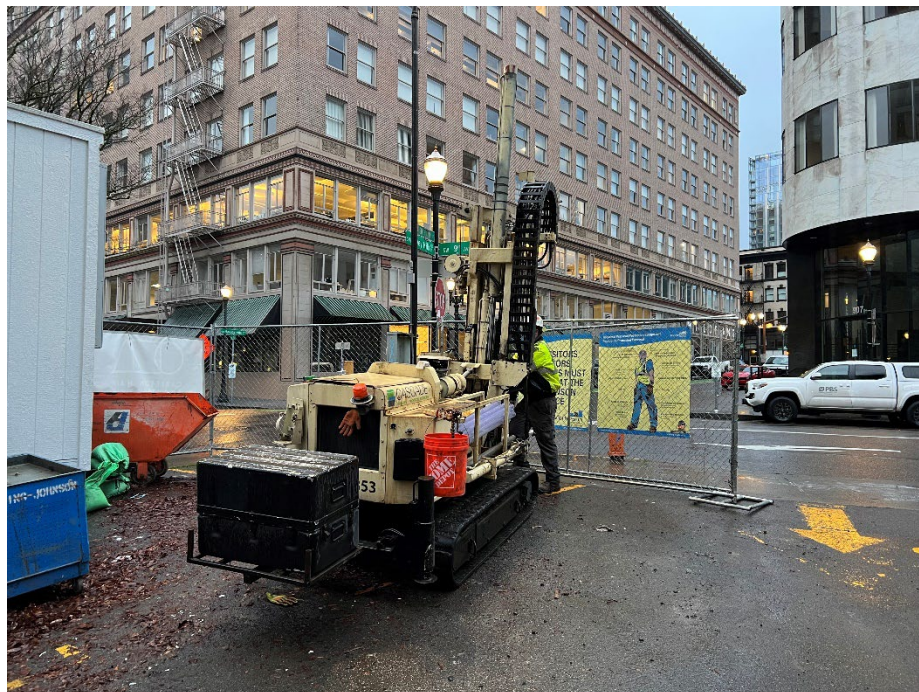
Photo 4. Cascade Drilling completed boring B-1 within the former tank excavation.

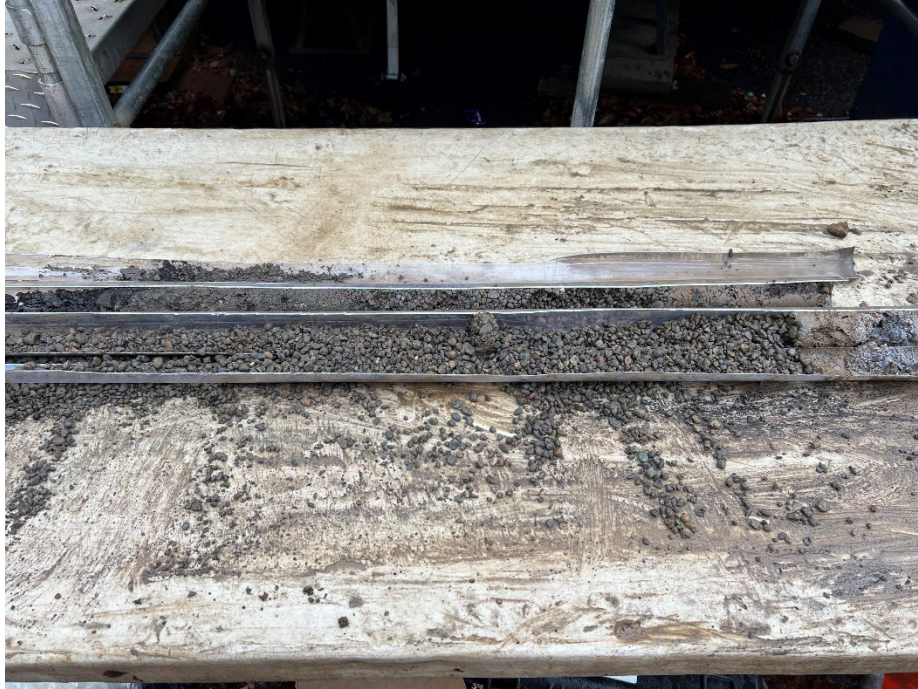
Photo 5. Pea gravel backfill material was observed in borings B-1 and B-3, advanced through the large excavation that was detected during the geophysical survey.

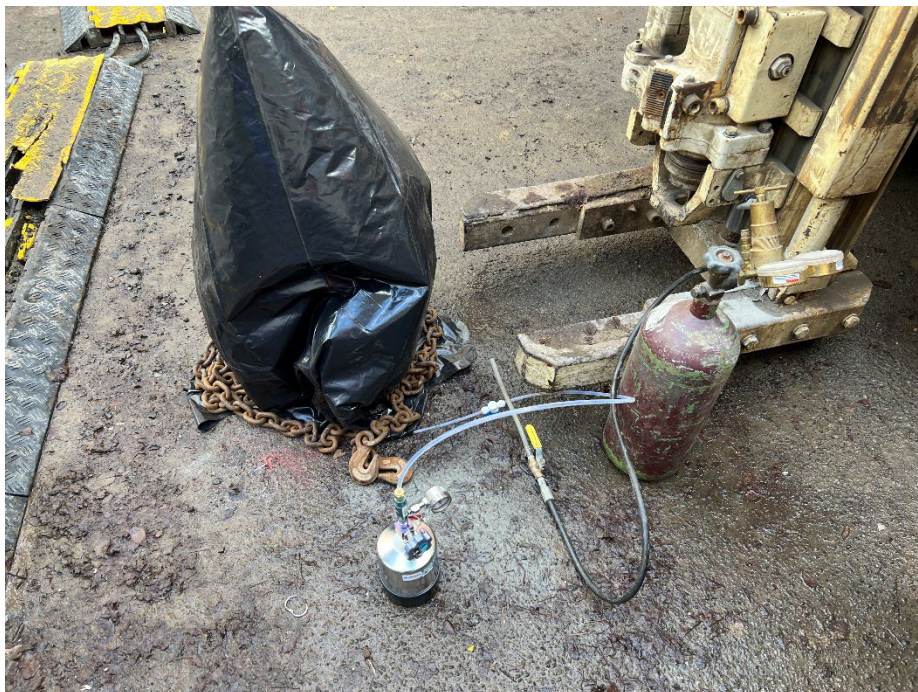
Photo 6. A soil gas sample was collected from boring B-6 using a post-run tubing (PRT) sampler. Helium was used as a tracer gas for leak detection.

Helium was used for leak detection. The VI Guidance allows up to 5% helium to be present in the sample, which is deemed to represent an insignificant contribution from ambient air. Helium was calculated at 3.85% in the sample as shown in Table 5, which indicates the contribution from ambient air is negligible and the results are within acceptable limits.

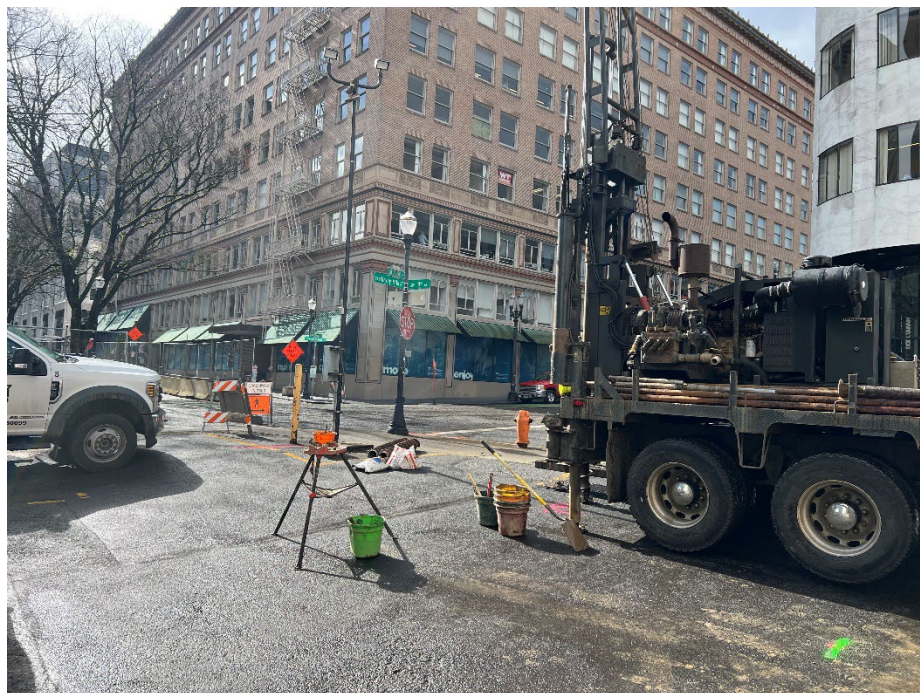
Photo 7. A truck-mounted hollow stem auger with a split-spoon sampler was used to advance borings B-7 through B-9.

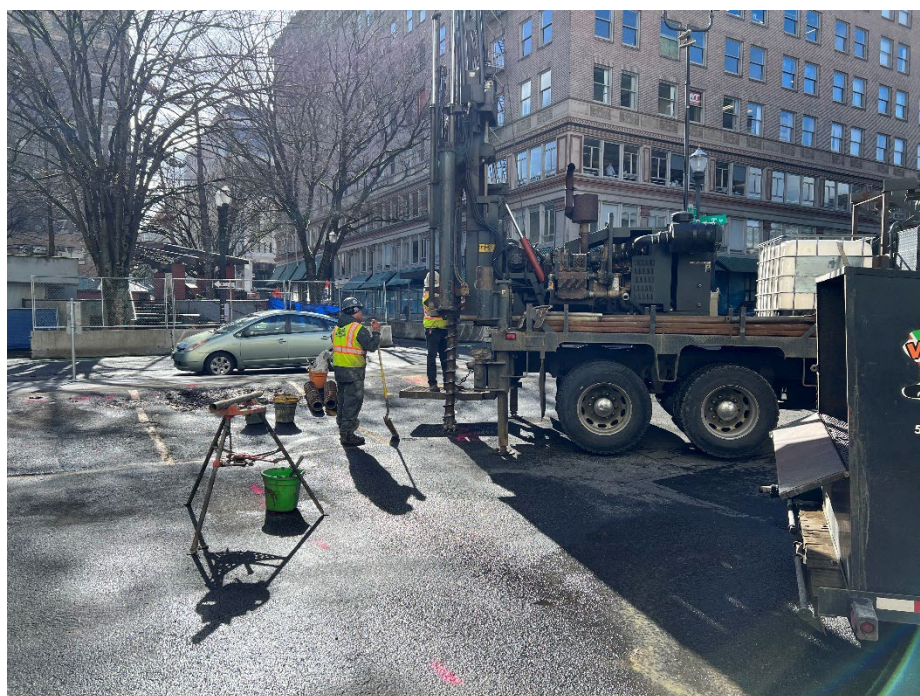
Photo 8. Boring B-8 being completed to the east of B-1.

A total of three borings (B-7, B-8, and B-9) were advanced during the additional assessment, to depths ranging from 10 to 15 feet bgs. Figure 2 shows the location of the temporary boreholes advanced at the site.
