| Project/File: | 227704604 | Date: | November 12, 2024 |

**Reference:     Rock Creek Reconnaissance Work Plan  
                     Oregon Plastic Tubing Facility  
                     6401 and 6402 South Miller Road, Hubbard, Oregon  
                     ECSI Site #6521, LUST #03-22-0412**

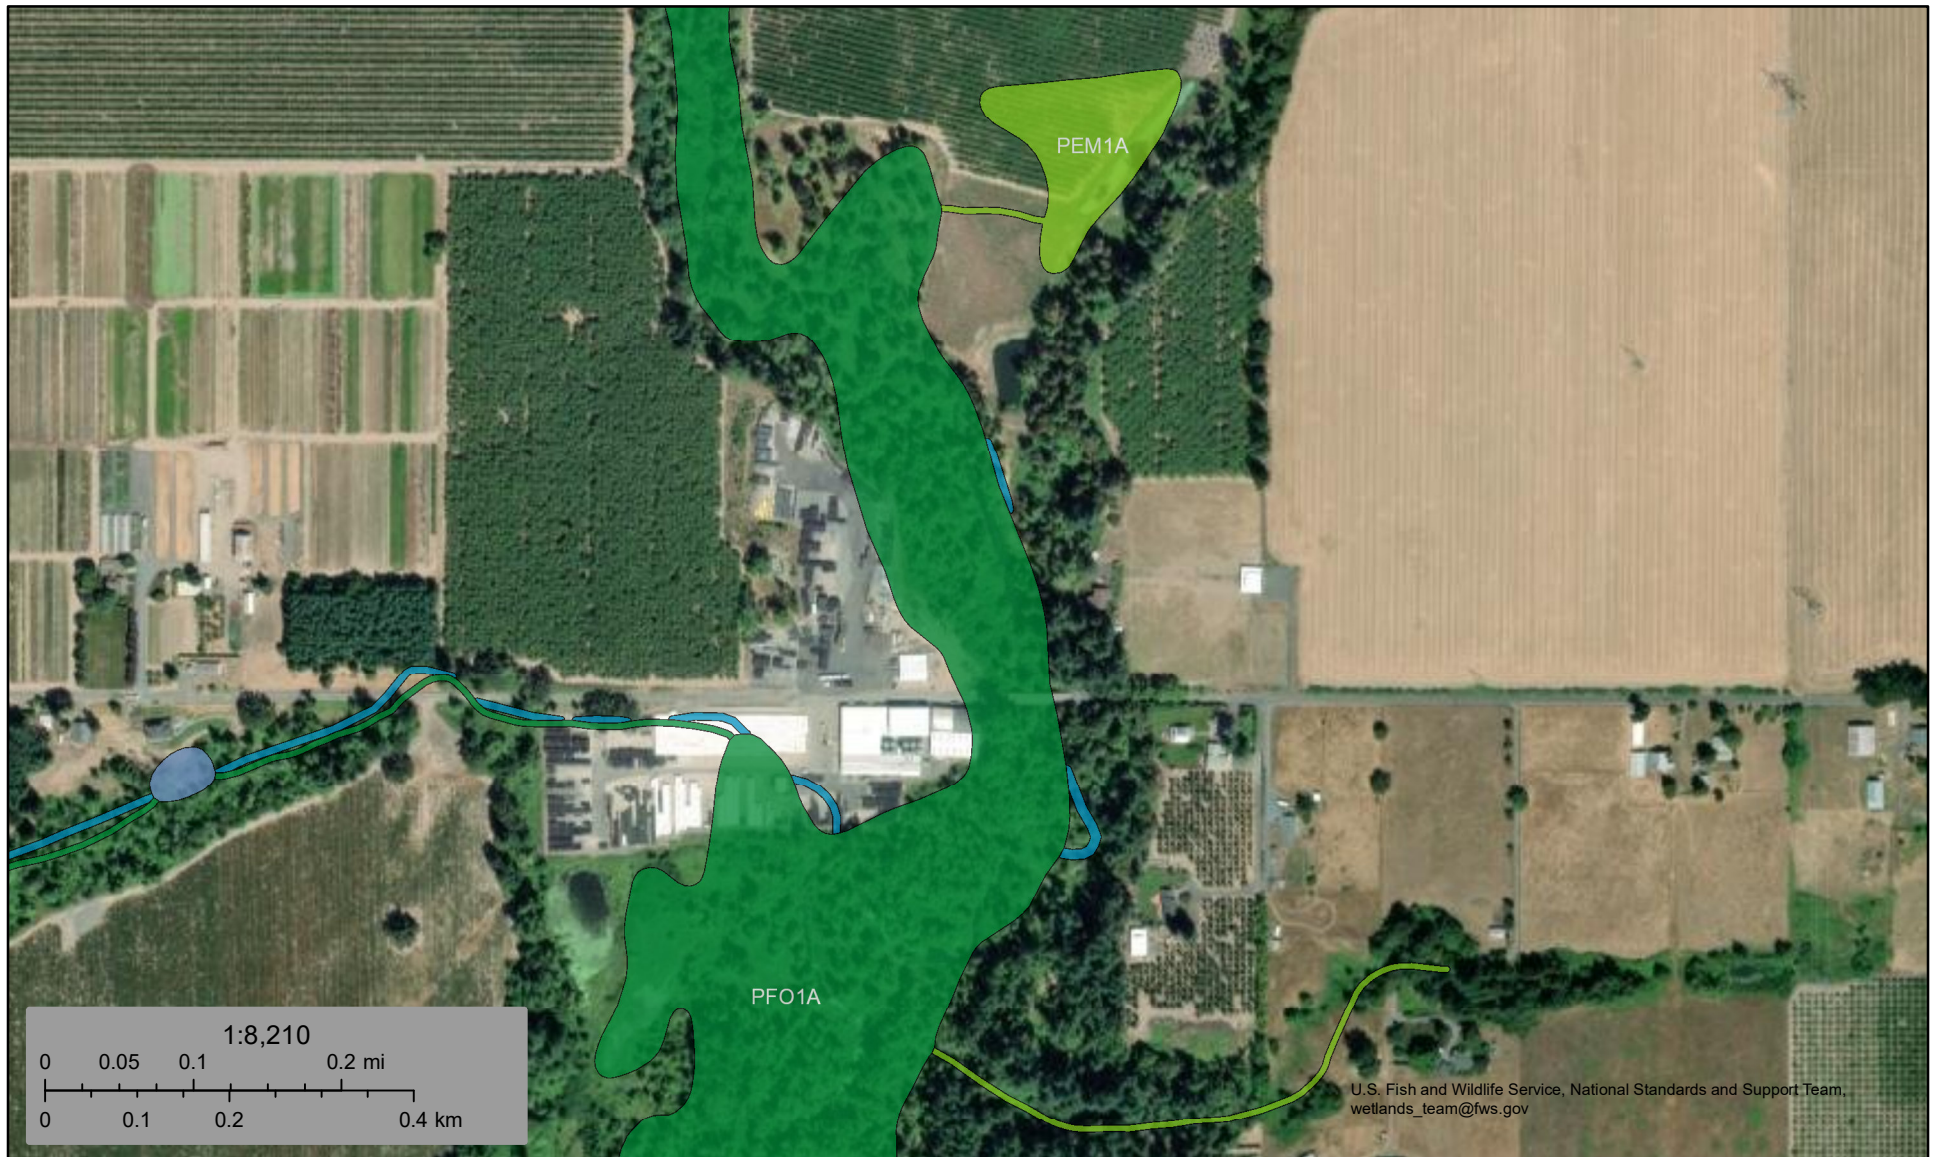
## Oregon Plastic Tubing NWI figure

## National Wetlands Inventory

a Palustrine system, Forested class, Broad-Leafed Deciduous subclass with a Temporary Flooded water regime (**Attachment A**).
