Construction Completion Report

River Terrace Crossing Area 10 Development Southwest of SW Hawk Ridge Road and SW 150th Avenue Tigard, Oregon ECSI Site No. 6156

GeoDesign Project: Polygon-145-07

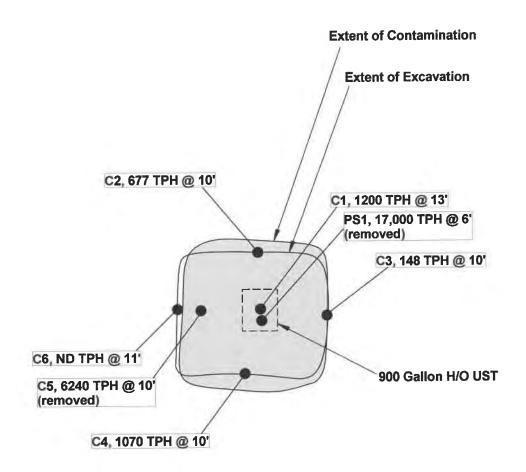
Site Map

All soil samples were analyzed for heating oil using DEQ approved method NWTPH-Dx. The locations of all samples collected by K&S at the site are noted on the attached site map. The location and results of all soil samples are summarized in the following table. Complete certified analytical reports with chain of custody documentation are included with this report.

United Excavators 15515 SW 150th Ave. Tigard, OR K&S Environmental, Inc.

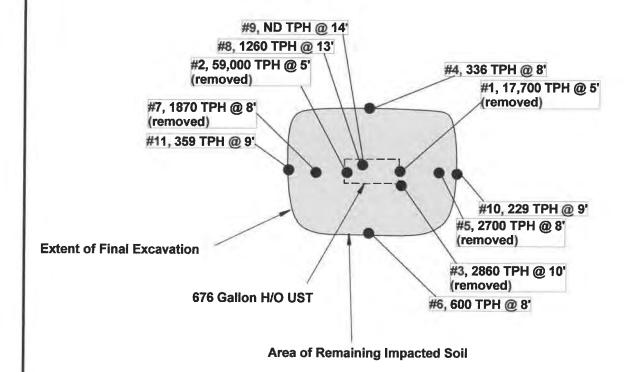
Site Map

United Excavators 15685 SW 150th Ave. Tigard, OR K&S Environmental, Inc.
