CONSTRUCTION COMPLETION REPORT

Roshak Ridge
SW Roy Rogers Road and SW Bull Mountain Road
Tigard, Oregon
ECSI Site No. 5781

For
Polygon Northwest Company
May 2, 2019

GeoDesign Project: Polygon-113-03-03

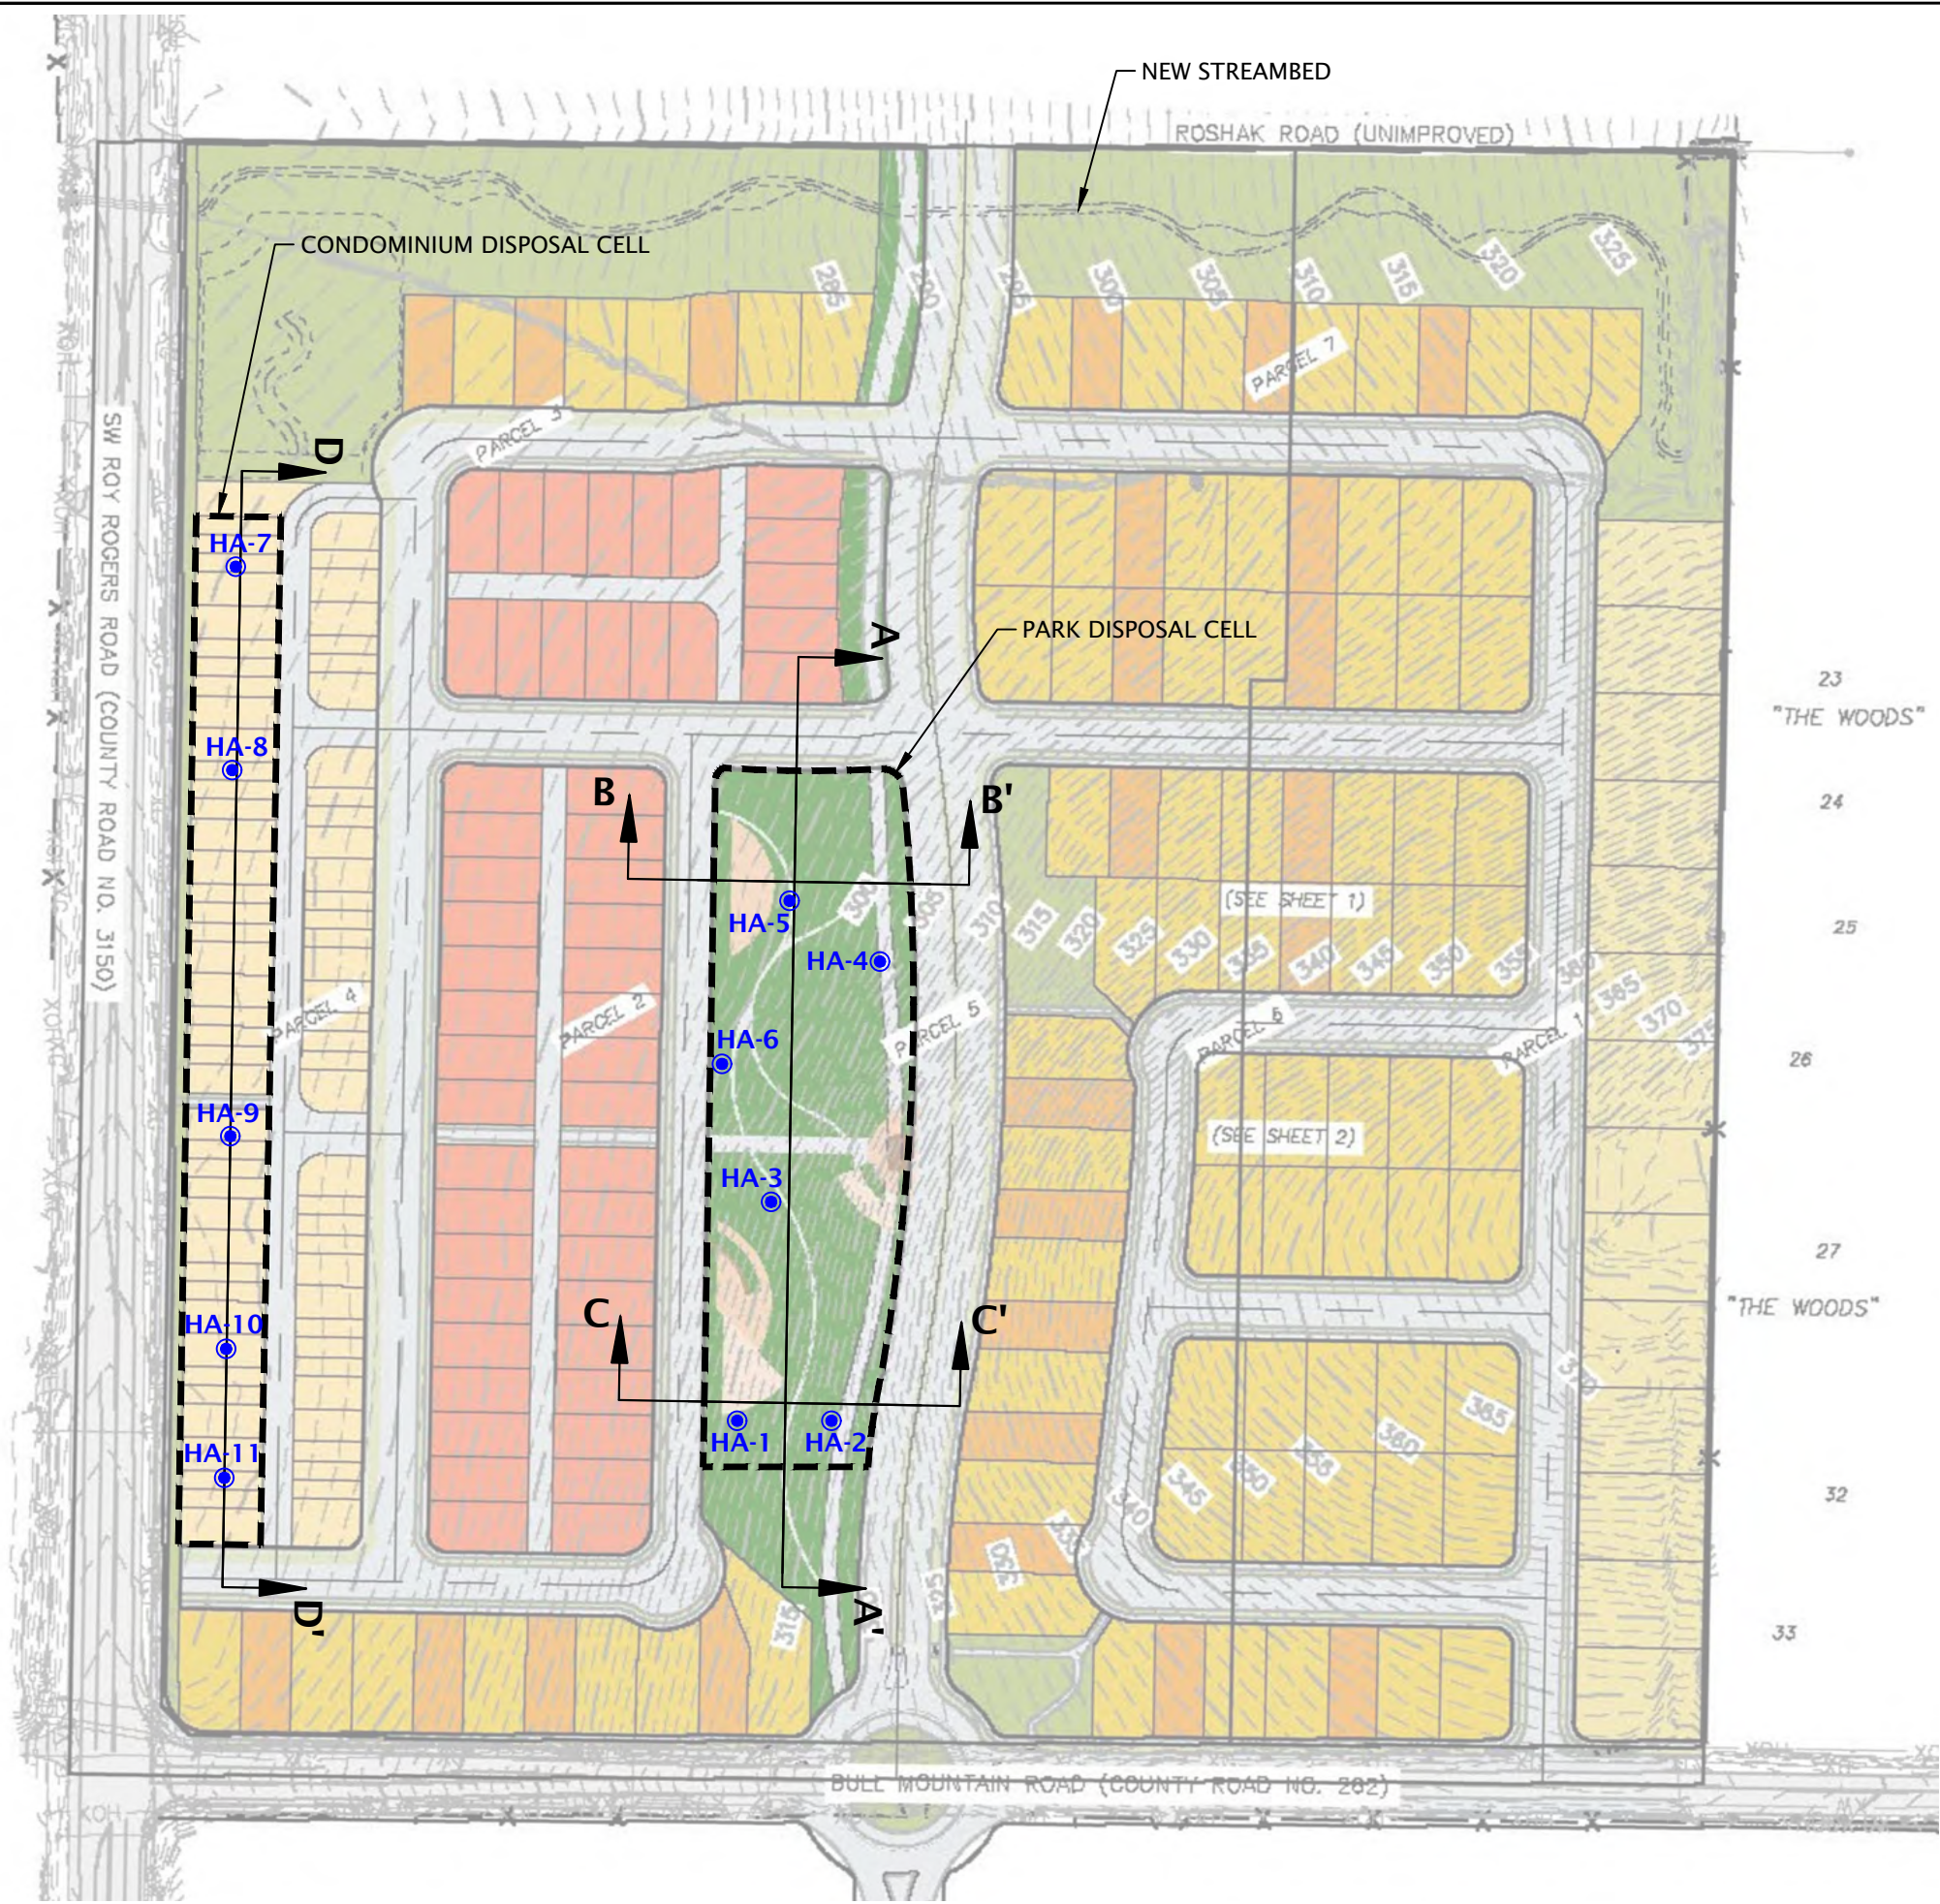
<div>GeoDESIGN²</div> <div>9450 SW Commerce Circle - Suite 300 Wilsonville OR 97070 503.968.8787 www.geodesigninc.com</div>	POLYGON-113-03-03	SITE PLAN	
	MAY 2019	ROSHAK RIDGE TIGARD, OR	
		FIGURE 2

- DISPOSAL CELL BOUNDARY
- HA-1 ● HAND AUGER BORING (GEODESIGN 2018)
- A A' CROSS SECTION

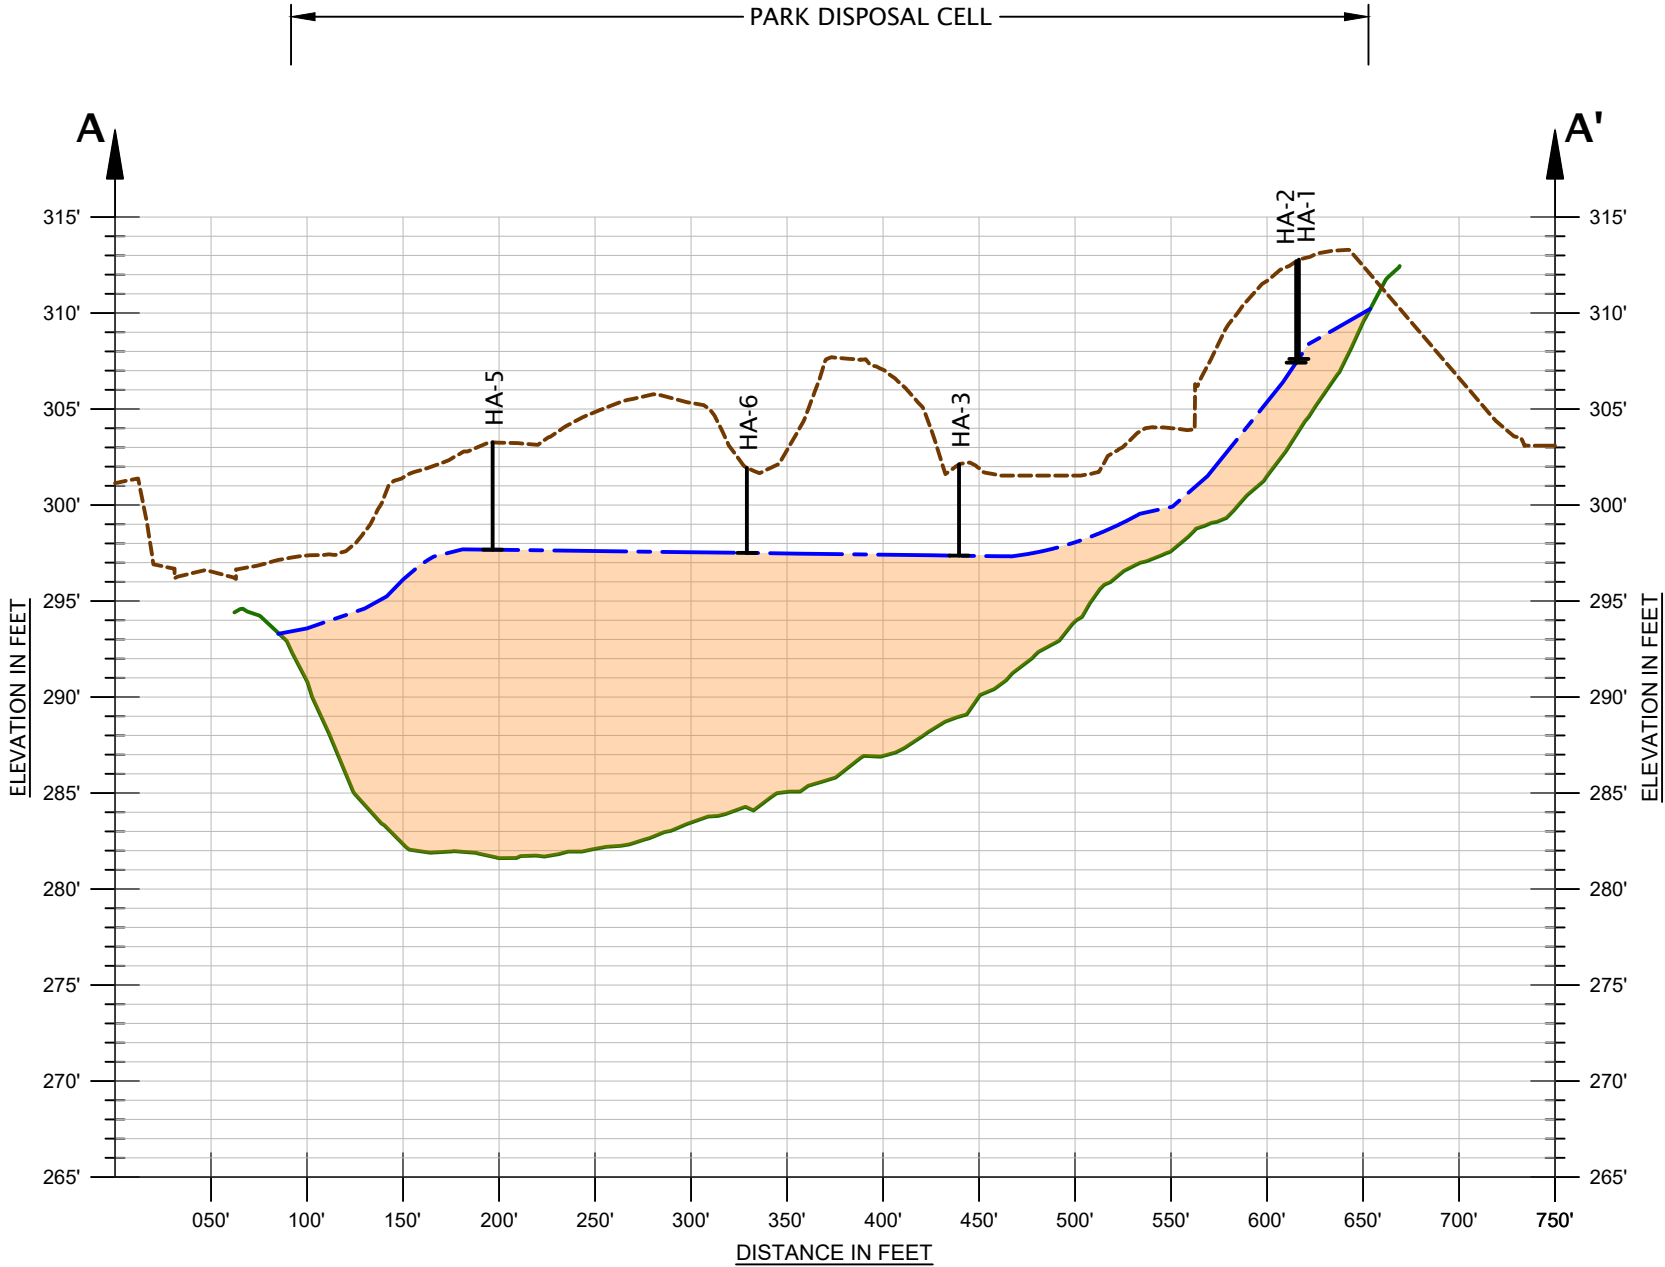
POLYGON-113-03-03	CROSS SECTION A-A'	
	ROSHAK RIDGE TIGARD, OR	FIGURE 3
MAY 2019		
<div><div><div>GEODESIGN</div><div>9450 SW Commerce Circle - Suite 300 Wilsonville OR 97070 503.968.8787 www.geodesigninc.com</div></div></div>

- LEGEND:**
- FINAL GRADE PROFILE
 - APPROXIMATE LOCATION OF DEMARCATION LAYER
 - APPROXIMATE LOCATION OF CONTAMINATED SOIL
 - SUBGRADE PROFILE
 - HAND AUGER BORING

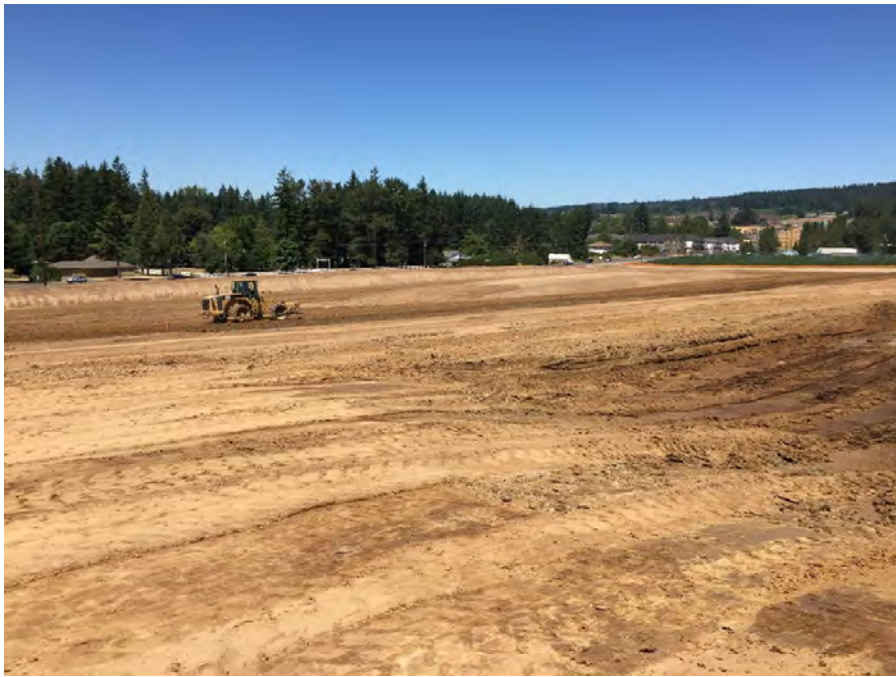
INITIAL GRADING OF THE WESTERN PORTION OF THE PROJECT SITE USING SCRAPPERS AND BULLDOZERS. PHOTOGRAPH TAKEN FACING WEST.

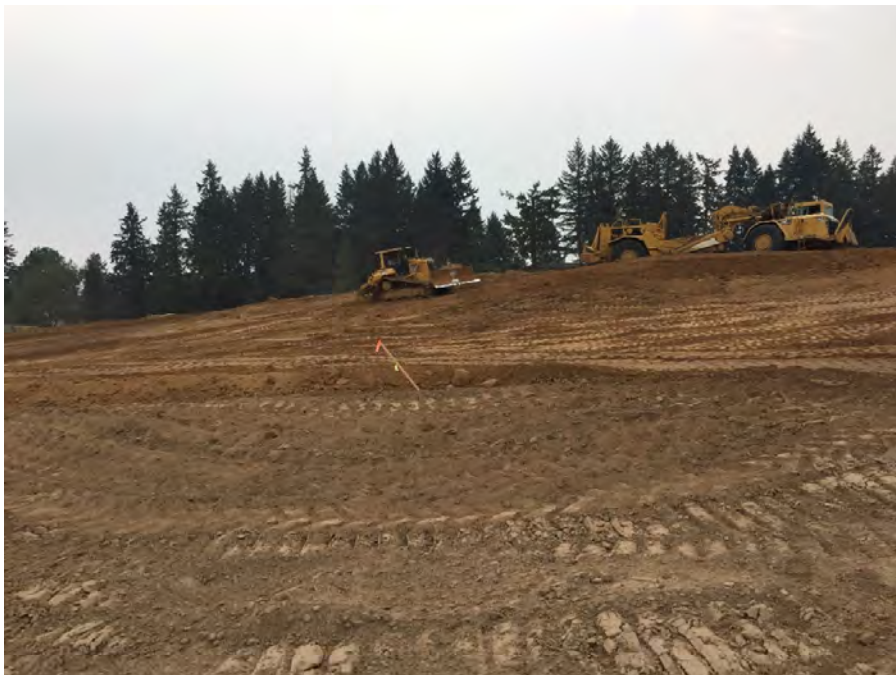
EXCAVATION OF THE PARK DISPOSAL CELL USING SCRAPPERS. PHOTOGRAPH TAKEN FACING SOUTHWEST.

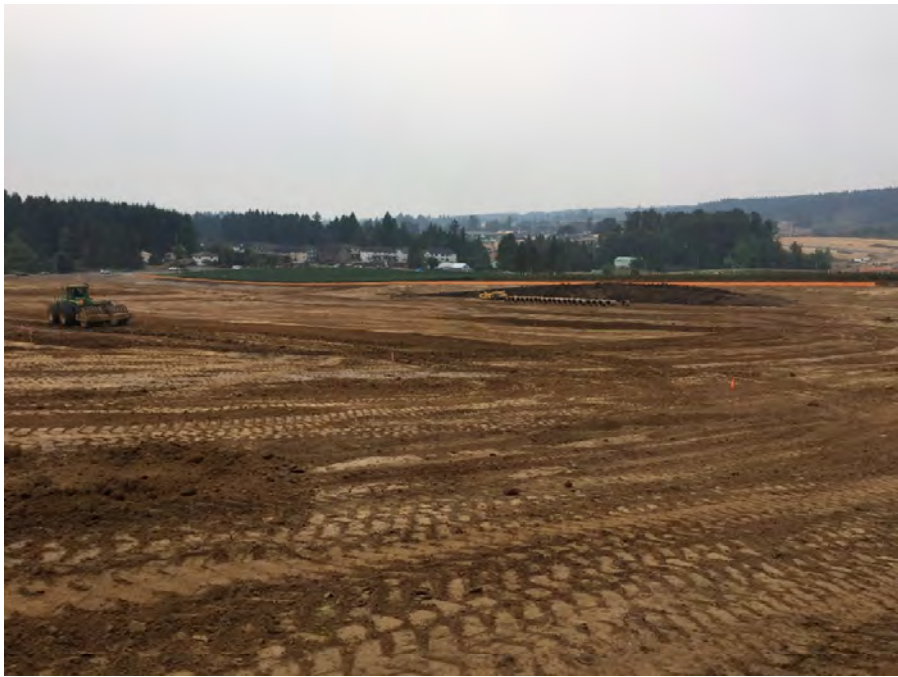
GRADING OF THE NORTHERN PORTION OF THE PROJECT SITE. PHOTOGRAPH TAKEN FACING NORTH.

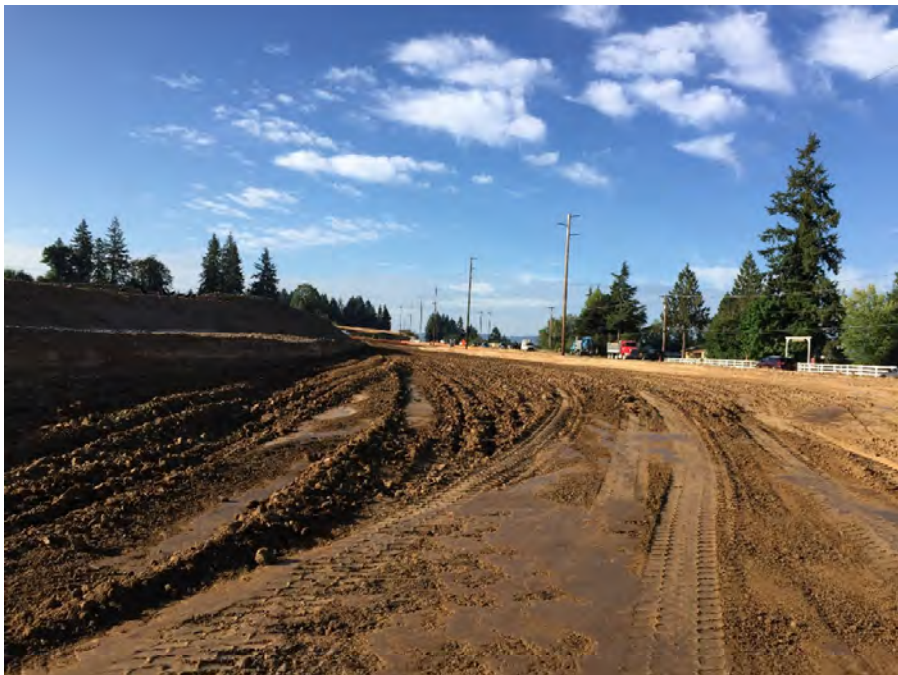
EXCAVATION OF THE CONDOMINIUM DISPOSAL CELL. PHOTOGRAPH TAKEN FACING SOUTHWEST.

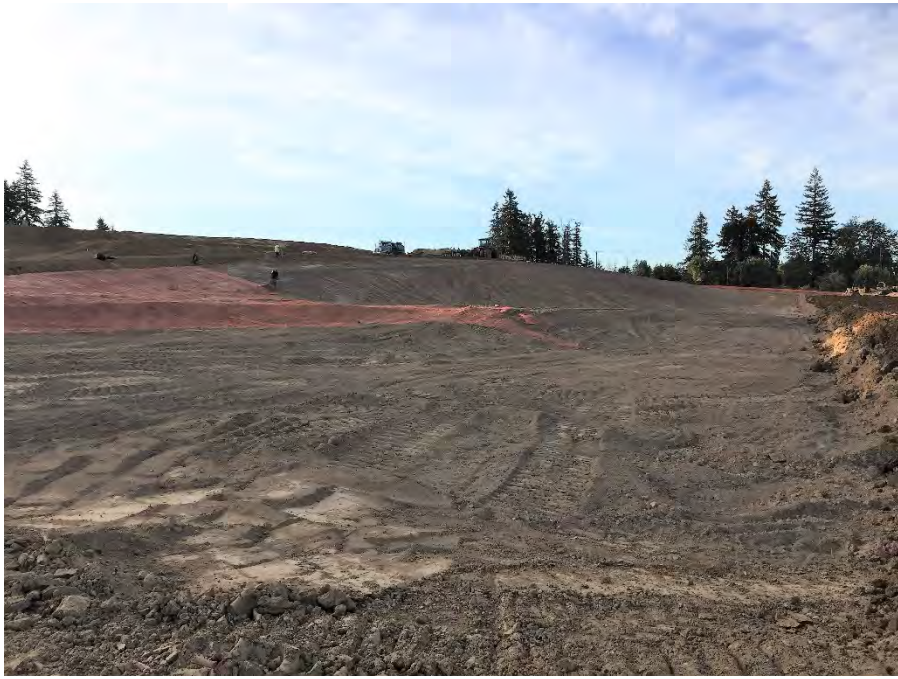
DEMARCATIION LAYER BEING INSTALLED ON THE SLOPES OF THE PARK DISPOSAL CELL.
PHOTOGRAPH TAKEN FACING SOUTH.

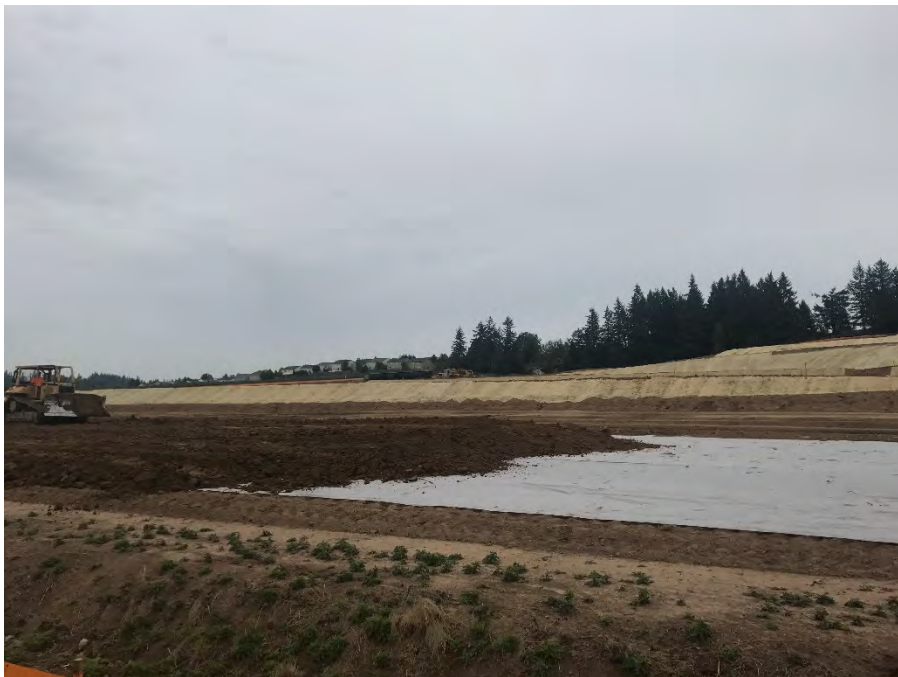
DEMARCATIION LAYER AT THE CONDOMINIUM DISPOSAL CELL. PHOTOGRAPH TAKEN
EAST.

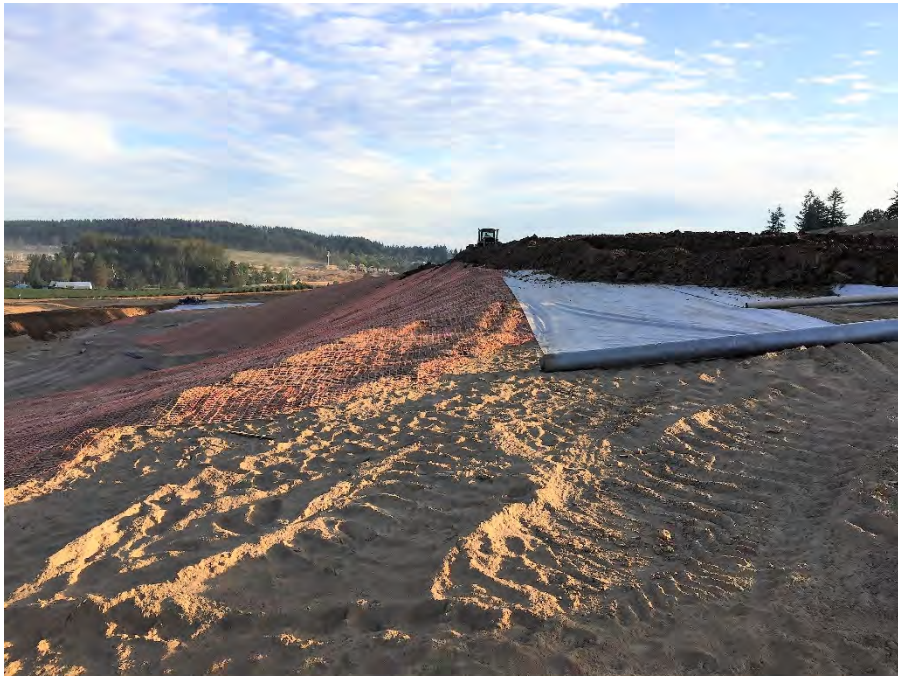
PARK DISPOSAL CELL DEMARCATION LAYERS. PHOTOGRAPH TAKEN FACING NORTH.

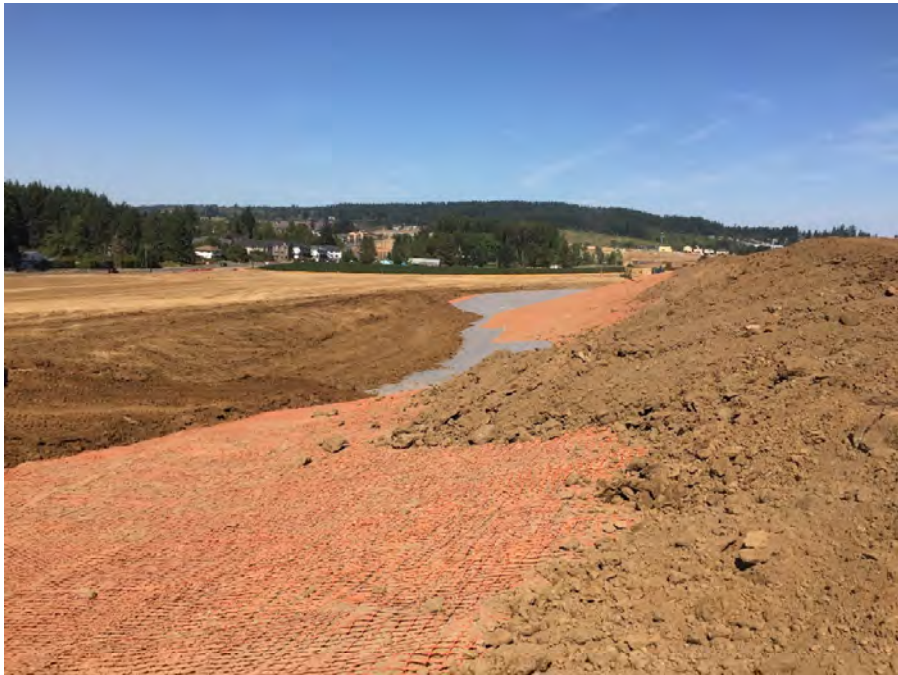
PLACING FILL ABOVE THE DEMARCATION LAYER OF THE PARK DISPOSAL CELL. PHOTOGRAPH TAKEN FACING NORTH.

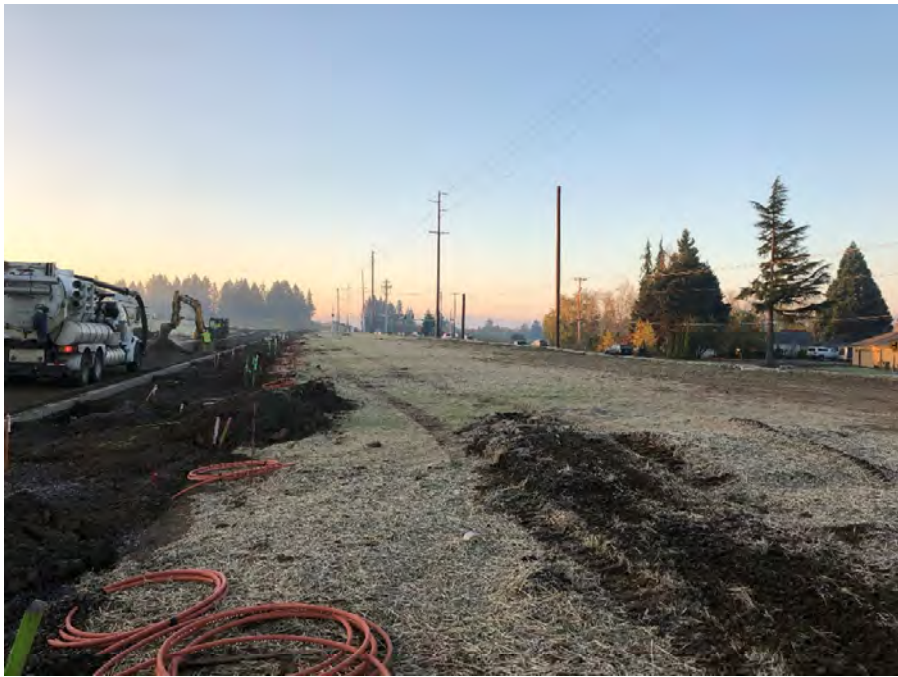
FINAL GRADE OF THE CONDOMINIUM DISPOSAL CELL. PHOTOGRAPH TAKEN FACING SOUTH.

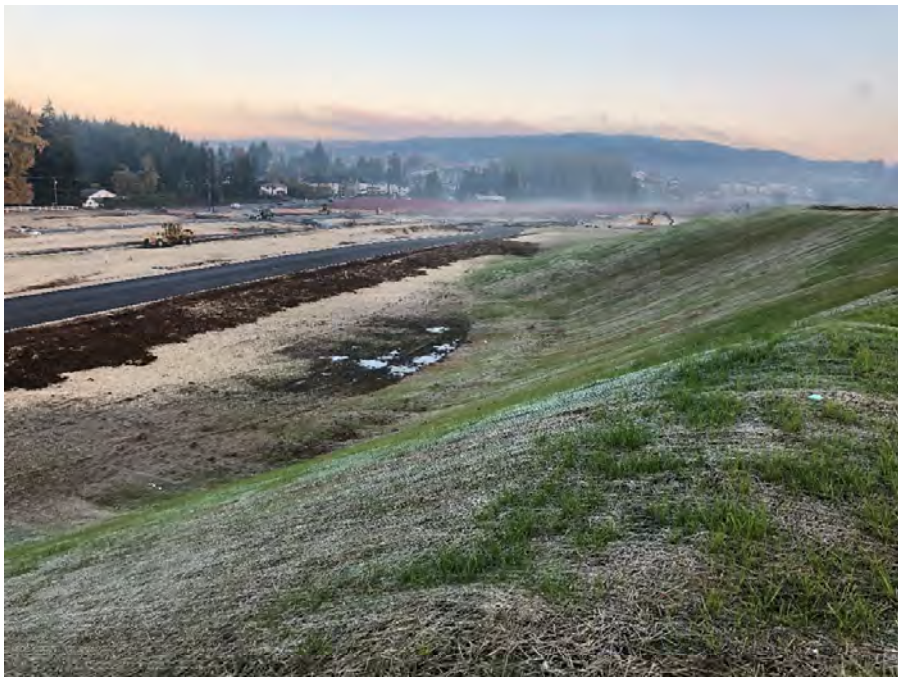
FINAL GRADE OF THE PARK DISPOSAL CELL. PHOTOGRAPH TAKEN FACING NORTHWEST.

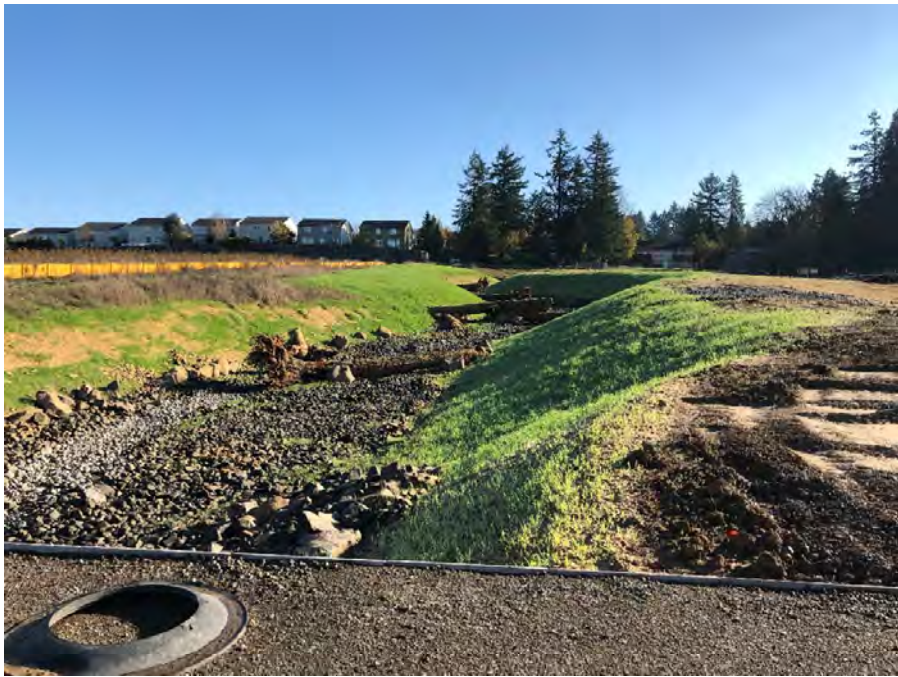
EASTERN PORTION OF REALIGNED STREAM BED. PHOTOGRAPH TAKEN FACING EAST.

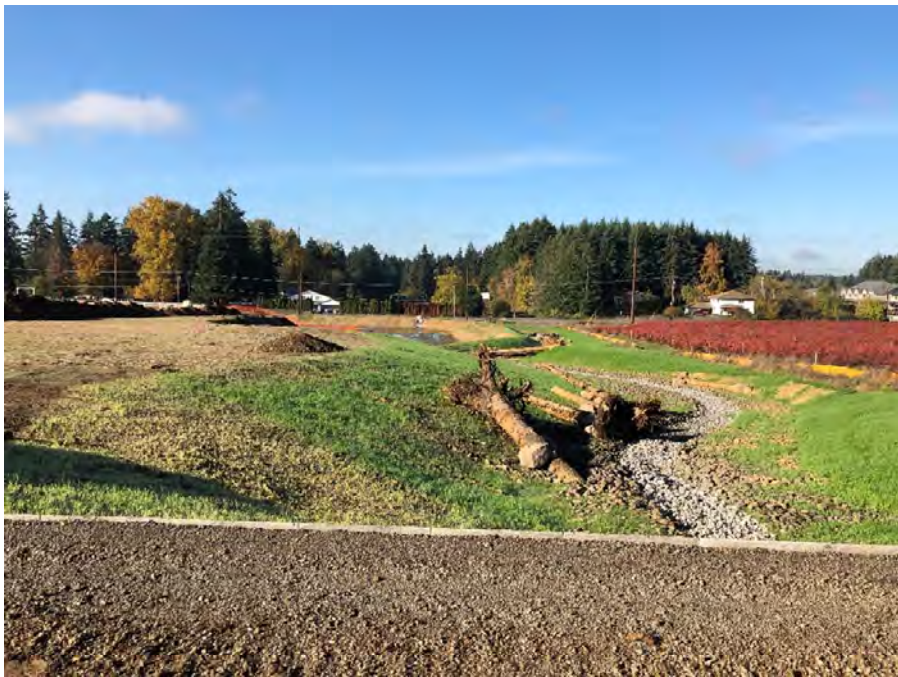
WESTERN PORTION OF REALIGNED STREAM BED. PHOTOGRAPH TAKEN FACING WEST.

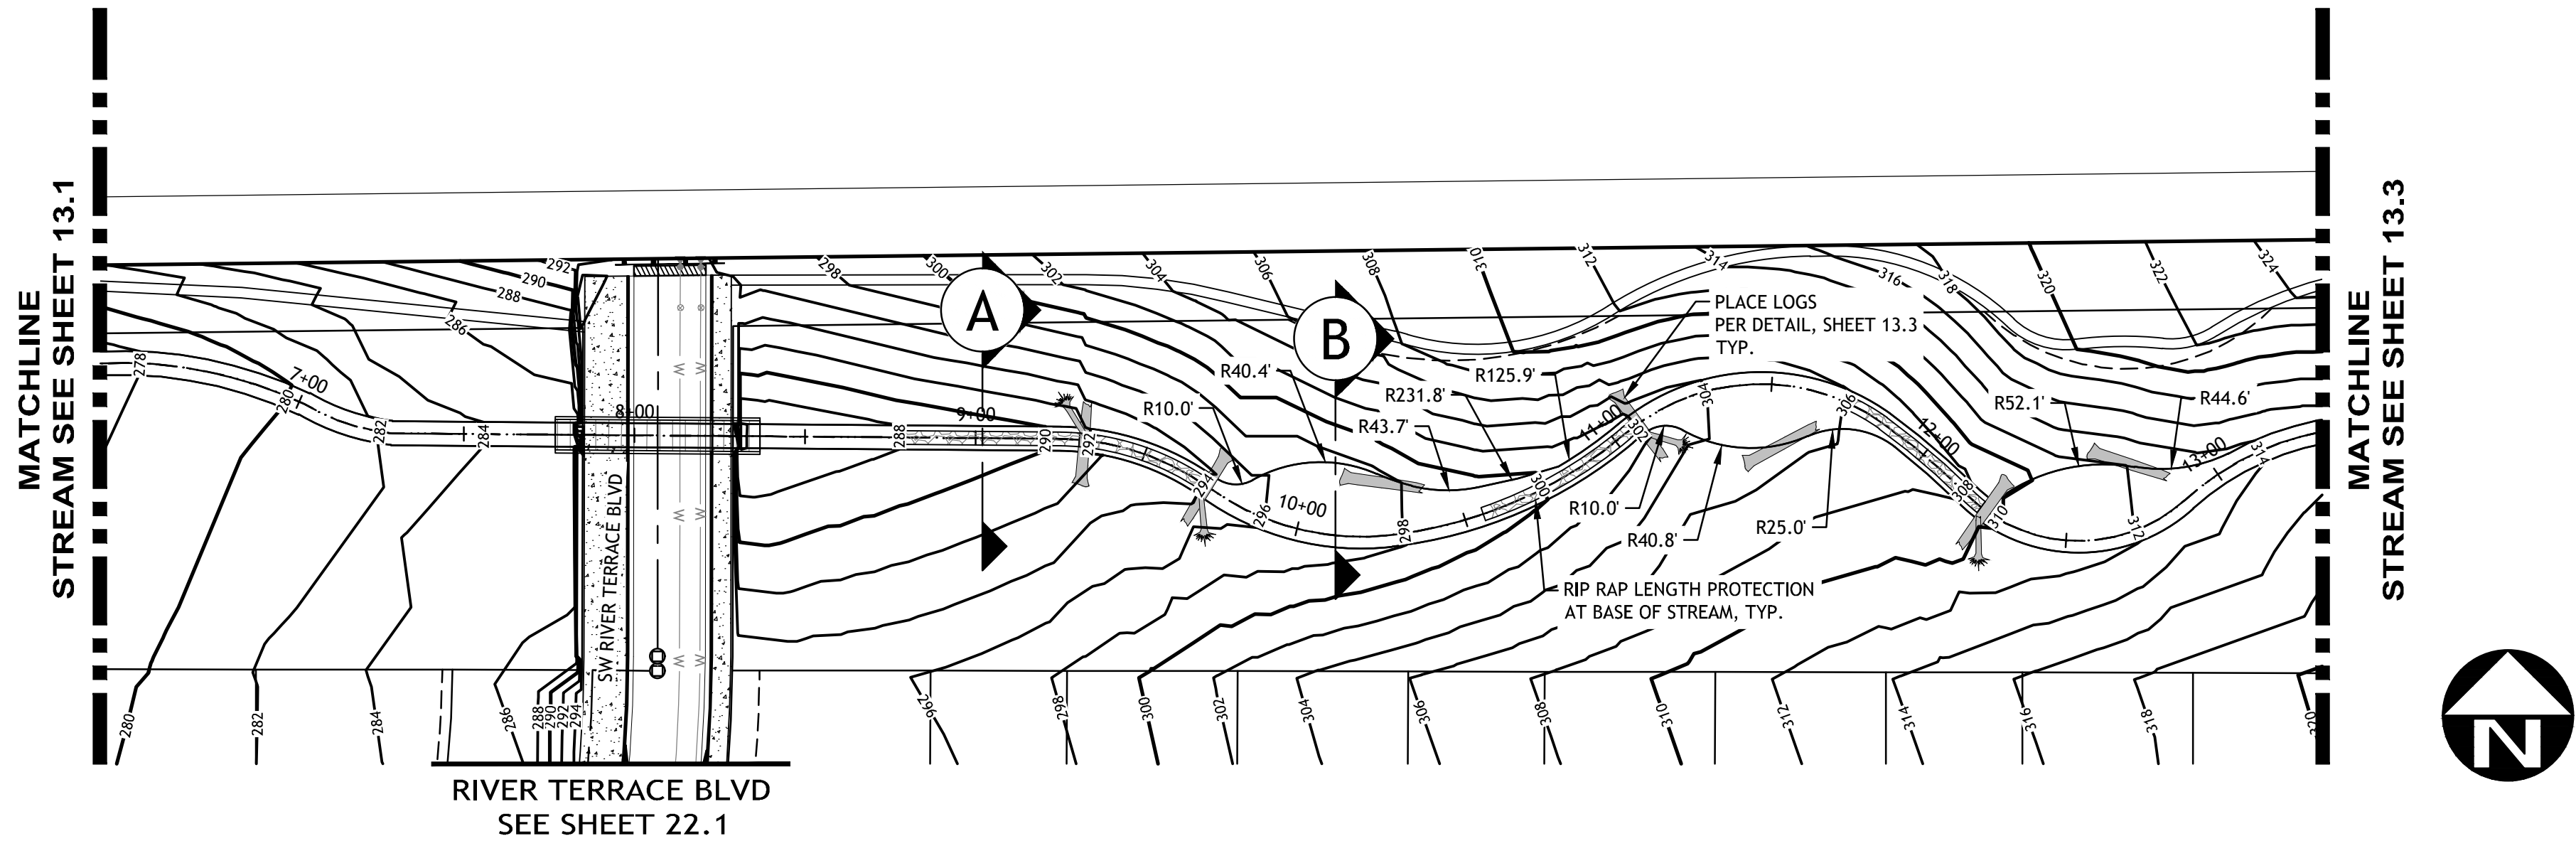
STREAM PLAN
HORIZ SCALE: 1" = 40'

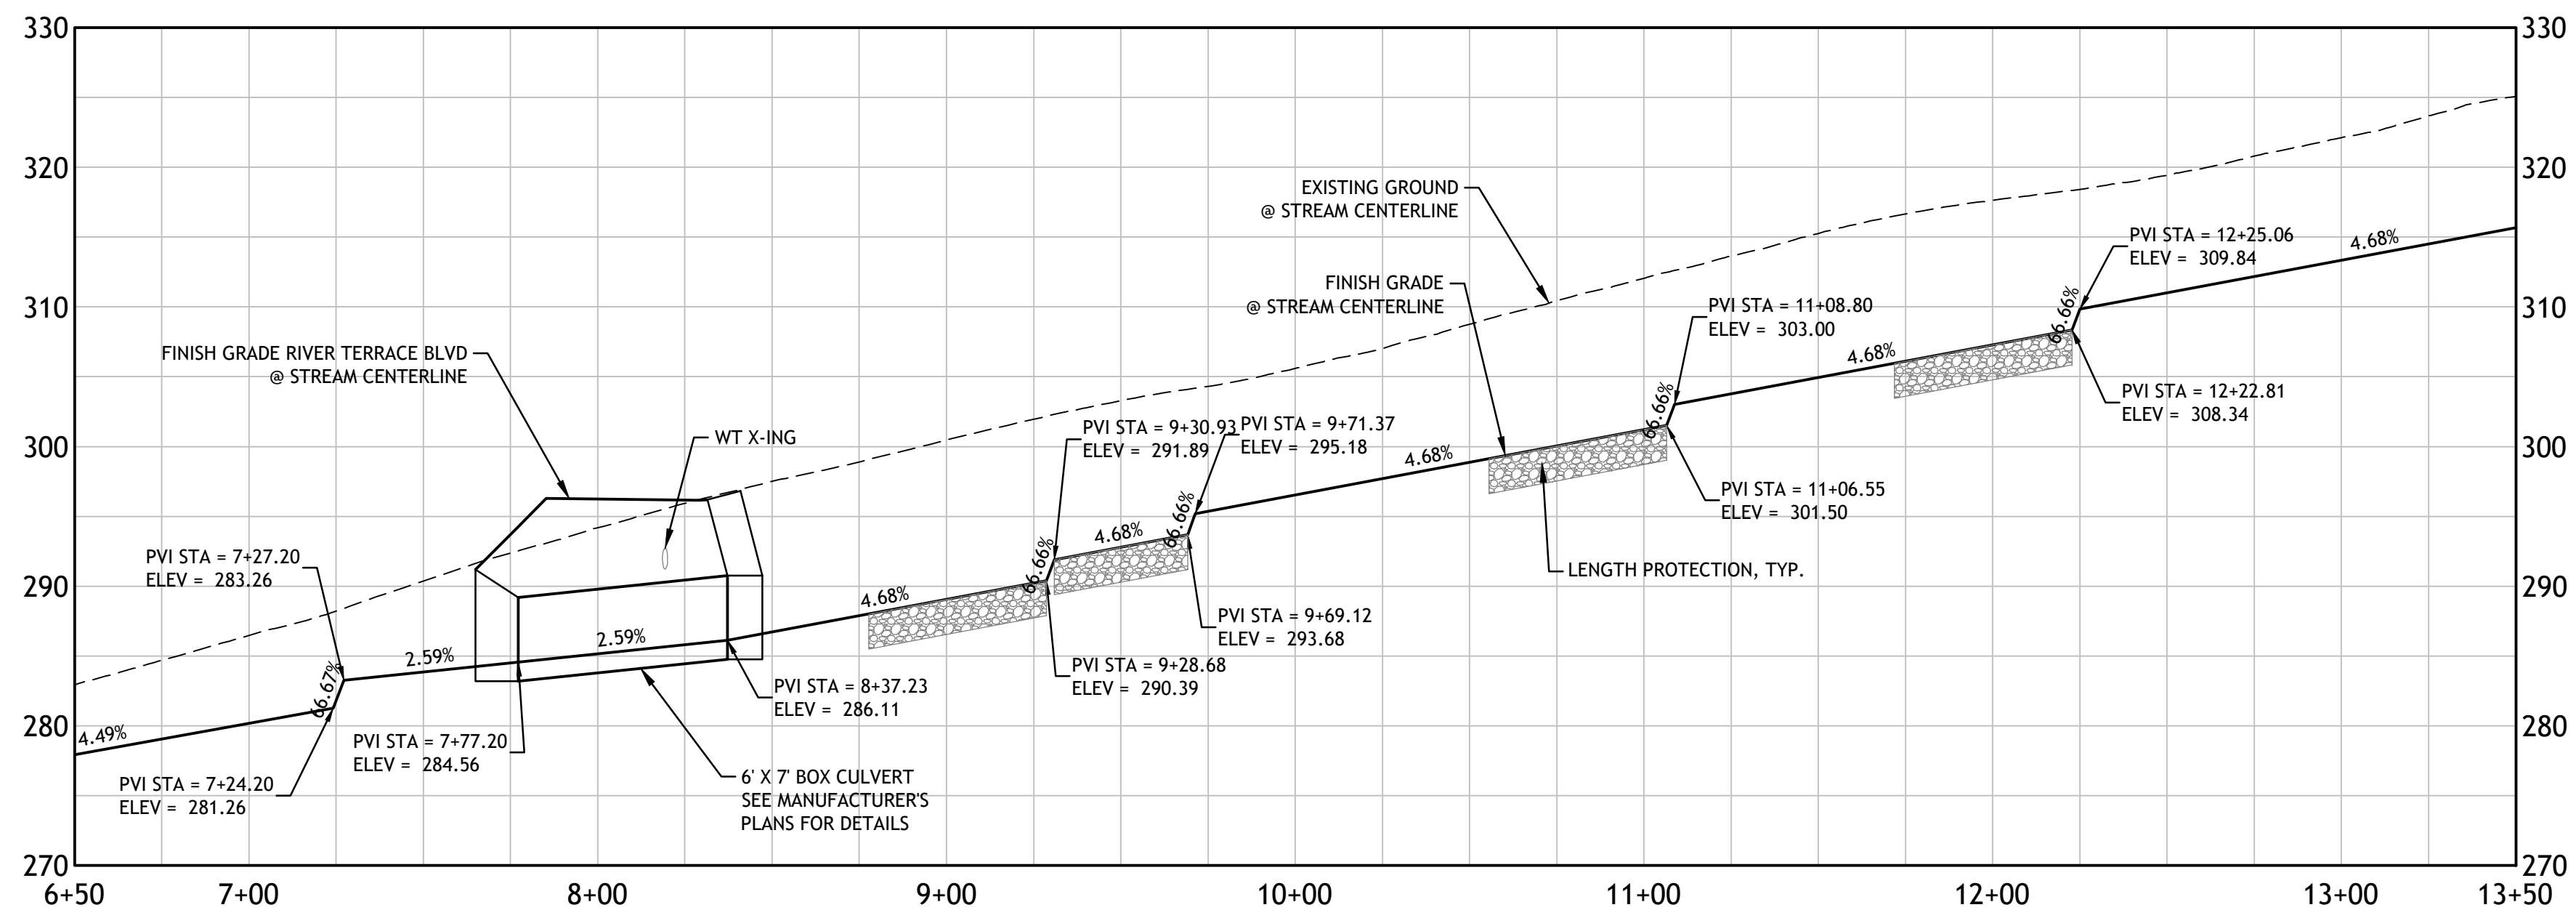
STREAM PROFILE
HORIZ SCALE: 1" = 40', VERT SCALE: 1" = 10'

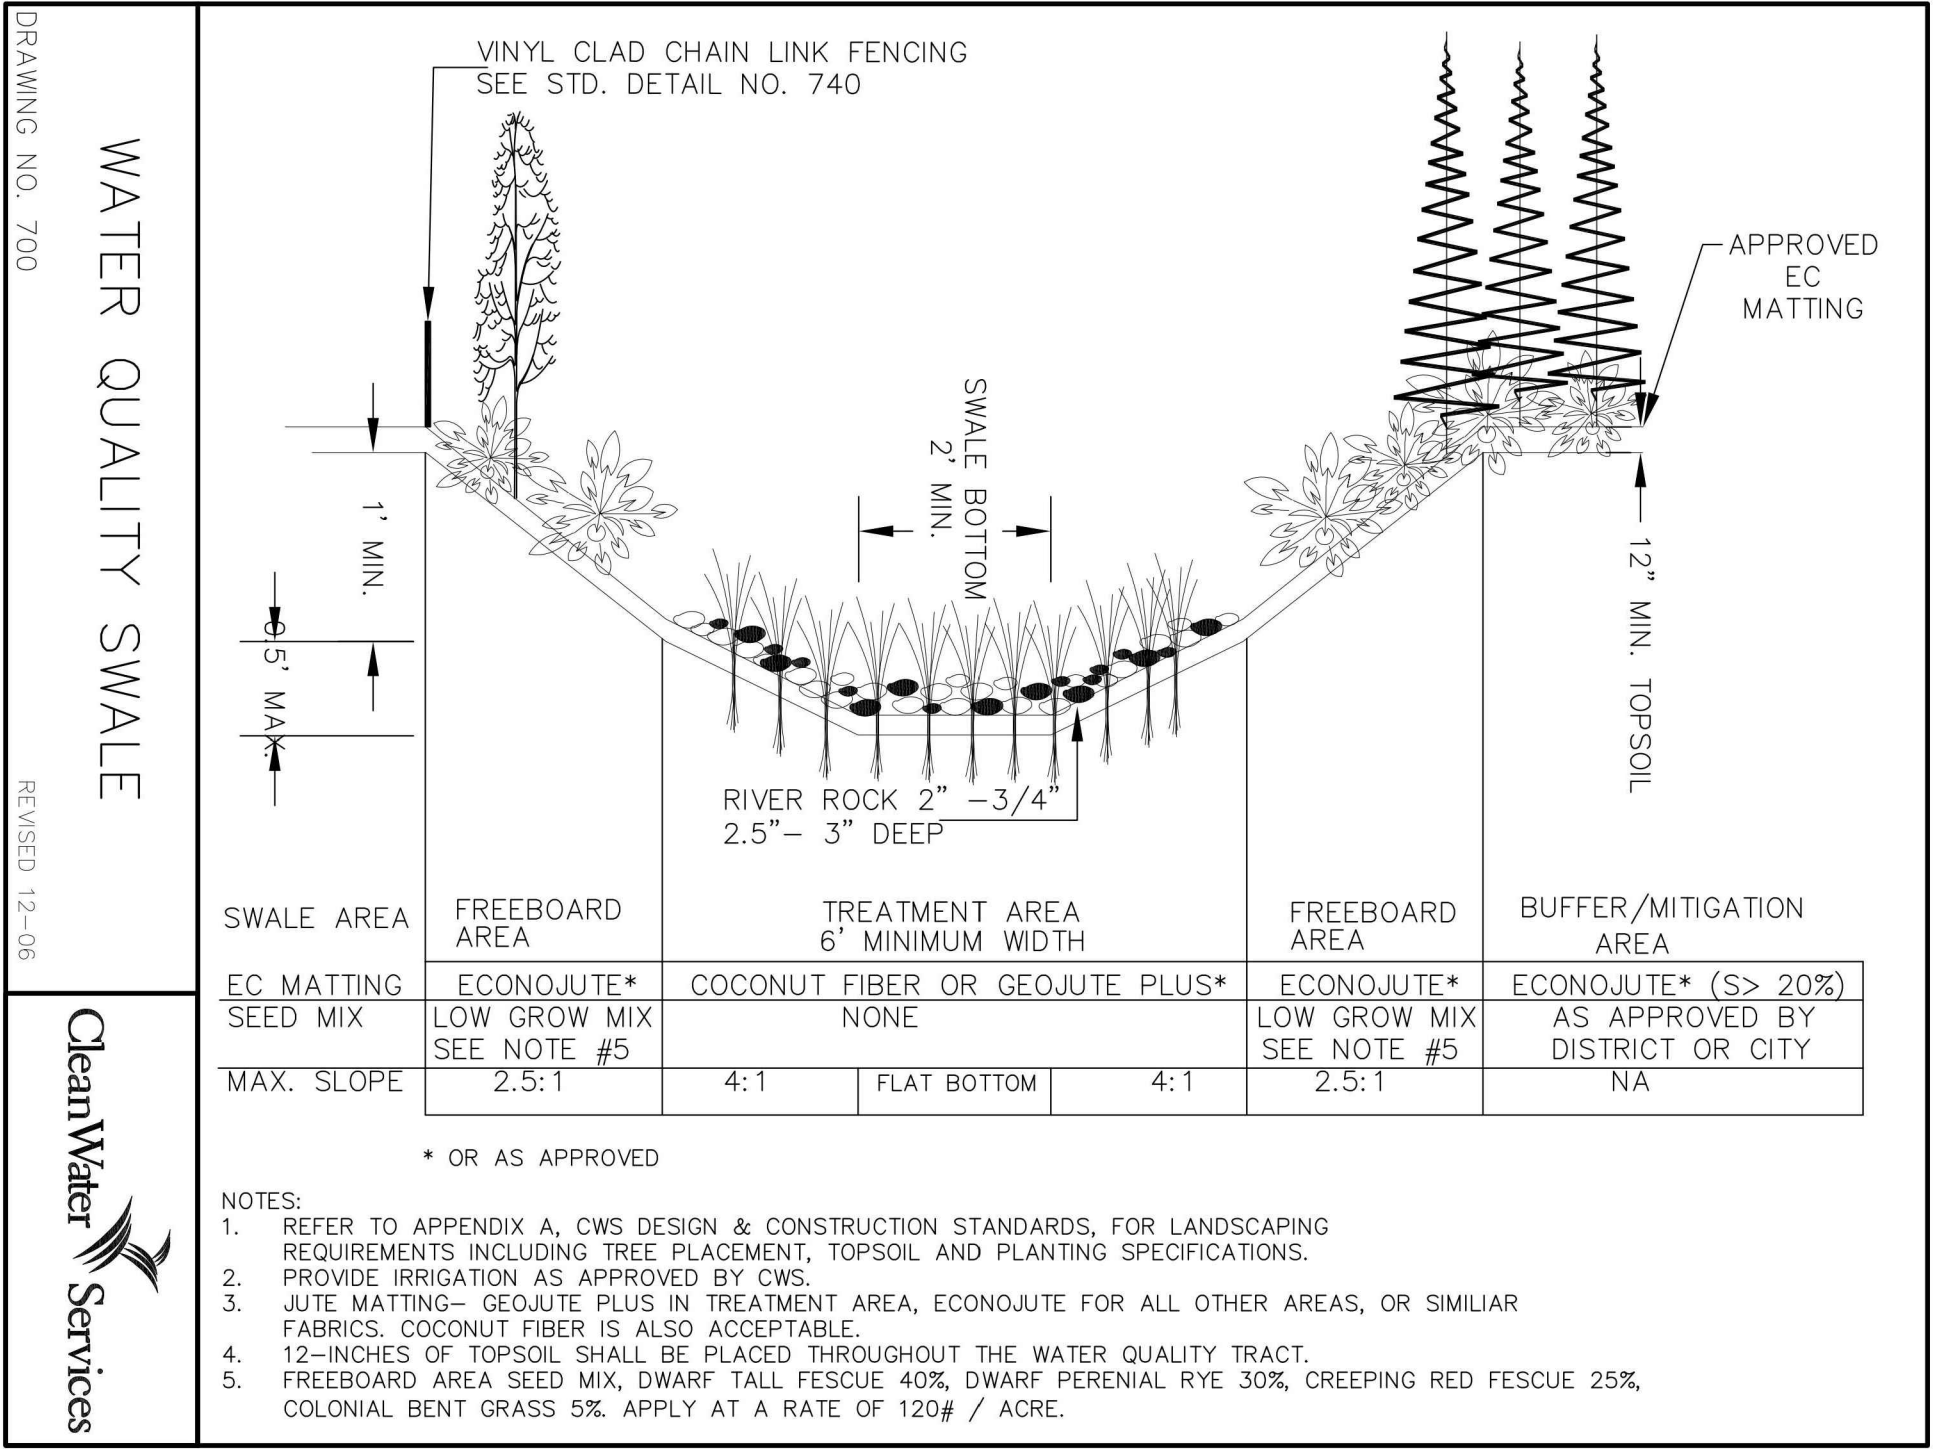
WATER QUALITY SWALE
DRAWING NO. 700
REVISED 12-06

- NOTES:
1. REFER TO APPENDIX A, CWS DESIGN & CONSTRUCTION STANDARDS, FOR LANDSCAPING REQUIREMENTS INCLUDING TREE PLACEMENT, TOPSOIL AND PLANTING SPECIFICATIONS.
 2. PROVIDE IRRIGATION AS APPROVED BY CWS.
 3. JUTE MATTING- GEOJUTE PLUS IN TREATMENT AREA, ECONOJUTE FOR ALL OTHER AREAS, OR SIMILAR FABRICS. COCONUT FIBER IS ALSO ACCEPTABLE.
 4. 12-INCHES OF TOPSOIL SHALL BE PLACED THROUGHOUT THE WATER QUALITY TRACT.
 5. FREEBOARD AREA SEED MIX, DWARF TALL FESCUE 40%, DWARF PERENNIAL RYE 30%, CREEPING RED FESCUE 25%, COLONIAL BENT GRASS 5%. APPLY AT A RATE OF 120# / ACRE.

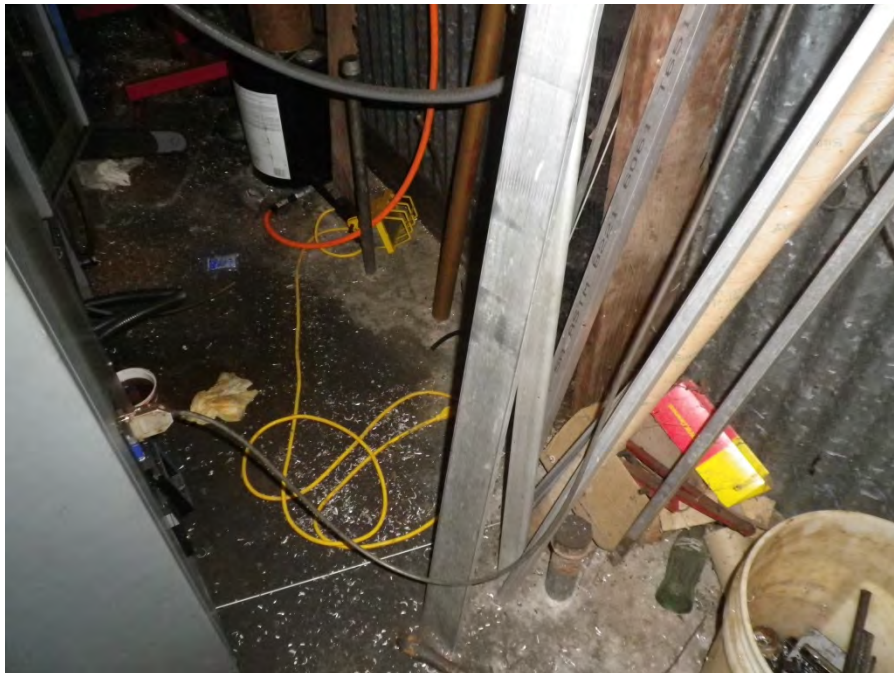
VIEW OF THE SUSPECT PIPING OBSERVED TO THE EAST IN THE MACHINE SHOP LOCATED ON TAX LOT 1100 AND DARK, OILY STAINING OBSERVED ON THE CONCRETE FLOOR BENEATH THE MILLING MACHINE.

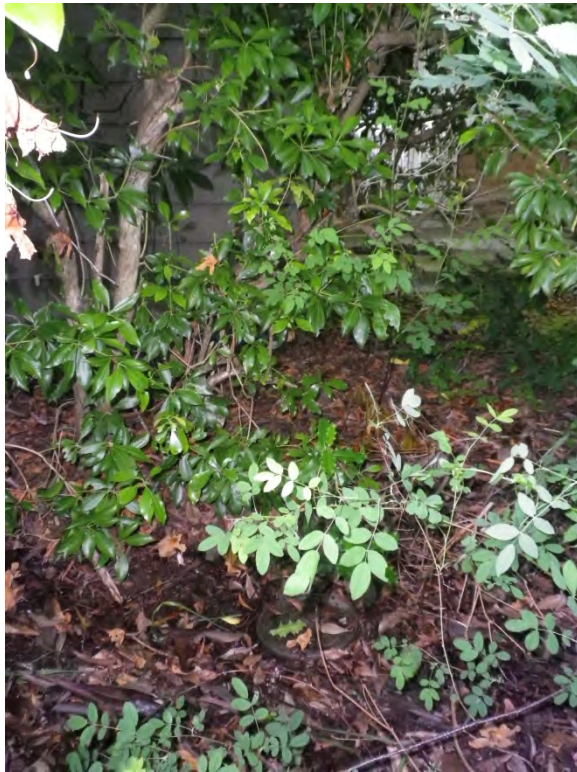
VIEW OF THE FILL PORT, LOCATED IN THE FOREGROUND, ASSOCIATED WITH THE HEATING OIL UST LOCATED DIRECTLY NORTH OF THE RESIDENCE ON TAX LOT 1101. PHOTOGRAPH TAKEN FACING SOUTH.

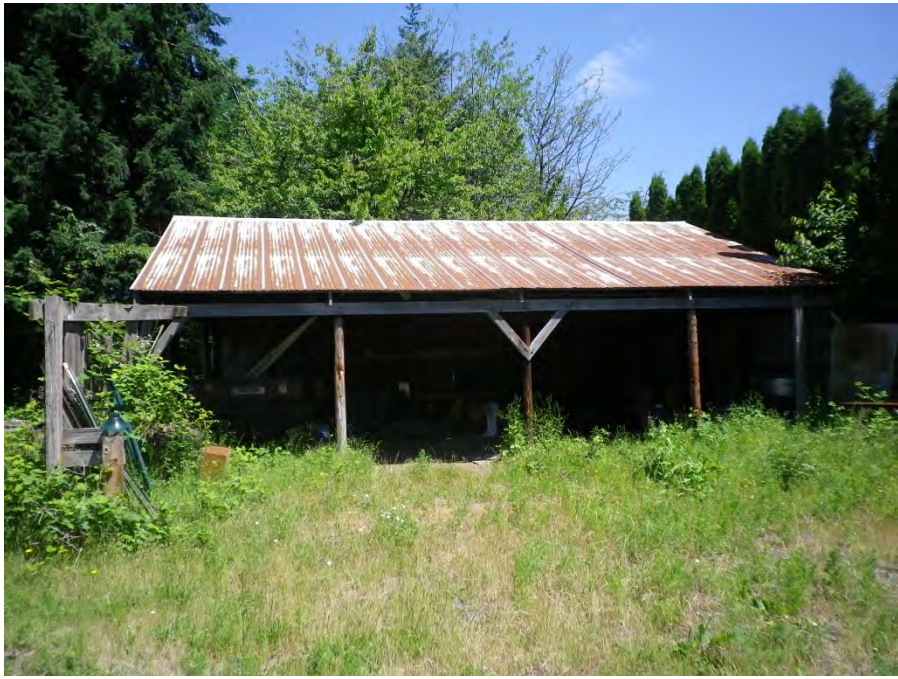
VIEW OF THE SHED LOCATED ON TAX LOT 3400, WHICH CONTAINED MULTIPLE ASTs AND DRUMS. PHOTOGRAPH TAKEN FACING NORTH.
