Re: UST-Multnomah County  
Chevron Station 3541

PRELIMINARY ENVIRONMENTAL  
ASSESSMENT  
CHEVRON U.S.A. INC.  
SERVICE STATION 3541  
MILWAUKIE, OREGON

Subject: Preliminary Environmental Assessment  
Chevron U.S.A. Inc. Service Station 3541  
Milwaukie, Oregon

<p>Date: April 1989 Project Number: 5E-1013</p>	<p>Chevron U.S.A. Inc. Service Station 3541/Milwaukie, OR</p>	Figure
	<p><b>SITE PLAN AND SAMPLING LOCATIONS</b></p>	<b>2</b>

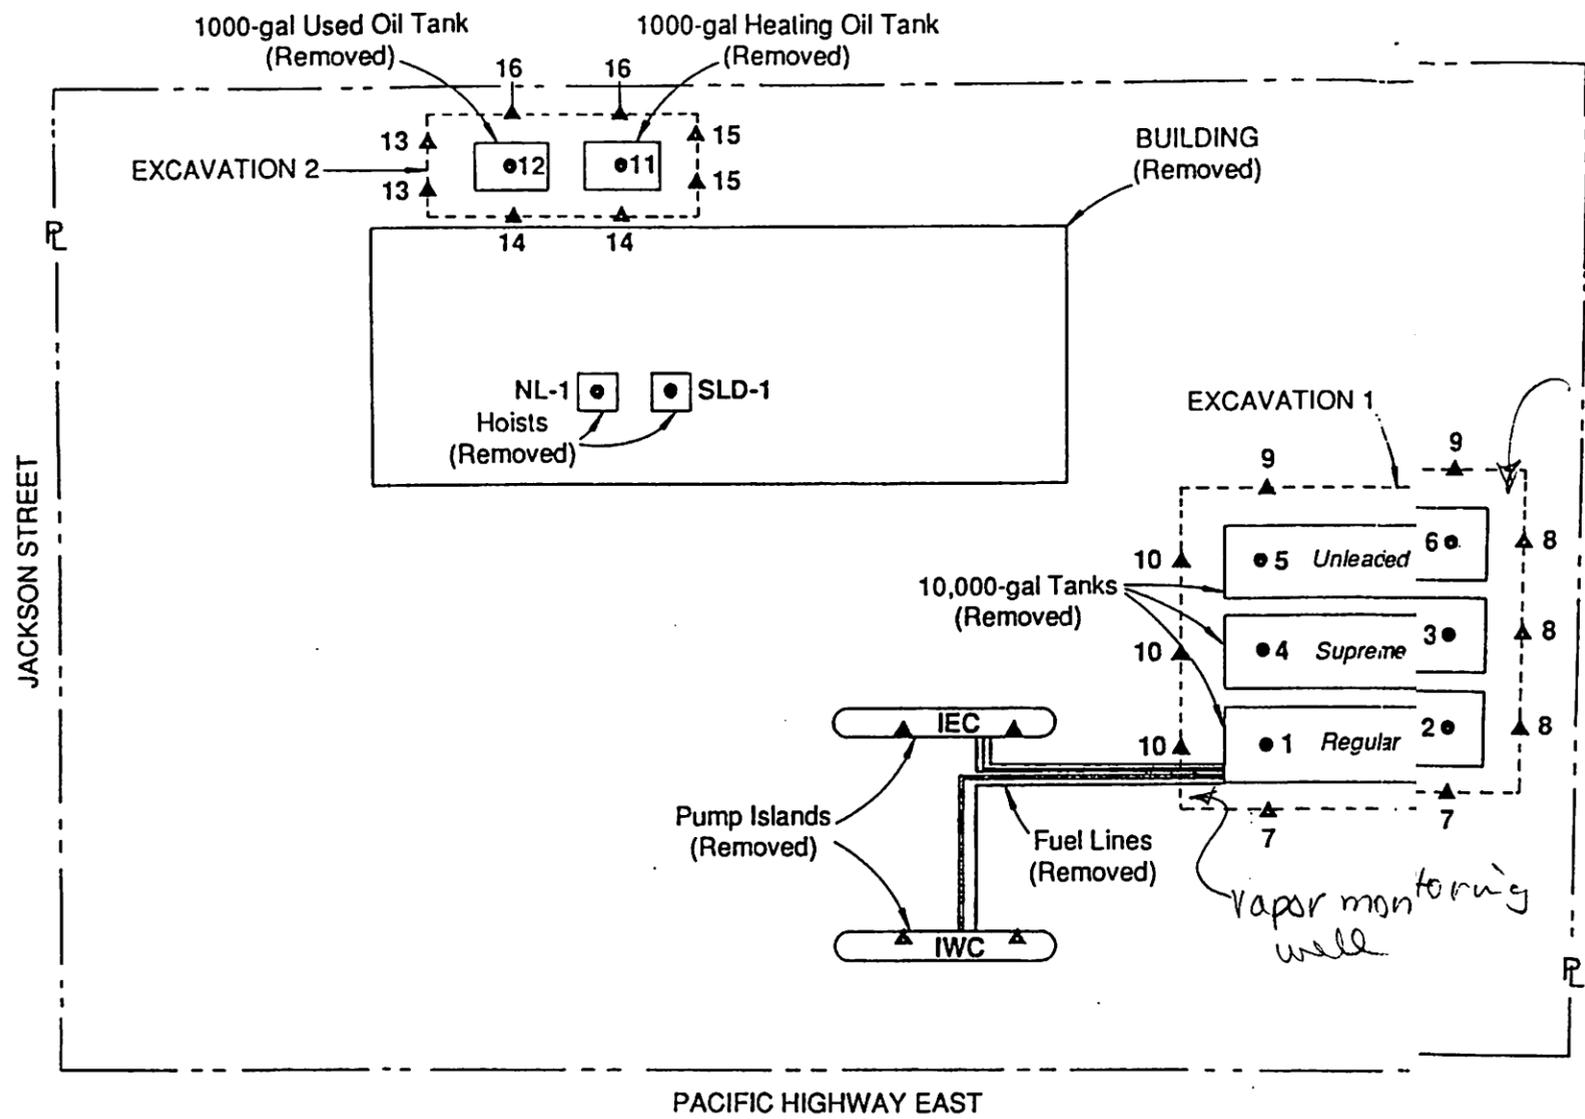
All underground structures were excavated and removed on February 15, 1989. Figure 2 shows a generalized site plan and depicts the sampling locations. Prior to removing the gasoline storage tanks, approximately 30 pounds of dry ice were placed within each tank, and the associated fuel supply lines were disconnected and allowed to drain into containers. Absorbent material was placed in the orifice of each supply line to collect any residual.

Soil samples were collected from excavations completed to remove the underground structures, at the locations shown on figure 2. A backhoe was used to remove the material for sampling from the floor and sidewalls of each excavation. Samples were obtained directly from material within the interior of the backhoe bucket.

Samples which were field-composited are shown on Figure 2 with common sample location numbers.

Soil Sample Identification Codes and Description of Sampling Locations.

<u>SAMPLE I.D.</u>	<u>SOIL SAMPLE LOCATION DESCRIPTION</u>
SS-1 & SS-2	Discrete samples from beneath bottom of regular gasoline tank
SS-3 & SS-4	Discrete samples from beneath bottom of supreme gasoline tank
SS-5 & SS-6	Discrete samples from beneath bottom of unleaded gasoline tank
SS-7	Discrete samples from west wall of Excavation One
SS-8	Discrete samples from south wall of Excavation One
SS-9	Discrete samples from east wall of Excavation One
SS-10	Discrete samples from north wall of Excavation One
SS-11	Discrete sample from beneath bottom of heating oil tank
SS-12	Discrete sample from beneath bottom of used oil tank
SS-13	Discrete samples from north wall of Excavation Two
SS-14	Discrete samples from west wall of Excavation Two
SS-15	Discrete samples from south wall of Excavation Two
SS-16	Discrete samples from east wall of Excavation Two
NL-1	Discrete sample from about one foot beneath northern hydraulic hoist ram

SLD-1	Discrete sample from about one ft. beneath southern hydraulic hoist ram
SLC-1	Composite sample from about one five ft. beneath southern hydraulic hoist ram
IEC	Composite sample from beneath eastern pump island
IWC	Composite sample from beneath western pump island

EXPLANATION

- Discrete Sample Location
- ▲ Composite Sample Location
- Approximate Excavation Limits

Figure 2 presents the numerical sampling locations referred to in the following text. Copies of the laboratory reports are in Appendix A.

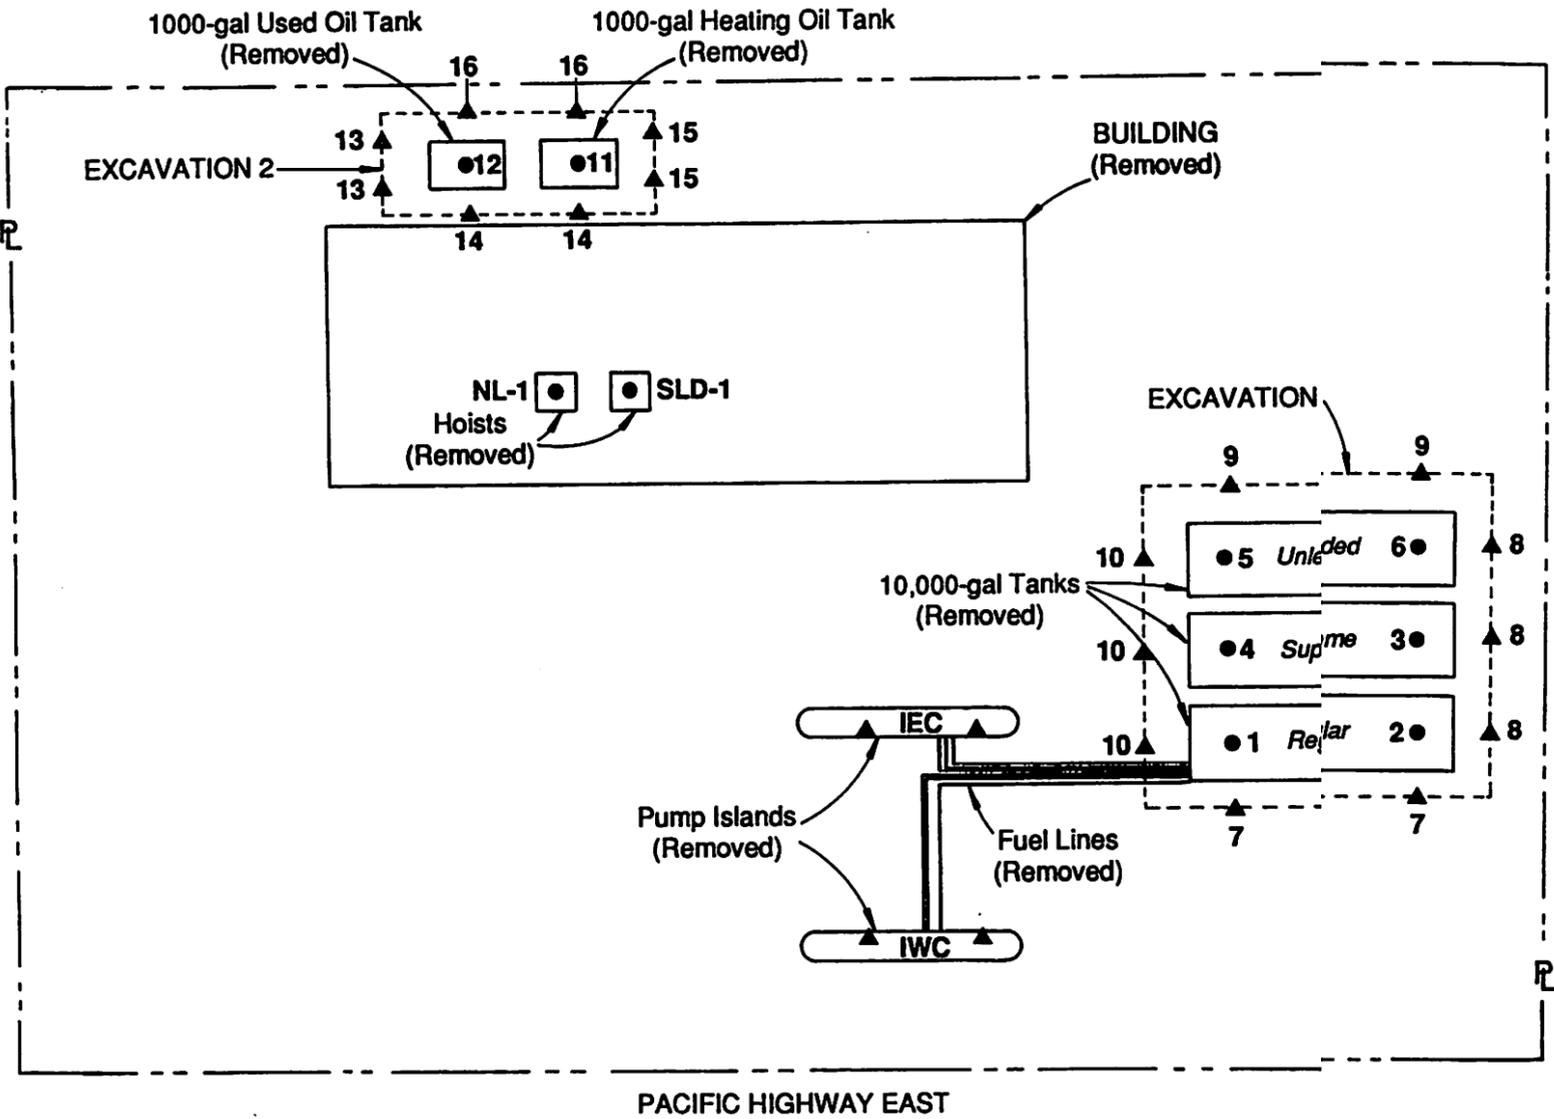
**EXPLANATION**

- Discrete Sample Location
- ▲ Composite Sample Location
- Approximate Excavation Limits

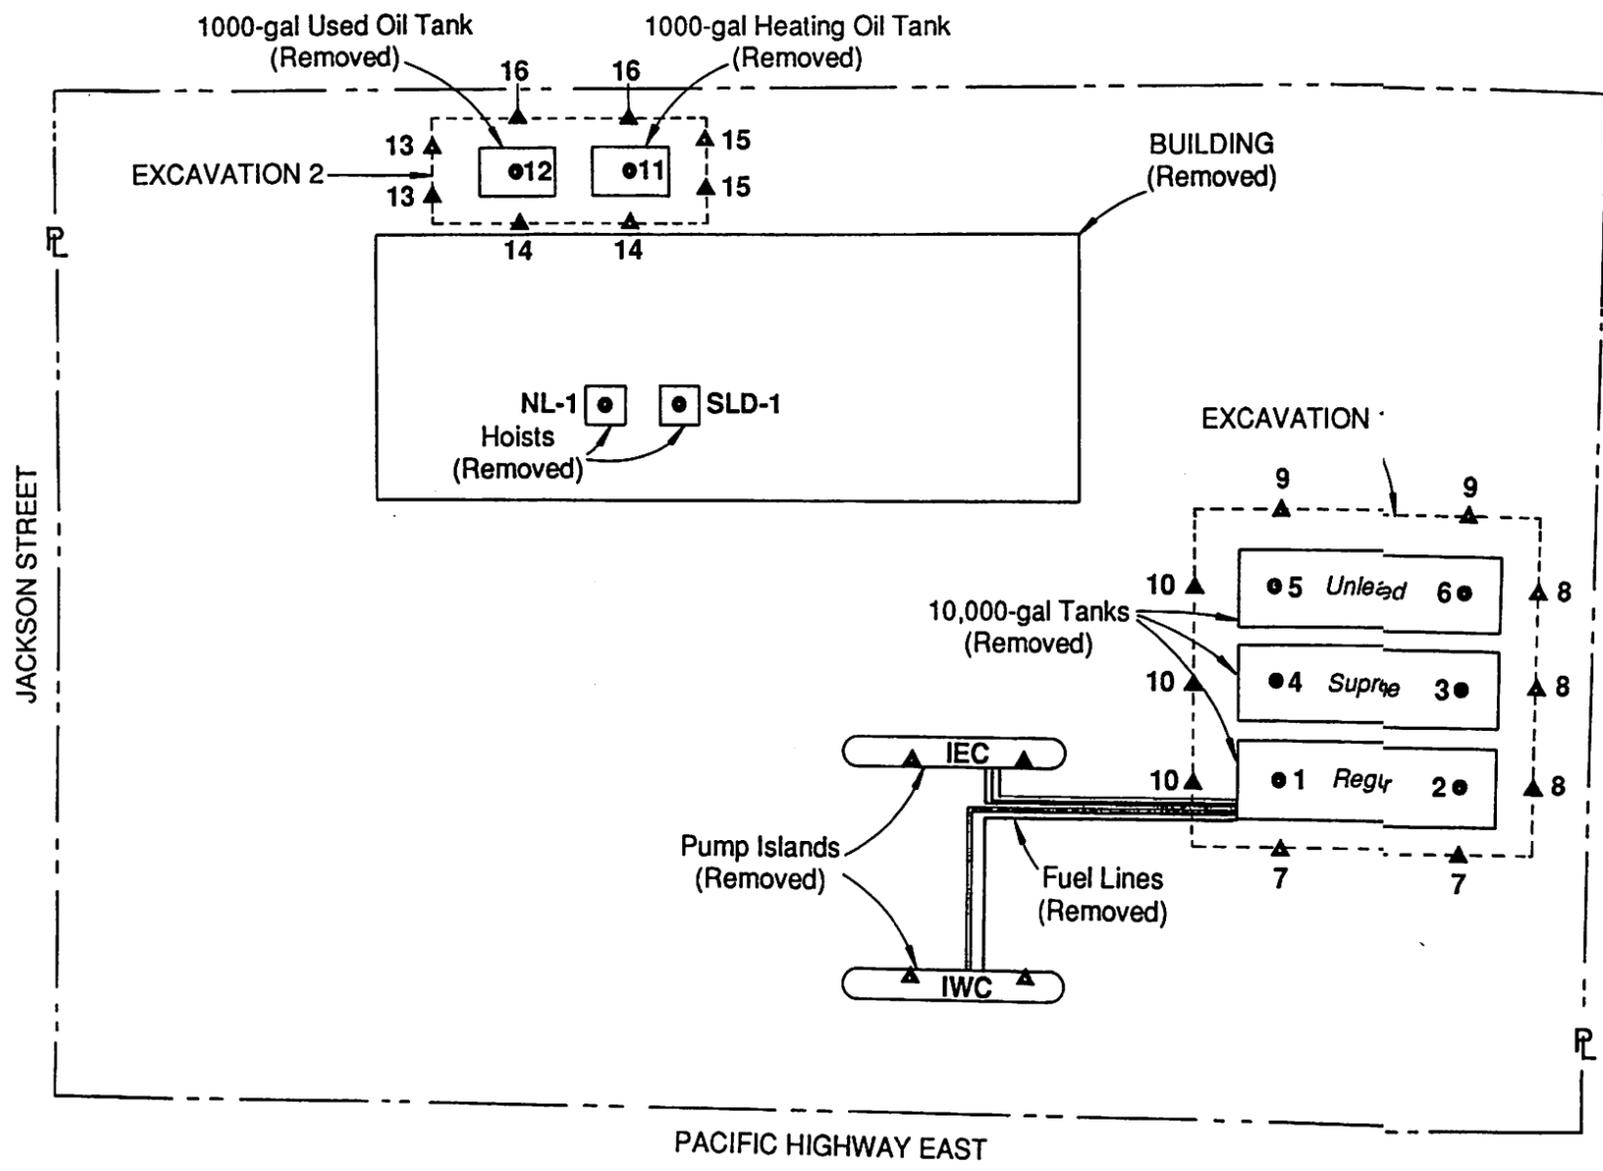
Soil Sample Identification Codes and Description of Sampling Locations.

<u>SAMPLE I.D.</u>	<u>SOIL SAMPLE LOCATION DESCRIPTION</u>
SS-1 & SS-2	Discrete samples from beneath bottom of regular gasoline tank
SS-3 & SS-4	Discrete samples from beneath bottom of supreme gasoline tank
SS-4 & SS-5	Discrete samples from beneath bottom of unleaded gasoline tank
SS-7	Discrete samples from west wall of Excavation One
SS-8	Discrete samples from south wall of Excavation One
SS-9	Discrete samples from east wall of Excavation One
SS-10	Discrete samples from north wall of Excavation One
SS-11	Discrete sample from beneath bottom of heating oil tank
SS-12	Discrete sample from beneath bottom of used oil tank
SS-13	Discrete samples from north wall of Excavation Two
SS-14	Discrete samples from west wall of Excavation Two
SS-15	Discrete samples from south wall of Excavation Two
SS-16	Discrete samples from east wall of Excavation Two
NL-1	Discrete sample from about one foot beneath northern hydraulic hoist ram
