# RISK-BASED CORRECTIVE ACTION DETERMINATION

**FORMER 12<sup>TH</sup> AVENUE MOTOR SERVICE  
LUST FACILITY #26-23-0131  
2436 SE 12<sup>TH</sup> AVENUE  
PORTLAND, MULTNOMAH COUNTY, OREGON**

**Point Source Solutions Project No: OR230123-3B  
February 20, 2025**

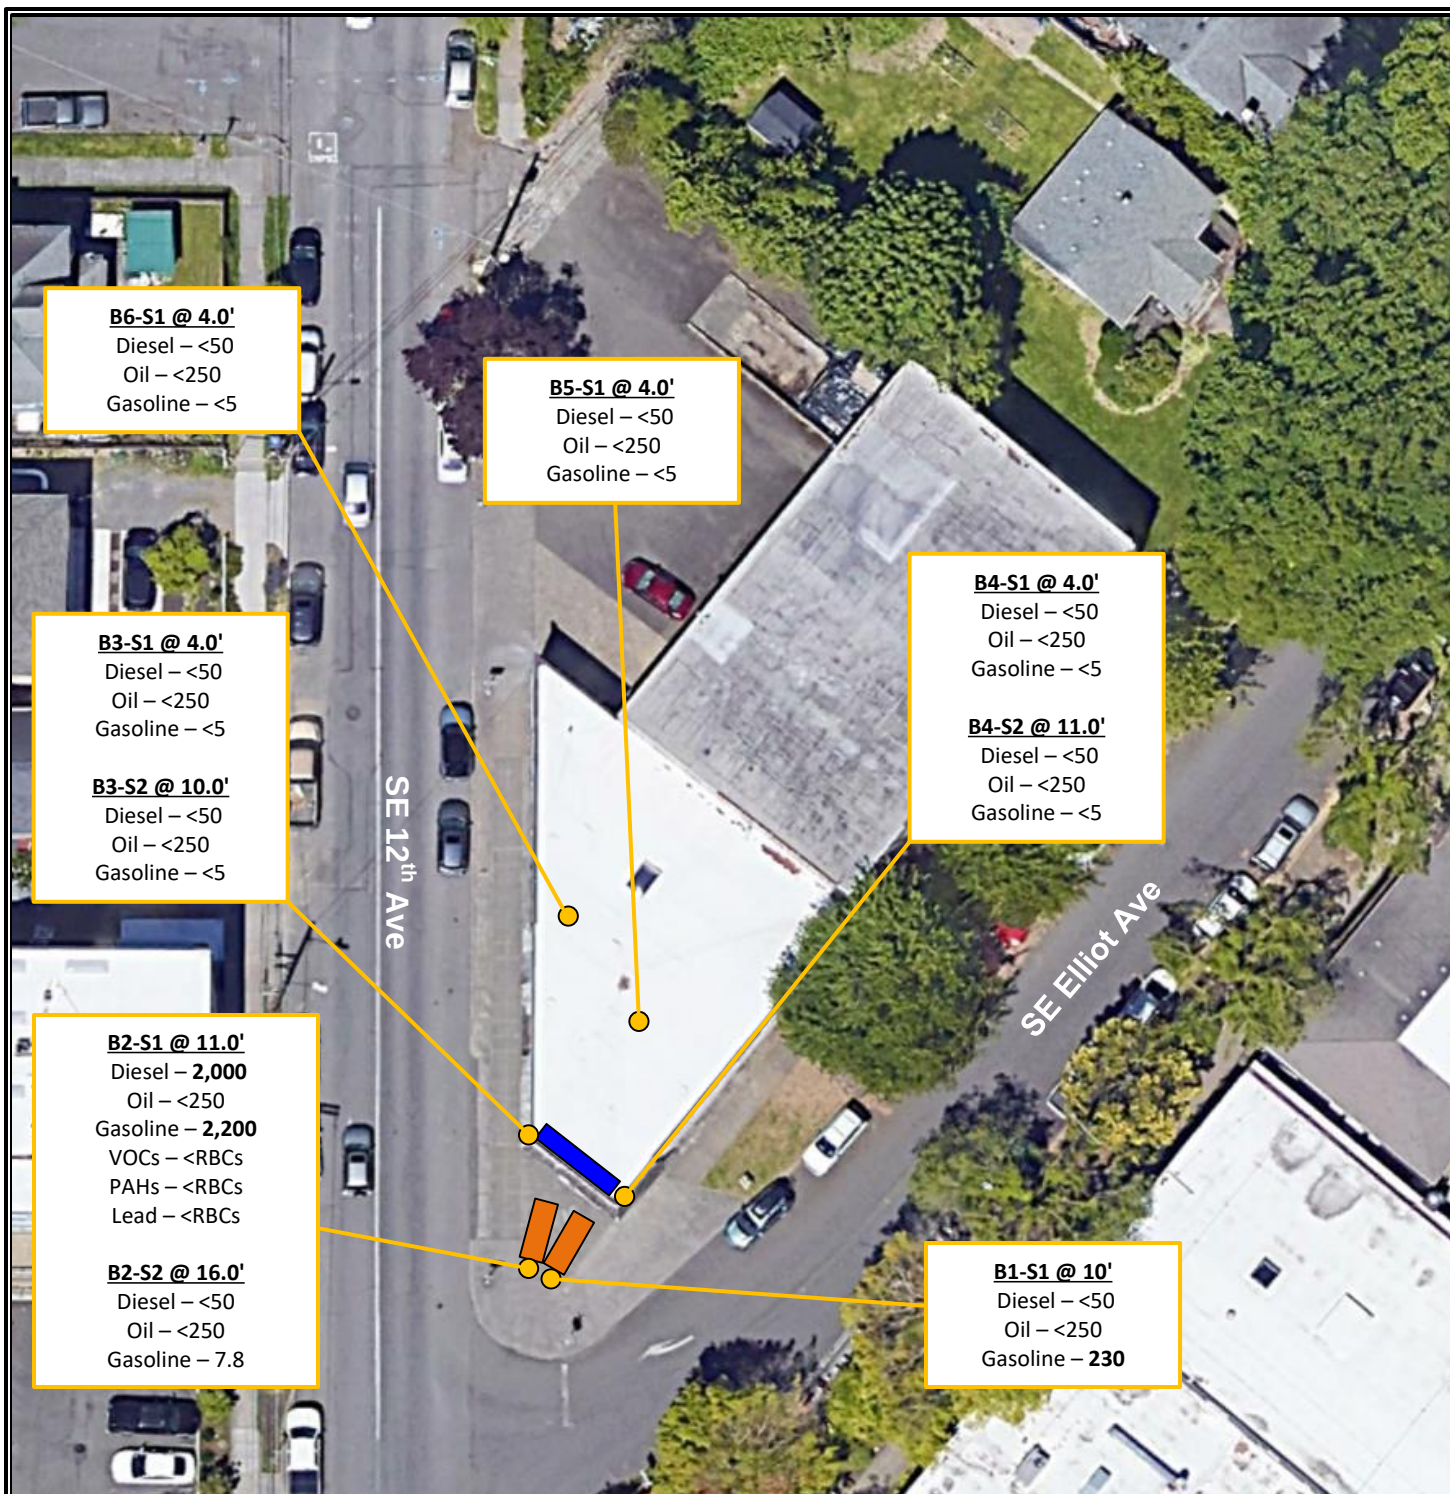
**FIGURE 3: SAMPLE LOCATION DIAGRAM**

- Boring B1 was advanced to 13.0 feet below ground surface (bgs) adjacent to the south tank end of the UST on the east side of the corner, labelled T1. Progress refusal was met at 13.0 feet bgs. **Soil contamination in the form of staining, odor, and volatile organic compound (VOC) detections with a hand-held photo-ionization detector (PID) was noted in this boring.** A soil sample was collected from below the tank bottom at the highest observed impact, 11.0 feet deep bgs.

- Boring B2 was advanced to 16.0 feet bgs adjacent to the south tank end of the UST on the west side of the corner, labelled T2. Progress refusal was met at 16.0 feet bgs. **Soil contamination in the form of staining, odor, or VOC detections with a PID was noted in this boring.** A soil sample was collected from below the tank bottom at the highest observed impact, 11.0 feet bgs, and at terminal depth, 16.0 feet bgs.

- Boring B3 was advanced to 10.0 feet bgs adjacent to the north tank end of T2 and the west side of the dispenser island. Progress refusal was met at 10.0 feet bgs. Soil contamination in the form of staining, odor, or VOC detections with a PID was not noted in this boring. A soil sample was collected from below the dispenser island at 4.0 feet bgs, and at terminal depth, 10.0 feet bgs.

- Boring B4 was advanced to 11.0 feet bgs adjacent to the north tank end of T1 and the east side of the dispenser island. Soil contamination in the form of staining, odor, or VOC detections with a PID was not noted in this boring. A soil sample was collected from below the dispenser island at 4.0 feet bgs, and at terminal depth, 11.0 feet bgs.

- Boring B5 was advanced to 4.0 feet bgs adjacent to a subsurface sewer line plumbed into the floor drain in the Site building interior. Soil contamination in the form of staining, odor, or VOC detections with a PID was not noted in this boring. A soil sample was collected from below the sewer line at terminal depth, 4.0 feet bgs.

- Boring B6 was advanced to 4.0 feet bgs adjacent to a former garage bay in the original auto repair shop area of the Site building interior. Soil contamination in the form of staining, odor, or VOC detections with a PID was not noted in this boring. A soil sample was collected from below the terminal depth of the boring at 4.0 feet bgs.

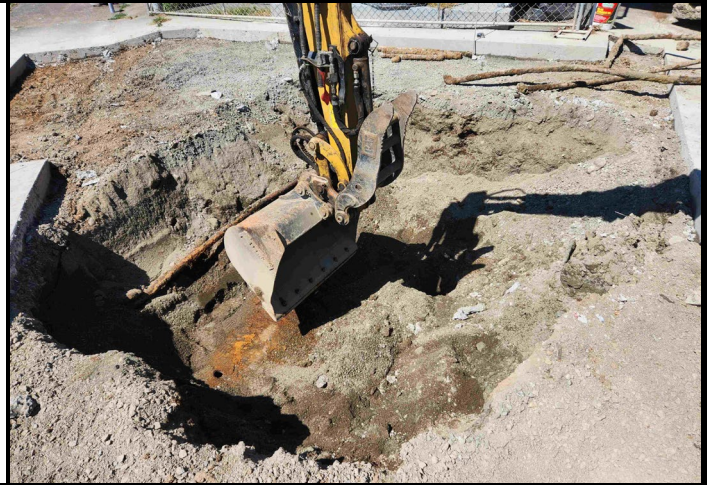
Photo #2: Initial Excavation

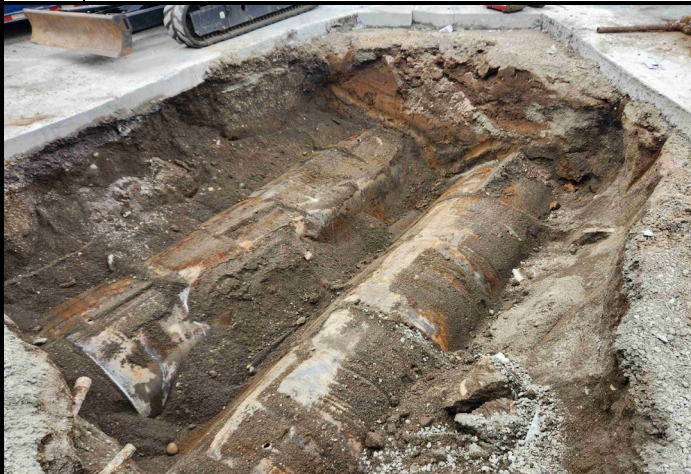
Photo #3: Exposed USTs

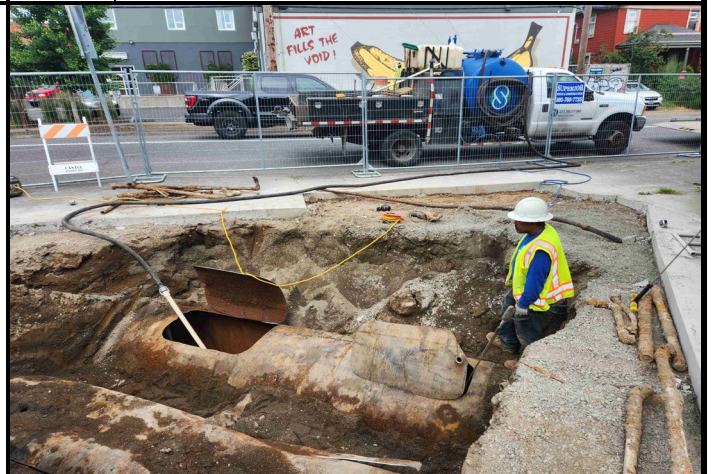
Photo #4: Decommissioning and Cleaning

The USTs were decommissioned by removal by Soil Solutions Environmental Services (SSES). A total of 12.03 tons of PCS were removed from an approximately 200 square foot excavation and hauled under non-hazardous waste profile #140298OR to the Waste Management – Hillsboro Landfill. A copy of the transaction history of the waste profile used for the excavation is included as **Appendix B**.

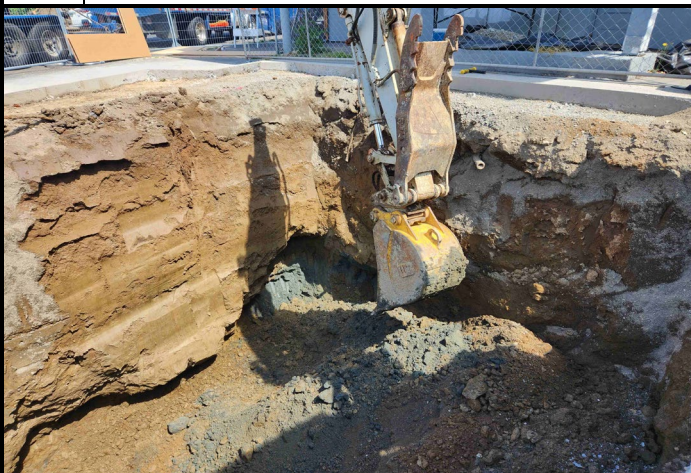
Photo #5: Excavation of PCS

A total of 12.03 tons of PCS was removed from an approximately 200 square foot excavation and hauled under non-hazardous waste profile #140298OR to Waste Management – Hillsboro landfill. A copy of the transaction history of the waste profile used for the excavation is included as **Appendix B**.

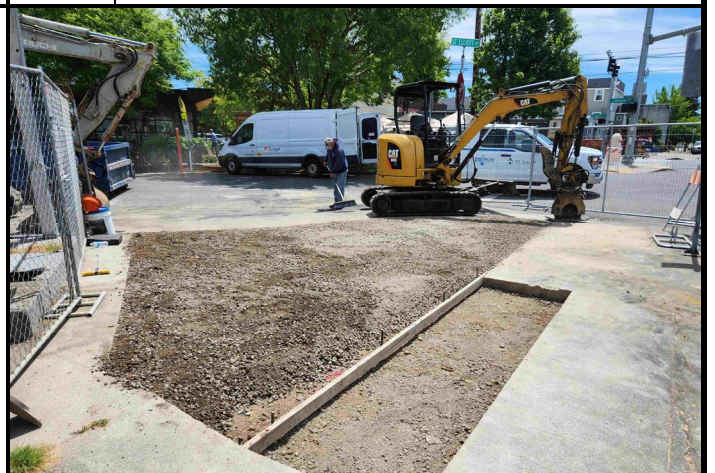
Photo #6: Site Restoration
