# RISK-BASED CORRECTIVE ACTION DETERMINATION

**FORMER 12<sup>TH</sup> AVENUE MOTOR SERVICE  
LUST FACILITY #26-23-0131  
2436 SE 12<sup>TH</sup> AVENUE  
PORTLAND, MULTNOMAH COUNTY, OREGON**

**Point Source Solutions Project No: OR230123-3B  
February 20, 2025**

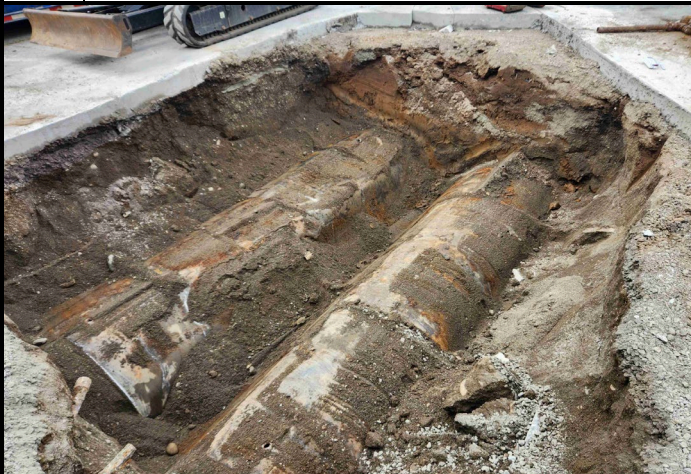
Photo #3: Exposed USTs

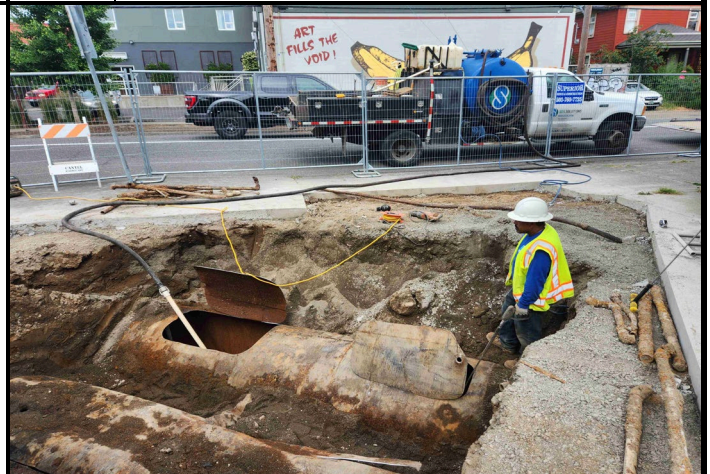
Photo #4: Decommissioning and Cleaning
