**Aboveground Storage Tank Progress Report**  
**19251 SE Wooded Hills Drive**  
**Damascus, Oregon 97089**  
**ECSI ID#6564**

June 1, 2023

Soil Solutions Environmental Services, Inc.  
3540 SE 28<sup>th</sup> Avenue  
Portland, Oregon 97202

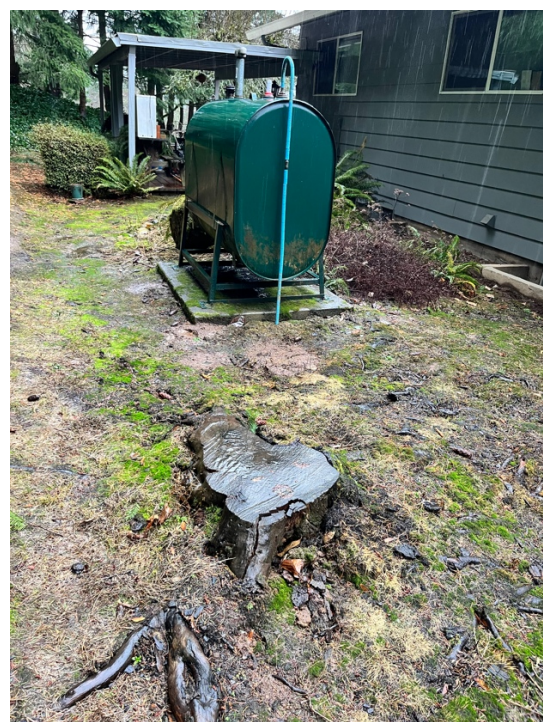
Photo 4. View of the AST and concrete pad. View is to the southwest.

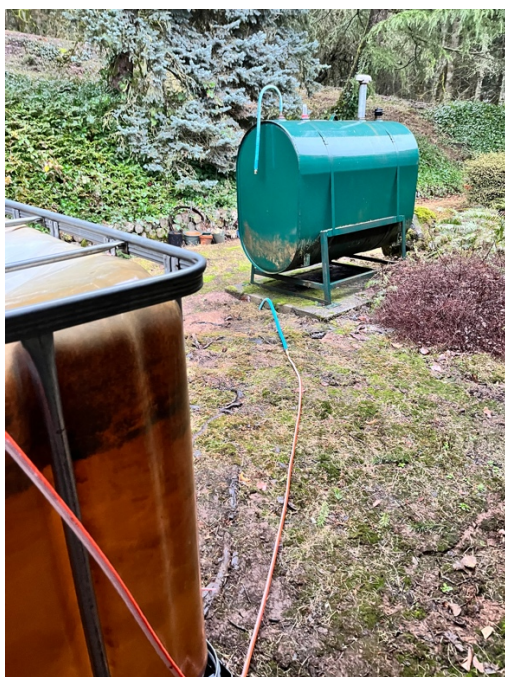
Photo 5. The AST contents were removed and product lines were transferred to a temporary AST for future use. View is to the southeast.

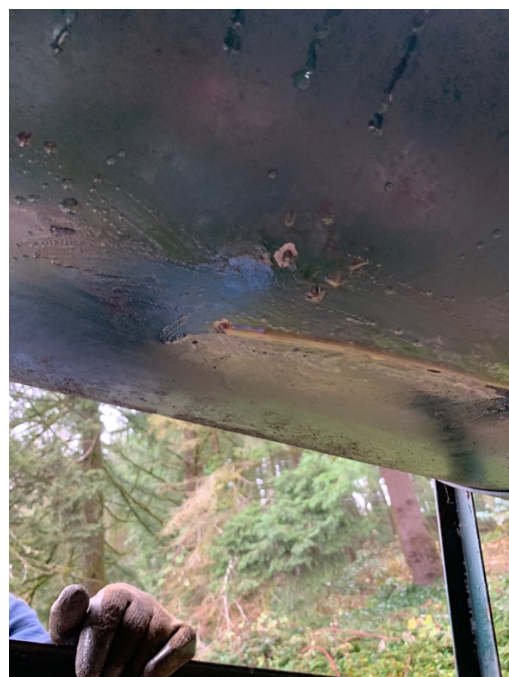
On January 13, 2023, holes were observed on the tank bottom and concrete pad below showed visual and olfactory indications of petroleum contamination. Traces of product and approximately 3 gallons of sludge were removed from the tank and the interior was thoroughly pressure-washed. The oily rinse water was transported to SSES equipment yard for temporary storage and later transported, in bulk, by Oil Re-Refining Company (ORRCO) for proper disposal. The tank was removed from concrete pad and transported to SSES equipment yard for temporary storage. The

Photo 6. A pinhole and pitting were observed on the tank bottom. View is from under the tank.

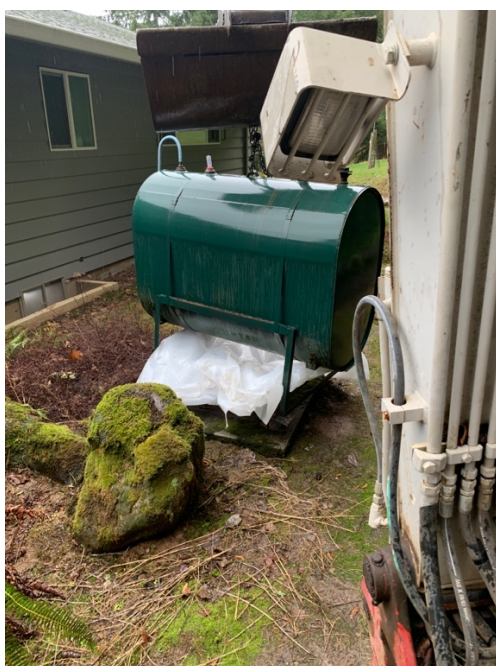
Photo 7. The AST was emptied and removed from the property. View is to the northwest.

tank was later recycled, in bulk, by Metro Metals Northwest, Inc. Disposal receipts are included in Appendix C.

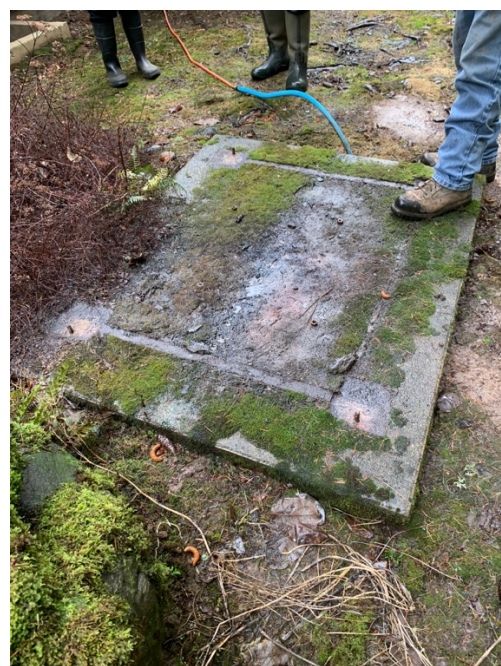
Photo 8. Contaminated concrete was observed below the former AST location. View of concrete pad.

The concrete pad was cut and removed from the former AST area and placed into a dropbox on site. Approximately 4 tons of contaminated soil were removed from below the former AST area and placed into a dropbox on site.

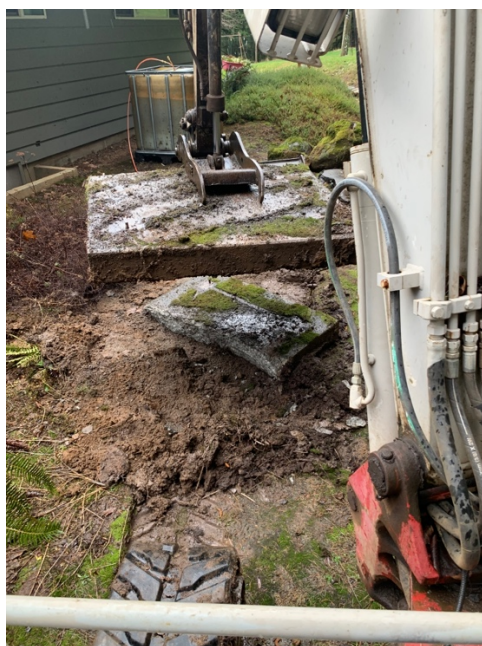
Photo 9. The concrete pad was removed. View is to the northwest.

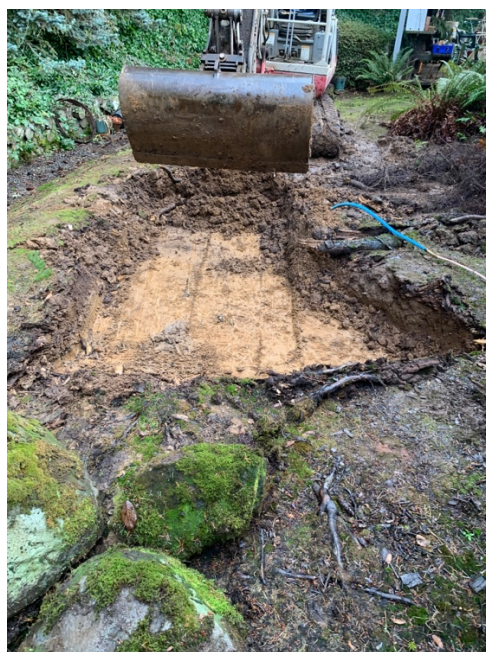
Photo 10. Contaminated soil removal began below the former AST location. View is to the south.

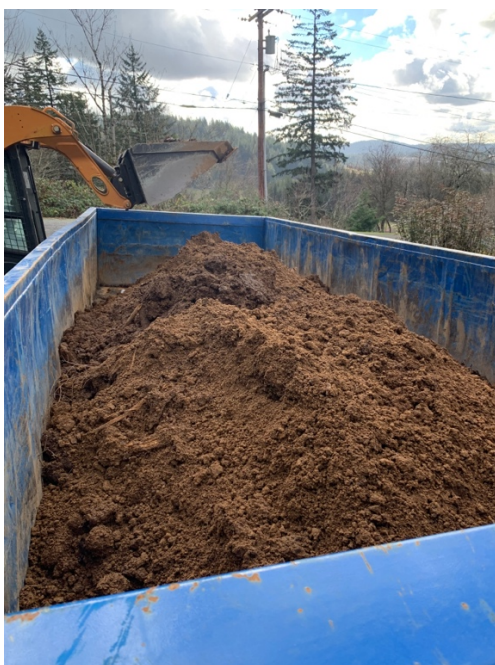
Photo 11. Contaminated soil was transported for proper disposal. View is of removed soil.

On January 16, 2023, an additional approximately 8-tons of petroleum-contaminated soil (PCS) was placed into a dropbox on site. The PCS was transported to Waste Management Hillsboro Landfill for Department of Environmental Quality (DEQ) approved disposal.

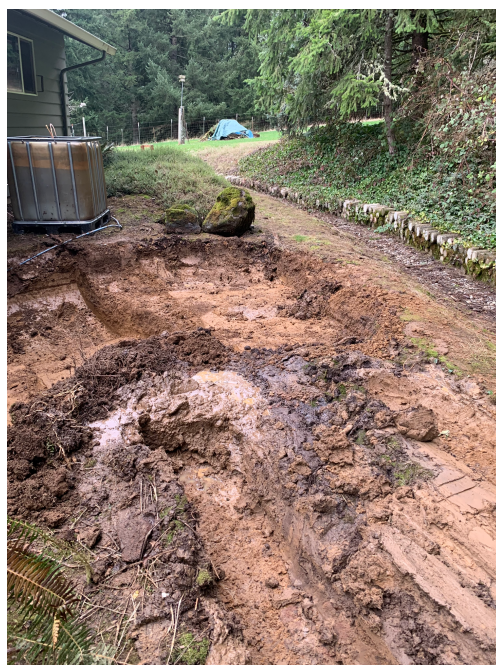
Photo 12. Excavation area. View is to the north.

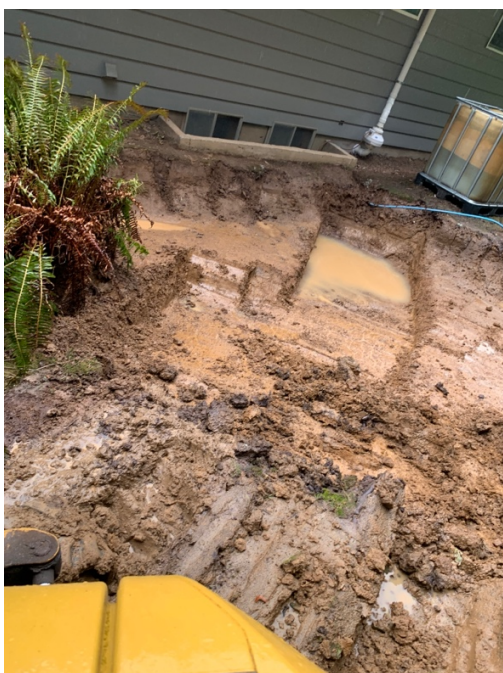
Photo 13. Excavation area. View is to the west.

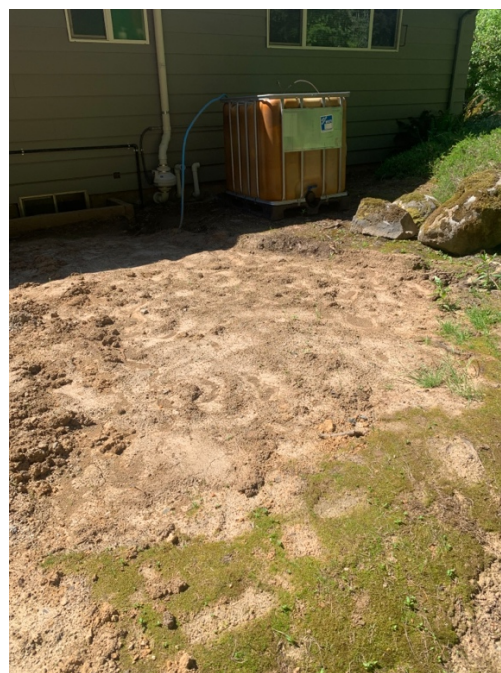
Photo 14. The excavation area was backfilled with gravel. View is to the west.

On February 22, 2023, the excavation area was backfilled with gravel and compacted, and the surface was later restored to grade with soil.

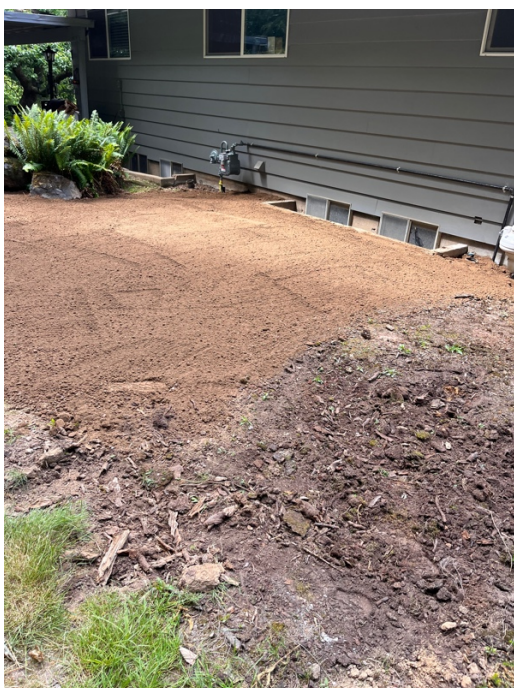
Photo 15. The former AST area was restored to grade with soil. View is to the southwest.

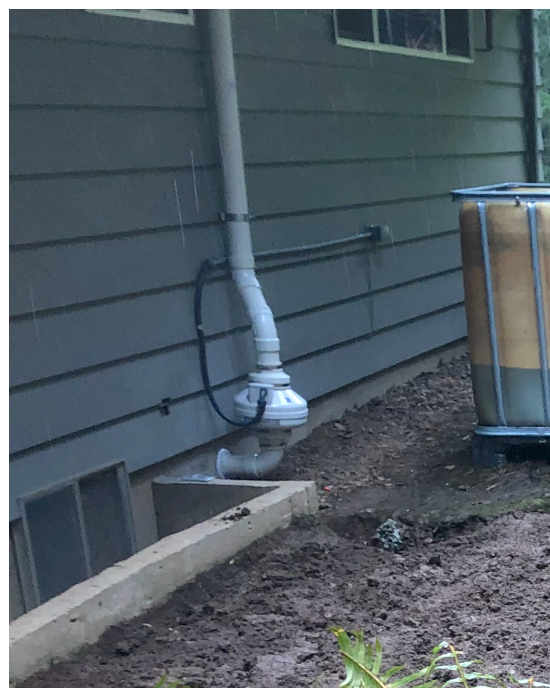
Photo 16. A vapor mitigation system was installed on the east side of the house. View is to the northwest.

On April 3, 2023, SSES installed a sub-slab depressurization system to mitigate any potential harmful vapors from entering the residence.
