RE: No Further Action Determination  
for Rosemont Court, Portland  
ECSI #6730

**Subject:** Rosemont Court (ECSI #6730)  
Staff Memorandum in support of a No Further Action determination

This document presents the basis for the Oregon Department of Environmental Quality's (DEQ's) recommended No Further Action (NFA) determination for the Rosemont Court property (Site) in Portland, OR. As discussed in this report, contaminant concentrations in soil are below acceptable risk levels or have been determined by DEQ to not pose a significant risk for applicable exposure pathways.

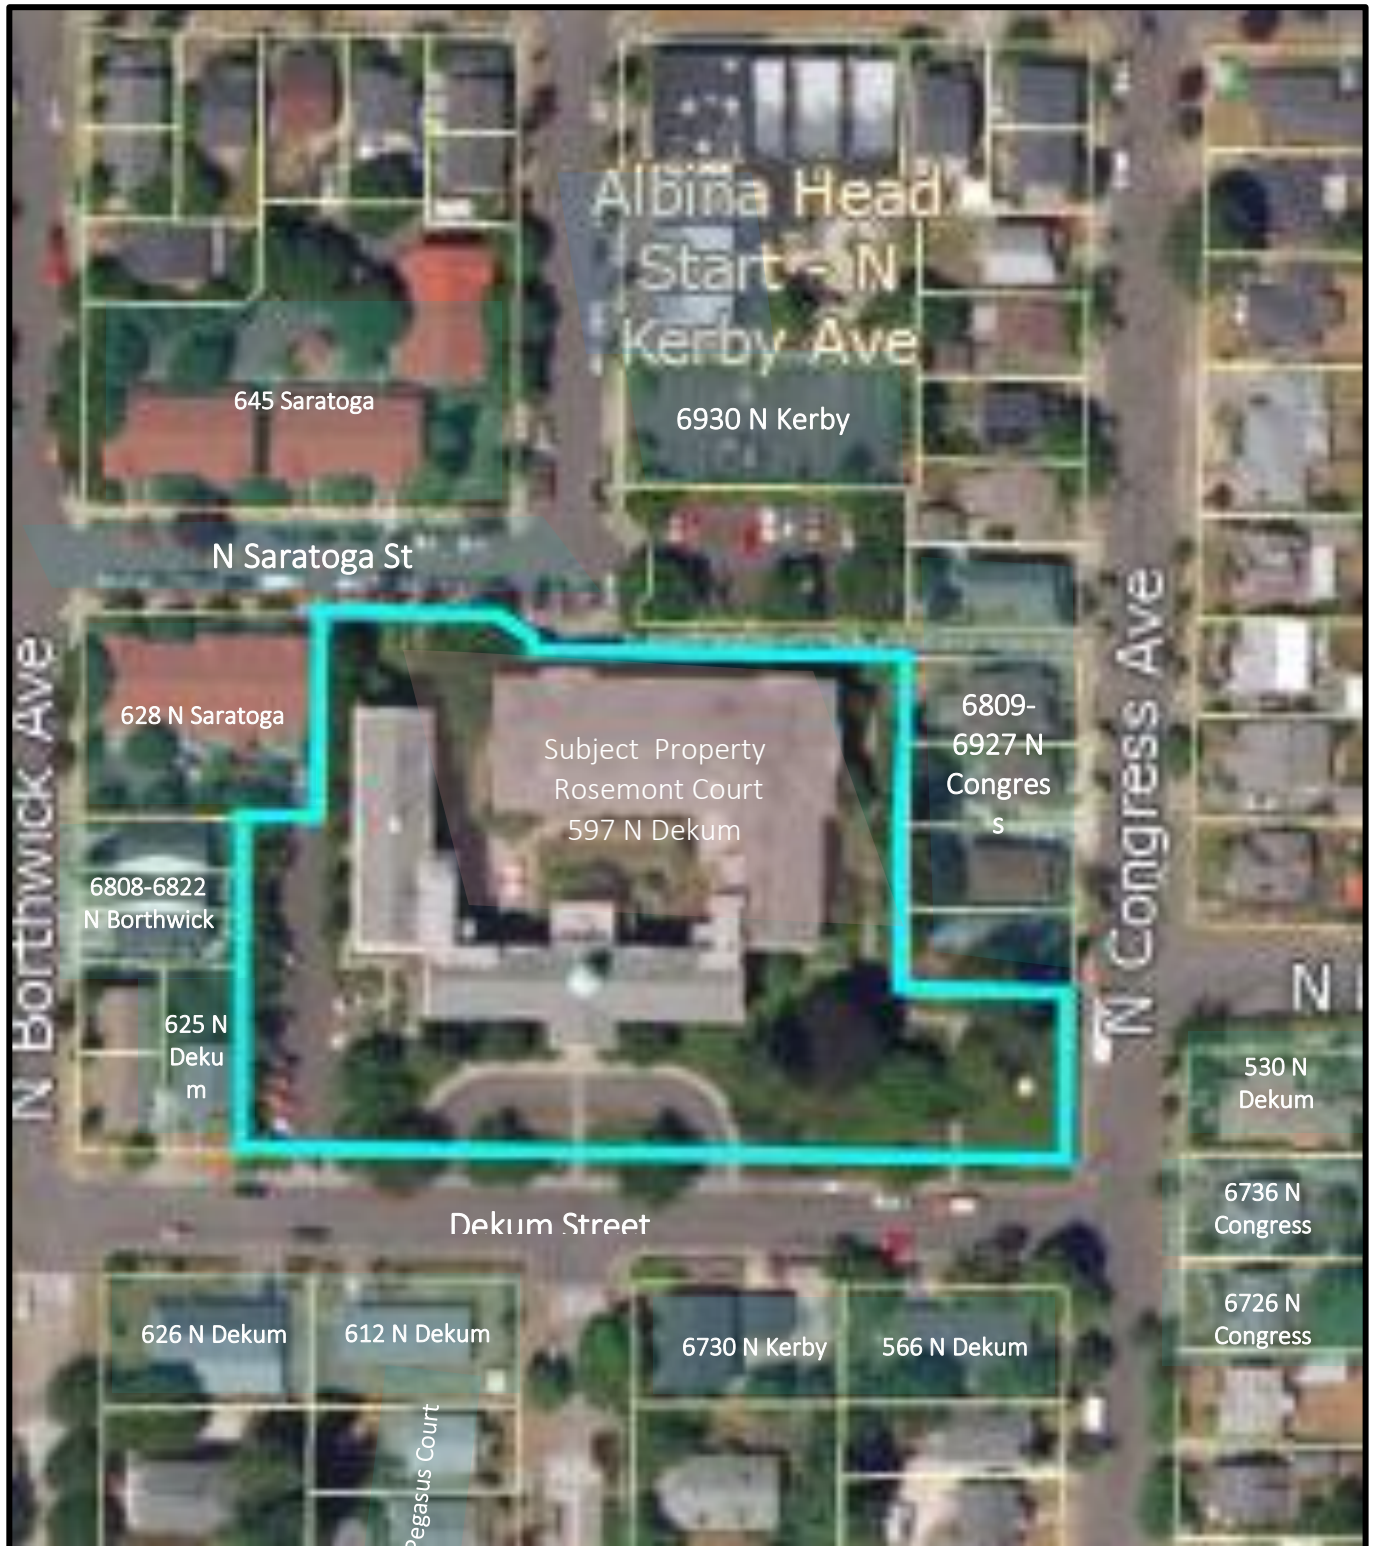
Figure 2- Site Map  
August 2022  
597 N Dekum | Portland, Oregon  
Phase I ESA: Rosemont Court

The Site is located at 597 N Dekum St., Portland, Multnomah County, Oregon (Figure 1). The Site's location is further defined as geographic coordinates: 45.5722 latitude, -122.6728 longitude; and Multnomah County tax map ID 1N1E15BD-00114, Township 1 North, Range 1 East, Section 15.

The Site is comprised of a 1.87-acre tax lot improved with the 97,000 square-foot Rosemont Court affordable housing development. In addition to Site buildings, the Site is further improved with asphalt-paved driveways and parking lot, concrete sidewalks and landscaping, and grassed areas.

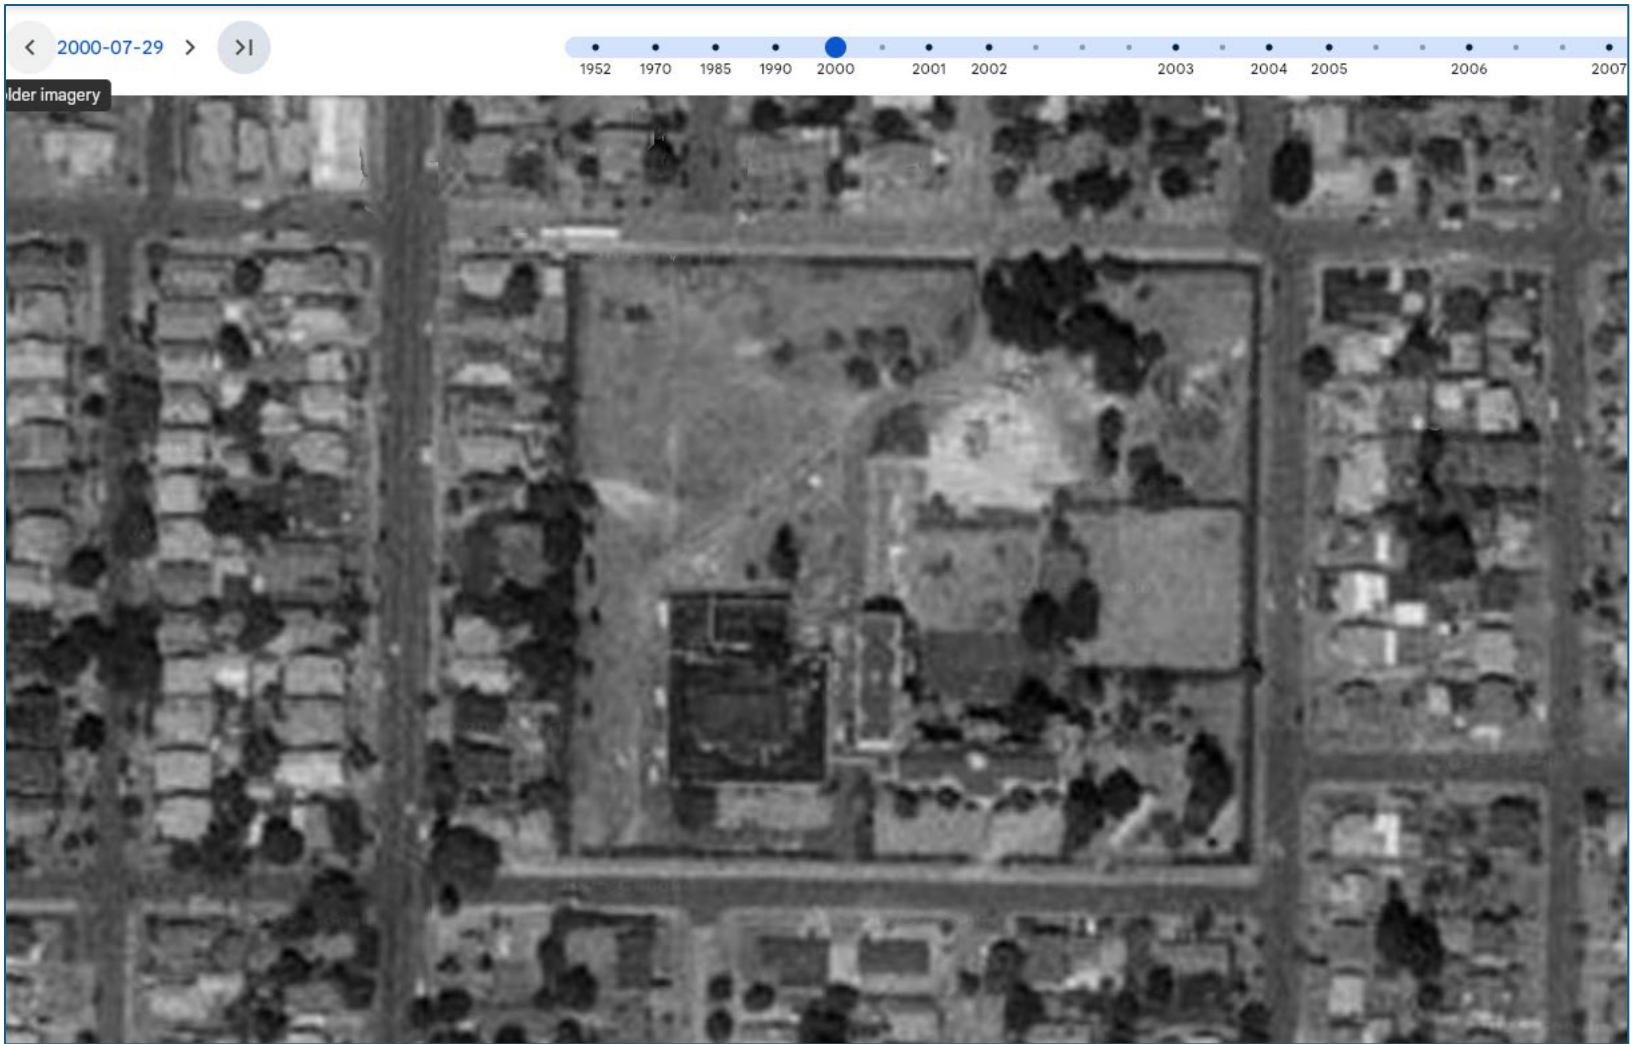
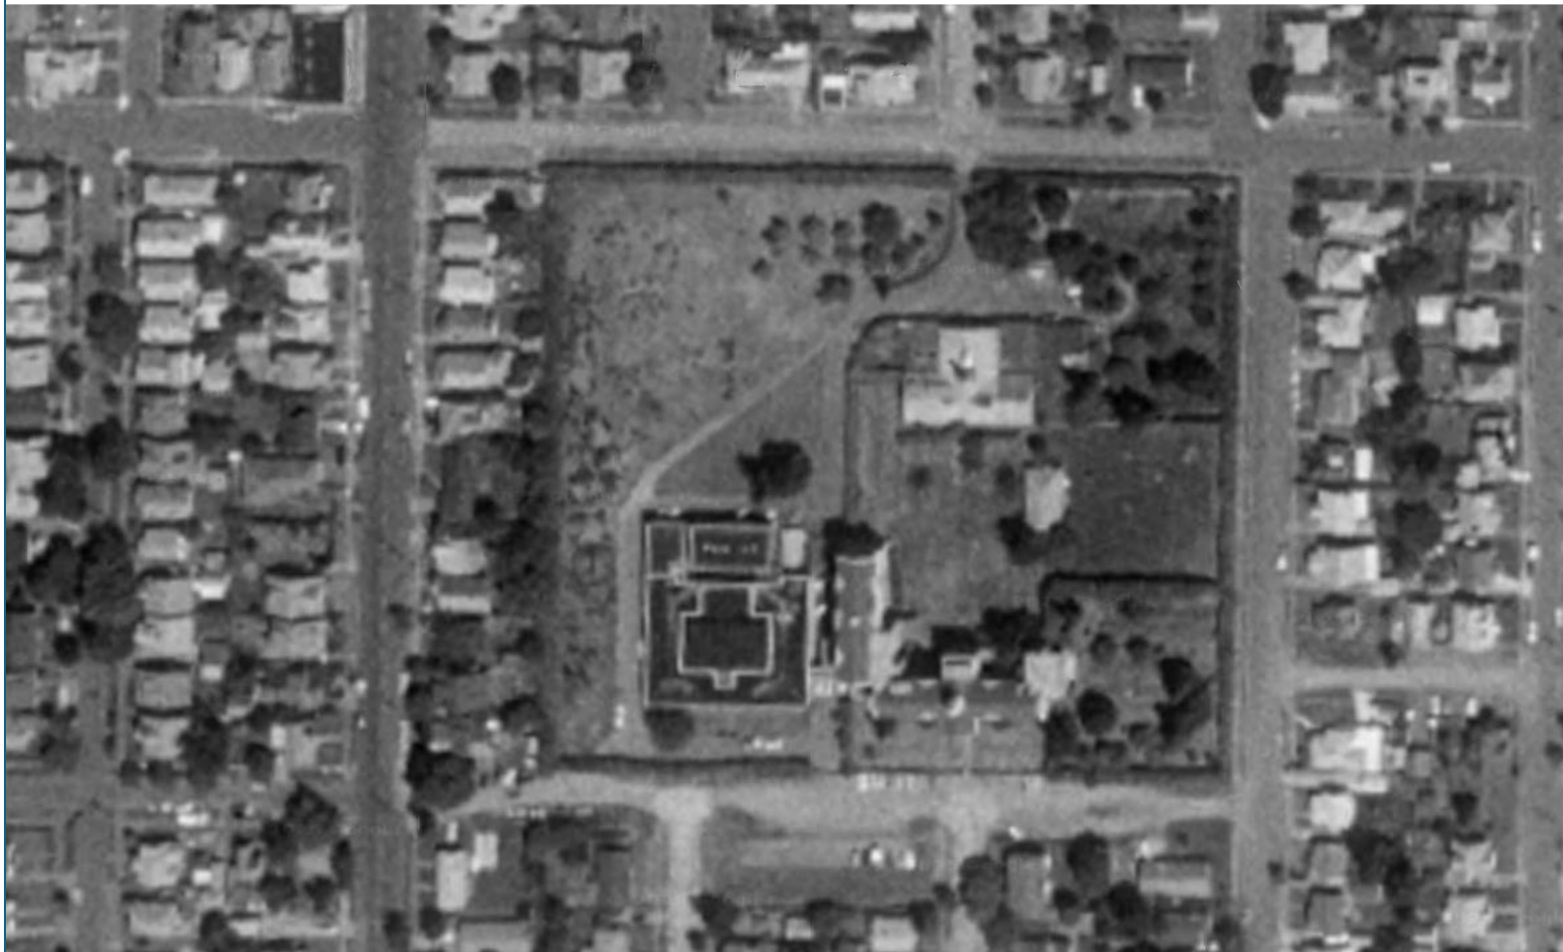
## GOOGLE EARTH IMAGES

< 1990-07-15 > >|

DEQ's soil direct contact RBCs for residential and occupational receptors. However, based on Google Earth imagery, current Site conditions around DU-6 do not appear to be representative of conditions during the 2000 sampling. Further, the existing concrete sidewalk and established trees and hedges limit access with soil and likely reduce the potential for exposure to residual contamination in this area. Therefore, residual lead contamination in DU-6 is unlikely to pose an unacceptable risk to Site users.

- 1) Current site conditions along the western side of the West Wing are not representative of those at the time of prior sampling. The gymnasium building was formerly located west of the Convent's West Wing, and the two buildings appear previously connected by a covered walkway or structure that is in a different configuration to the current landscaping (see attached Google Earth images). It is assumed that demolition of the gymnasium and redevelopment of the area immediately west of the West Wing into an asphalt-paved access driveway and parking lot would have involved some ground disturbance adjacent to the building.
