## MEMORANDUM

**Re:** North Ridge Estates Superfund Site, 2025 Repository Repairs

### 2025 REPOSITORY REPAIRS

North Ridge Estates Superfund Site – Repository Repairs Photo Documentation  
Telluric Completed Repairs April 16-18, 2025

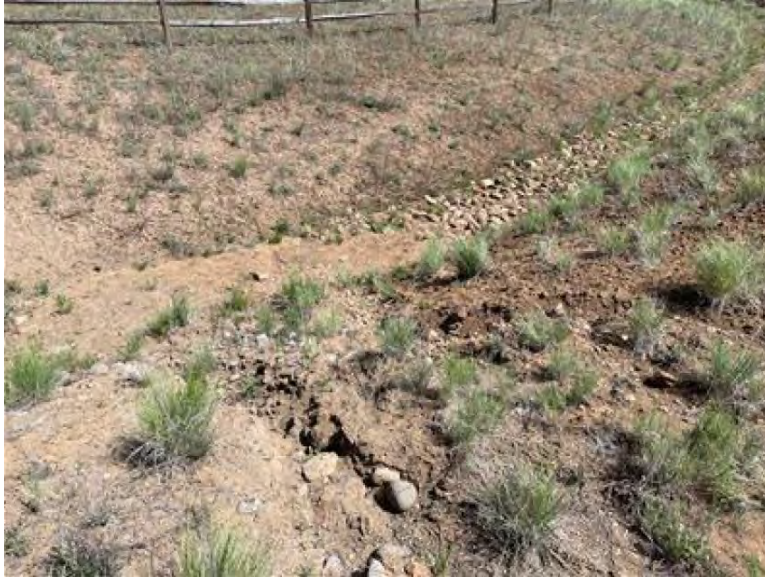
- Memorial Park Repository (Parcels MBK-D, L)
  - **Collect before and after photos of all completed repairs.**
  - Gully (approx. 6-8" deep) on west corner of Parcel MBK-D: grade side slopes and backfill/armor with 1" quarry rock to prevent additional erosion (see photo below).

- Backfilled gully (approximately 6 to 8 inches deep) near the west corner of Parcel MBK-D, grade side slopes, and backfill/armor with 1-inch quarry rock to prevent additional erosion; and
- Repair sparse vegetation (approximately 500 square feet) on the west central area of Parcel L and reseed with native grass to re-establish vegetation and prevent additional erosion.

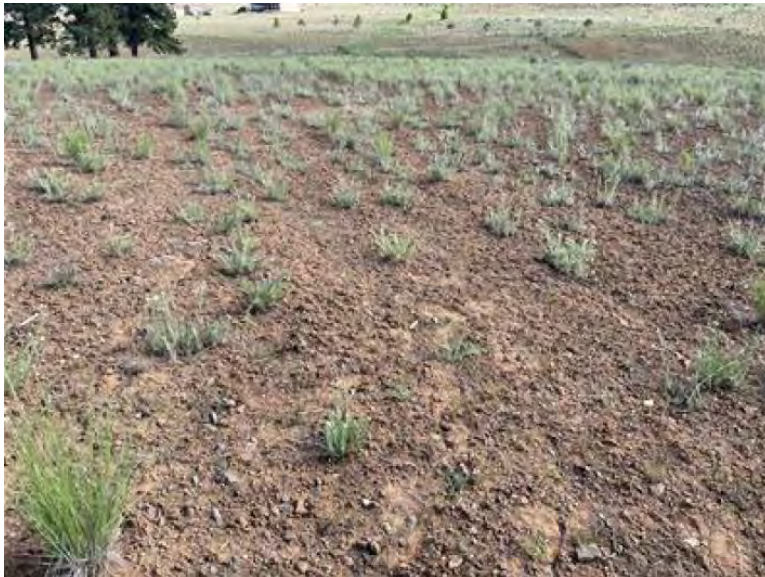
- Sparse vegetation (approx. 500 sq. ft.) on west central area of Parcel L (top of repository): reseed with native grass to re-establish vegetation and prevent additional erosion (see photo below).

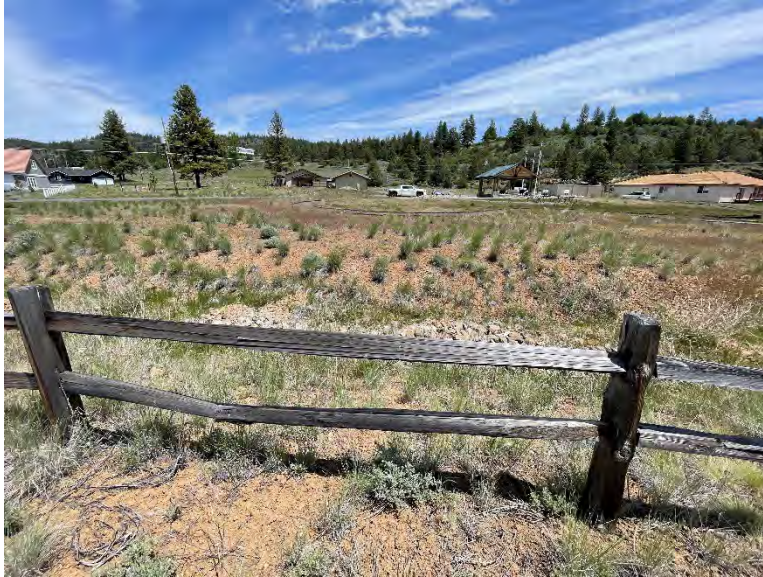
- Swimming Pool Repository (Parcels AI, AL, MBK-E, AG)
  - Broken sections of split rail fencing near the east and south corners of Parcel AG: replace broken split rails (2) to prevent unauthorized access to the repository (see photo below).

- Repair section(s) of split rail fencing near the east and south corners of Parcel AG to prevent unauthorized access to the repository; and
- Backfill gully (approximately 4 to 6 inches deep at 150 feet in length) near the south corner of Parcel AG, grade side slopes, and backfill/armor with 1-inch quarry rock to prevent additional erosion.

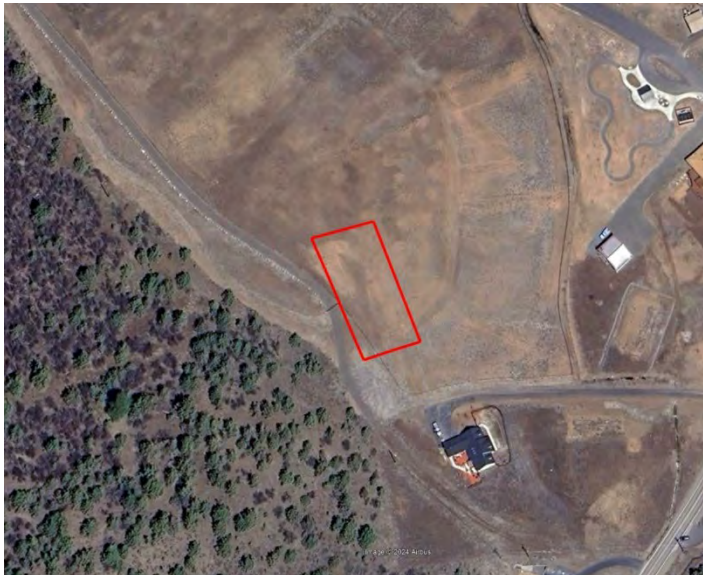
- Gully (approx. 4-6" deep, 150 ft long) near south corner of Parcel AG: grade side slopes and backfill/armor with 1" quarry rock to prevent additional erosion (see aerial photo below).

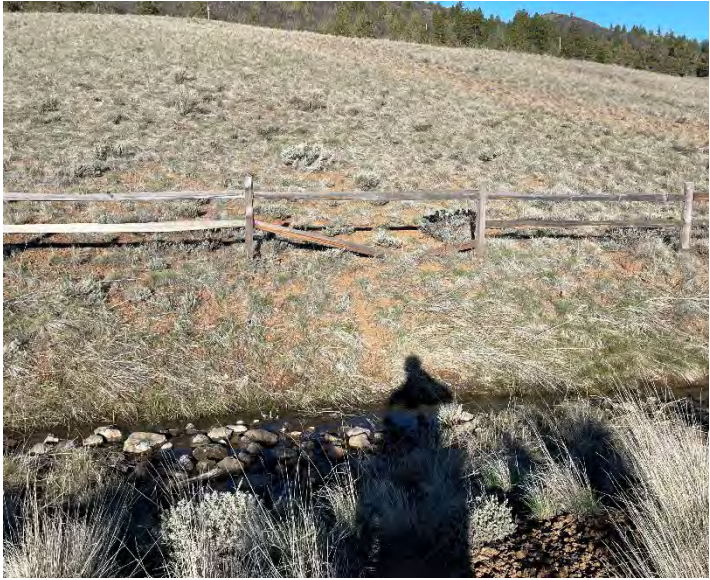
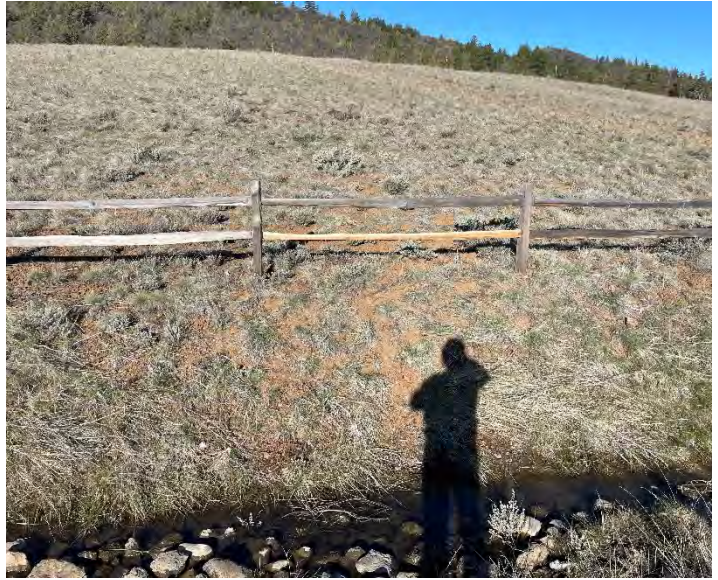
**Swimming Pool Repository** – Before/after view of repaired split rail fencing.

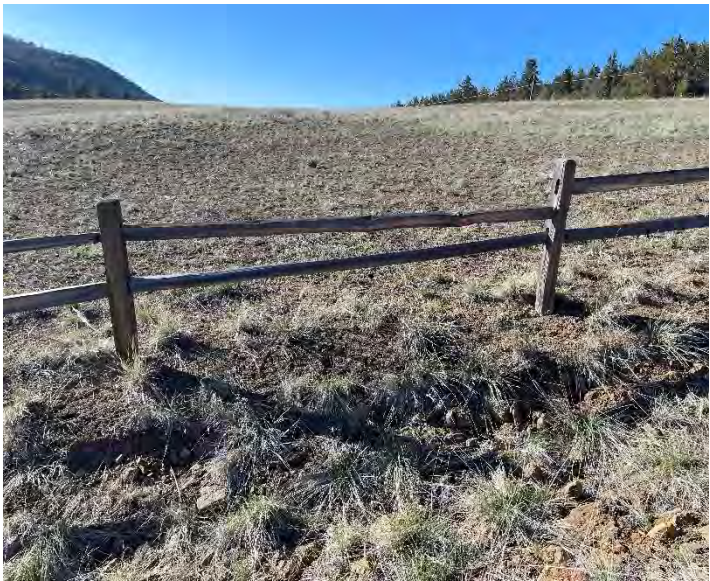
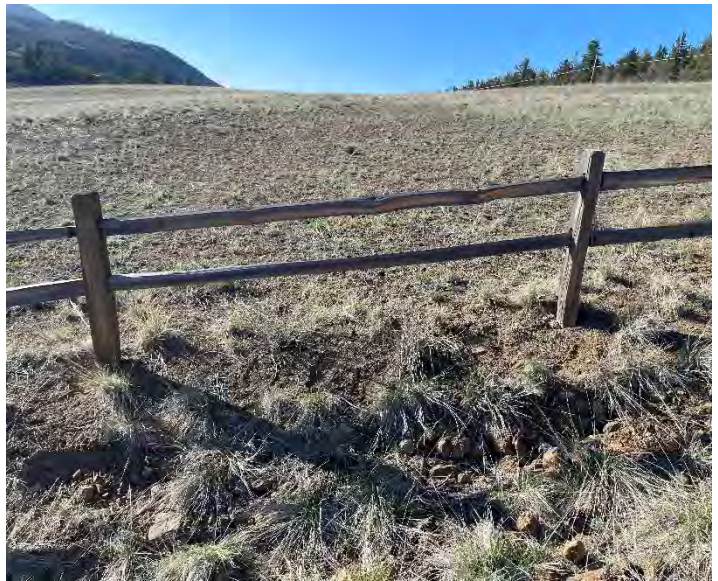
**Swimming Pool Repository** – Before/after view of repaired split rail fencing.

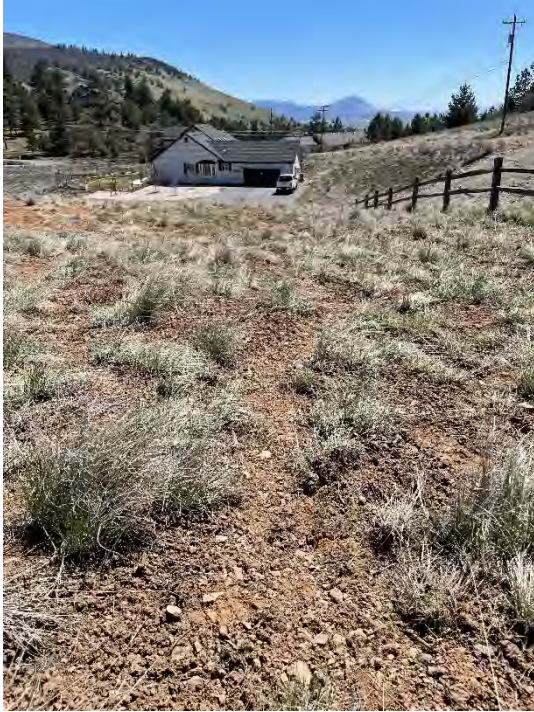
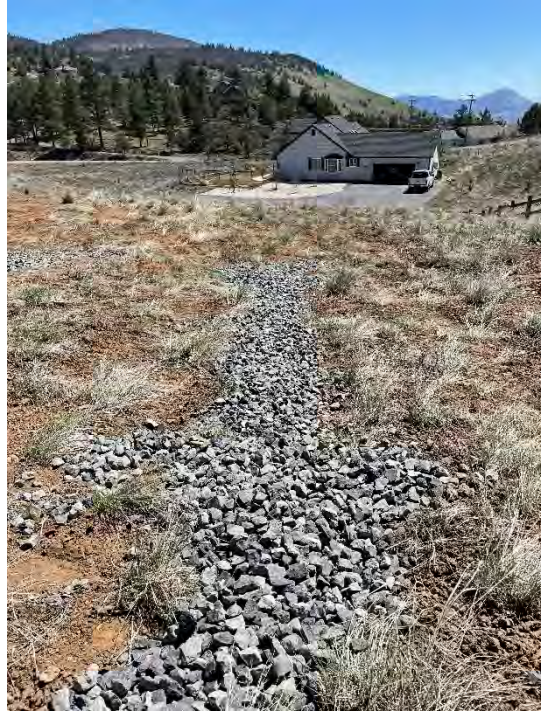
**Swimming Pool Repository** – Before/after view of repaired gully on Parcel AG; the gully was armored/backfilled with quarry rock to prevent additional erosion.

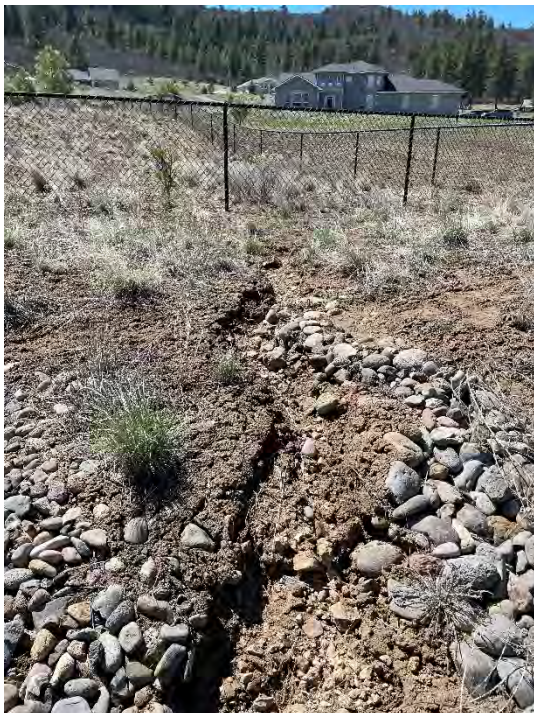
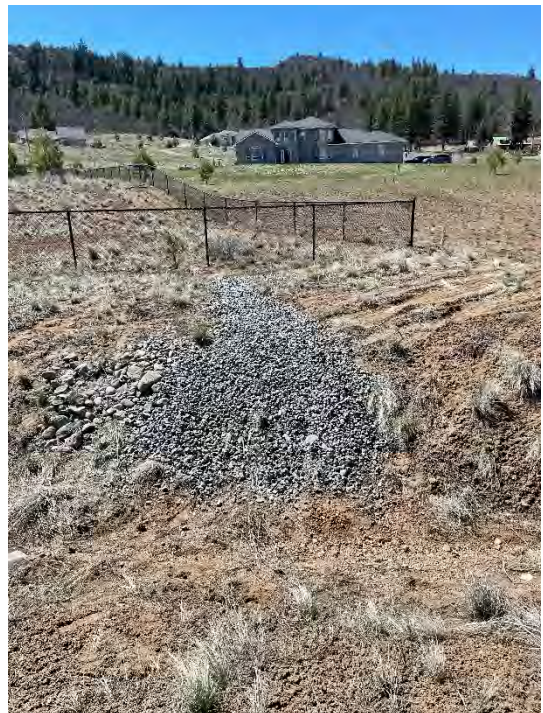
**Memorial Park Repository** – Before/after view of repaired gully along Parcels MBK-D and P; the gully was armored/backfilled with quarry rock to prevent additional erosion.

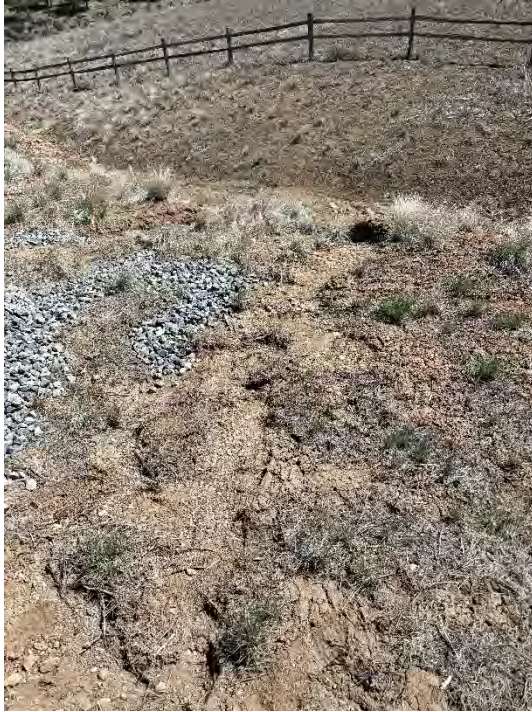
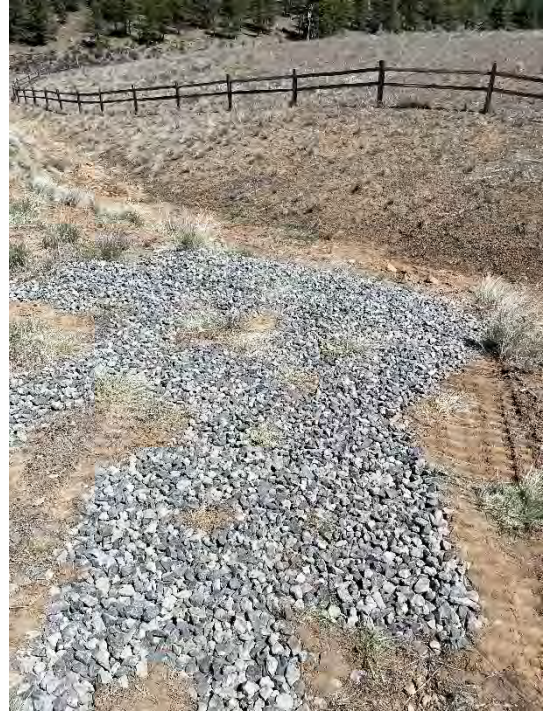
**Memorial Park Repository** – Before/after view of repaired gully along Hunters Ridge Road on Parcel MBK-D; the gully was armored/backfilled with quarry rock to prevent additional erosion.
