Aboveground Storage Tank Cleanup Report
1234 NE Highland Street
Portland, Oregon 97211
DEQ File #26-24-0634
Cleanup ID #6713

October 4, 2024

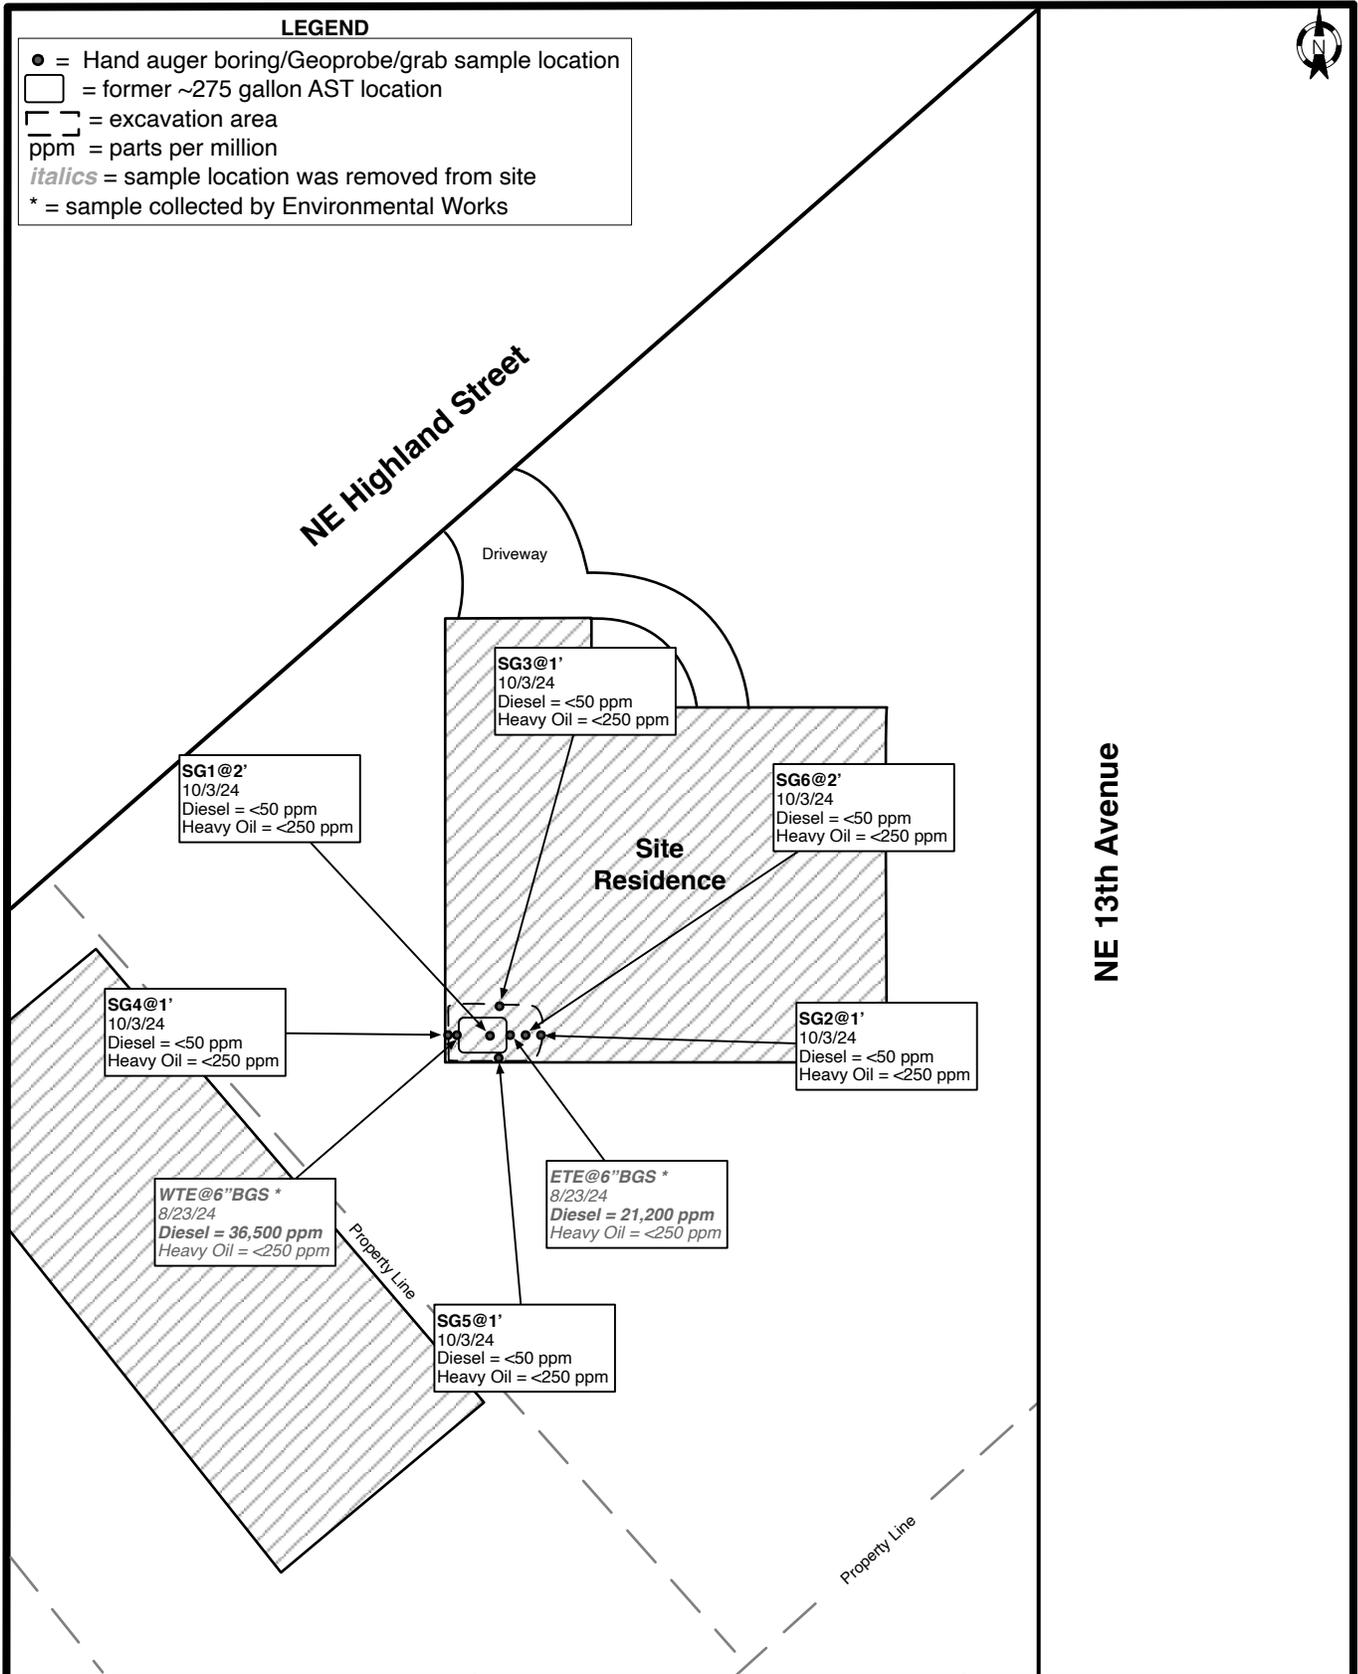
Figure 2:
Soil Sample Location Map
1234 NE Highland Street
Portland, Oregon 97211
LUST #26-24-0634 Project #6713

SSES collected six soil grab samples, designated 1 through 6, located on the excavation center, at a depth of 2-feet, the east, north, west, and south excavation walls at 1-foot bgs, and the east excavation bottom at 2-feet bgs. Laboratory analysis revealed no diesel and heavy oil concentrations were detected above laboratory reporting limits in samples 1 through 6. Associated product lines, vent and fill pipes were removed and properly disposed.

A magnitude of 36,500 ppm diesel was detected by EW. Following removal of PCS, diesel and heavy oil were not detected above laboratory reporting limits in confirmation soil samples 1 through 6.

Samples were transported under chain of custody documentation to Friedman & Bruya, Inc. laboratory in Seattle, Washington. Laboratory analysis in soil included diesel and residual range oil by Northwest Total Petroleum Hydrocarbons diesel extended method (NWTPH-Dx). Laboratory results are presented in Table 1 and results are shown on Figure 2.

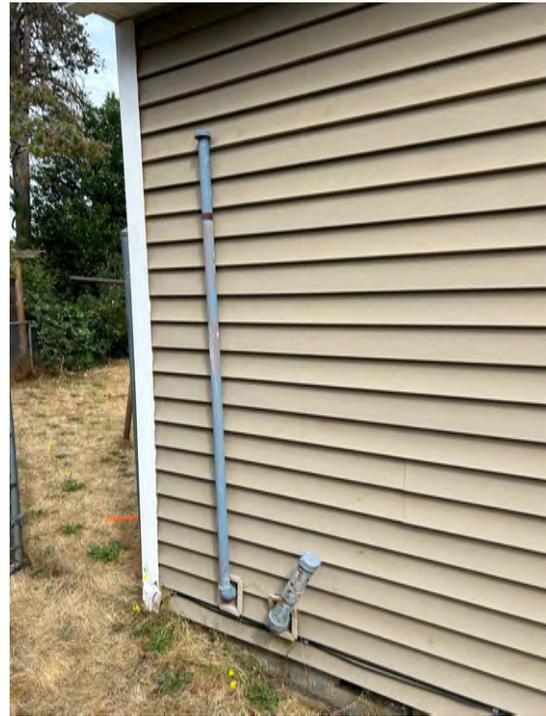
Photo 2. Vent and fill pipes were located on the south side of the southwest corner of the house. View is to the northwest.

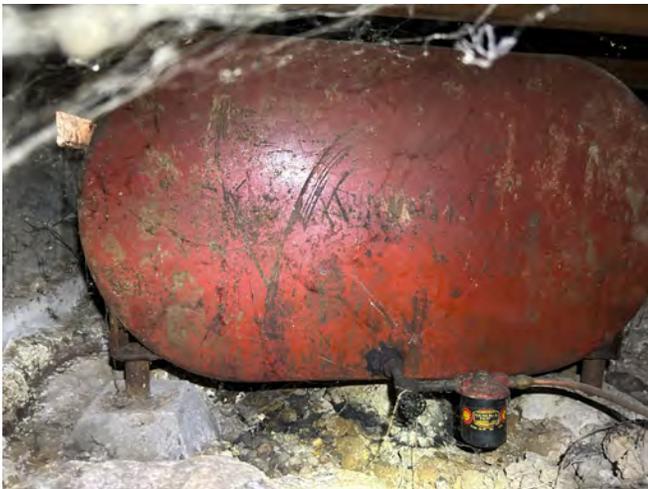
Photo 3. The AST was located in the southwest corner of the crawlspace.

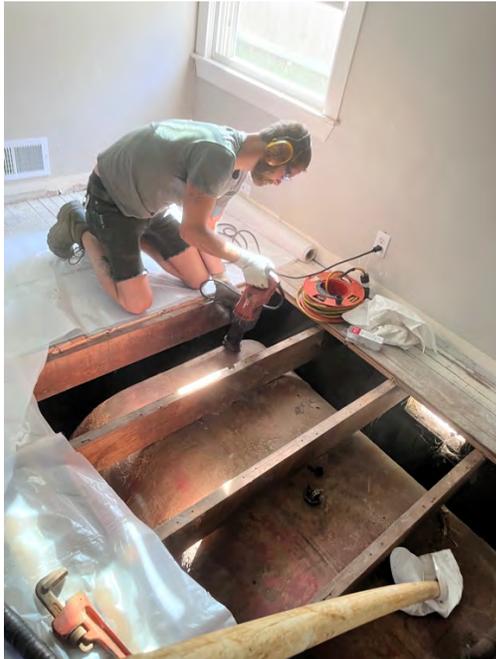
Photo 5. Fuel was removed from the AST and the interior was thoroughly pressure-washed. View is of the tank top.

On October 2, 2024, following the removal of flooring above the AST location, SSES removed product residue from the AST and the interior was thoroughly pressure-washed. The tank contents were transported to SSES equipment yard for temporary storage. The oily water was consolidated for transportation, in bulk, by Oil Re-Refining Company (ORRCO) for proper disposal.

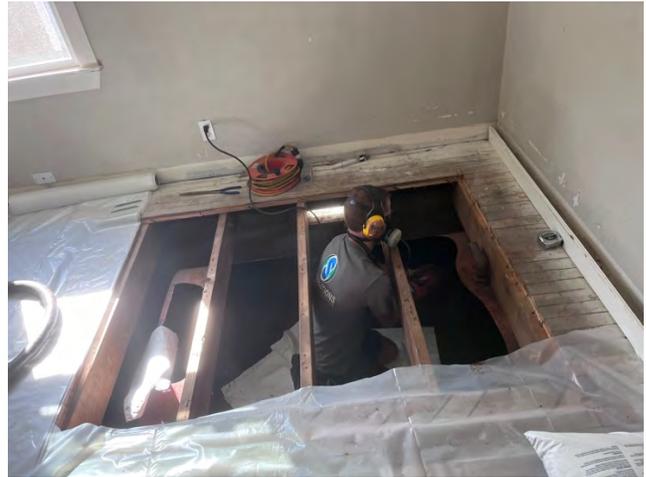
Photo 6. AST was cut into pieces and removed. View is to the south.

The tank was cut into pieces and removed from the crawlspace and transported to the SSES equipment yard for temporary storage. The tank and piping were recycled, in bulk, by Metro Metals Northwest, Inc. Diesel-stained soil was observed below the former AST location.

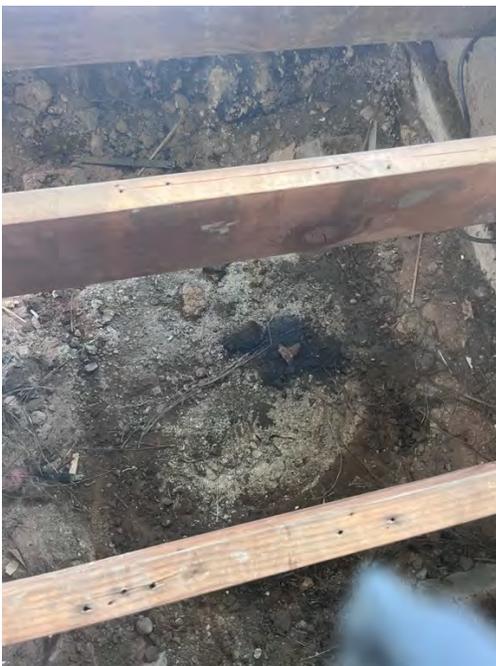
Photo 7. View is of contaminated soil present below the former AST location.

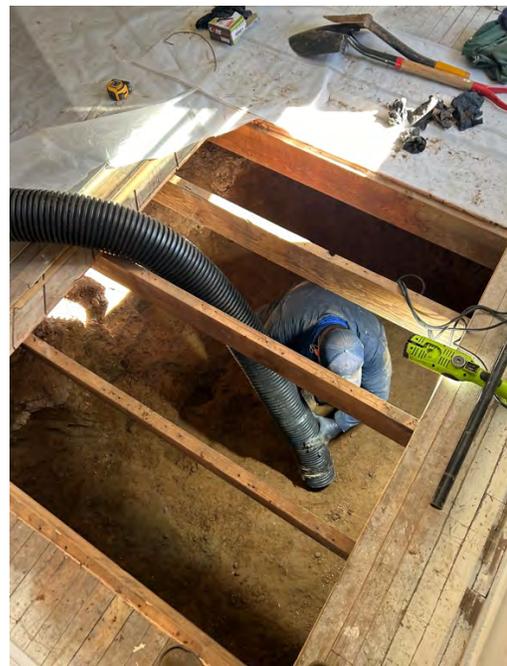
Photo 8. Contaminated soil was removed from AST area. View is of the vacuum excavation.

On October 3, 2024, petroleum-contaminated soil (PCS) was removed from the AST area. Approximately 1.78-tons of PCS was removed by Emeritec, under SSES oversight, using a vac truck. Final dimensions of the excavation were approximately 9.5-feet bgs in length, 6-feet in width, and 2-feet in depth. The PCS was transported to Waste Management Hillsboro Landfill for DEQ approved disposal.

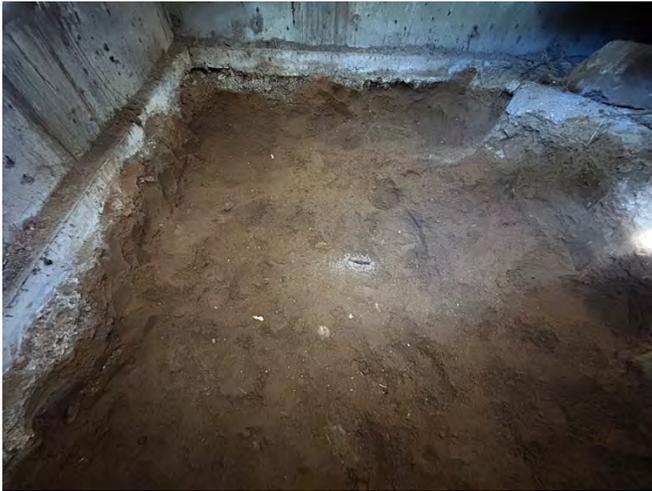
Photo 9. Approximately 1.78-tons of contaminated soil was removed. View is to the southwest.

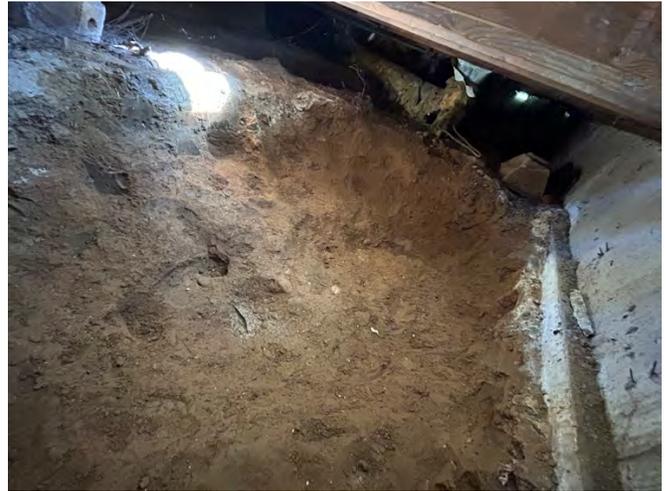
Photo 10. Contamination was not detected to remain in the AST area. View is to the east.
