**Re: Sub-Slab Soil-Gas Investigation at the
Ultimate Smile Building
17535 SW Tualatin Valley Highway in Aloha
DEQ File Number 34-90-0432**

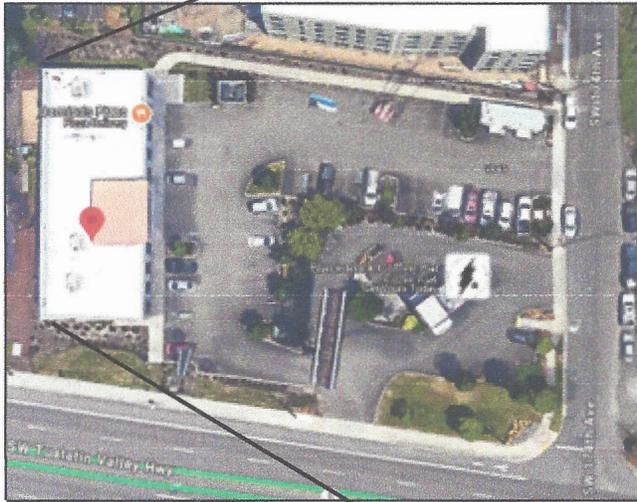
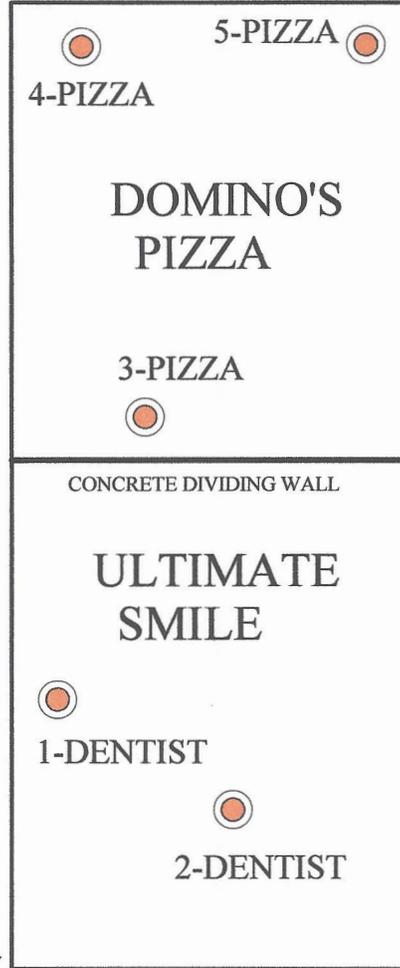
SITE PLAN		N ↑
NAME: COMMERCIAL PROPERTY ADDRESS: 17535 SW TUALATIN VALLEY HIGHWAY		PROPOSED LOCATIONS
DEQ FILE 34-90-0432	APRIL 15, 2025	FIGURE 1
SCALE: 1 INCH = 25 FEET		SOIL-GAS
XAVIER ENVIRONMENTAL INC. P.O. BOX 11289, PORTLAND, OR 97211

Therefore, on April 8, 2025, five (5) sub-slab soil-gas sampling stations were established in the building, as indicated on Figure 1 and the attached photographs. Initially at each location, a 1.56-inch-diameter core was advanced 1.75 inches into the 4-inch-thick slab. Then a 5/8-inch diameter hole was drilled through the remainder of the slab, vapor barrier, and into the underlying gravel. After vacuuming the cuttings from the hole, a Vapor Pin® (VP) and silicone sleeve were inserted into the lower portion of the slab. The pressure under the slab relative to the room pressure was measured with an Infiltec DM1 micromanometer and barometric pressures and outdoor temperatures were noted from the Hillsboro Airport. The following Table 1 summarizes these numbers. The inside temperature was 72 °F. Following the 30-minute equilibrium duration, the VP was covered with a VP Cap and Flush-Mount cover.
