Subject: UST Remedial Action Report and Request for Full No Further Action (NFA), 7285 Long Prairie Road in Tillamook, Oregon, 97141. Port of Tillamook Bay, NE Site K1-K8: ECSI 4604

UST Remedial Action Report

7285 Long Prairie Road, Tillamook, Oregon 97141

Port of Tillamook Bay, NE Site K1-K8: ECSI 4604

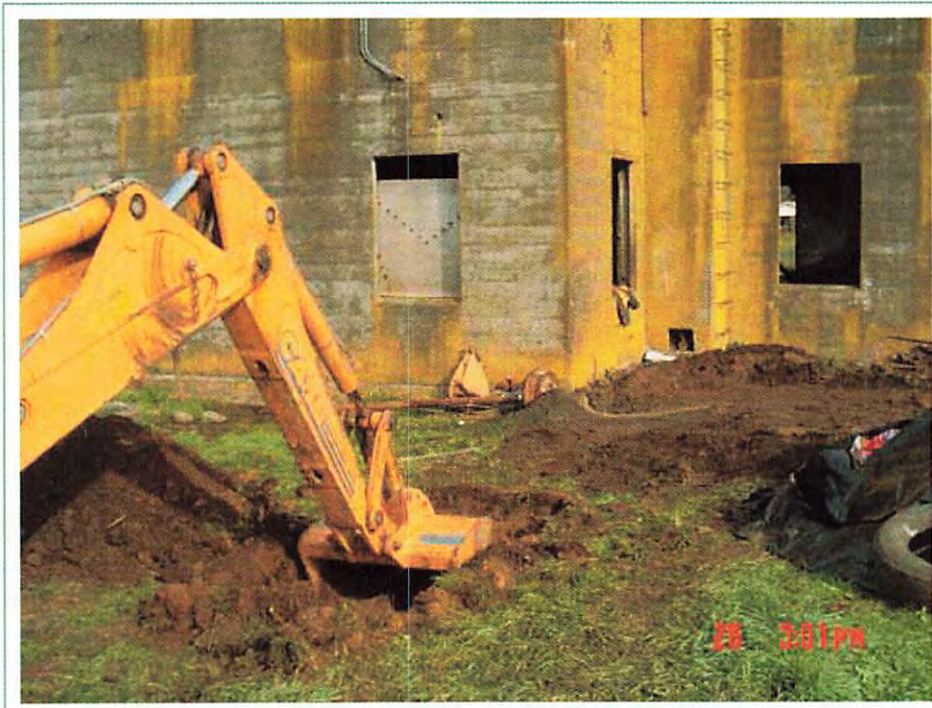
Photo 1
Uncovering the UST.

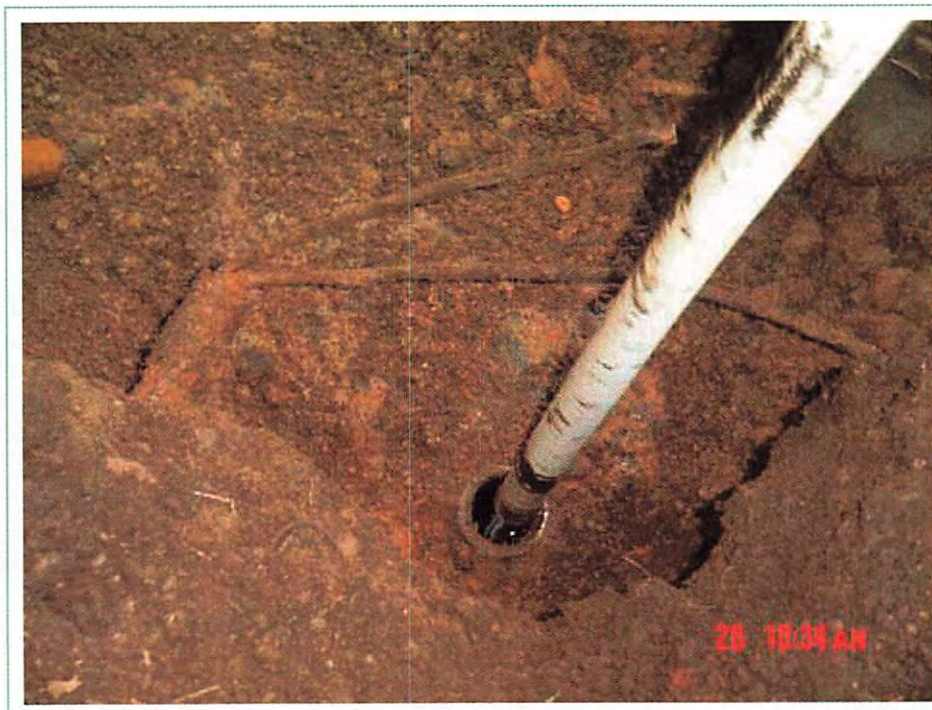
Photo 2
Removal of liquids from
the UST.

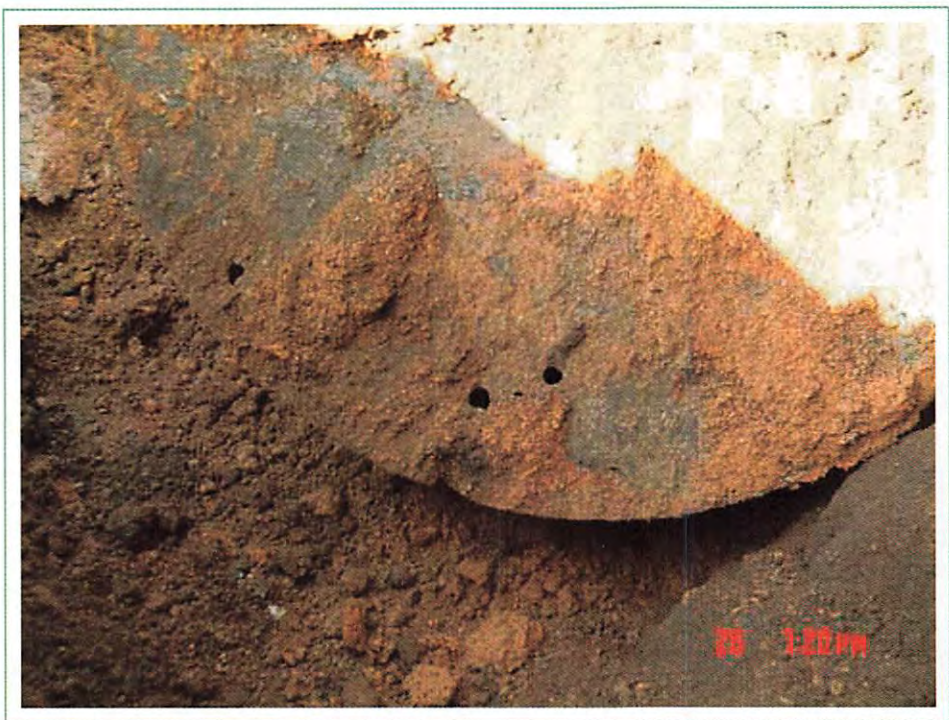
Photo 3
Removal of UST. Holes are apparent along bottom of UST.

south of the tank. Upon removal, the tank was measured and the dimensions were determined to be 38 inches by 60 inches, equal to a capacity of approximately 300 gallons. Numerous holes were observed on the sides of the UST. A small puddle of water was observed in the base of the tank cavity. This water was pumped out and no groundwater recharge was observed.

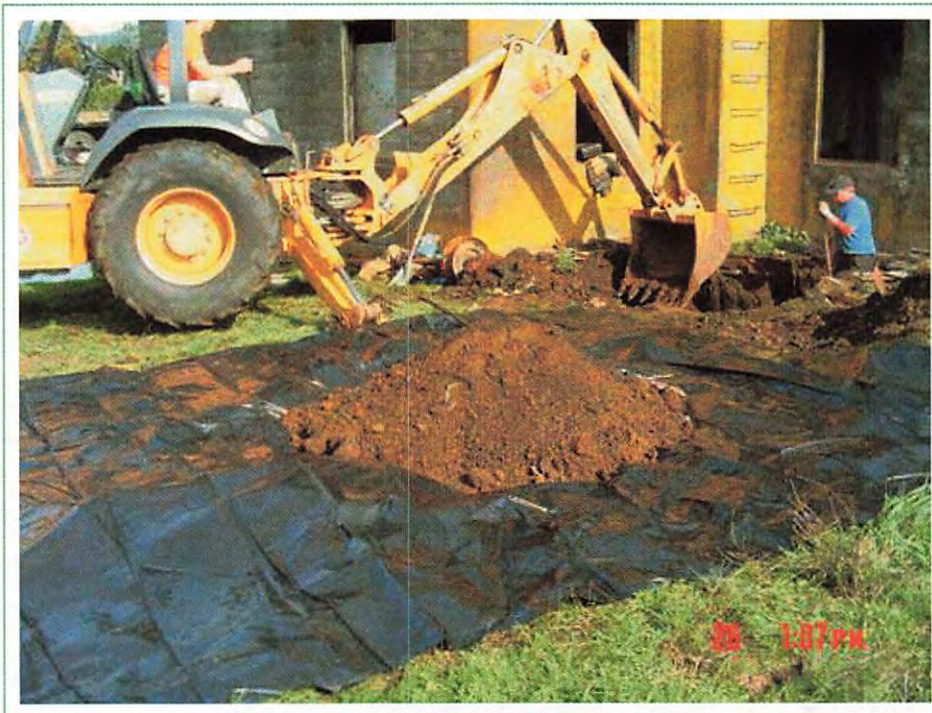
Photo 5
Stockpiling of
contaminated soil.

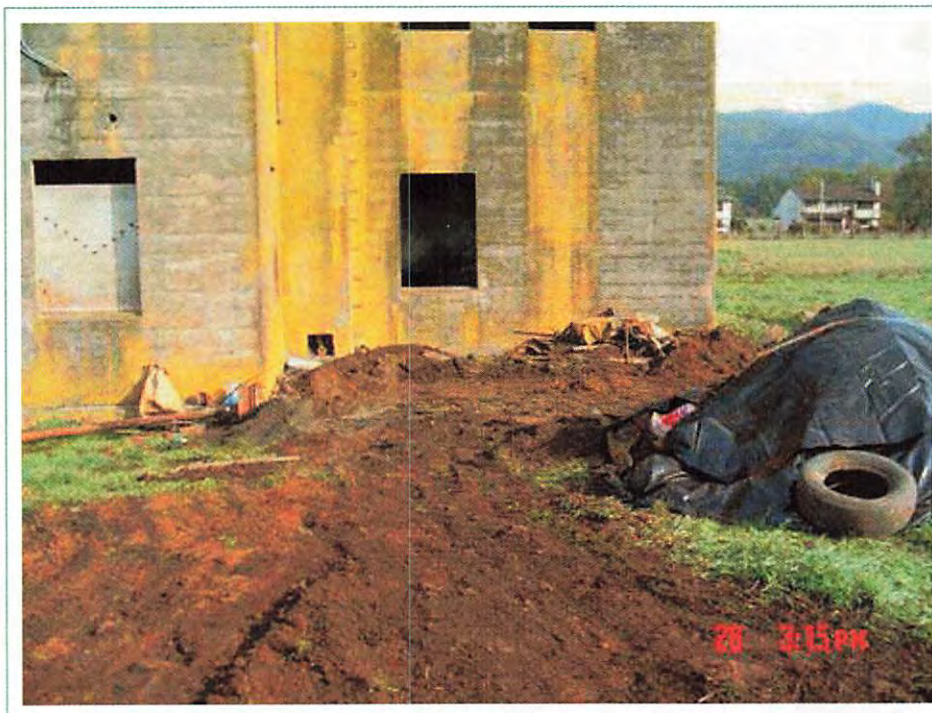
Photo 6
Stockpiled soil covered
with visquene plastic;
cover anchored with
tires and rock. UST
cavity backfilled.

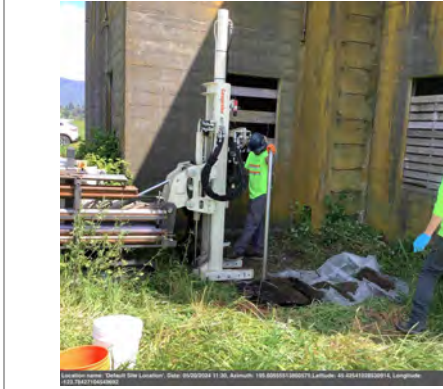
Picture taken at: 11:30
Caption: Drilling LPR-SBUST-3
Latitude: 45.42541028530914
Longitude: -123.7842710454969

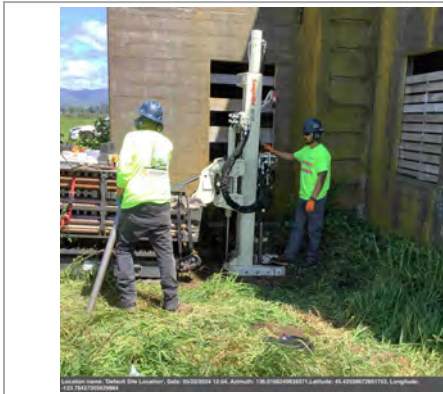
11:56 Possibly missed the UST cavity (silt from 5 feet). Move 40 inches east and drill LPR-SB-UST-3R

Picture taken at: 12:04
Caption: Drilling LPR-SBUST-3R
Latitude: 45.42538672851753
Longitude: -123.7842735562998

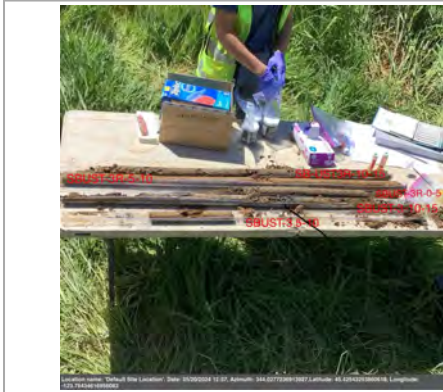
12:15 PID readings in original borehole higher than step out, place screen in first hole screened 10-15 feet bgs. Collect soil samples from high PID reading intervals in first borehole.

Picture taken at: 12:37
Caption: Cuttings LPR-SBUST-3 and 3R
Latitude: 45.42543253860618
Longitude: -123.7843461695608

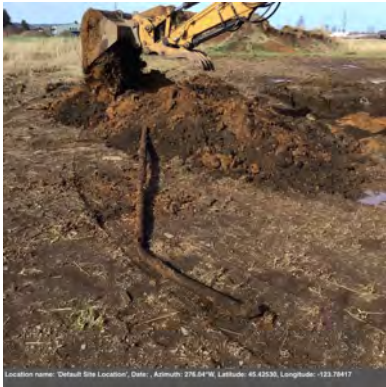
Picture taken at: 10:52
Caption: Pipe aligned East-west at ~3 ft. Some rusted holes. No odor
Latitude: 45.42529709516666
Longitude: -123.7841685135

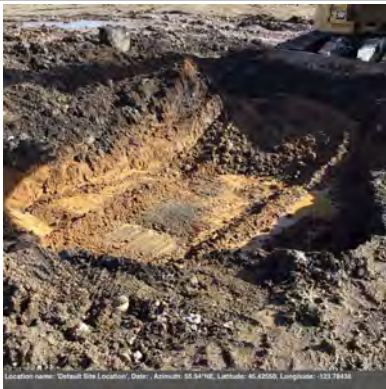
Picture taken at: 10:57
Caption: Excavation at ~3-4 ft bgs
Latitude: 45.42549567198789
Longitude: -123.7843778816115

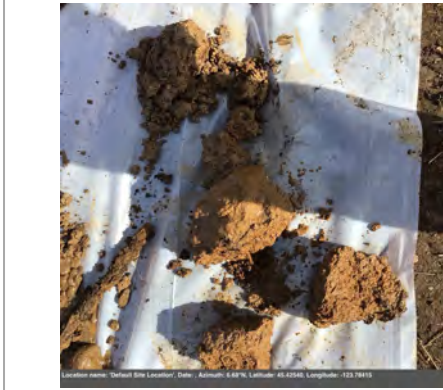
13:55 Digging bottom. Sample Base1-EXC-10 (south, PID = 0.3 ppm) and Base2-EXC-10 (north, PID = 1.6 ppm). Dense at 10' bgs. Collapsing as soil is removed due to standing water in excavation.

Picture taken at: 14:06
Caption: North base soils at ~10' bgs - sample base 2
Latitude: 45.42539944834044
Longitude: -123.7841458392203

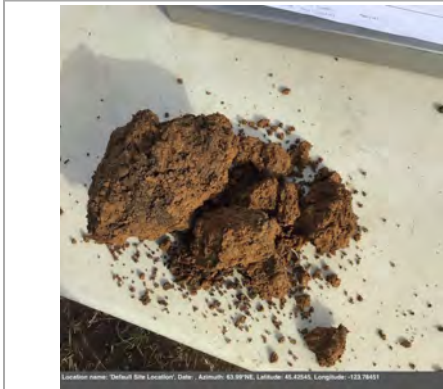
14:35 Expanding east sidewall. Sample at 9' bgs "E-EXC-8.0" PID = 0.2 ppm

Picture taken at: 14:41
Caption: East sidewall soil sample
Latitude: 45.42544986016666
Longitude: -123.7845059196667

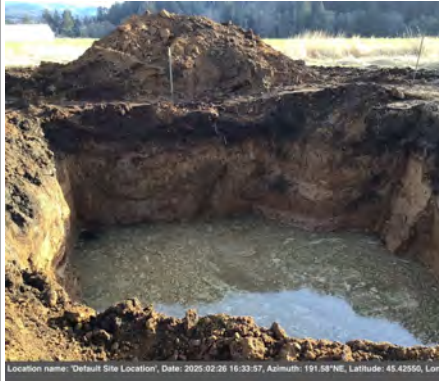
Picture taken at: 16:46
Caption: Final south sidewall
Latitude: 45.4255
Longitude: -123.7843083333333

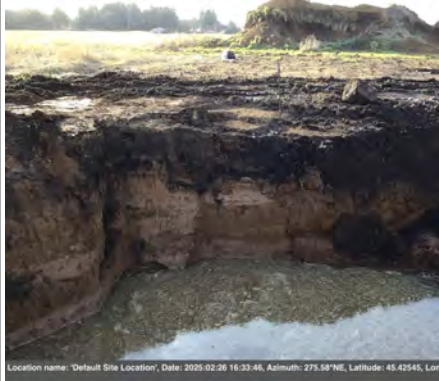
Picture taken at: 16:46
Caption: Final west sidewall
Latitude: 45.42545
Longitude: -123.7842416666667

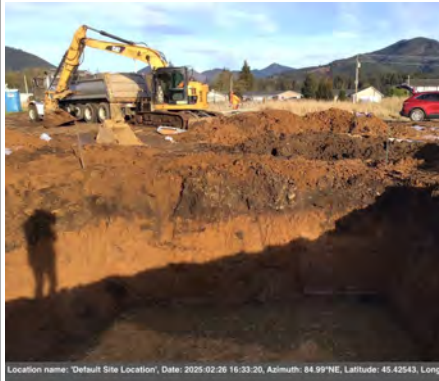
Picture taken at: 16:46
Caption: Final east sidewall
Latitude: 45.425433333333333
Longitude: -123.7843633333333

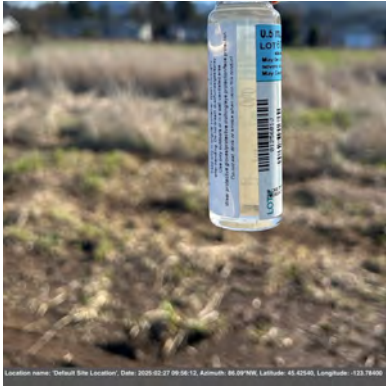
Picture taken at: 10:09
Caption: Very slight turbidity and minor flocculants
Latitude: 45.4254
Longitude: -123.783996666667

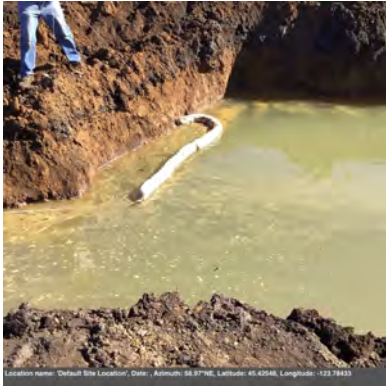
Picture taken at: 11:08
Caption: Boom across surface
Latitude: 45.42548390178351
Longitude: -123.7843309615416

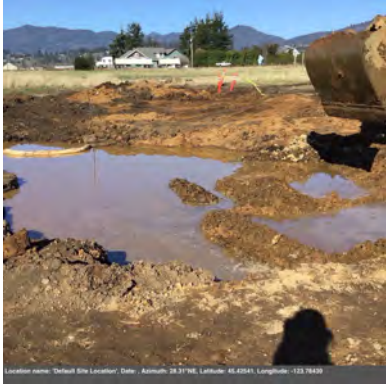
Picture taken at: 14:30
Caption: 8 loads of rip rap in. Water reached top of excavation.
Latitude: 45.42540623661363
Longitude: -123.7843029183941

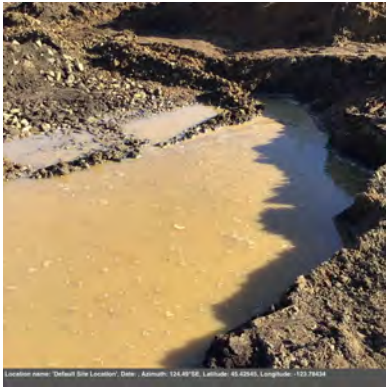
Picture taken at: 15:16
Caption: Water level after ~1 hr
Latitude: 45.42544513509798
Longitude: -123.7843403511224

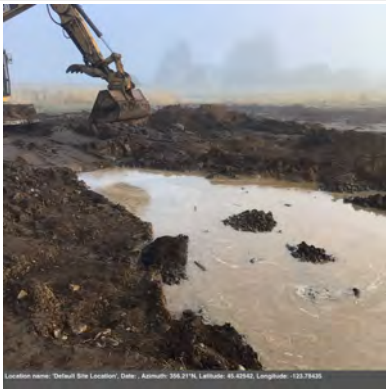
Picture taken at: 08:10
Caption: Creating berm along northwest side of excavation
Latitude: 45.42542011666735
Longitude: -123.7843453309675

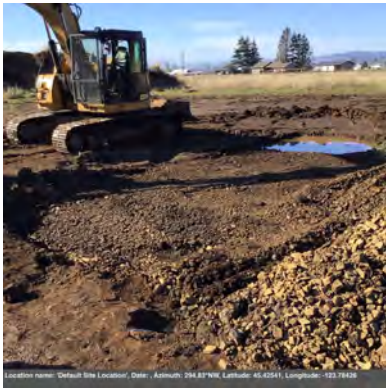
Picture taken at: 14:54
Caption: Excavation nearly completely backfilled
Latitude: 45.42540936919146
Longitude: -123.784255056213

On February 27 through March 1, 2025, the excavation was backfilled with quarry spalls up to 4 inches in diameter supplied by Braxling & Braxling of Tillamook, Oregon. The surface of the excavation was compacted using a plate compactor and the excavator bucket and covered with 3 to 4 inches of soil from the upper 5 feet bgs.

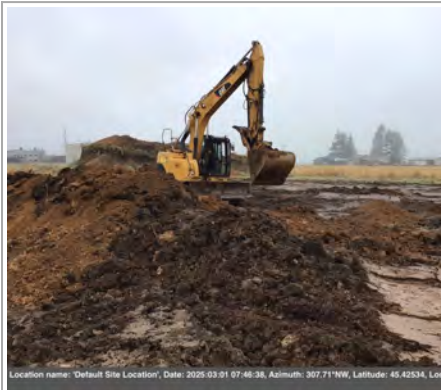
Picture taken at: 07:46
Caption: Placing soil cover
Latitude: 45.42533666666667
Longitude: -123.78413333333333
