Re: Beneficial Water and Land Use Survey

Clackamas County Fire District #1

2614-01

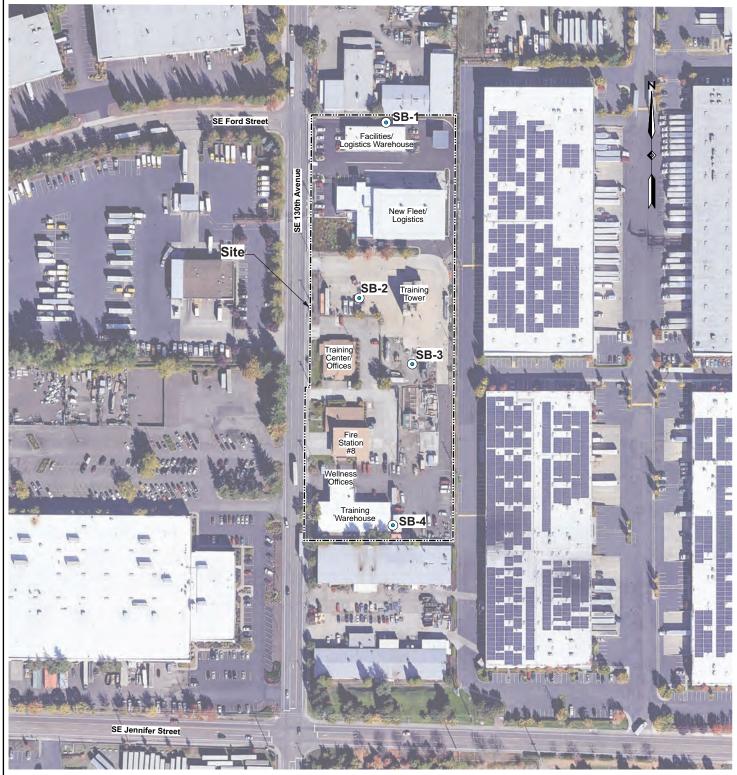
Project Number: 320002614-01	Drawn: JP	Approved: HG	Figure
April	2021		2

Figure 2 - Site Plan

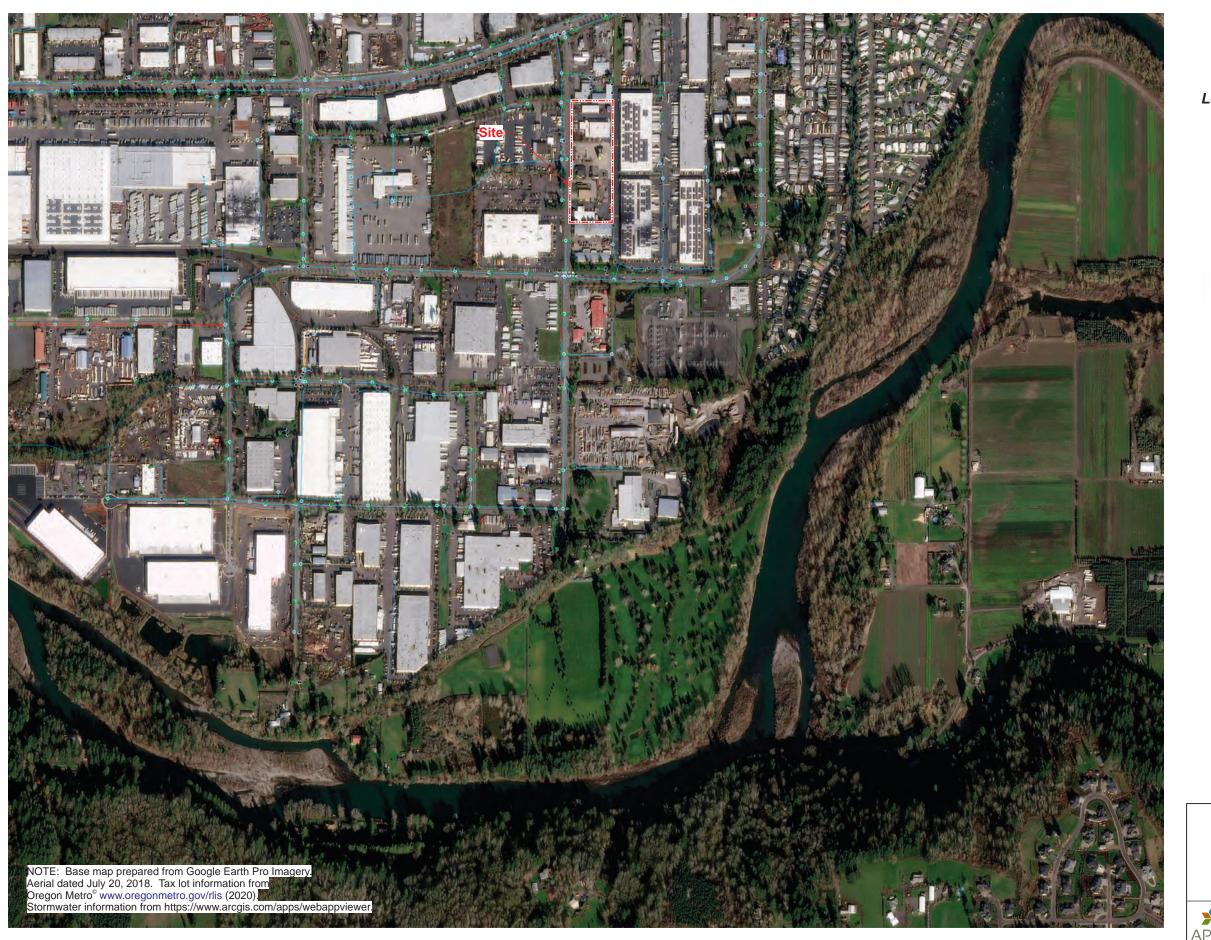
Project Number:	Drawn:	Approved:	Figure
320002614-01	JP	HG	9
April		3

# Stormwater Drainage Plan

Beneficial Use Survey Clackamas Fire District Facility - 15800 SE 130th Clackamas, Oregon

Based on review of the online stormwater drainage system map prepared by Multnomah County (which includes the portion of Clackamas County where the Site is located), the stormwater catch basin on-site discharges west towards SE 130<sup>th</sup> Avenue, into stormwater piping that is part of the Cedar Creek stormwater basin. According to the MS4 NPDES Permit for Clackamas County, all stormwater within the municipal storm sewer system ultimately discharges to the Clackamas River, the Lower Willamette River, the Tualatin River, or connected tributaries and creeks. Based on review of the stormwater drainage map, it is likely the stormwater collected within the on-site catch basin flows to a discharge point within the Clackamas River approximately 0.85 miles southwest of the Site (asset ID swDPT-00297) or a discharge point approximately 1.3 miles southwest of the Site (asset ID swDPT-00174). Figure 3 depicts the stormwater drainage system within the Site vicinity.
