# UST DECOMMISSIONING & RISK-BASED CORRECTIVE ACTION REPORT

FORMER 12<sup>TH</sup> AVENUE MOTOR SERVICE

LUST FACILITY #26-23-0131

Point Source Solutions Project No: OR230123-3B Revised August 6, 2025 Field Work Conducted and Report Prepared in General Accordance with the following:

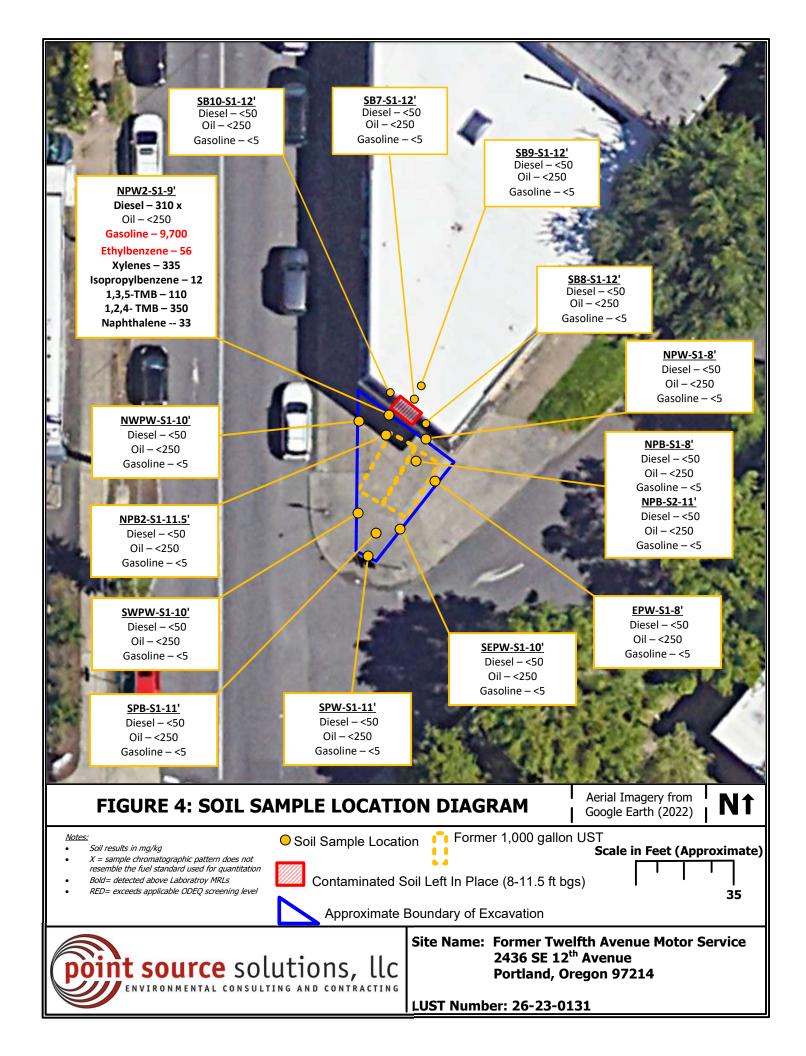
Figure 4: Soil Sample Location Diagram

- NPW-S1-8 was collected from the north pit wall of the excavation at a depth of 8 feet below ground surface (bgs). Staining and odor were not noted to a depth of 8 feet bgs in this area.

- EPW-S1-8 was collected from the east pit wall of the excavation at a depth of 8 feet bgs. Staining and odor were not noted.
- NPB-S1-8 was collected from the north pit bottom of the excavation at a depth of 8 feet bgs.
   Staining and odor were not noted.

- NPW2-S1-9 was collected from the north pit wall of the excavation at a depth of 9 feet bgs.
   Staining and odor were noted below 8 feet bgs in this area. Gx contamination was confirmed analytically.

- NPB-S2-11 was collected from the north pit bottom of the excavation at a depth of 11 feet bgs.
   Staining and odor were not noted. This appears to be the vertical extent of remaining PCS at the Site.

- SWPW-S1-10 was collected from the southwest pit wall of the excavation at a depth of 10 feet bgs. Staining and odor were not noted.
- SPB-S1-11 was collected from the south pit bottom of the excavation at a depth of 11 feet bgs. Staining and odor were not noted.

- SPW-S1-11 was collected from the south pit wall of the excavation at a depth of 11 feet bgs. Staining and odor were not noted.
- SEPW-S1-10 was collected from the southeast pit wall of the excavation at a depth of 10 feet bgs. Staining and odor were not noted.

- NWPW-S1-10 was collected from the northwest pit wall of the excavation at a depth of 10 feet bgs. Staining and odor were not noted.
- NPB2-S1-11.5 was collected from the north pit bottom of the excavation at a depth of 11.5 feet bgs. Staining and odor were not noted.

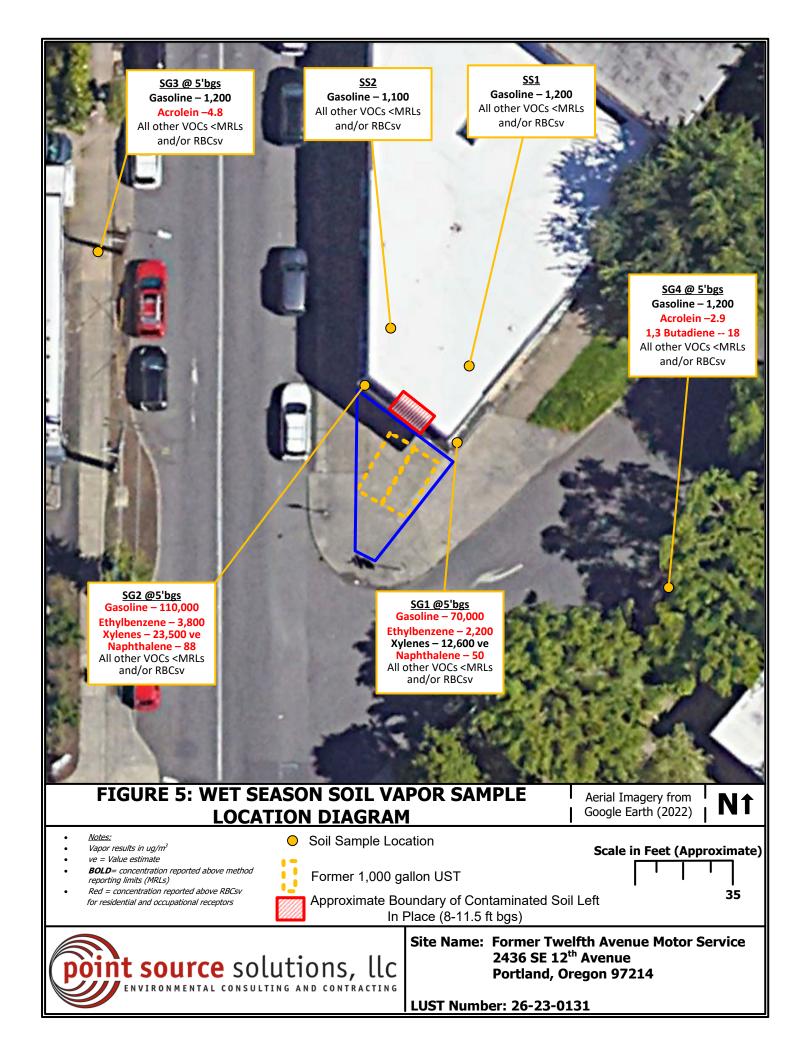
Figure 5: Soil Vapor Sample Location Diagram Wet Season Figure 5a: Soil Vapor Sample Location Diagram Dry Season

- Soil gas sample SG1 was advanced to 5 feet bgs beneath the concrete slab of the exterior portion of the Site approximately 8 feet east of the contaminated soil plume. The intention of this boring was to evaluate soil gas conditions in effort to demonstrate no offsite migration of vapors.

- Soil gas sample SG2 was advanced to 5 feet bgs beneath the concrete slab of the exterior portion of the Site approximately 8 feet west of contaminated soil plume. The intention of this boring was to evaluate soil gas conditions in effort to demonstrate no offsite migration of vapors.

- Soil gas sample SG3 was advanced to 5 feet bgs beneath the sidewalk west of SE 12<sup>th</sup> Avenue approximately 50 feet west of the contaminated soil plume. The intention of this boring was to evaluate soil gas conditions for offsite receptors to the west of the Site.

- Soil gas sample SG4 was advanced to 5 feet bgs beneath a landscaped area east of SE Elliot Avenue
  approximately 50 feet east of the contaminated soil plume. The intention of this boring was to
  evaluate soil gas conditions for offsite receptors to the east of the Site.

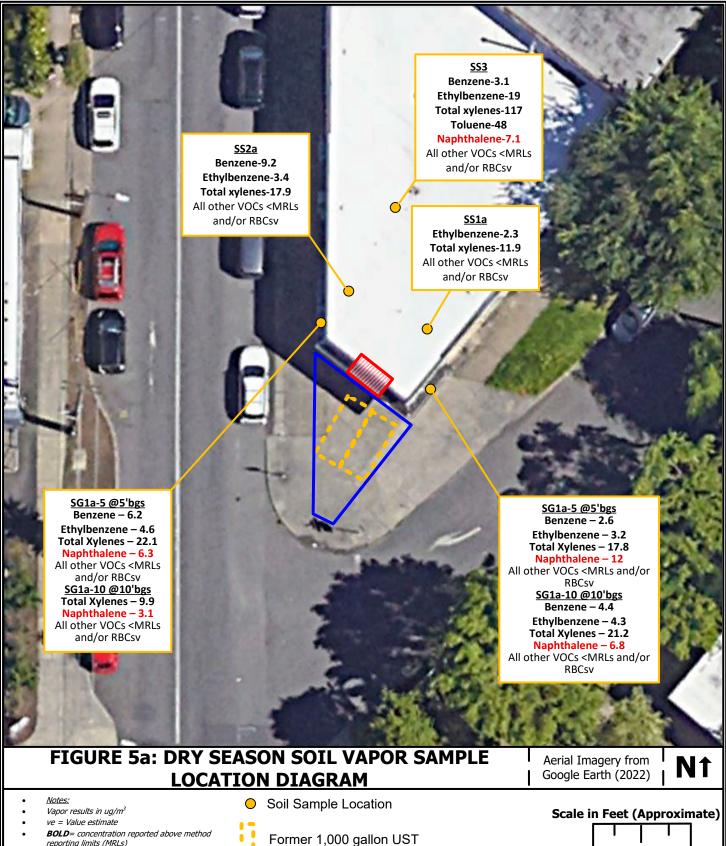
- Soil gas sample SG1a-5 was advanced to 5 feet bgs beneath the concrete slab of the exterior portion of the Site approximately 8 feet east of the contaminated soil plume co-located with wet season sample SG1. The intention of this boring was to evaluate soil gas conditions in effort to demonstrate no offsite migration of vapors and to compare to wet season conditions. PID and multi-gas readings from the sample tubing collected prior to TO-15 sample collection were 2.7 ppm VOCs; 0.11 % CO2, 16.95 % O2, and -0.02 % methane.

- Soil gas sample SG1a-10 was advanced to 10 feet bgs beneath the concrete slab of the exterior
  portion of the Site approximately 8 feet east of contaminated soil plume co-located with wet season
  sample SG1. The intention of this sample was to evaluate soil gas conditions in effort to
  demonstrate no offsite migration of vapors and compare to wet season conditions. PID and multigas readings from the sample tubing collected prior to TO-15 sample collection were 4.7 ppm VOCs;

of the Site approximately 8 feet west of the contaminated soil plume co-located with wet season sample SG2. The intention of this boring was to evaluate soil gas conditions in effort to demonstrate no offsite migration of vapors and to compare to wet season conditions. PID and four-gas readings from the sample tubing collected prior to TO-15 sample collection were 1.9 ppm VOCs; 0.15 % CO2, 20.44 % O2, and -0.04 % methane.

Soil gas sample SG2a-10 was advanced to 10 feet bgs beneath the concrete slab of the exterior
portion of the Site approximately 8 feet west of contaminated soil plume co-located with wet
season sample SG2. The intention of this sample was to evaluate soil gas conditions in effort to
demonstrate no offsite migration of vapors and compare to wet season conditions. PID and four-gas
readings from the sample tubing collected prior to TO-15 sample collection were 1.1 ppm VOCs;
0.17 % CO2, 20.17 % O2, and -0.06 % methane.

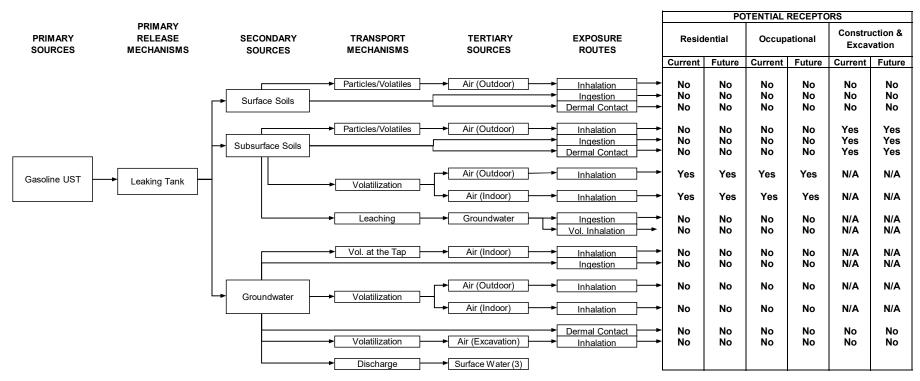
## APPENDIX F CONCEPTUAL SITE MODEL

SUMMARY OF CSM							
Pathway	Receptor	Applicable RBC?	Basis for selection/exclusion					
SOIL	SOIL							
Ingestion, Dermal Contact, and	Residential (Future)	No	Impacted soils were not observed above 3.0 feet bgs					
Inhalation	Occupational (Current and Future)	No						
	Construction worker (Current and Future)	Yes	Impacted subsurface soils may become accessible during future construction as					
	Excavation Worker (Current and Future)	Yes	a result of redevelopment of the Site
