ECSI Listing #6285
“Class-N-Kustom” Lot
Tax Lot 1N1E28CB0700
Portland, OR 97210

Point Source Solutions LLC (Point Source) is preparing this memorandum to provide a comprehensive summary of project activities related to the removal of Polychlorinated Biphenyl (PCB) impacted soils from the “Class-N-Kustom” (CNK) property formerly owned by ESCO Corporation. The CNK lot is located at 2404 NW Nicolai Street (Site) and is described by Multnomah County as tax lot 1N1E28CB0700. The CNK lot is adjoined by the ESCO “Main Plant” Site to the west and south, and is an out-parcel included in the ECSI #6285 listing.

SAMPLE LOCATION DIAGRAM

Site Photographs
Phase I Environmental Site Assessment
ESCO Auto Body Shop Property
2404 NW Nicolai Street
Portland, Oregon

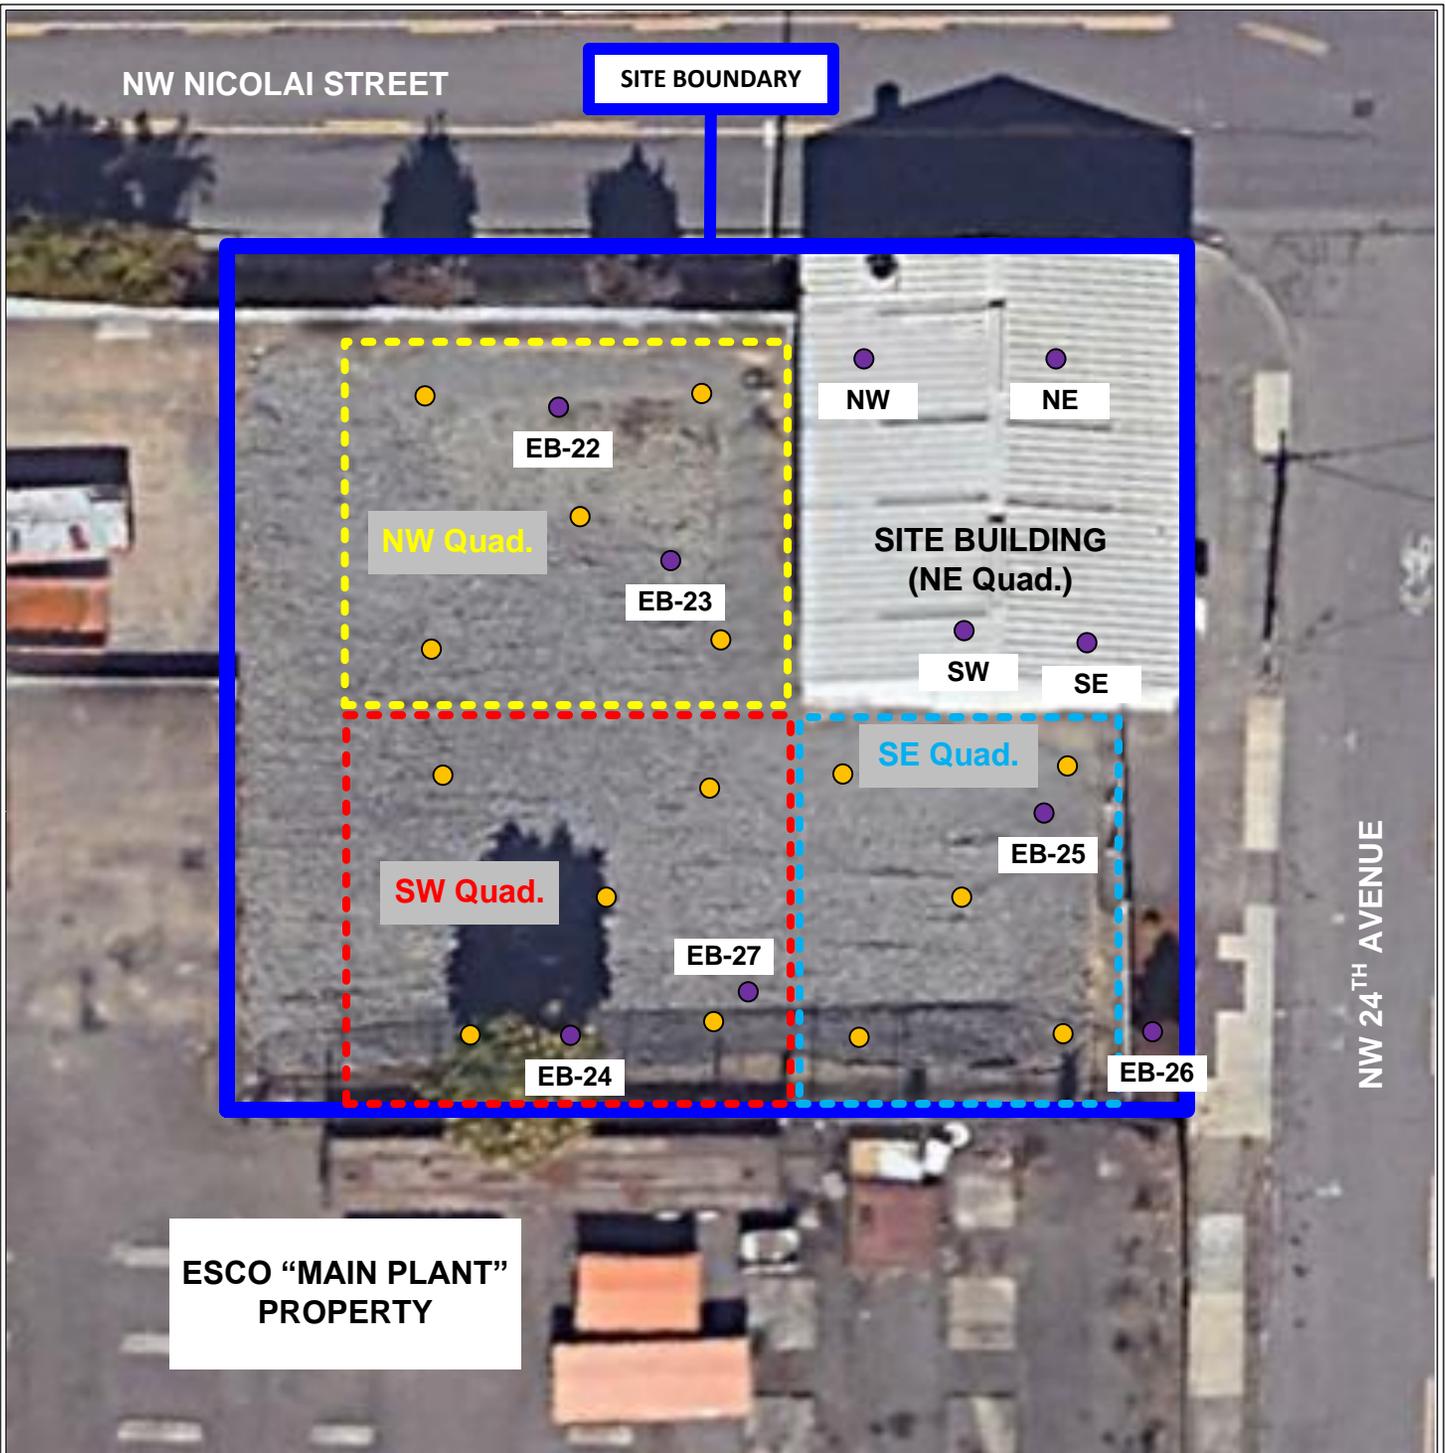
**ESCO "MAIN PLANT"
PROPERTY**

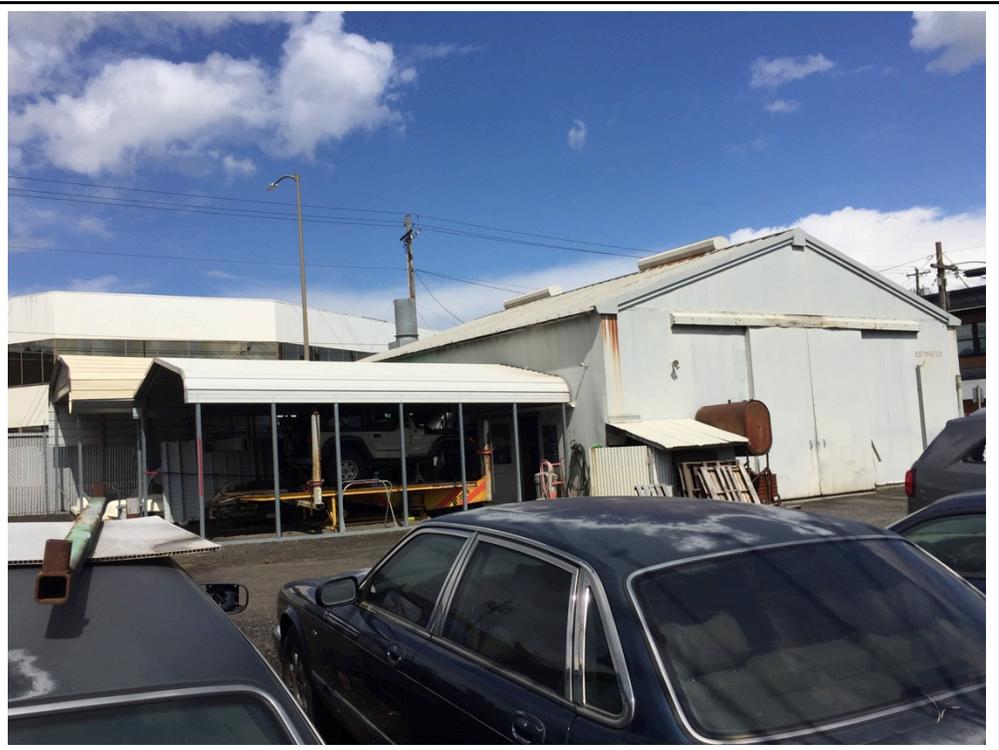
Direction:
North-Northeast

Comments: View of the subject property from its southern boundary, showing the shop building, carports, hoist, air compressor shed, and heating oil AST.

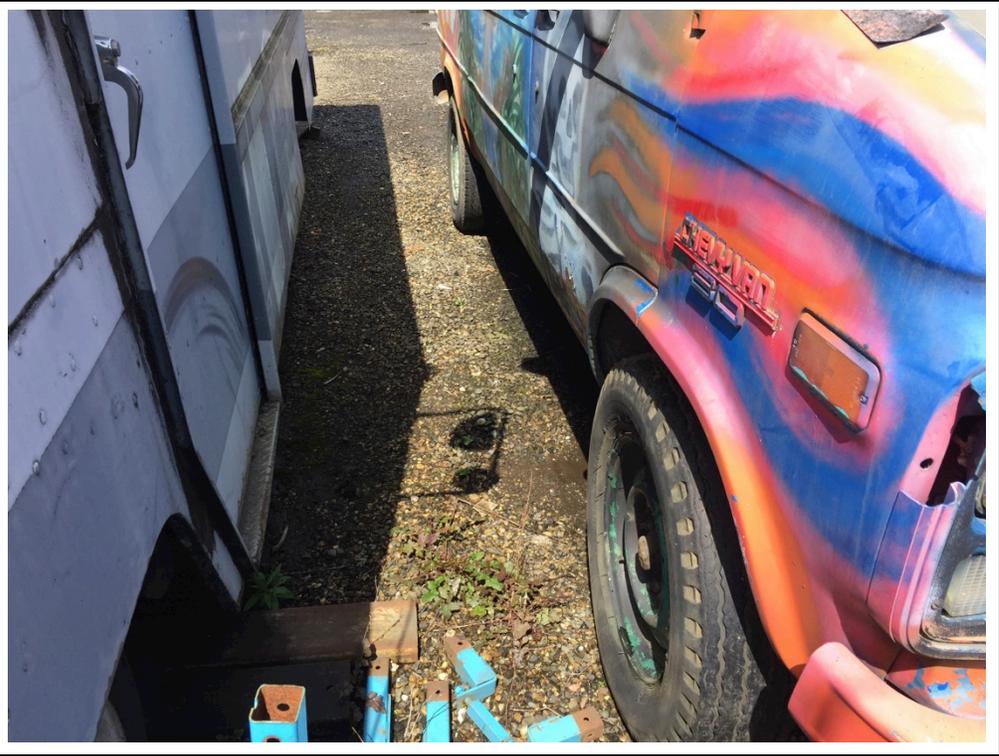
Photograph ID: 2

Oily staining was observed on the gravel ground surface in the southwestern portion of the subject property (Photograph 2). According to Mr. Clint Birch of Class-n-Kustom Autobody & Boat Repair, the property Occupant, this portion of the property was historically used by ESCO, the property Owner, for oil storage (see Section 7.3 *Summary of Historical Use*).

Comments: Oily staining in the location of a former oil storage shed.

1. An oil storage shed was historically located on the southwestern portion of the subject property from approximately the 1980s through 2005. The oil storage shed had a dirt floor, and oily staining was noted at this location.
Recommendation: Soil sampling should be performed at the subject property in the vicinity of the former oil storage shed to document the presence or absence of contamination.

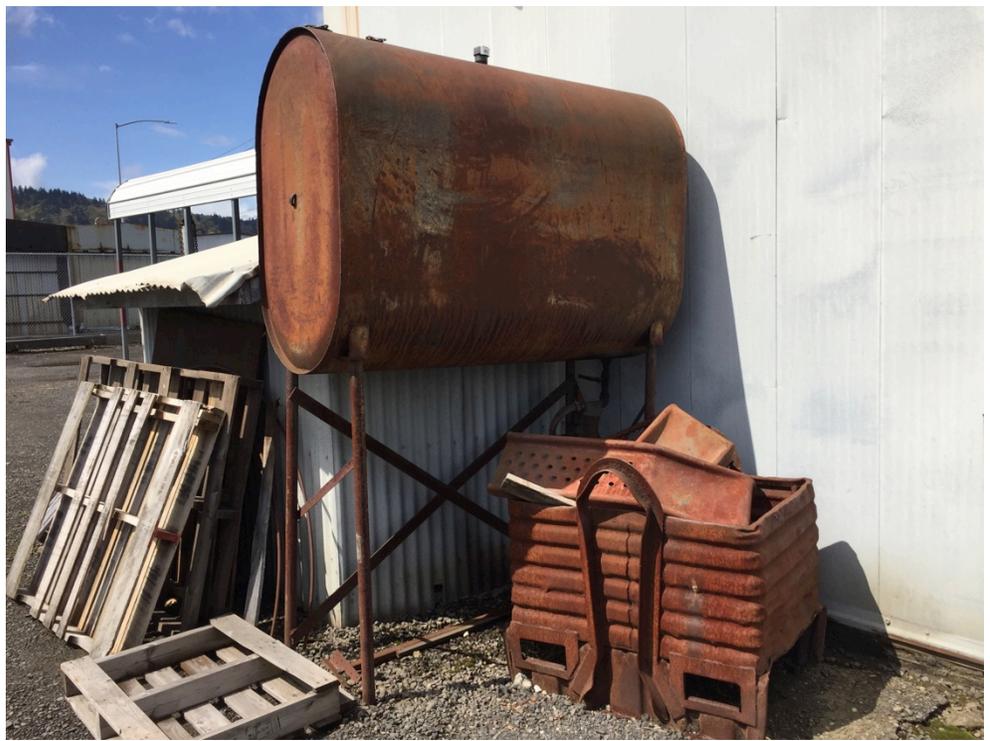
One 250-gallon AST was observed adjacent to the southern exterior wall of the building (Photographs 1 and 3). According to Mr. Clint Birch, the property Occupant, the AST stores stove (heating) oil, which is used to heat the building. The AST is located on an unpaved area and was not situated within secondary containment. Evidence of spills or leaks, such as odors or staining, was not observed in the vicinity of the AST.

Direction:
West-Northwest

Comments: The heating oil AST and air compressor shed.

Recommendation: It is recommended that the tank be placed within appropriate secondary containment. In addition, if soil sampling activities are planned at the property, it may be prudent to collect a sample from the vicinity of this tank.

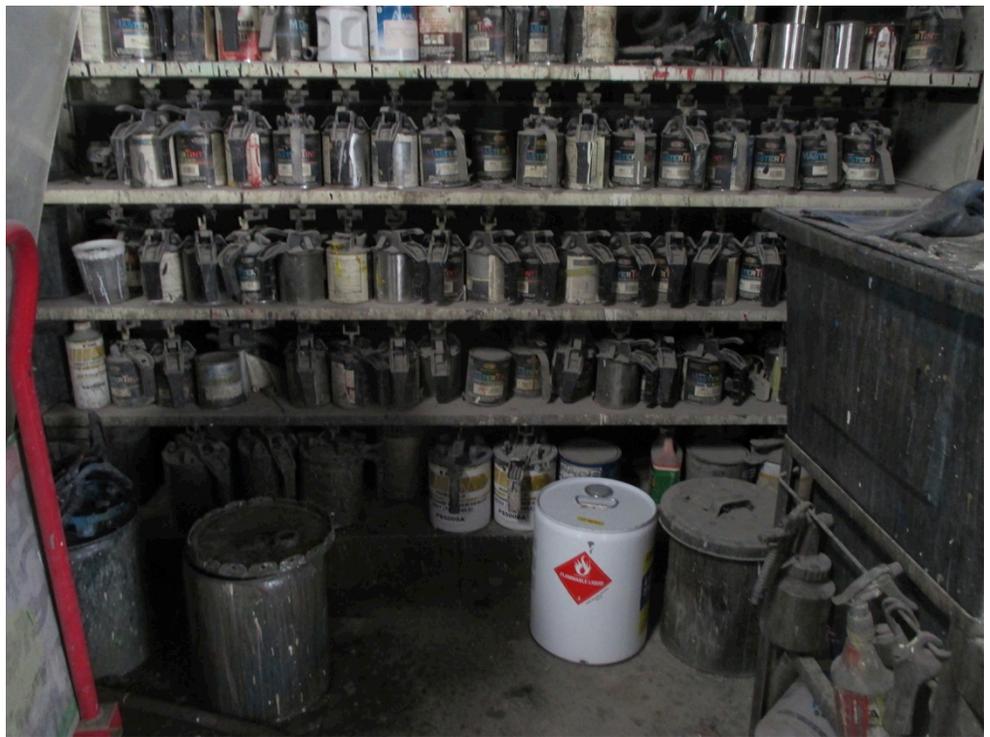
Photograph ID: 4

Numerous containers of paint, paint thinner, paint additives, and other typical auto body shop fluids were observed at the subject property (Photograph 4). They were stored within the shop area of the building and in a shipping container located adjacent to the western exterior wall of the building. Approximately 30 paint thinner containers were stacked on an unpaved area under a carport canopy. According to Mr. Clint Birch, the property Operator, all of these containers were empty.

An enclosed automatic paint gun cleaner was observed in the building (Photograph 4). According to Mr. Birch, the gun cleaner uses a lacquer thinner (non-chlorinated) solvent. Waste solvent is emptied from the gun cleaner approximately once per year and is collected in a 15-gallon container provided by Safety Kleen. Safety Kleen collects the used solvent as needed.

Comments: Typical storage of paint and paint thinner. The paint gun cleaner is visible on the right side of the photograph.

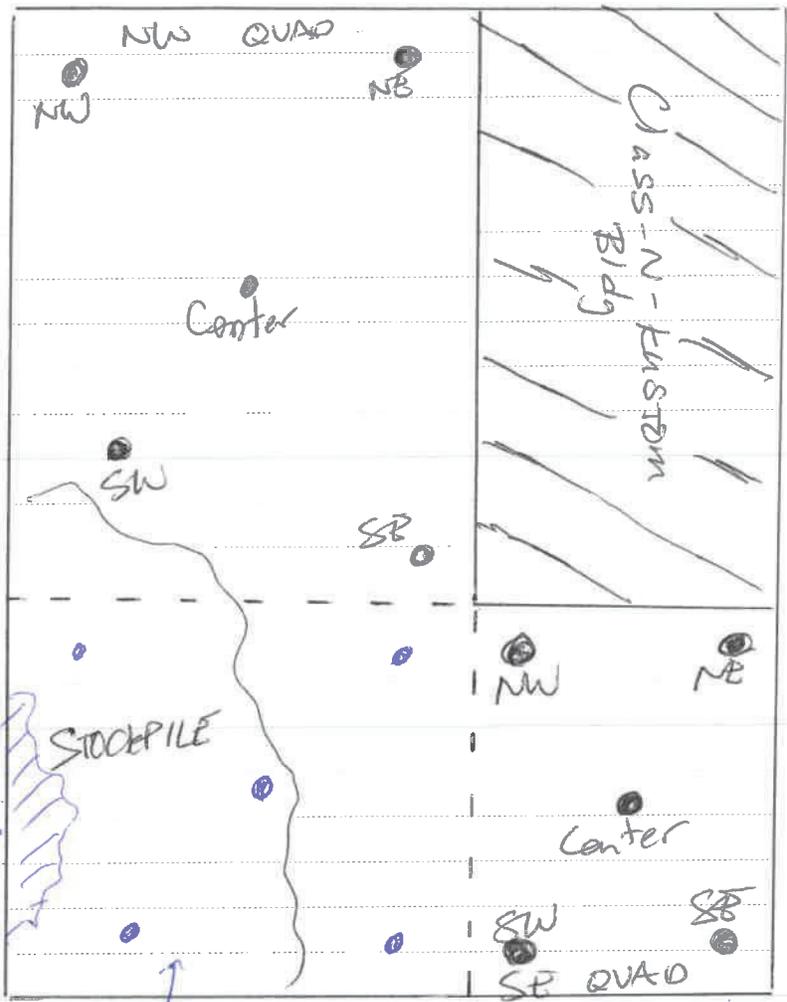
NOT TO SCALE

pile removed pm 6/12/18, then sampled
