RE: 2025 Annual Cap Inspection
Starlight (formerly Westwind) Apartments, 355 NW 6th Avenue, Portland, Oregon
(ECSI 6492/5315)

PHOTOGRAPHIC LOG

Starlight (Formerly Westwind) Apartments
355 NW 6th Avenue
Portland, Oregon

Project No.
1017-21002-05

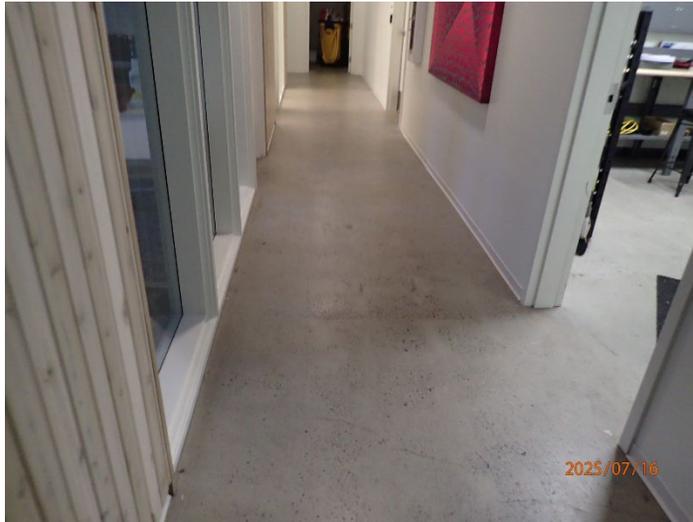
View of concrete floor within the office/maintenance spaces. The condition of the concrete floor in this area is typical of resident and employee areas of the ground floor and is in good condition.

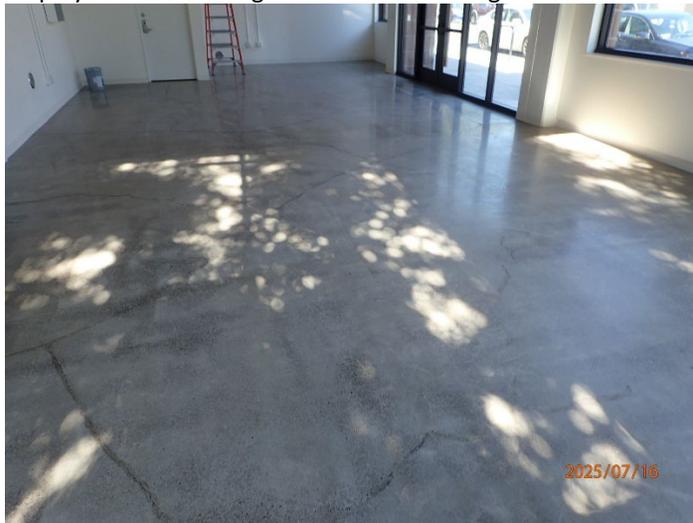
The floor of the unoccupied commercial space has been finished with a concrete slab. Edges and surficial cracks were sealed with polyurethane sealant and a glossy coating was applied to the surface. The space remains unoccupied at this time.

Floor has been finished within the commercial space in the northeast portion of the building. The concrete slab was poured to match the original partial slab and footings. The edges were sealed with a polyurethane sealant, along with minor surficial cracking. The entire surface was then coated with a sealant resulting in a glossy finish. The commercial space remains unoccupied.

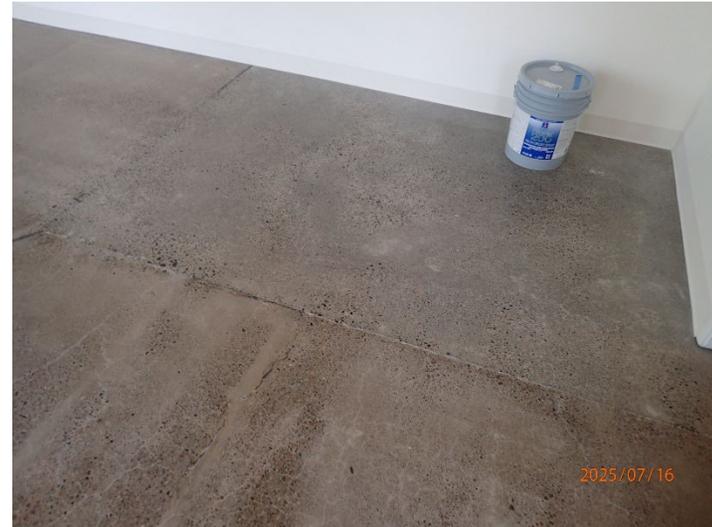
View of the new concrete floor against the original concrete footing within the commercial space. Edges and surficial cracks were sealed with polyurethane sealant and a glossy coating was applied to the surface.

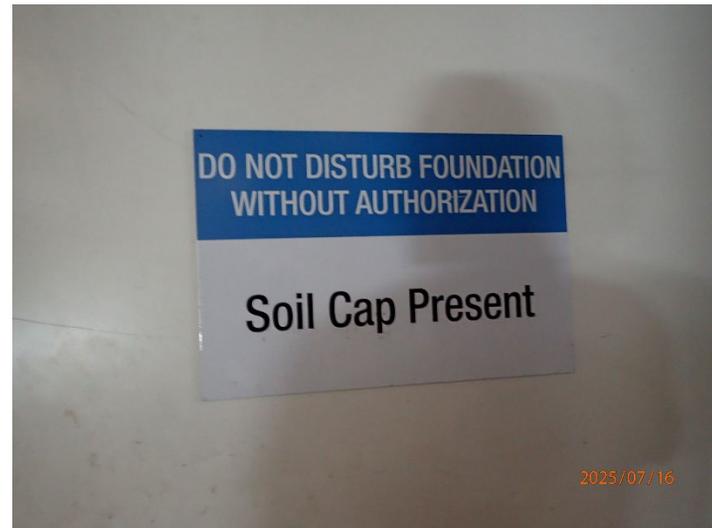
Signage posted warning of soil cap. Several signs are located throughout the ground floor.
