**2023 Annual Monitoring Report**  
Former Mt. Hood Solutions Warehouse Site  
4444 NW Yeon Avenue  
Portland, Oregon  
Project: MtHoodChem-4-002

## SUB-SLAB DEPRESSURIZATION/SUB-SLAB VENTILATION SYSTEM DESCRIPTION

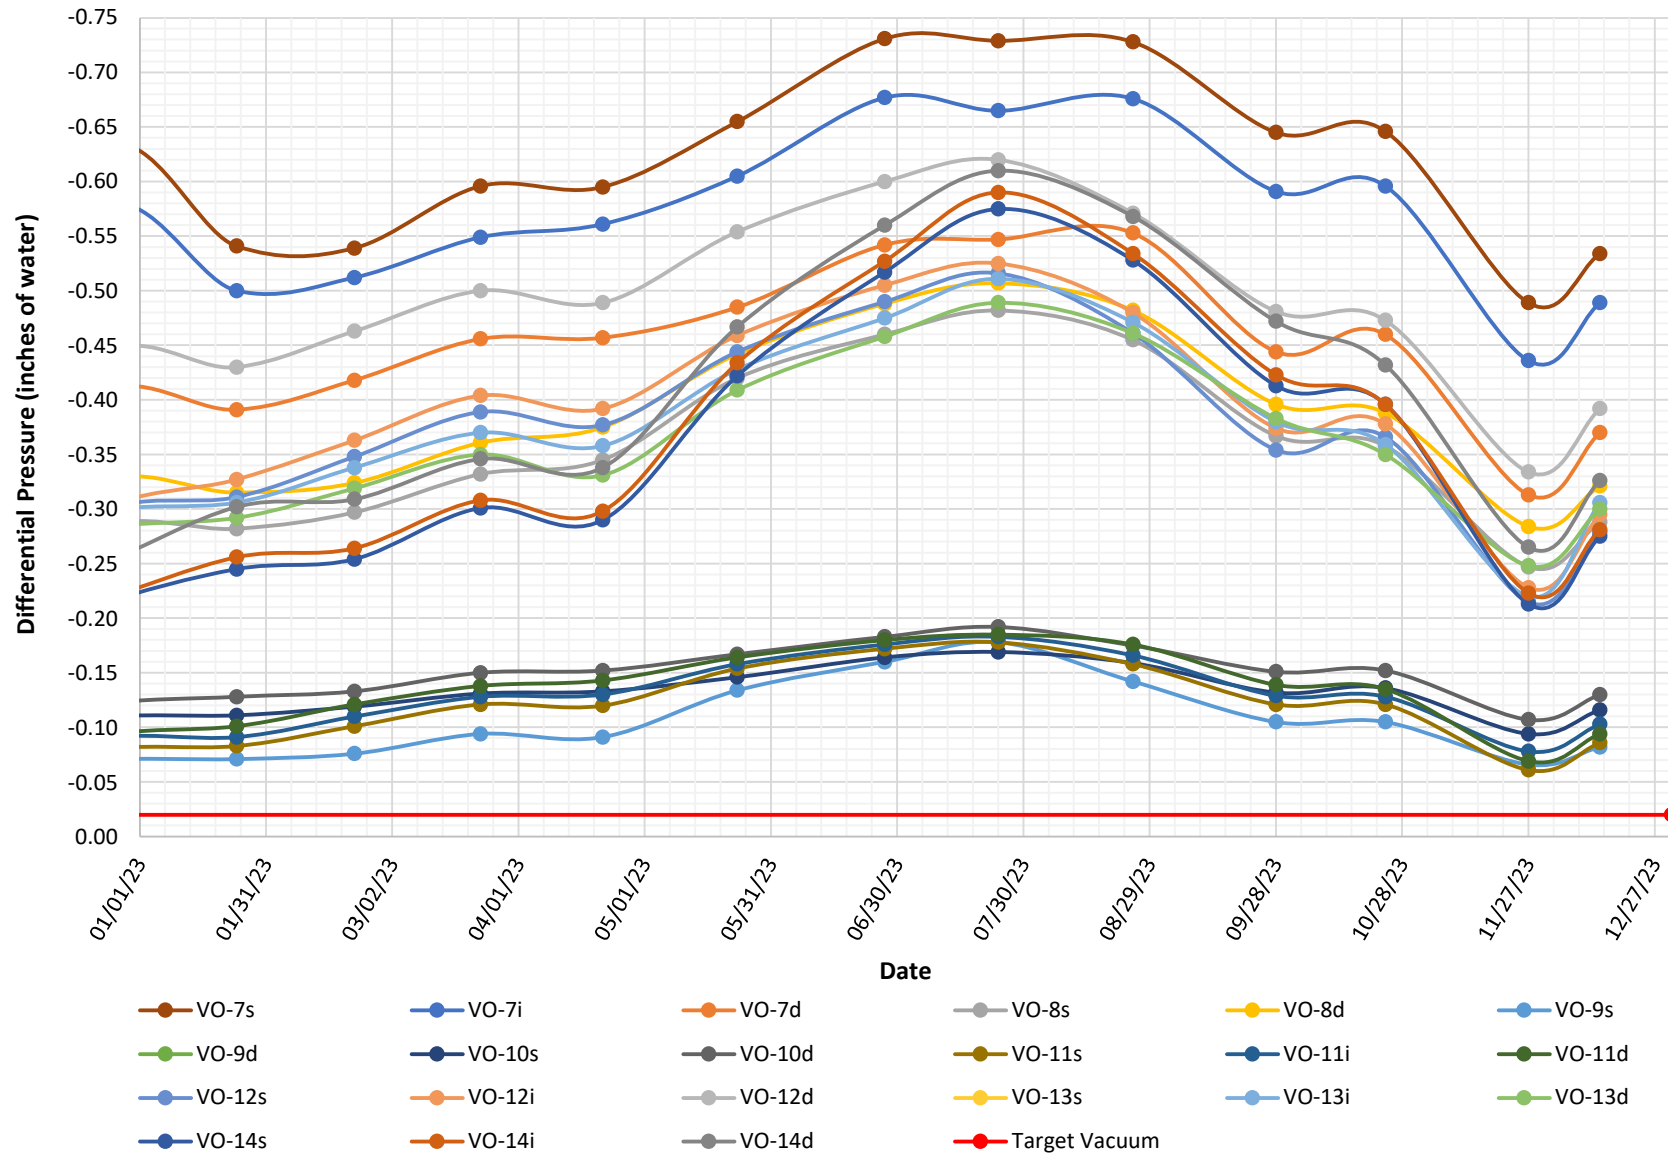
The Attachment presents summary charts depicting trends in differential pressure (vacuum), flow readings measured in each ventilation line, and selected monitoring point-induced vacuum readings throughout the monitoring period (January through December 2023).

## SSD/SSV System Trends - Induced Vacuum at Monitoring Points Calendar Year 2023

The SSD/SSV system operated continuously throughout calendar year 2023 without disruption. The performance objective of the SSD/SSV system is to (1) operate continuously and (2) maintain an adequate level of induced vacuum to help prevent excessive buildup of vapors beneath the warehouse structure floor slab. Specifically, the target level of induced sub-slab vacuum throughout the warehouse area is -0.02 inch of water, consistent with the value recommended by the U.S. Environmental Protection Agency.<sup>6</sup> A review of the 2023 performance and monitoring data indicates that the SSD/SSV is exceeding this objective.
