UST Decommissioning Report

Jackson County Curb Ramp (Ashland) UST Investigation at Waters St.
Project (Key #22208)
OR 99 M.P. 19.11
Jackson County

1/21/2024

Oregon Department of Transportation

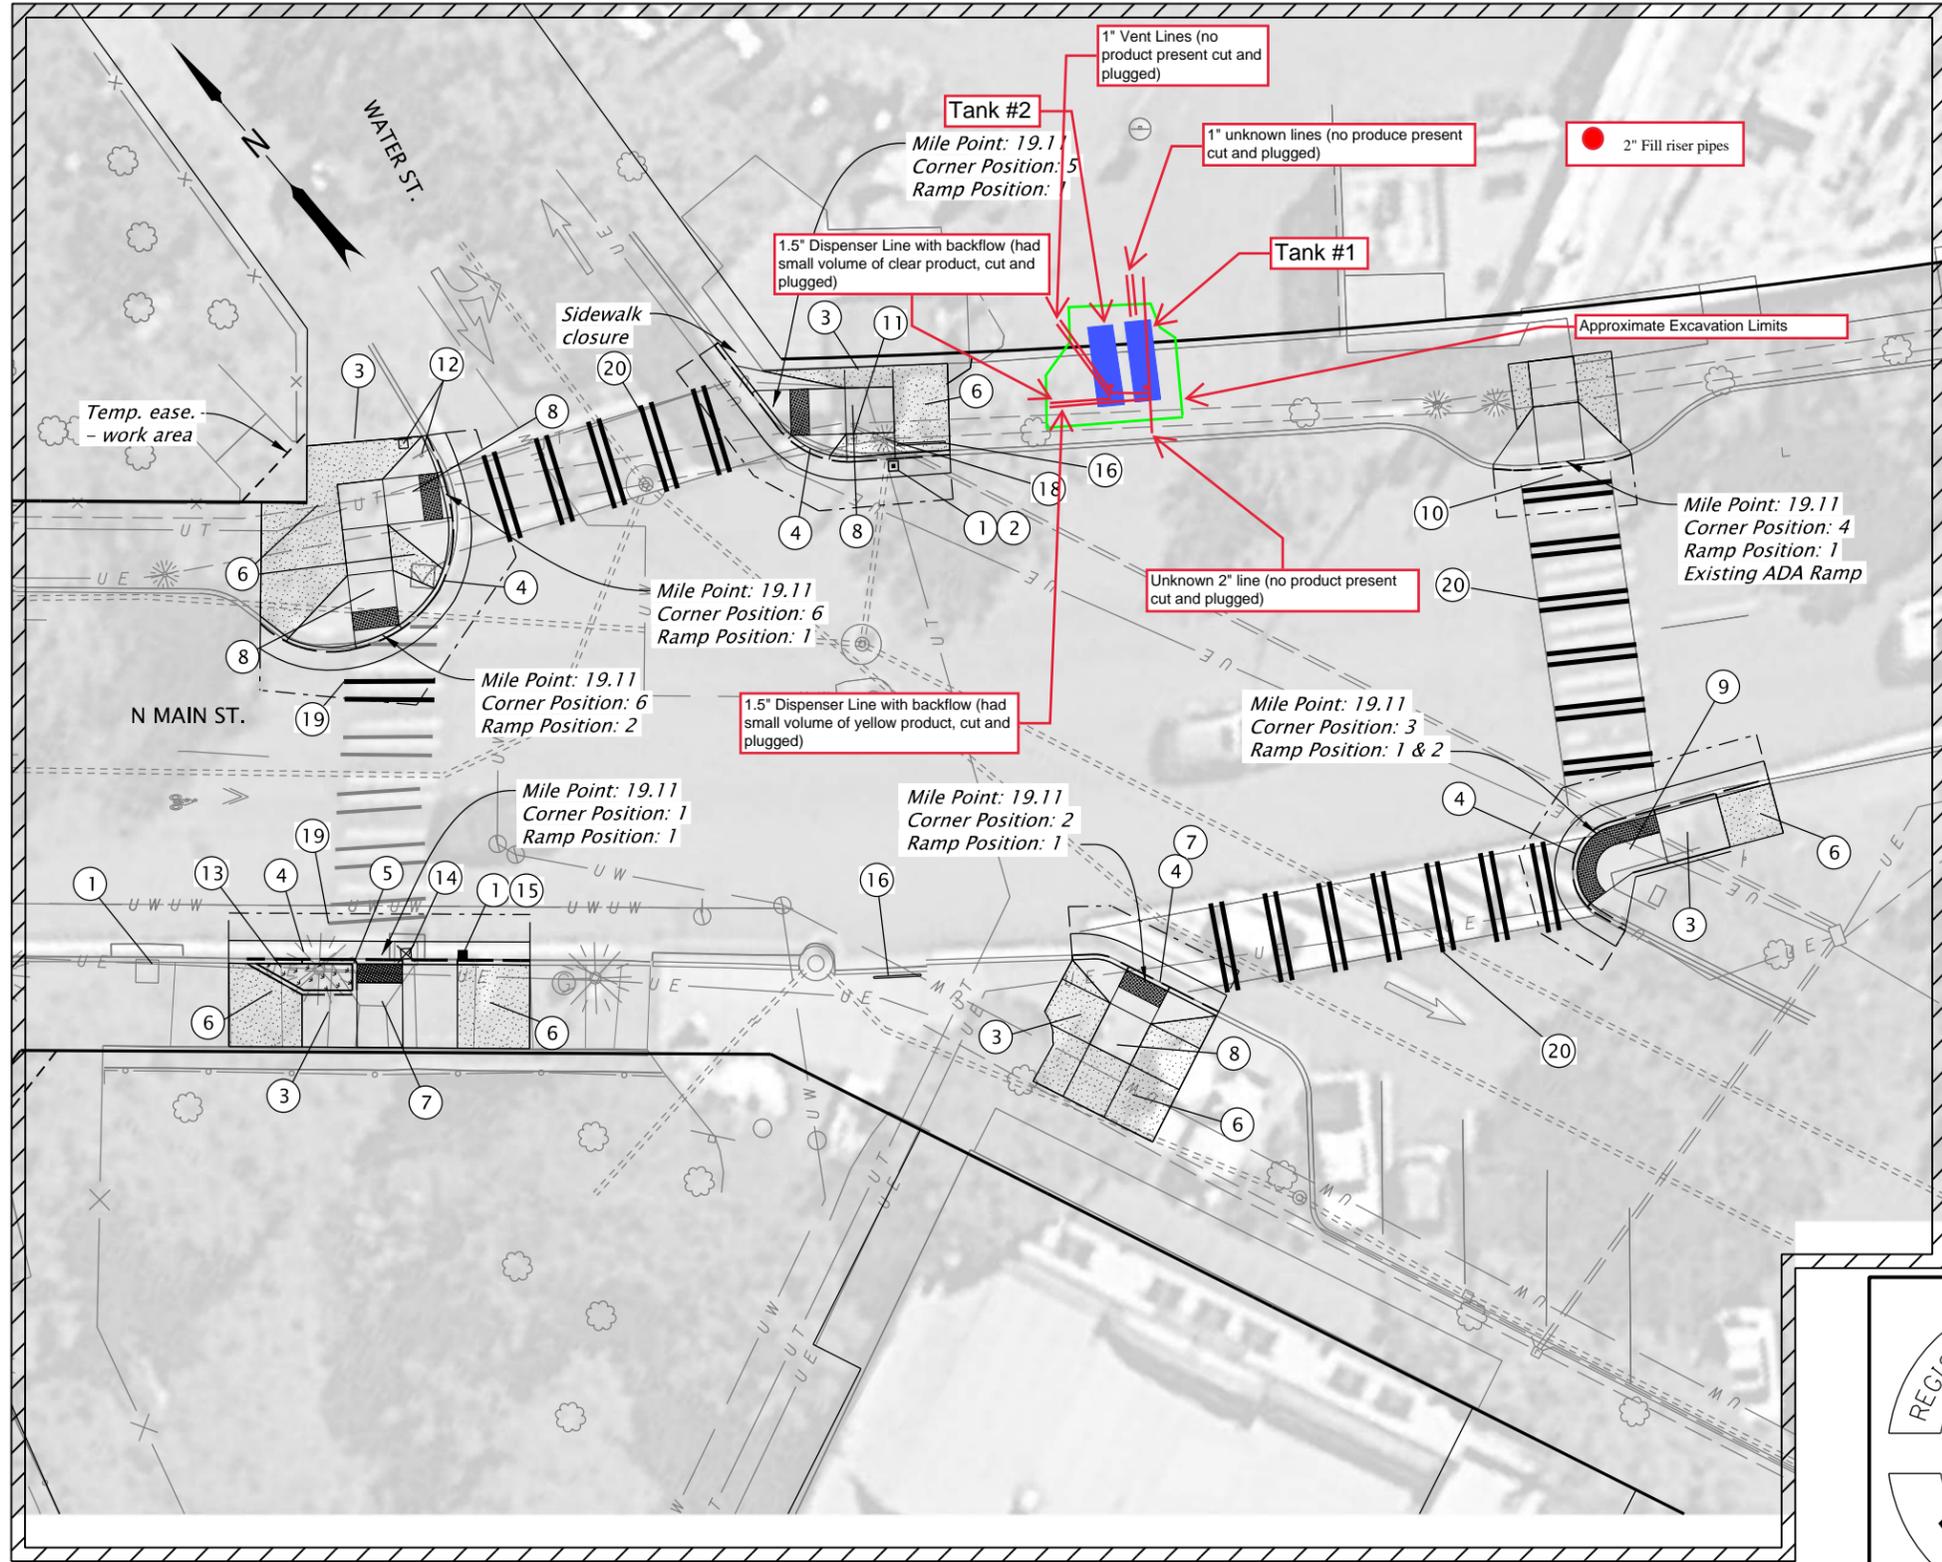
Figure 2 - Tank Location Map
 Lines and dimensions are approximate

07:40 - R3 HazMat arrived on site and WSE was defuming the tank with dry ice via the discovered riser pipe (VP1) as depicted in Figure 2 – Tank Location Map.

09:00 - Andrea Garcia of DEQ arrived on site to witness decommissioning of the tanks. Hand excavation of the tank area uncovered lateral lines and another vertical pipe (VP2) approximately four feet north of VP1. After removing vapors from VP1, the line was plugged and no air flow was observed coming from VP2, insinuating no connection between the two vertical pipes. Further excavation located four other unknown lateral pipes at the top of tank (Tank #1). Further excavation uncovered an additional tank (Tank #2) approximately one foot to the north of Tank #1. The bottom of Tank #2 was measured at 6.9 feet bgs and contained approximately 1 inch of a unknow clear product. The top of both tanks were measured at 3.9 feet bgs and based on the orientation of the exposed sidewalls, both tanks seemed to be oriented in the same direction at approximately 50 degrees NE as shown in Figure 2.

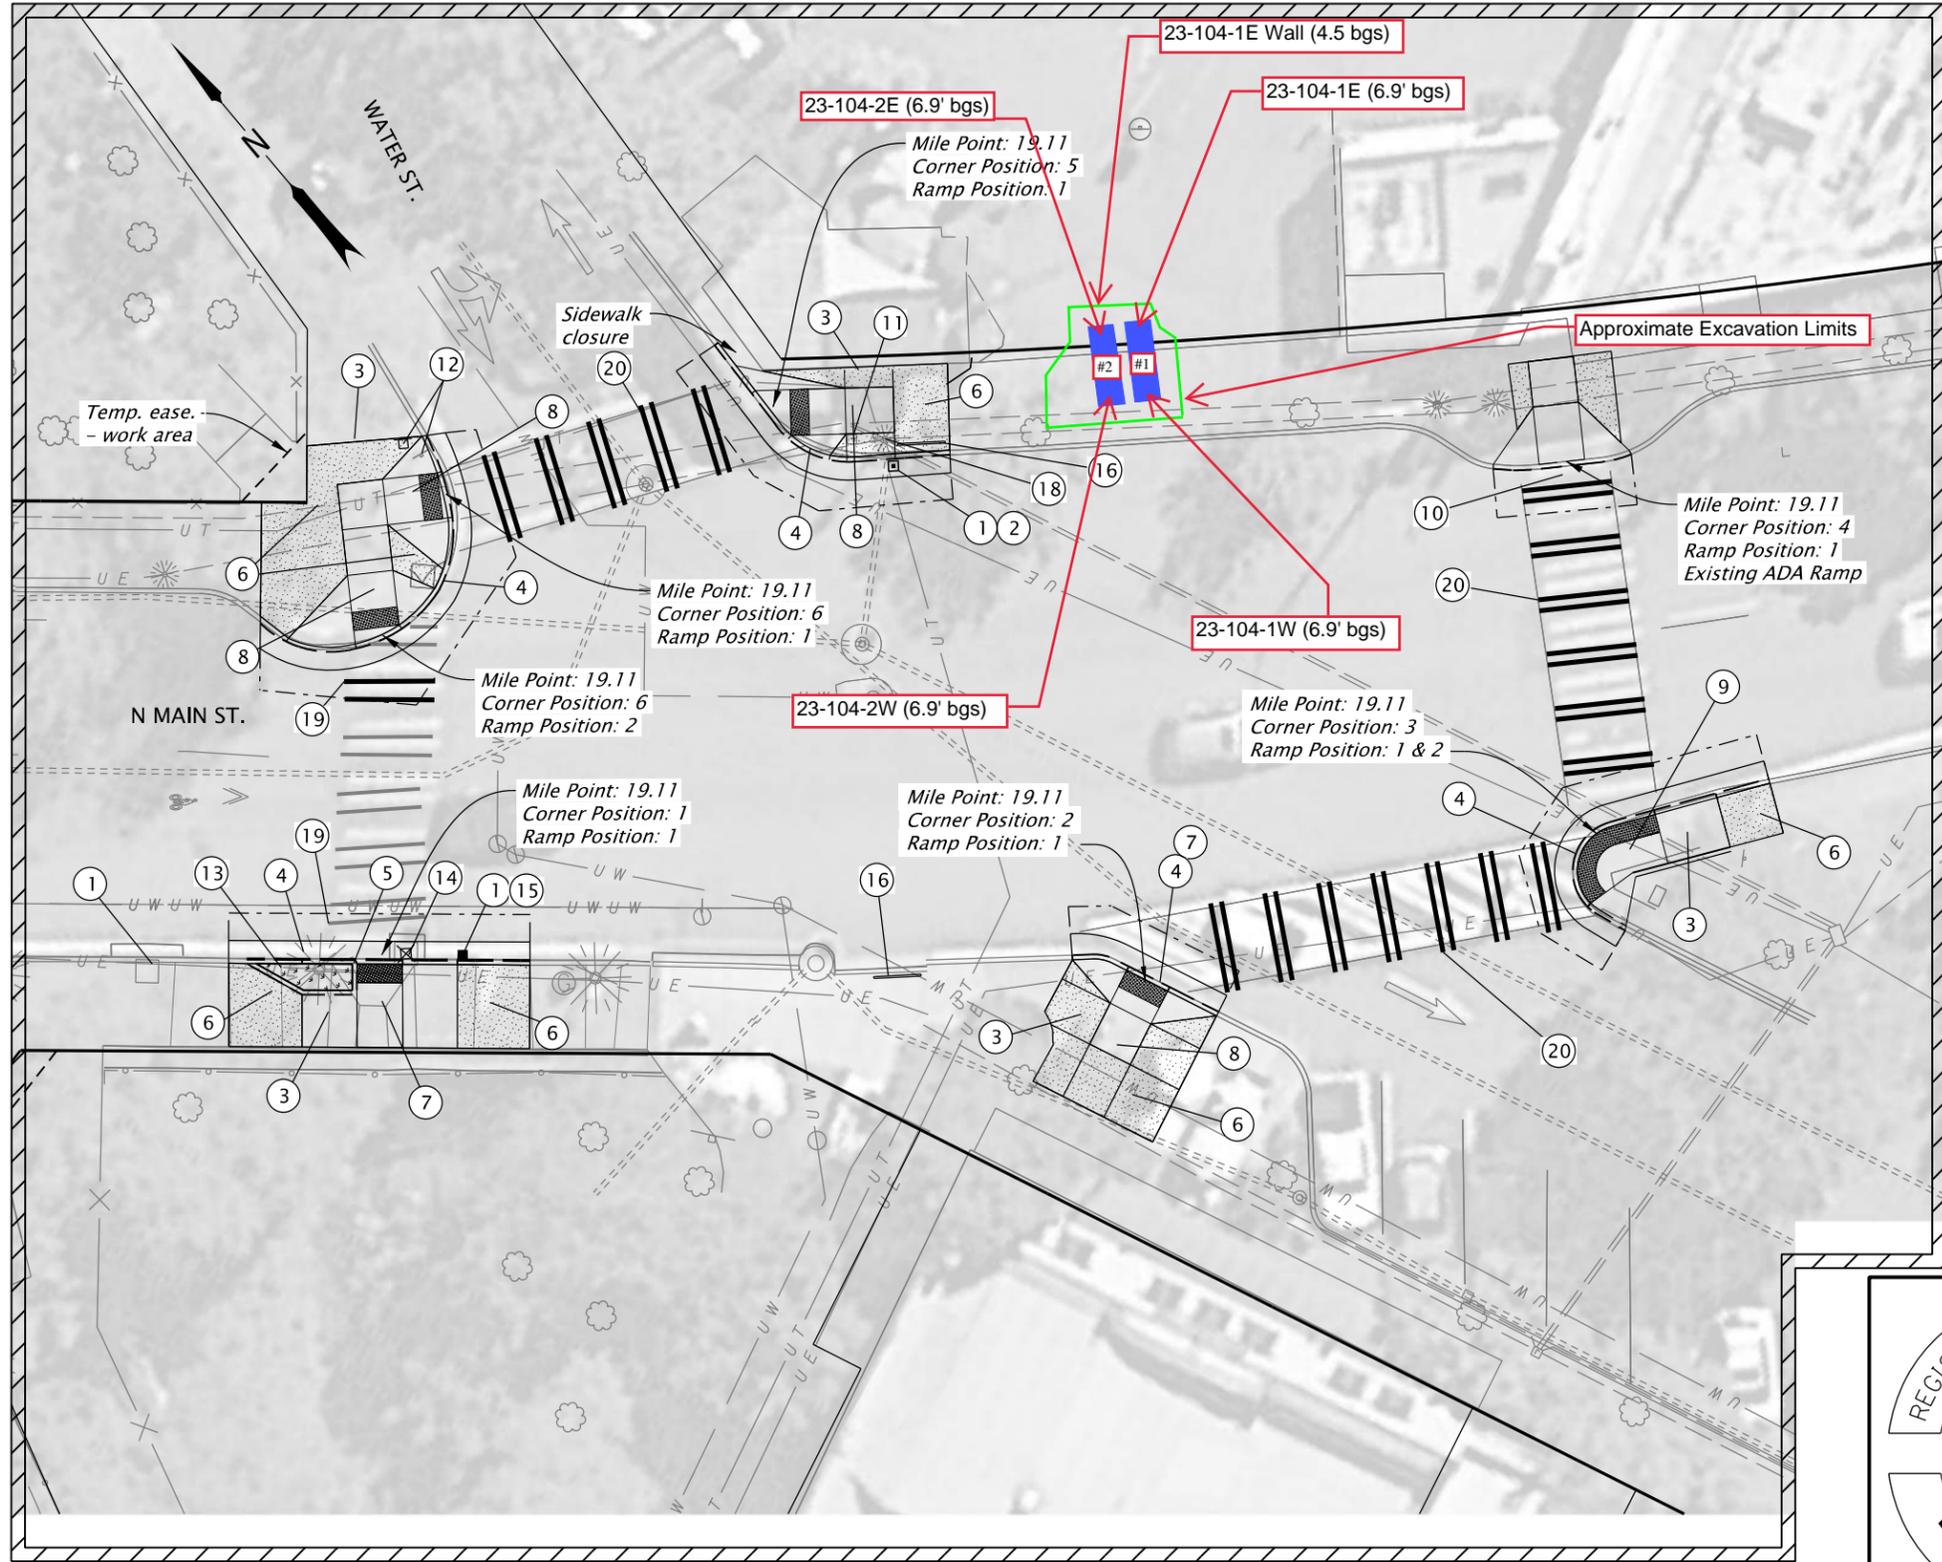
Figure 3 - Sample Location Map
 Sample locations are approximate

WSE collected five discrete soil samples from below the tank locations and the sidewalls of the excavation (see Figure 3 – Sample Location Map) OAR 340-122-0340. No staining or odor was observed in the samples and pit excavation.

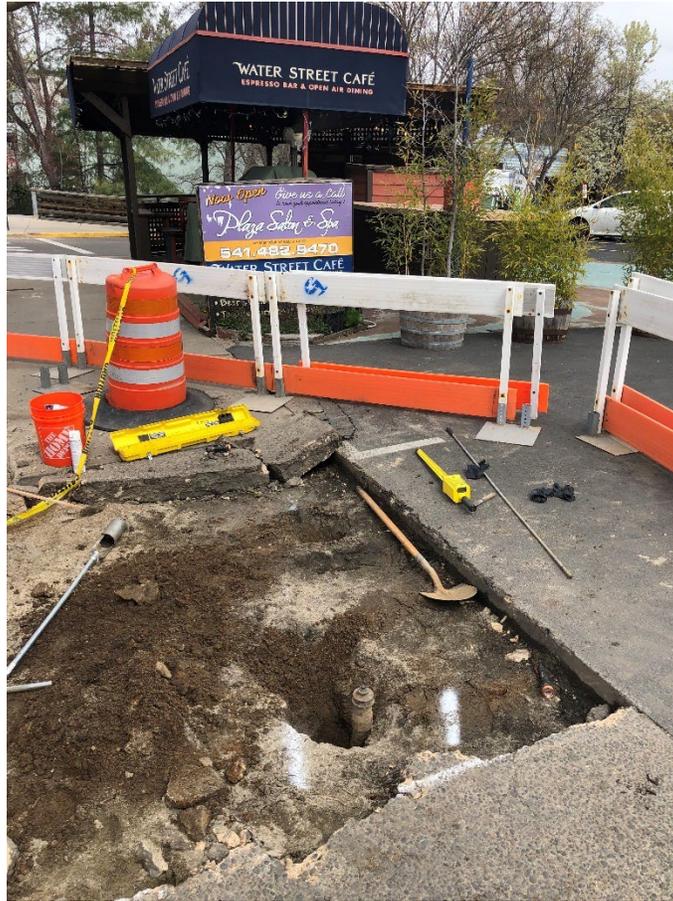
Discovered fill cap in sidewalk belonging to Tank #1 (looking North)

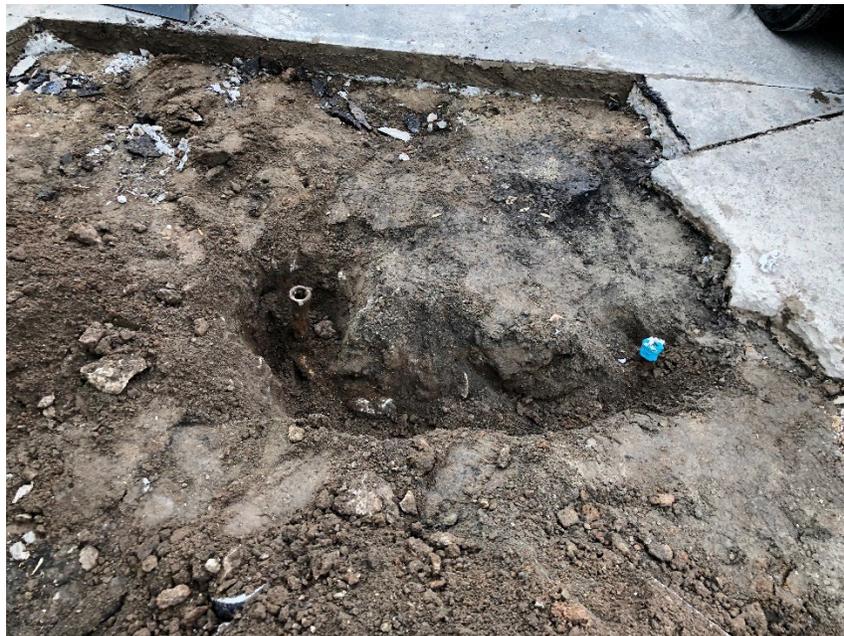
Second fill cap uncovered to the north belonging to Tank #2

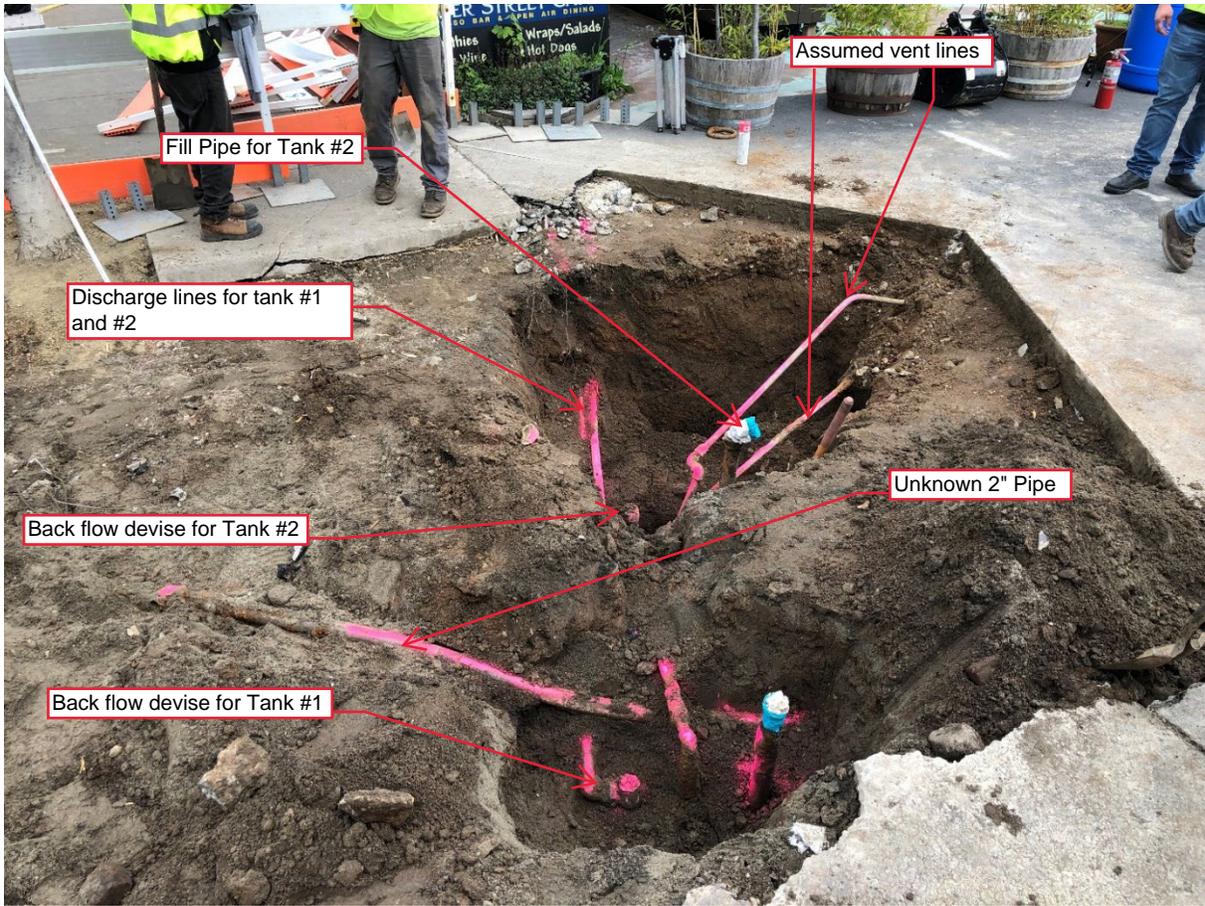
Exposed tank piping (looking North)

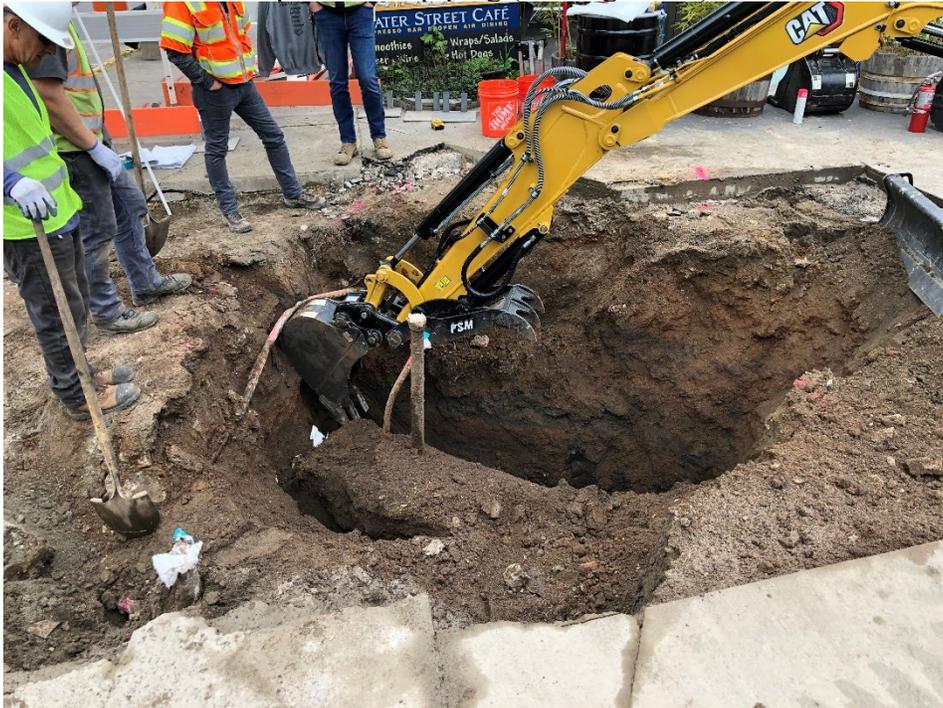
Exposed Tank #2 (looking North)

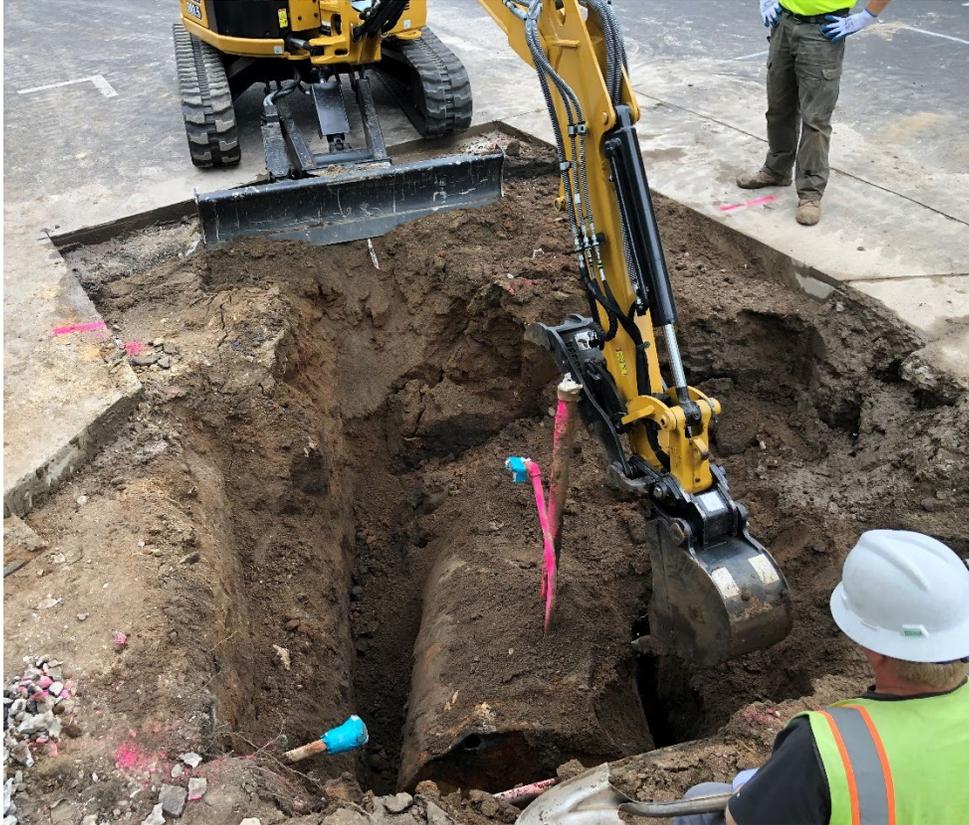
Exposed Tank #2 (looking East)

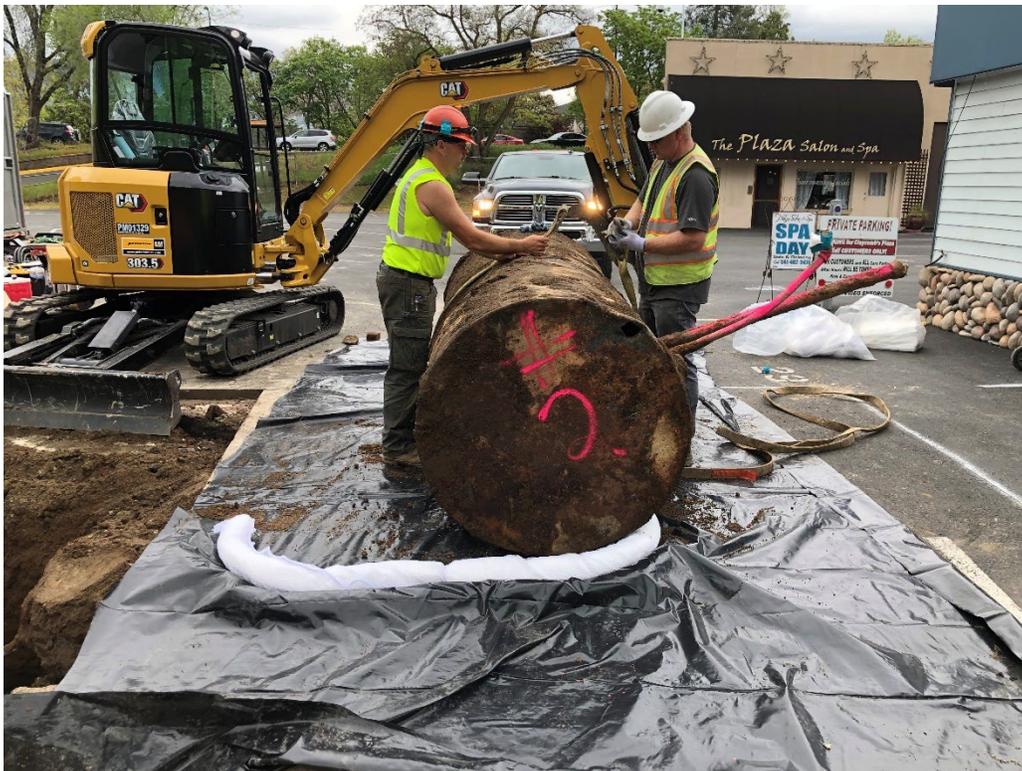
14:50 - Tank #2 was removed from the excavation and placed on plastic sheeting. The tanks dimensions were measured in the field at 8'Lx3.5'Wx3'H estimating the total capacity to be

approximately 575 gallons. No product was spilled during the removal and the tank showed no obvious signs of damage upon inspection. Soils adhered to the bottom of the tank and soil in the excavation had no obvious signs of staining or odor. Tank #2 was wrapped in plastic, placed in a dump truck and transported off-site to be properly disposed of by WSE.

Tank #2 pulled and placed on plastic

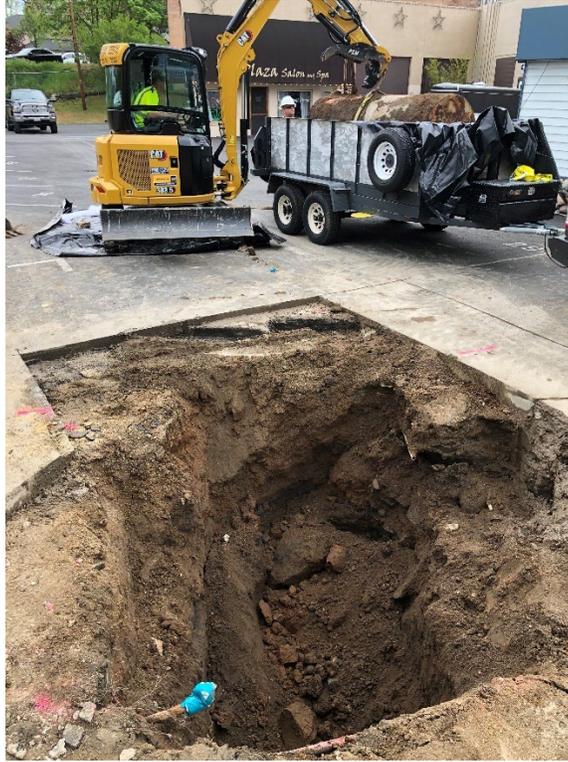
Tank #2 being hauled off site

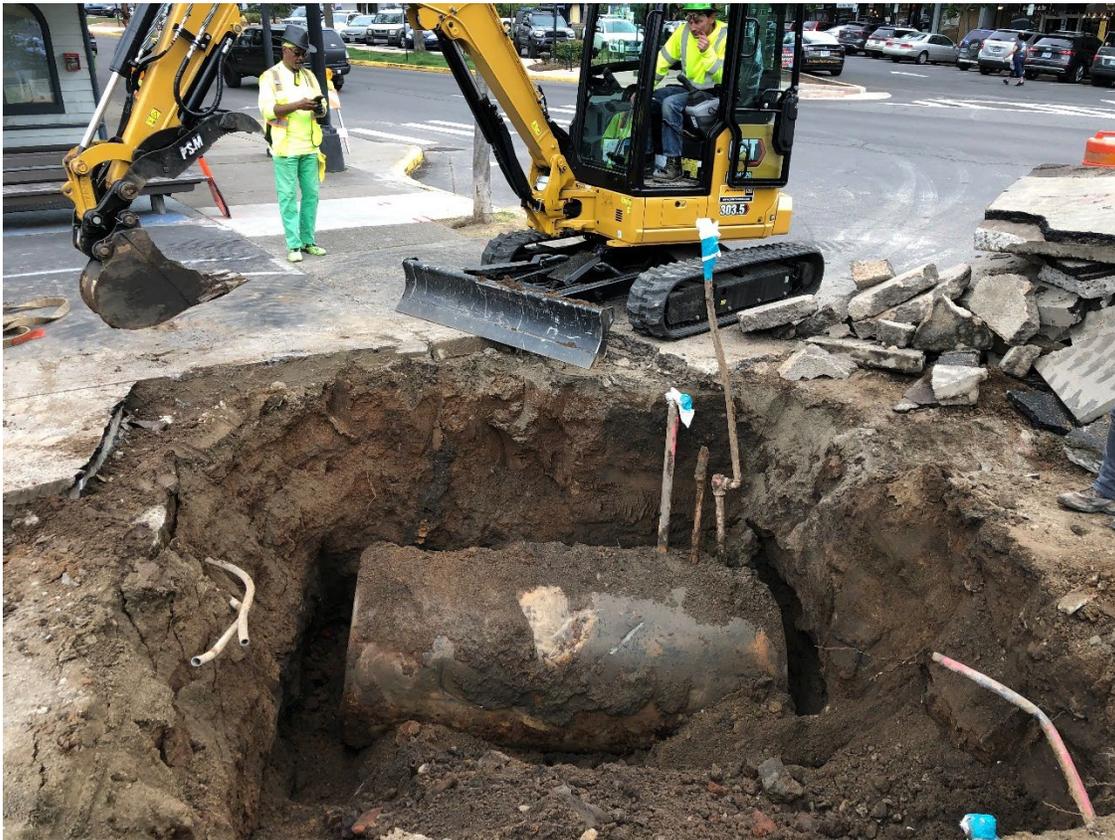
Tank #1 being exposed (looking South)

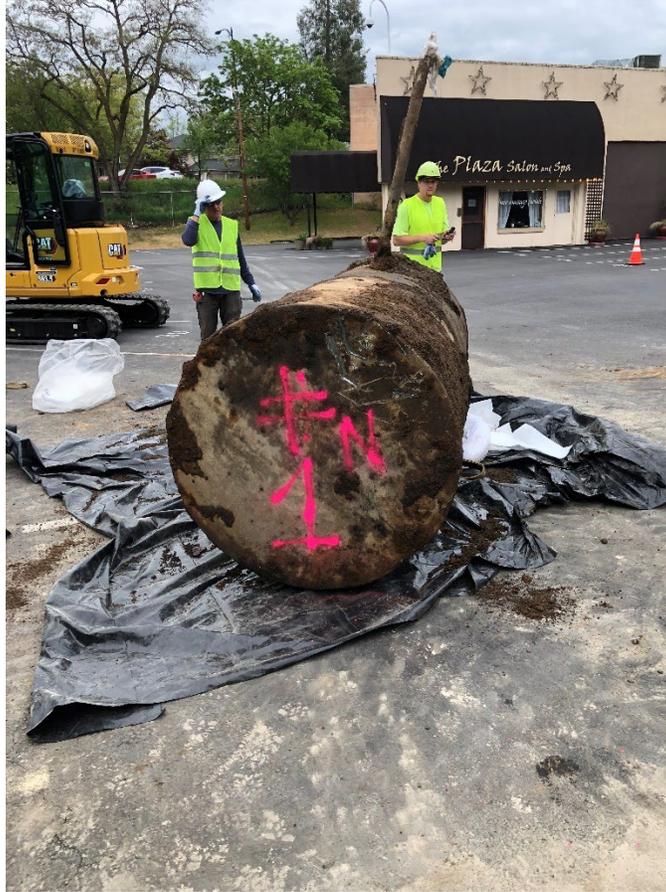
15:28 - Excavation of Tank #1 resumed and was removed from the excavation and placed on plastic at 16:38. The tanks dimensions were measured in the field to be the same as Tank #2 8'Lx3.5'Wx3'H estimating the total capacity to be approximately 575 gallons. Once the tank was placed on the plastic, a small volume (approximately 1 gallon) leaked from one end of the tank and was contained on the plastic and cleaned up with paper towels. One small corrosion hole in the bottom of the Tank #1 was observed and the rest of the tank appeared in good condition. Tank #1 was wrapped in plastic, placed in a dump truck and transported off-site to be properly disposed of by WSE. An additional 7 yards of loose dirt was excavated from the pit and transported to an off-site stockpile location to be scheduled for disposal. The final UST excavation was approximate 15'x12'x7', groundwater was never encountered in the excavation, and all piping was cut and plugged. Once samples had been collected from the excavation, site photos were taken, and site sketches of the open pit had been completed the excavation was backfilled with a 1 sack slurry mix.

Tank #1 pulled and set on plastic (looking East)

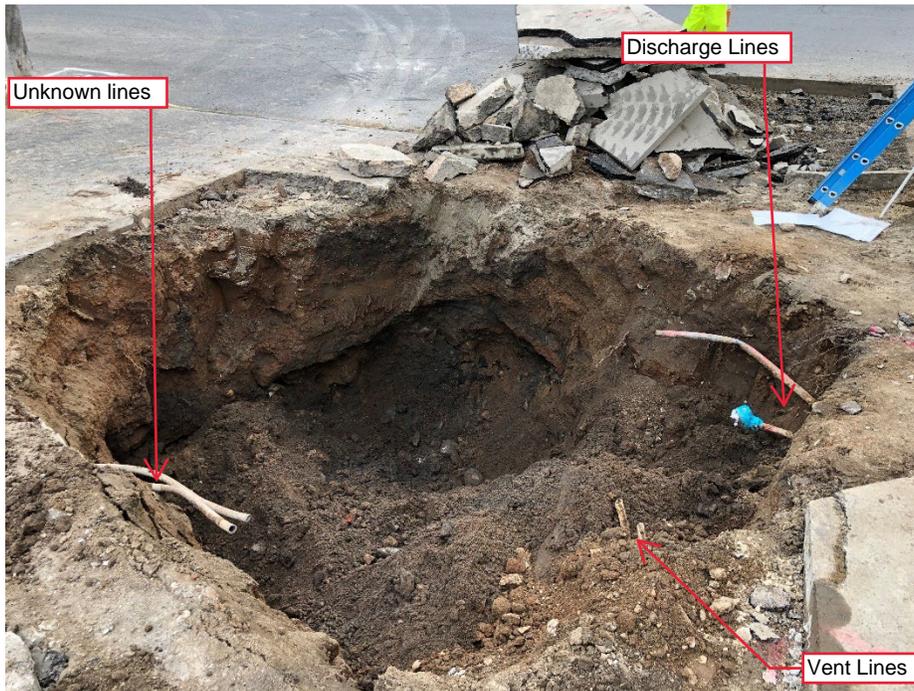
- After the two tanks and soil for the UST excavation had been removed no soil staining or odor was observed on the side walls and bottom of the excavation.

Pit after both tanks were removed
