RE: UST Compliance Inspection  
Circle K #9644, Florence OR  
**DEQ UST #713**

Oregon Department of Environmental Quality - Underground Storage Tank Program  
Technical Compliance Inspection - UST Inspection Report

Field Citation  
For UST Violations

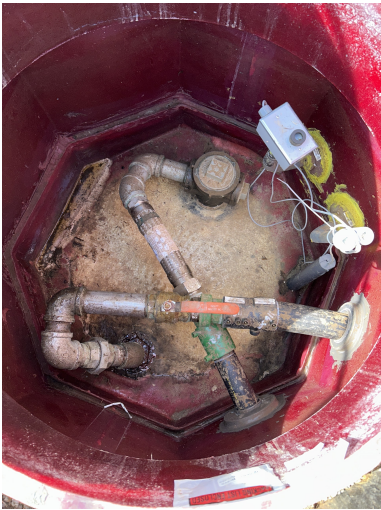
1. The sensors in the sumps were not in the lowest parts of the sumps

Three of your STP sumps had liquid in them, and the sensors were all placed away from where the liquid was collecting.

The corrective actions for these violations are due July 7, 2025.

- 1) Submit photographic proof that the liquid has been removed from the STP sumps and all sensors are positioned in the lowest part of the sumps
- 2) Submit photographic proof that the interstitial opening in the diesel STP sump is open
- 3) Submit photographic proof that the interstitial opening in UDC 7/8 is open
- 5) Submit a passing CP test
- 6) Submit a passing overfill test that includes measurements to support the determination. I've attached a test document to use
- 8) Submit passing hydrostatic tests for all of your non-vapor spill buckets that follow a nationally-recognized code of practice such as the PEI RP-1200
- 9) Submit passing hydrostatic tests for all of your containment sumps that follow a nationally-recognized code of practice such as the PEI RP-1200
