# Moore and Wright Islands Natural Area Sediment Cleanup

Columbia Slough Watershed Council: Quarterly Update

Sarah Miller and Heidi Nelson  
Oregon Department of Environmental Quality

October 8, 2025

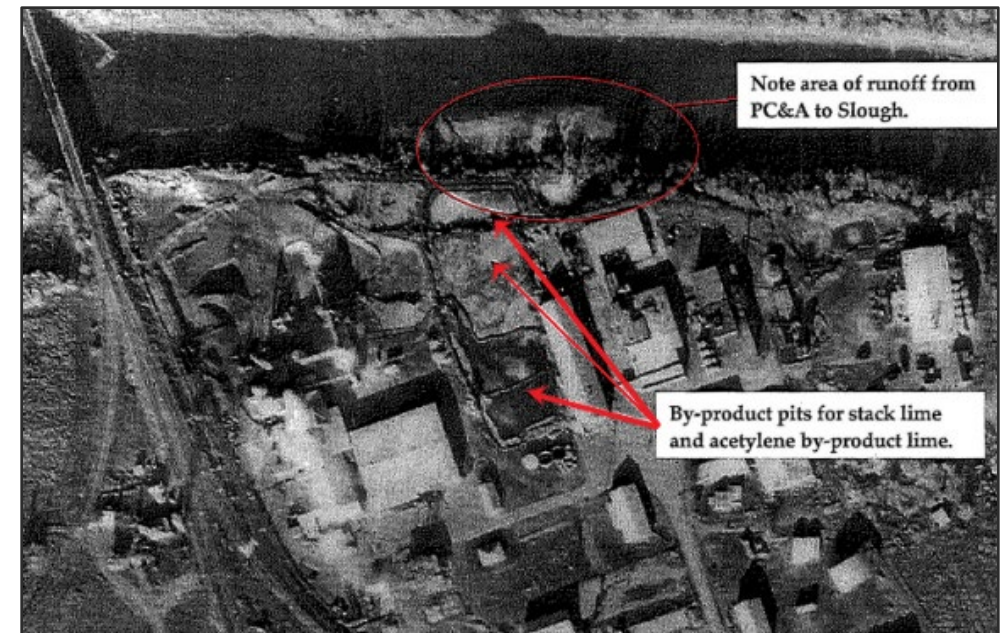
# Pacific Carbide Site Background

- Calcium carbide manufacturing plant (1940s-1987)
- Wastes stored onsite settling basins adjacent to slough
- Discharge pipes and bank failures between basins and slough prior to 1970s
- Contaminants: PAHs, PCBs, metals,  
pH and significant calcium
- 2003 enters DEQ VCP
- Upland source control in 2013
  - RP settled for in-water impacts
- 2015-DEQ investigation & design
- 2023-Orphan declared in adjacent sediments

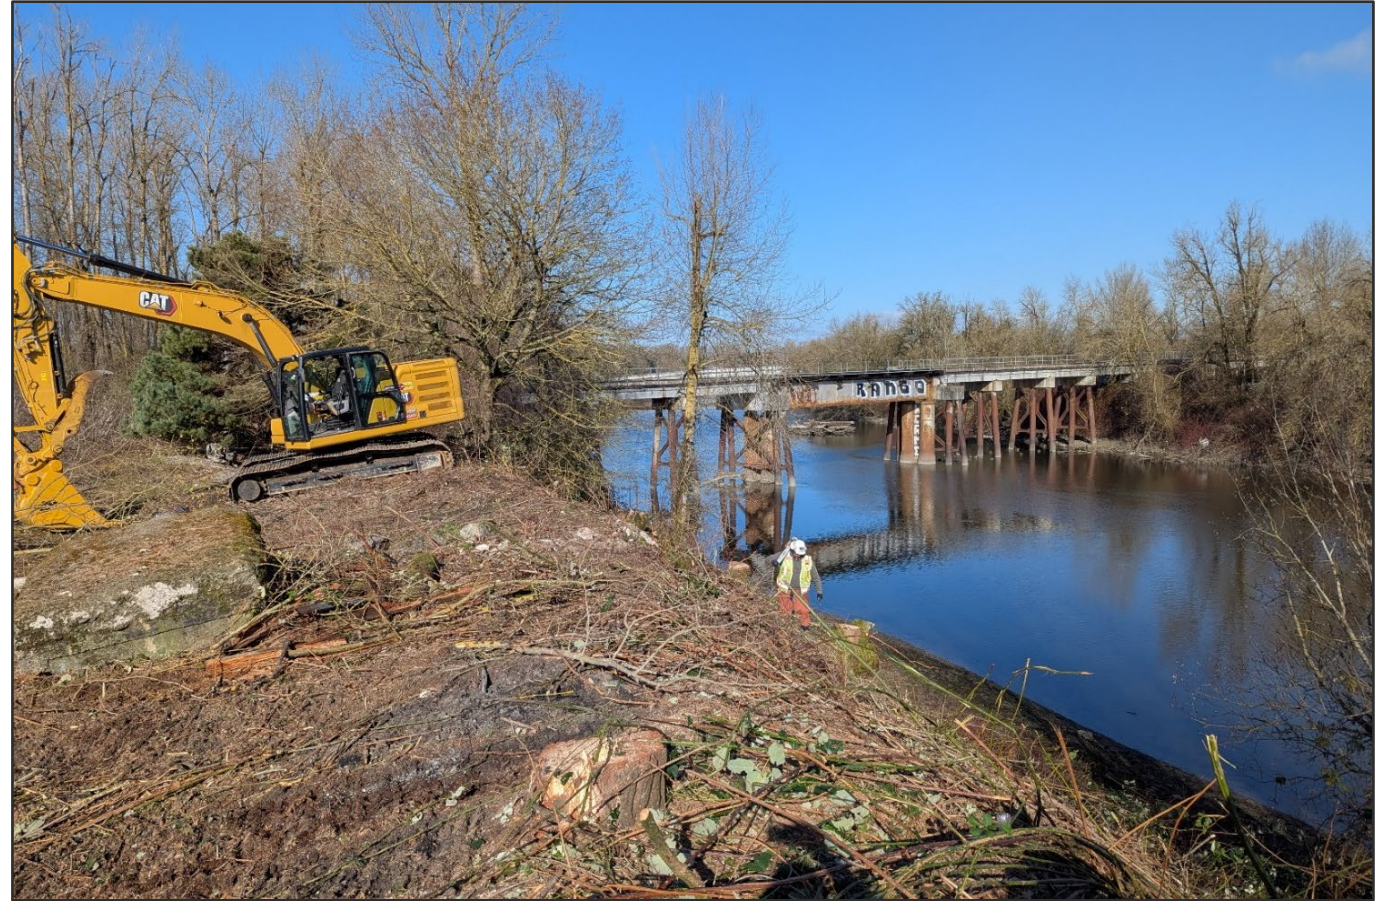
# March 2025 – Site Prep Work Completed

- Installed erosion controls
- Installed tree protection fencing at bank boundaries
- Cleared vegetation flush to ground surface to reduce chances of nesting birds
- Applied seedless hydro-mulch to stabilize the bank and prevent erosion
- Stockpiled cut logs on-site for reuse in future habitat and bank restoration efforts

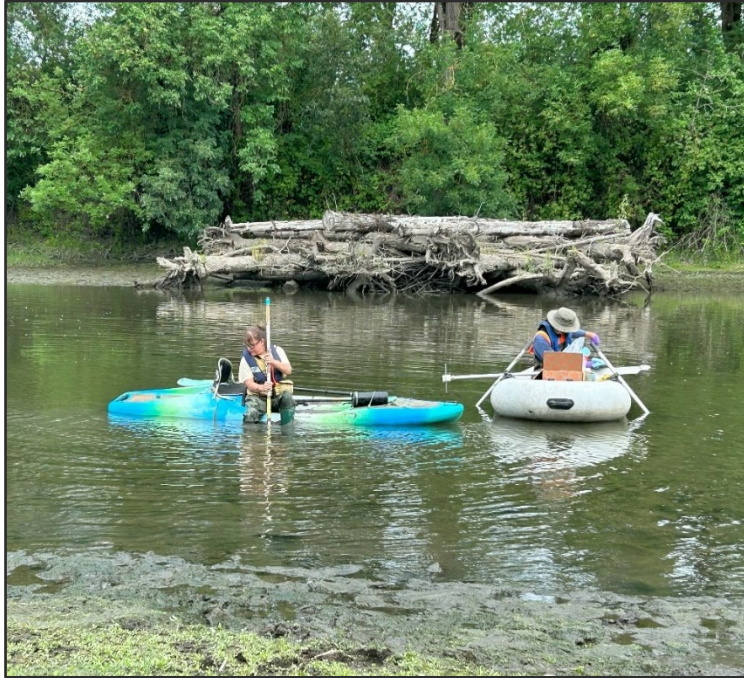
# Pre-Construction Work – Benthic Survey

## Spring round of benthic monitoring

5 Locations:

SL-1, SL-2, SL-3/Dup,  
SL-4, SL-5/Dup

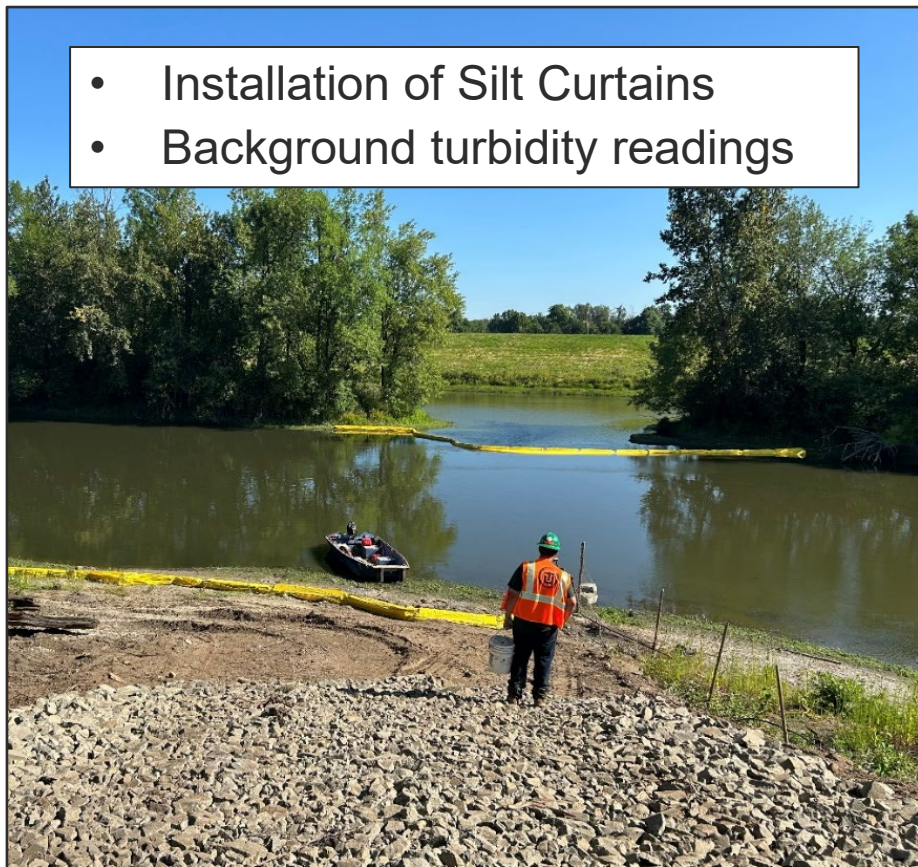
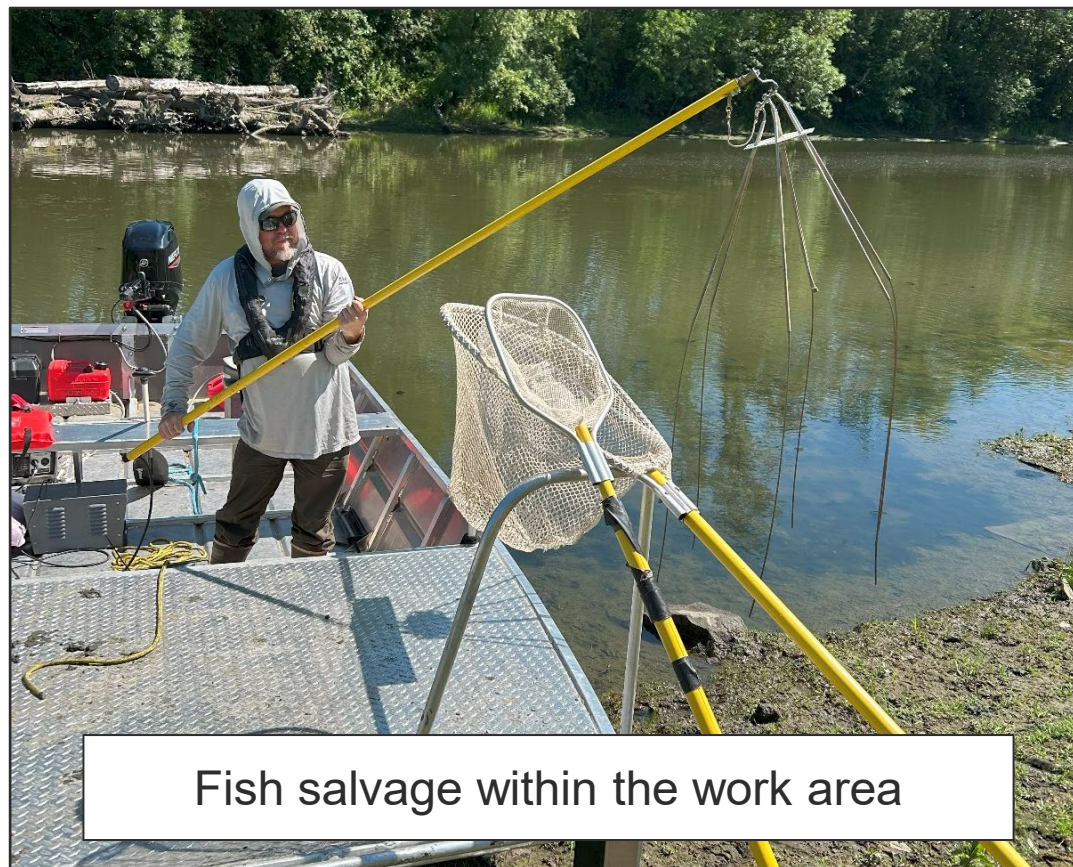
# Pre-Construction Work – BMPs and Fish Salvage

- Installation of Silt Curtains
- Background turbidity readings

Fish salvage within the work area

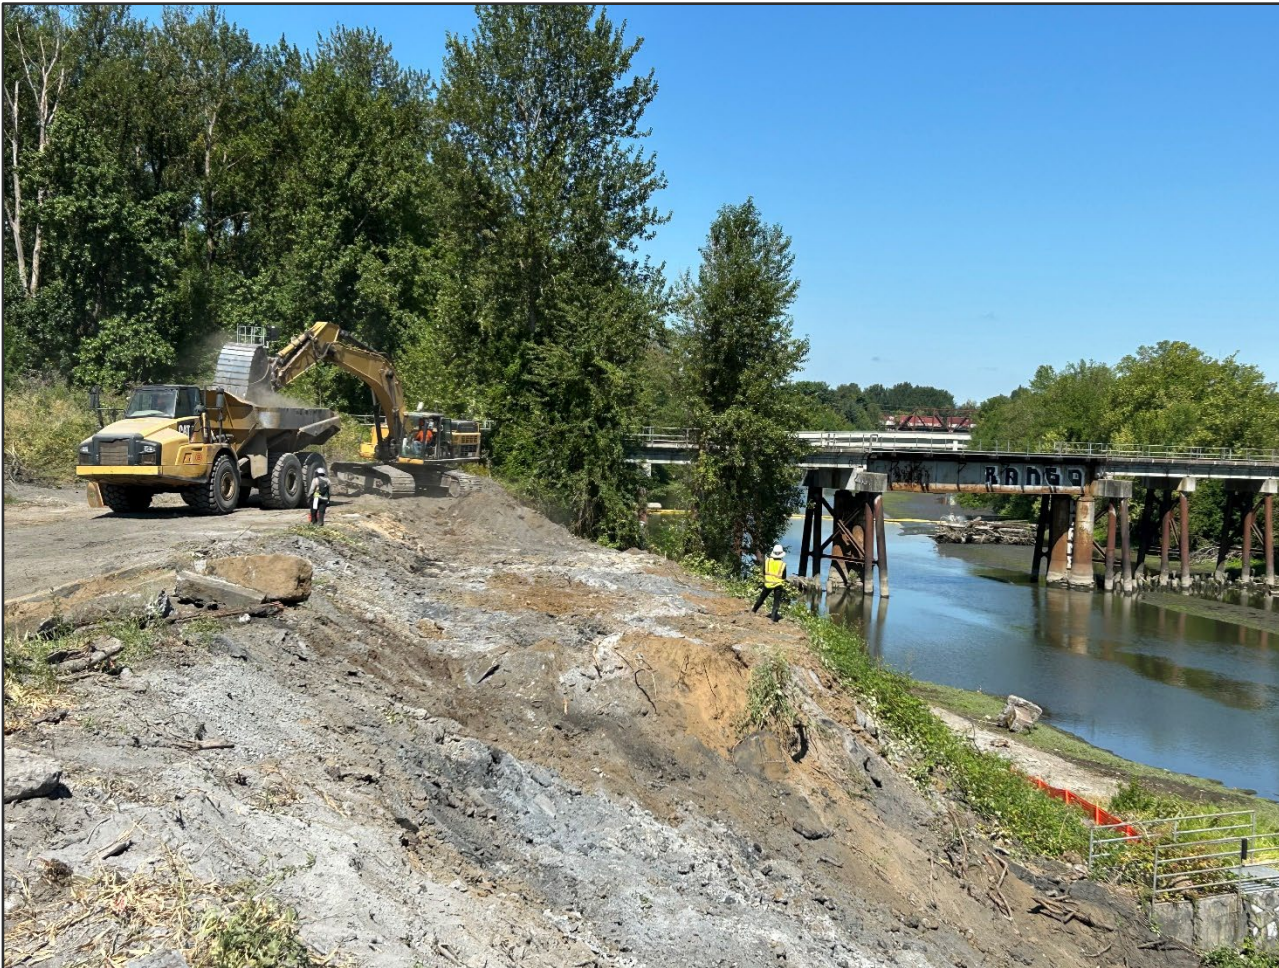
# Bank Soil Removal

- Above ordinary high water (line of the orange silt curtain)
- Reduce slopes
- Create additional flood storage (cut/fill balance)
- Removed about 2,600 yards (residually impacted soil)

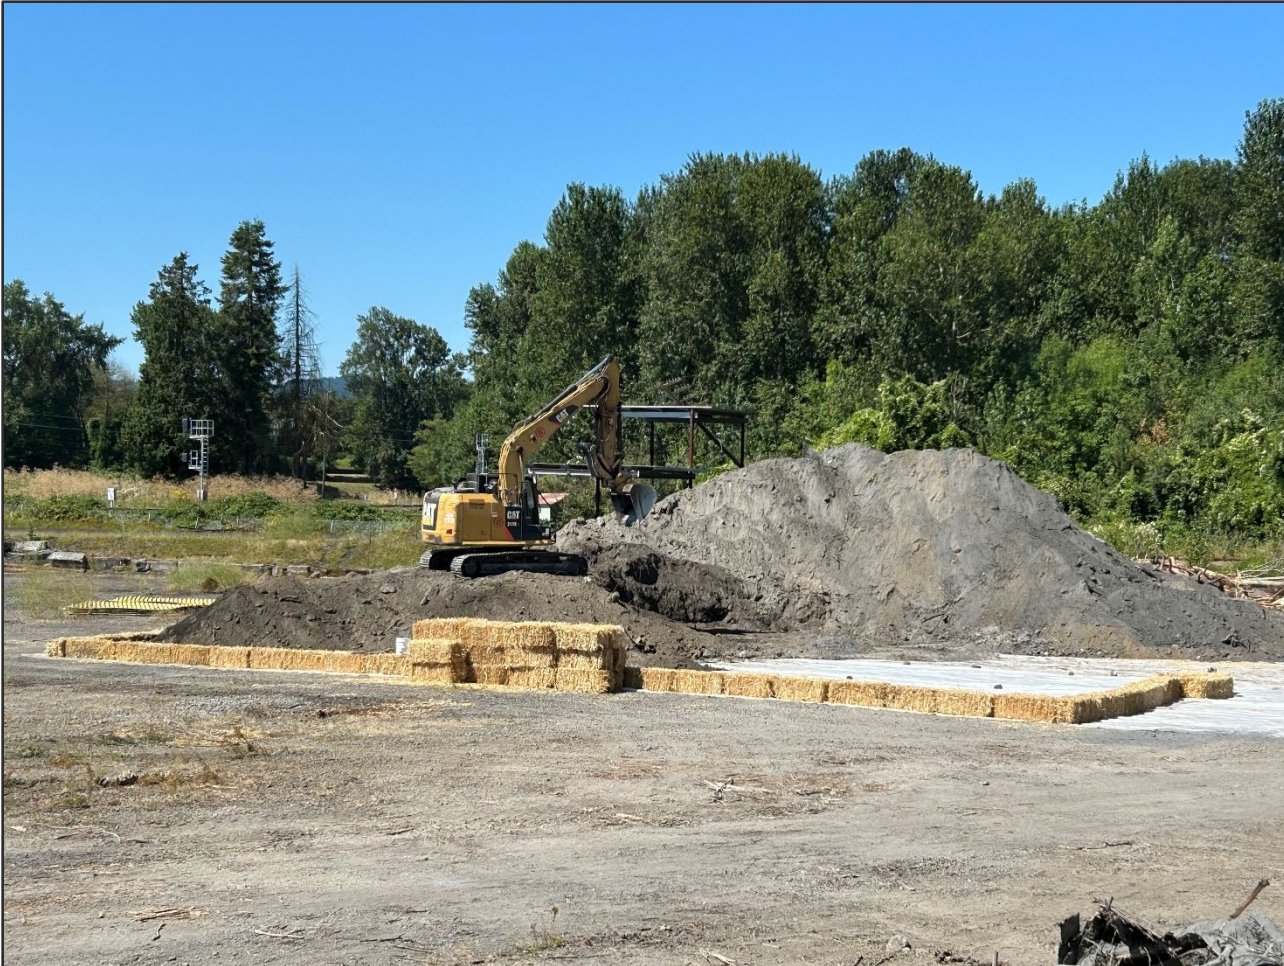
# Soil Stockpiling and Management

- Stockpile management area
  - Lined
  - Bermed
  - Covered when not actively placing soil
- Material profiled as non-hazardous waste
- Material transported off-site to Wasco County Landfill for disposal

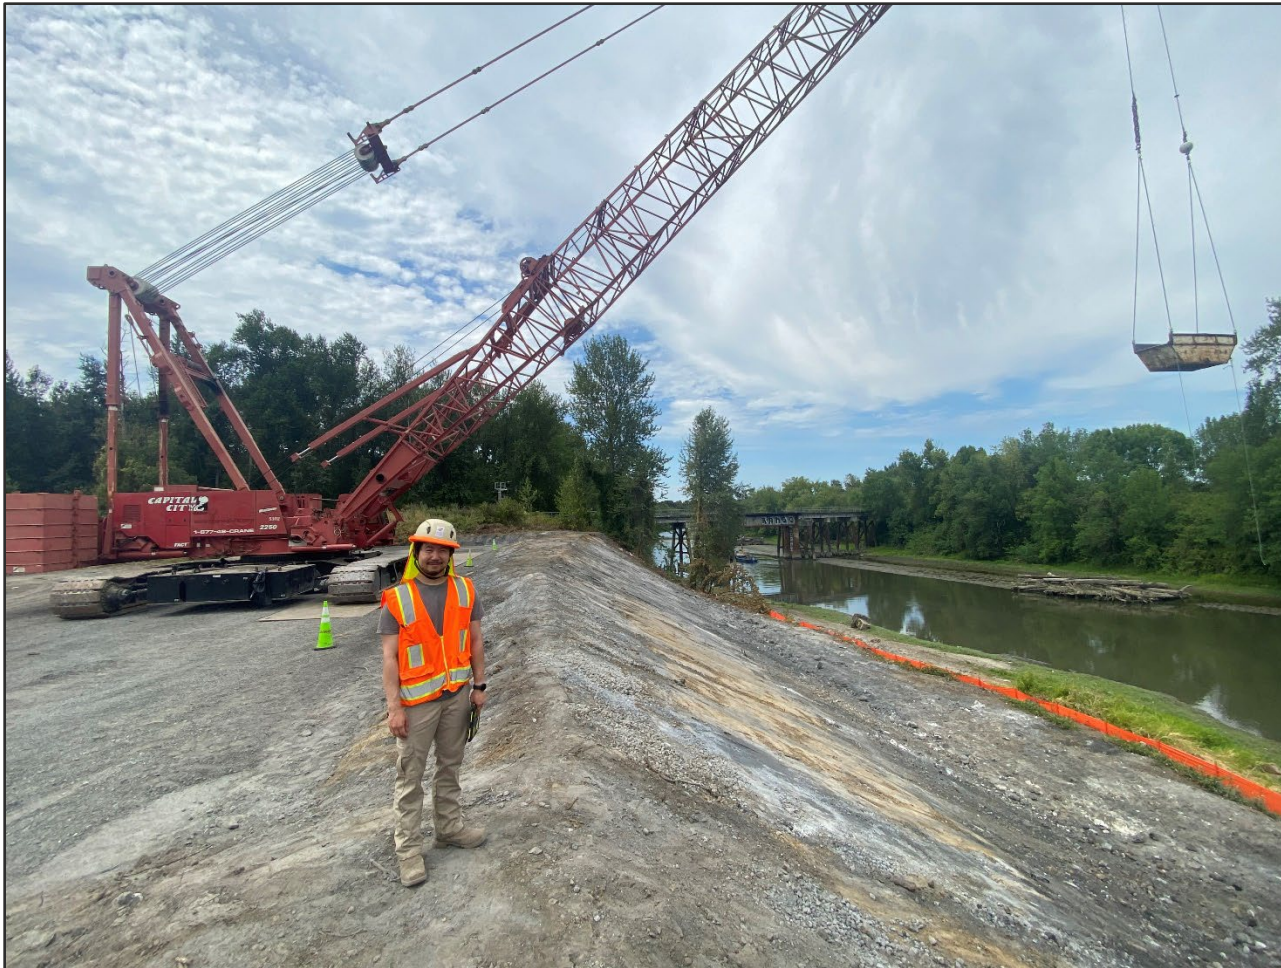
# Graded Bank

- Final bank slope 2:1
  - Stable bank and lowered erosion potential
  - Easier access for animals moving within this habitat corridor (island and downgradient trails and natural areas near Smith and Bybee)
- Ready for additional top-soil and native plantings

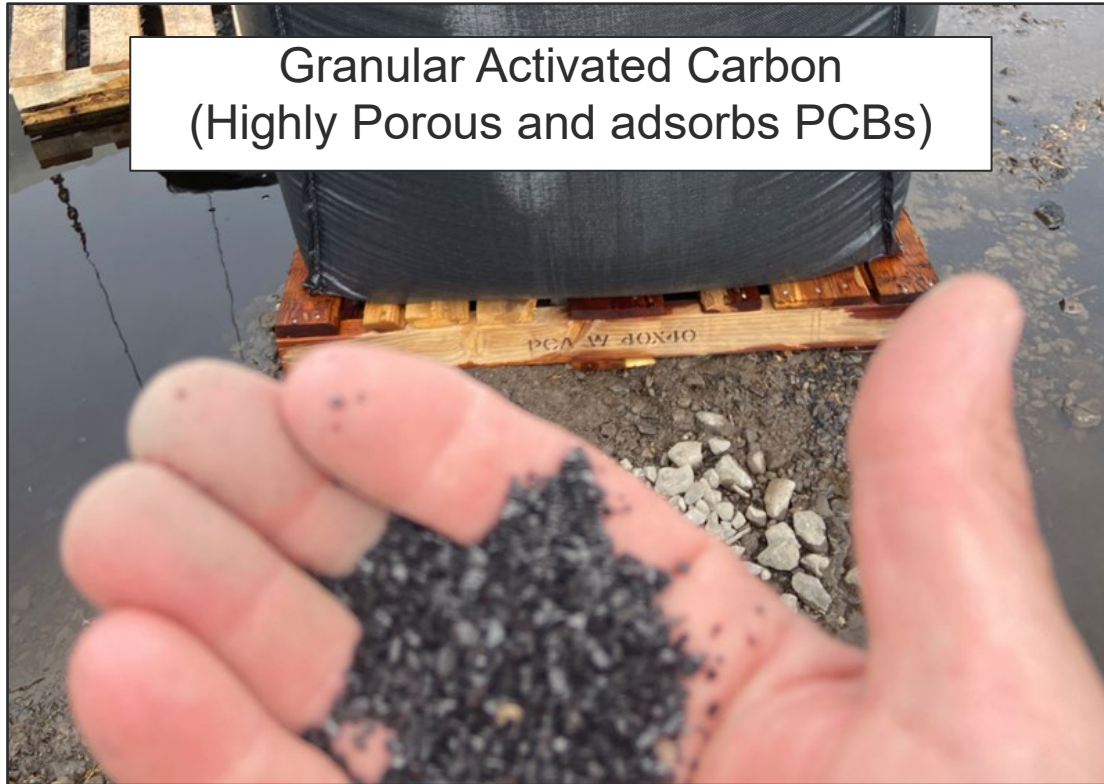
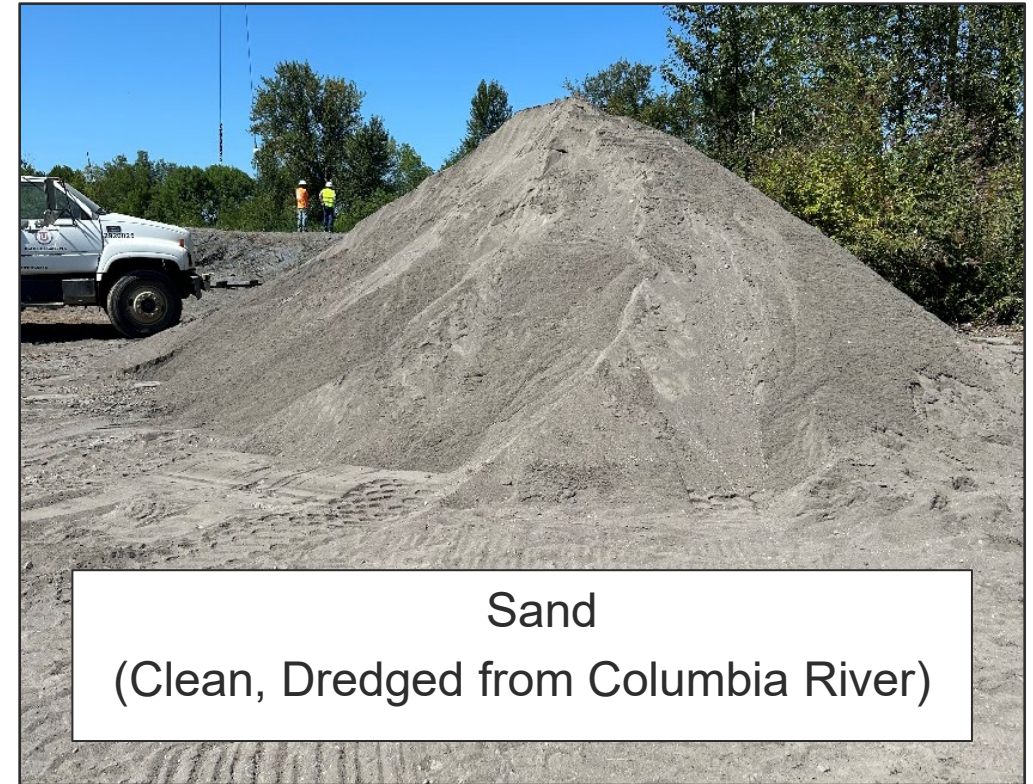
# Amended Sand Cap Materials

- GAC is placed in water to hydrate
- Sand is added to GAC
- Mix ratio is 5% GAC to Sand
- Excavator combines in hopper
- Hopper is transferred by the crane to the overwater barge
- GAC is placed on the surface using a bark spreader

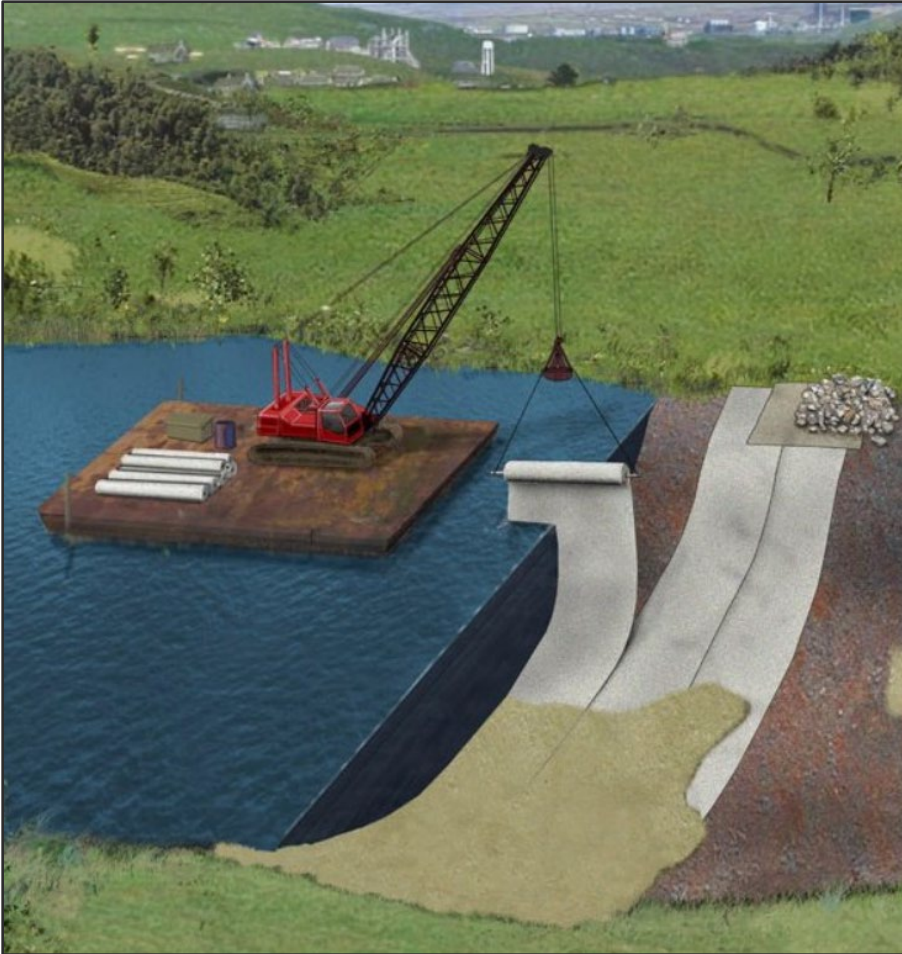
# Reactive Core Mat Overview

Placement area with schematic of  
how the panels are laid down.

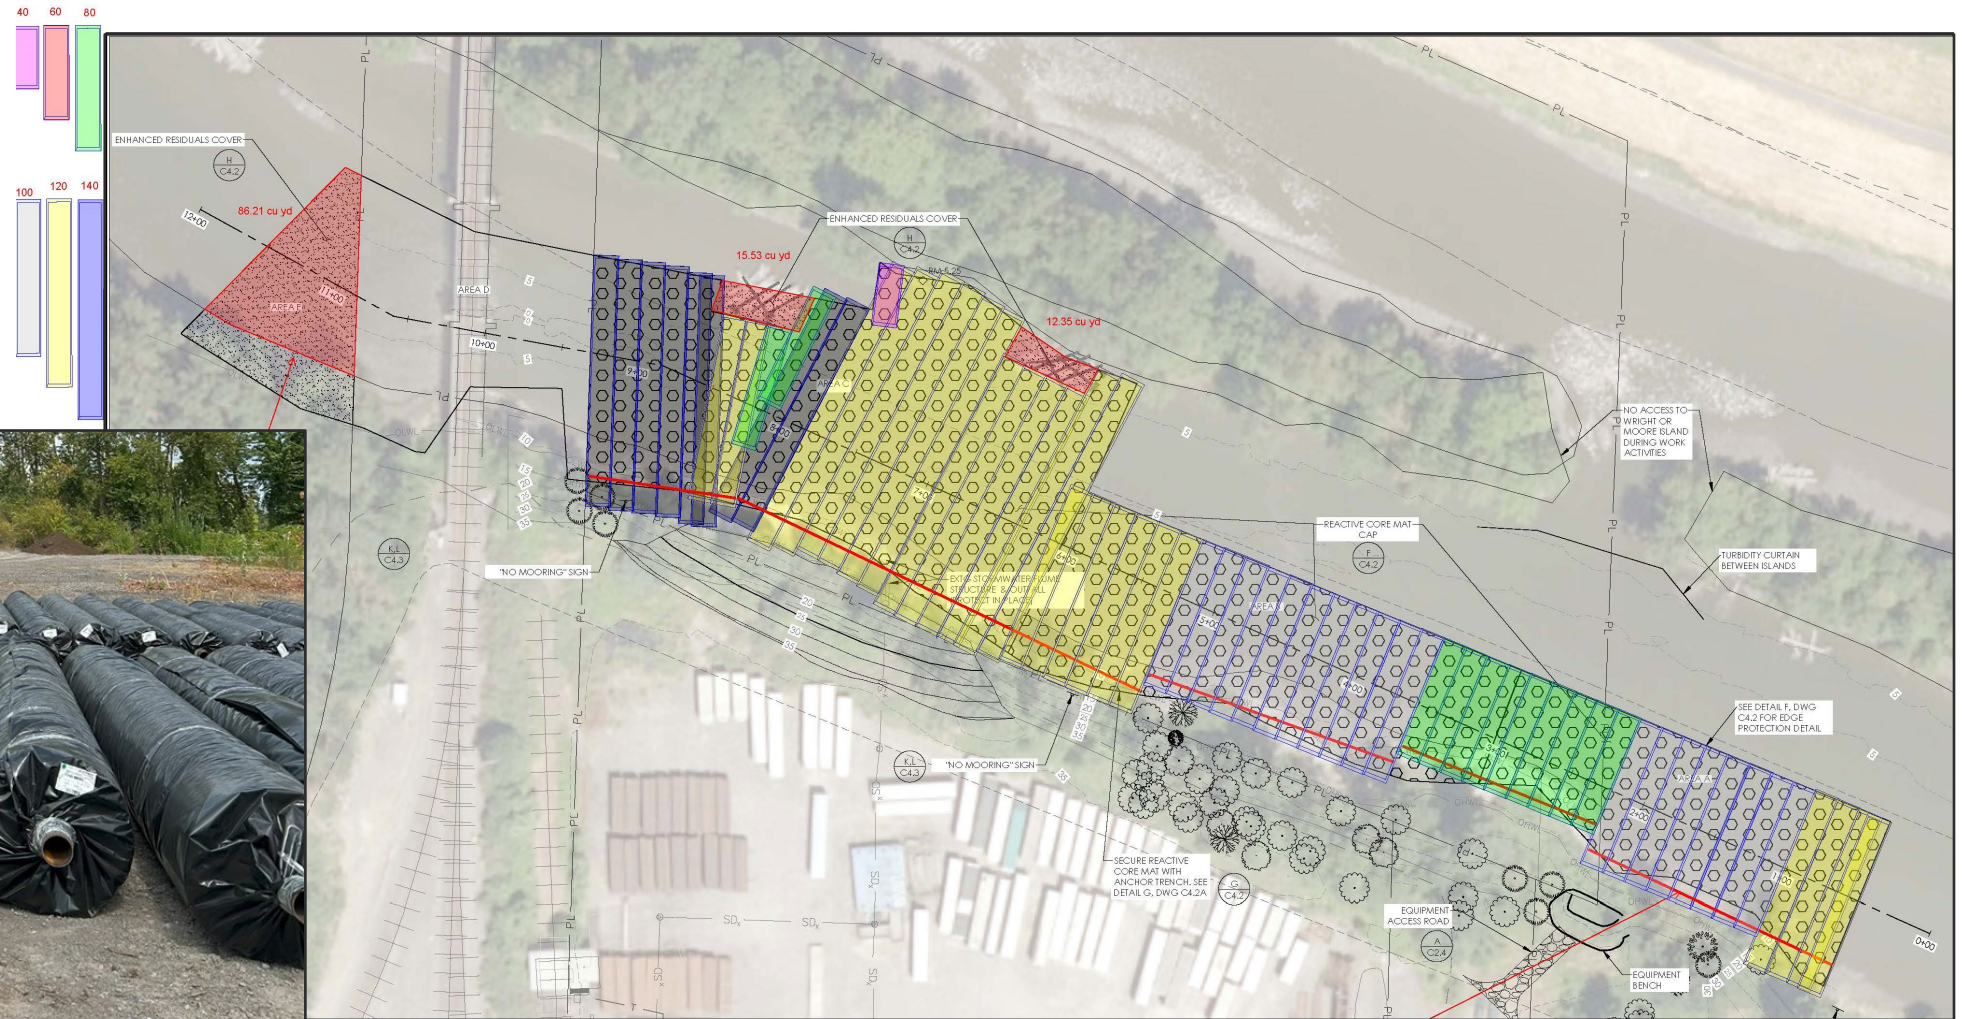
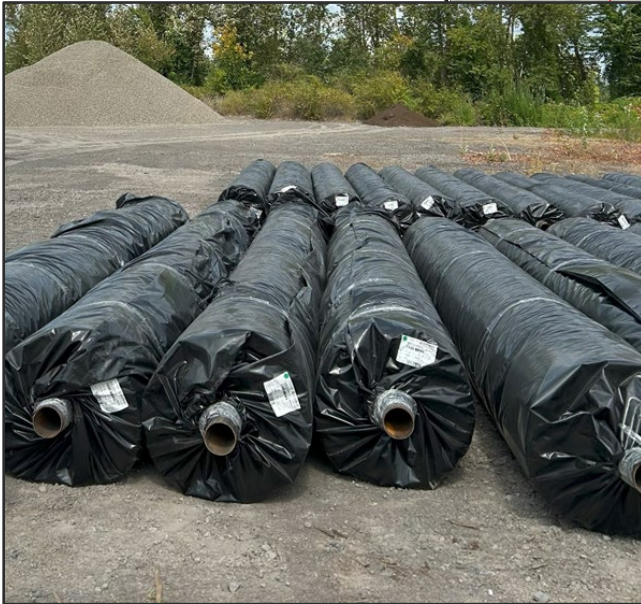
# Reactive Core Mat Panel Layout

Pre-cut panels delivered to the site, ranging in size from 40 to 200 feet

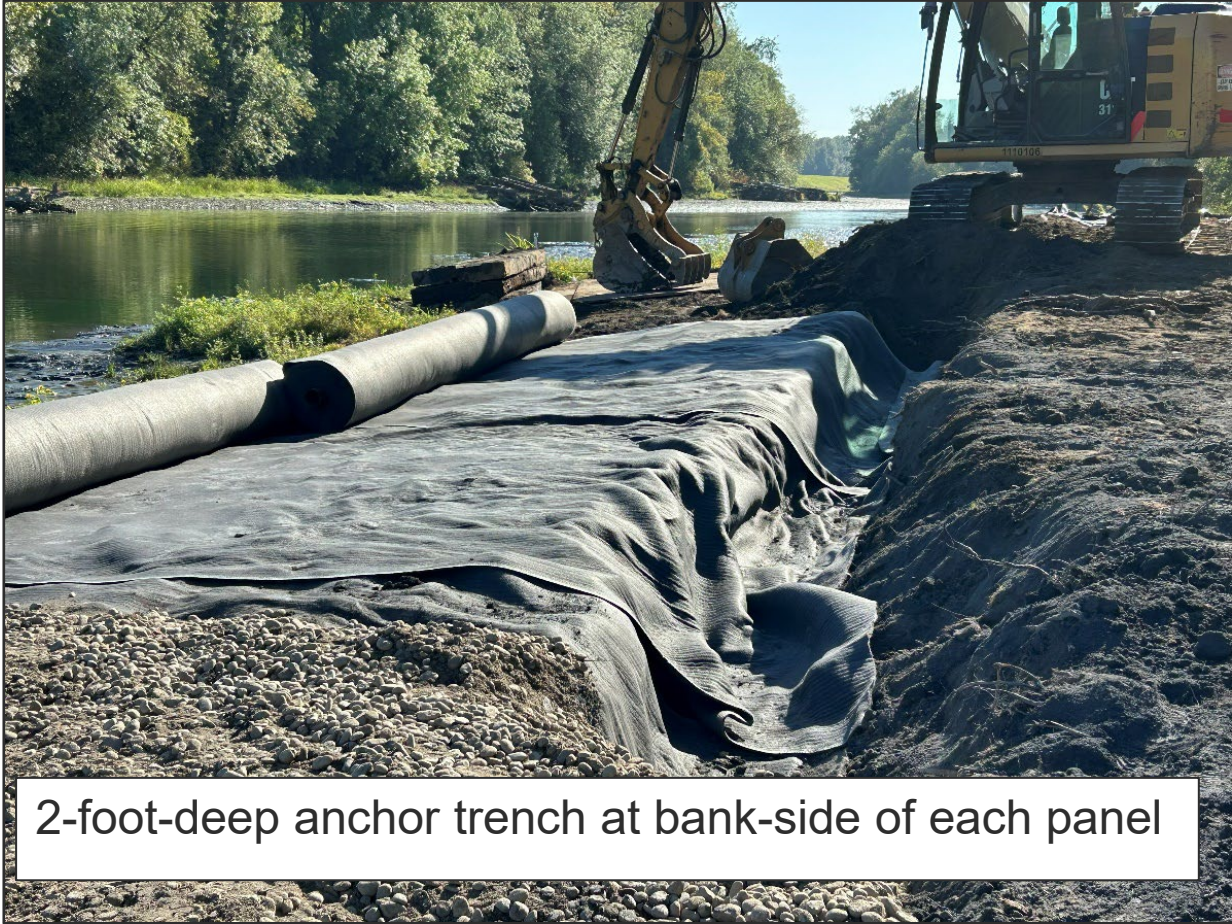
2-foot-deep anchor trench at bank-side of each panel

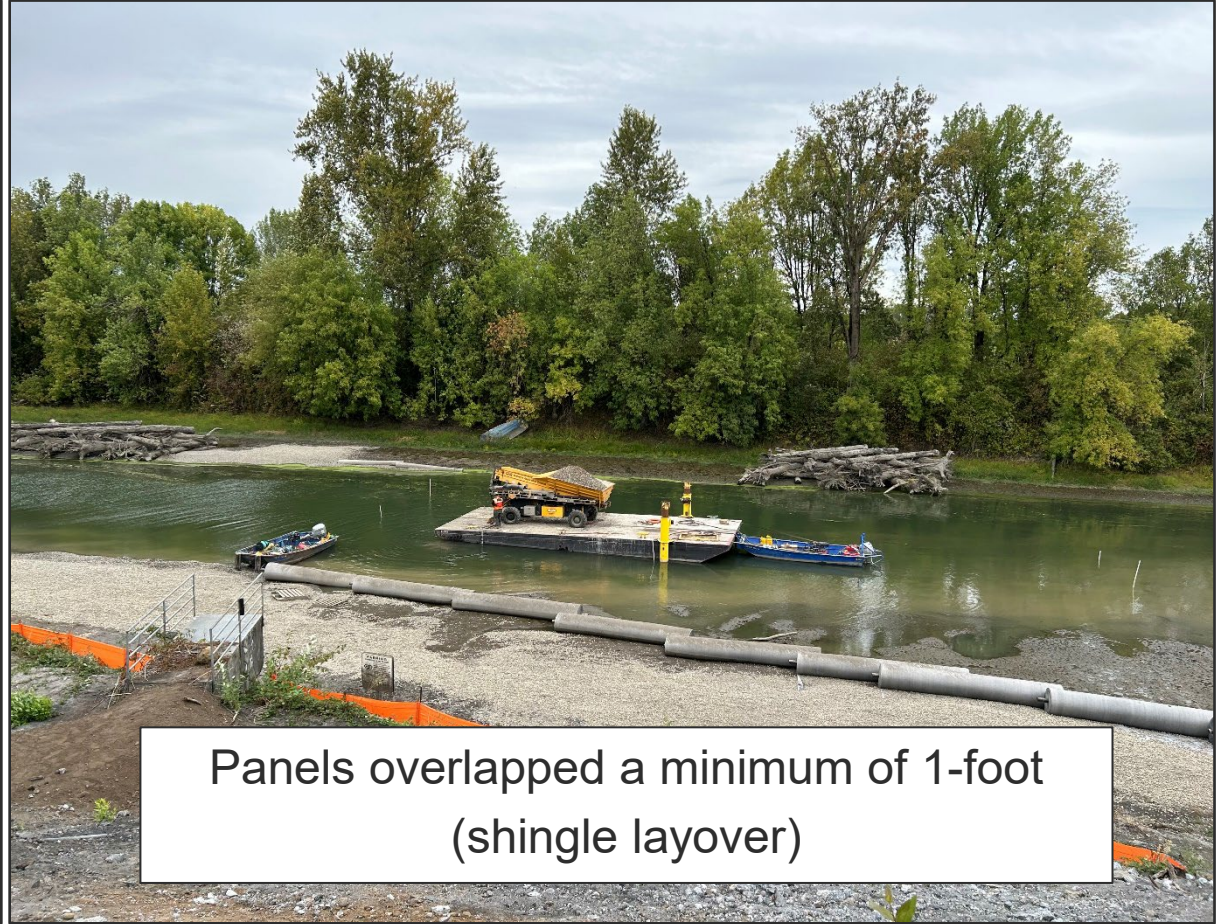
Panels overlapped a minimum of 1-foot  
(shingle layover)

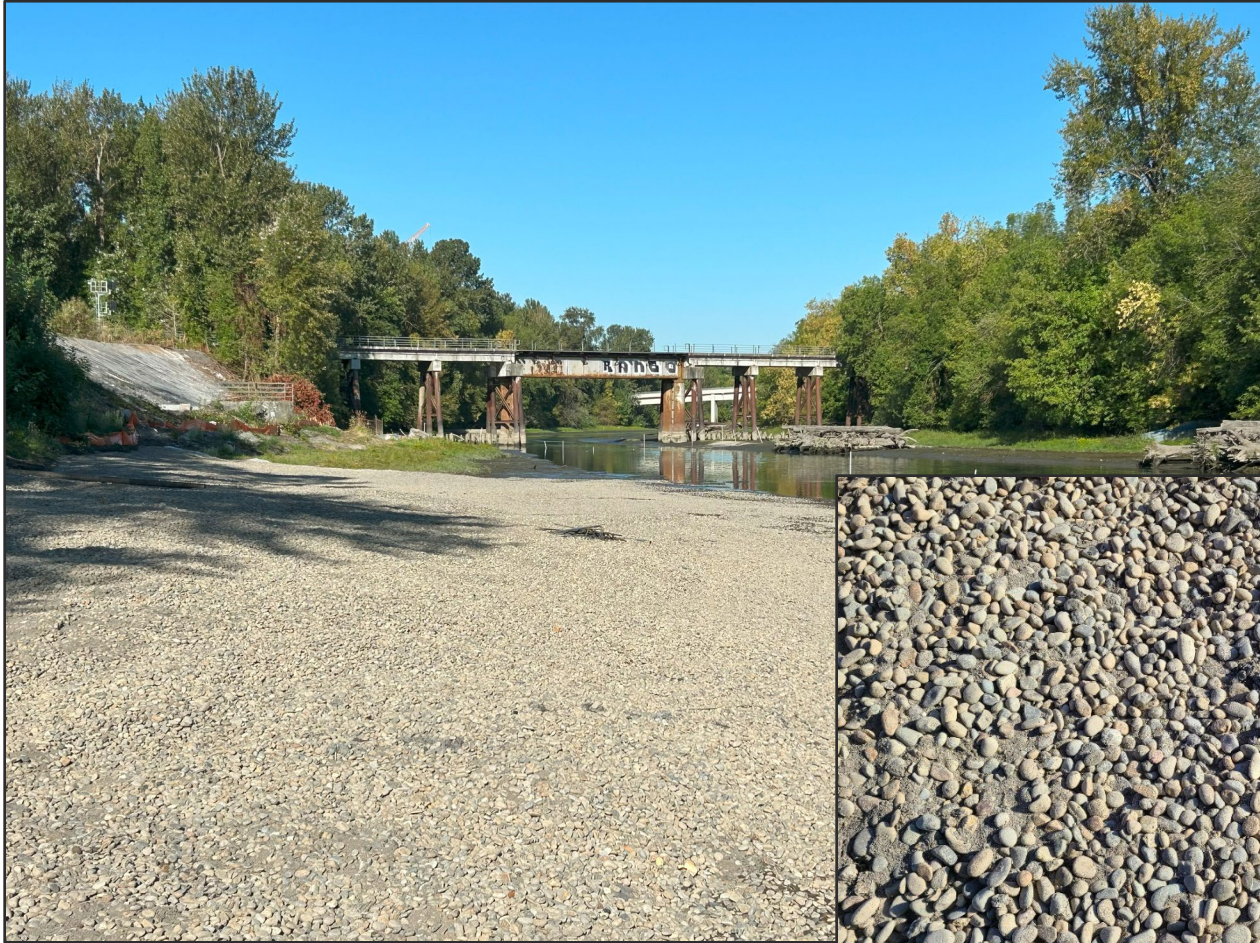
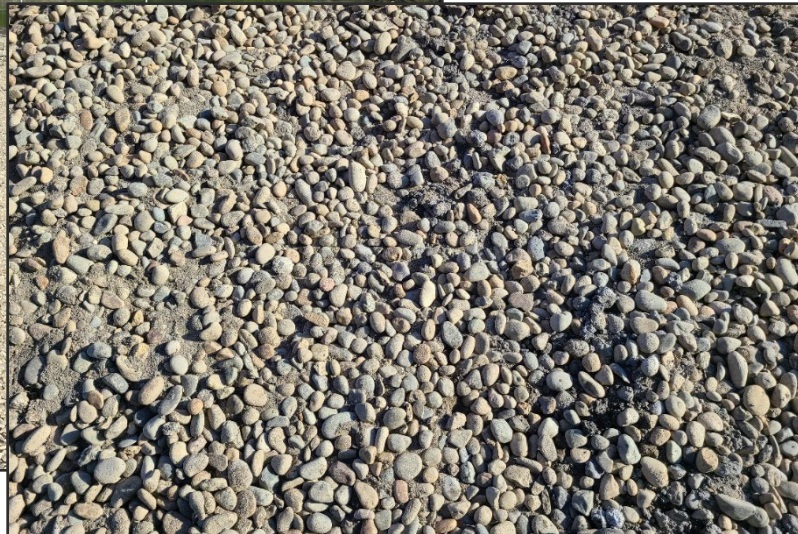
# RCM Liner Armor Layer

- Graded rounded rock  
2-inch minus
- Minimum depth  
3-inches
- Rock is covered with clean sand
  - Habitat layer
  - Provide stability in rock lift

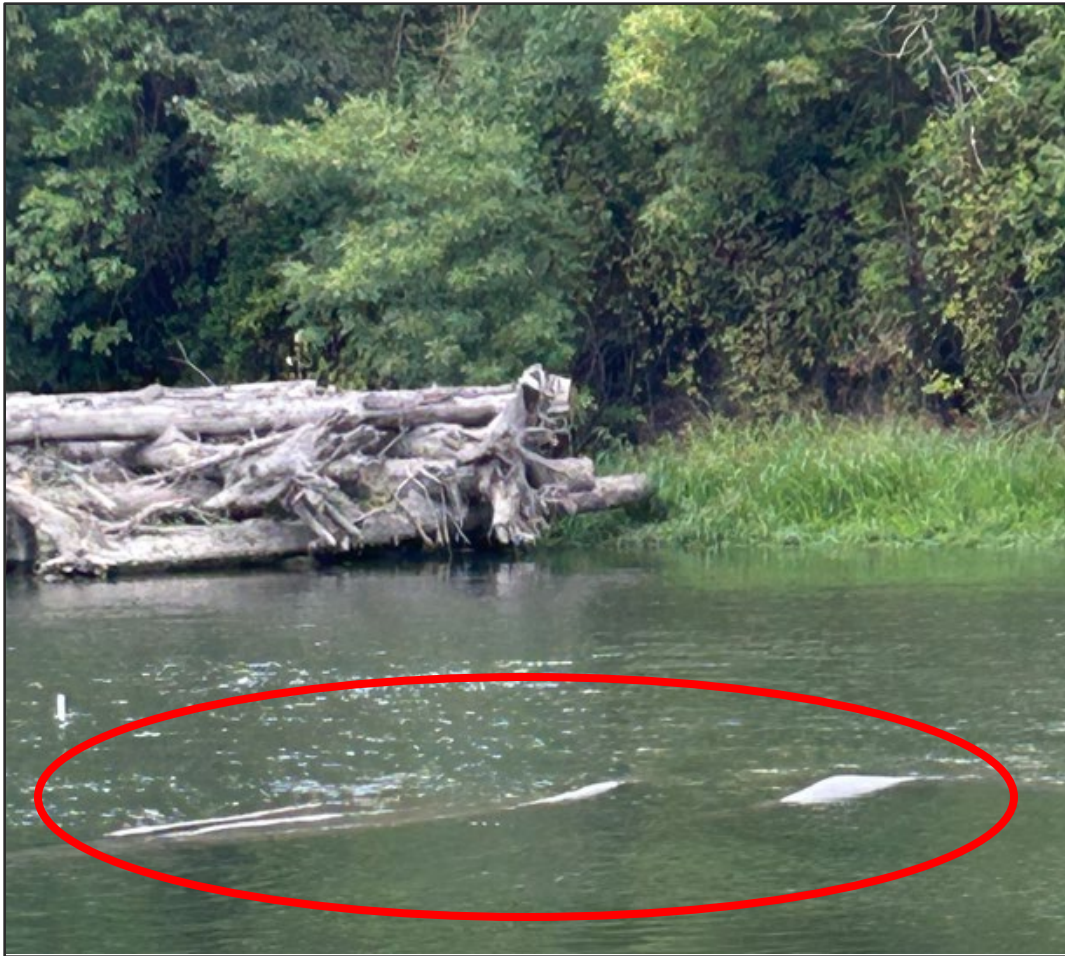
# Challenges

- Manufacture and shipping of custom capping materials took longer than expected and caused a ~ month delay
- Unknowns related to RCM installation and tidal fluctuations during king tides
- In-water work variance issued until Oct 17
- Vandalism – silt curtain and rigging materials

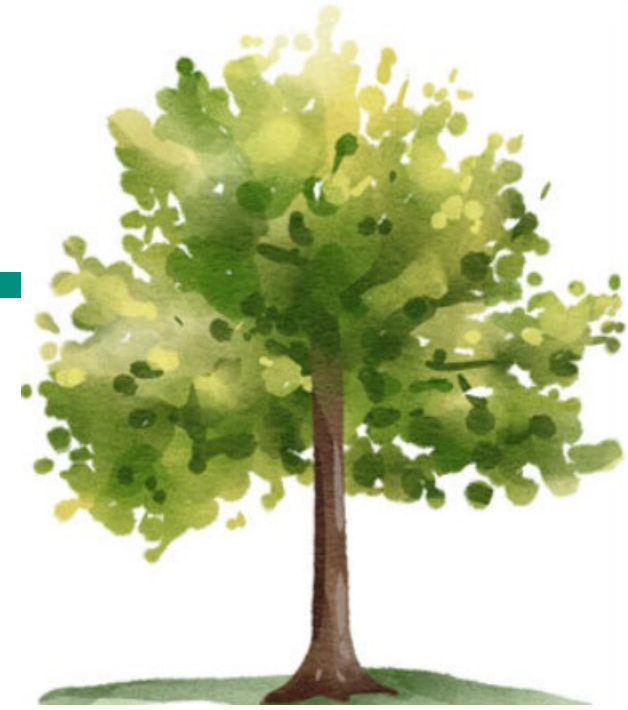
1 ENLARGED PLANTING PLAN: UPLAND  
SCALE: 1" = 5'

## PLANT LEGEND

- OREGON ASH, BIGLEAF MAPLE, OR DOUGLAS FIR
- RED TWIG DOGWOOD
- DOUGLAS' SPIREA
- TALL OREGON
- SNOWBERRY
- SWORDFERN
- PACIFIC WATER
