PHASE I ENVIRONMENTAL SITE ASSESSMENT

**4403 Commercial Street SE and
4516 Sunnyside Road SE
Salem, Oregon 97302
Marion County Tax Lots 03400 & 03500 on Map 083W10DA**

August 21, 2014

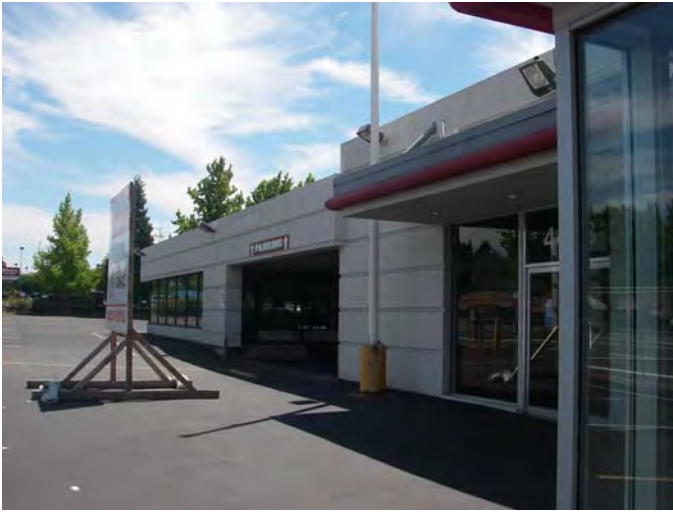
1. 4403 Commercial St SE: Photograph shows the east side of the Main Building, breeze way/canopy area, and Annex building, and asphalt-paved driveway along the easterly limits of the *subject property*. View faces south.

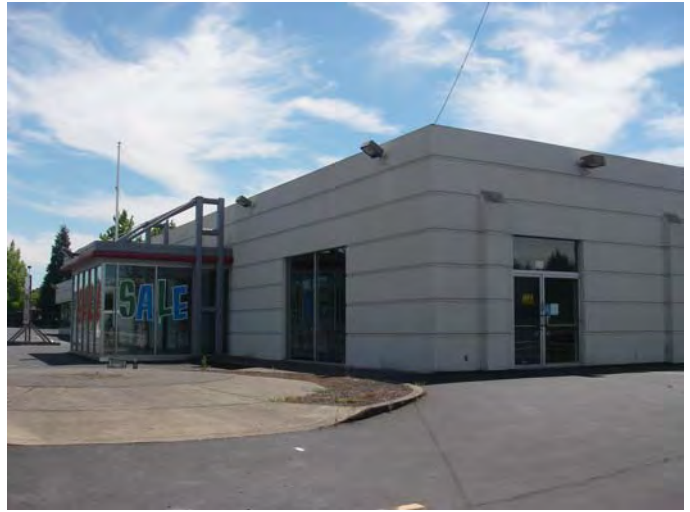
2. 4403 Commercial St SE: Photograph shows the north and east sides of the Main Building. View is from the northeast corner of the property facing south.

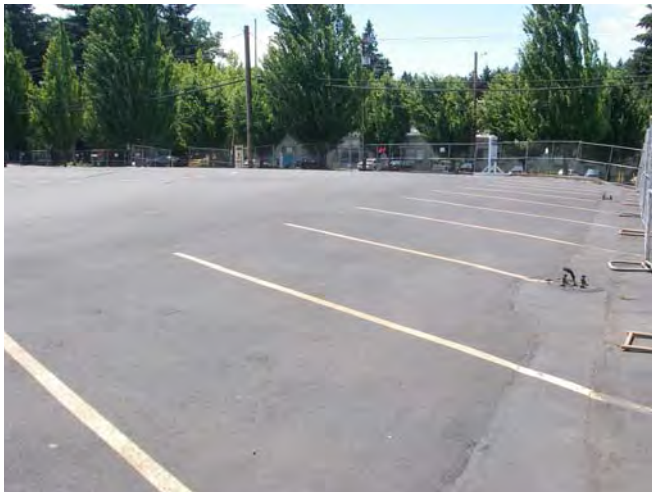
3. 4403 Commercial St SE: Photograph shows the asphalt-paved parking lot/driveway in the northern portion of the *subject property*. View is from the northeast corner of the property facing west.

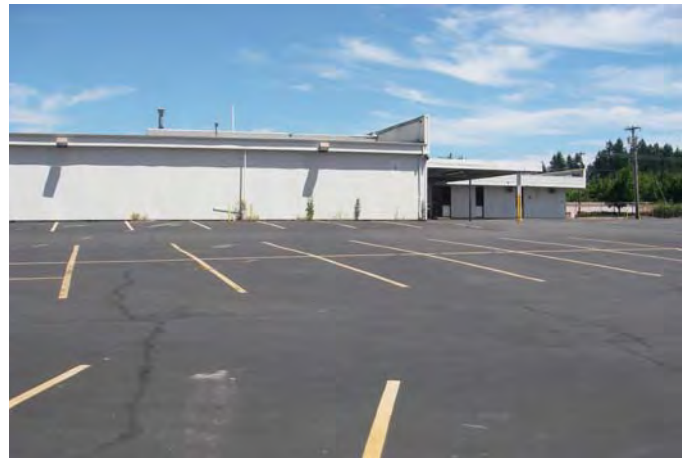
4. 4403 Commercial St SE: Photograph shows the north side of the Main Building and asphalt-paved parking lot/driveway. The former LUST was located centrally to the north side of the building. View is from the northerly limits of the *subject property* facing south.

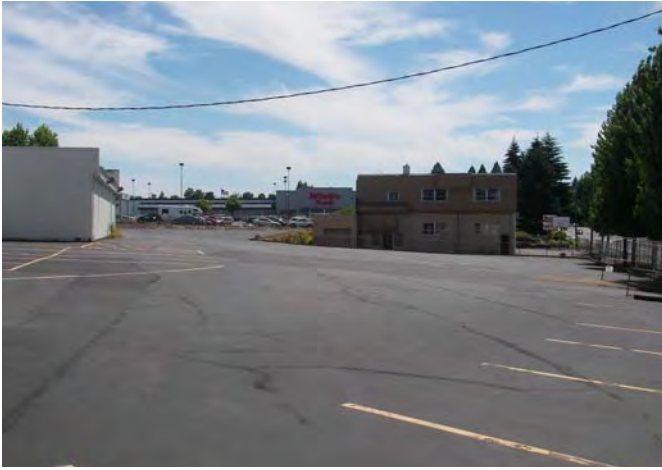
5. 4403 Commercial St SE/4516 Sunnyside Rd SE: Photograph shows the western portion of the *subject property*, including asphalt paved parking lot, Main Building (left) and the north side of the former "Firehouse" building. View is from the northerly limits of the *subject property* facing south.

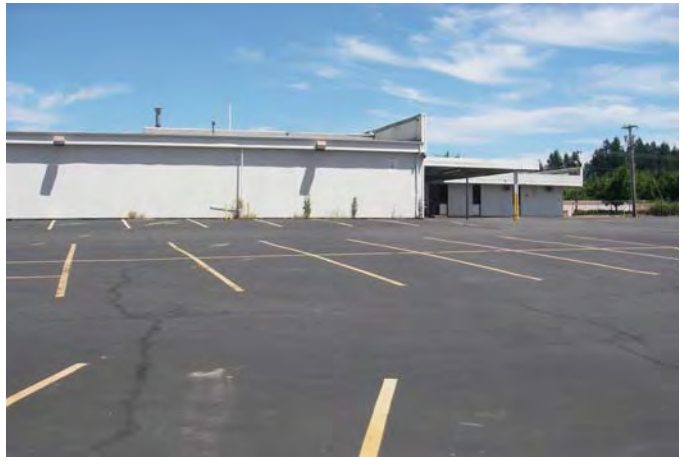
6. 4403 Commercial St. SE: Photograph shows the west side of the Main Building, the breeze way/canopy area, the Annex building, and asphalt-paved parking lot and driveway area to the west of the buildings. View faces east.

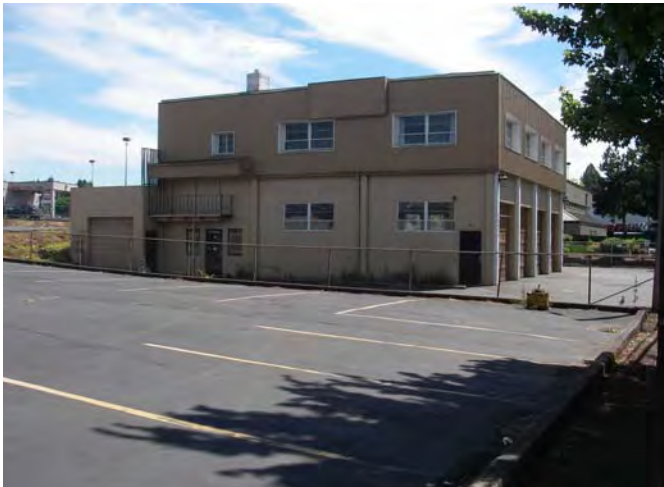
7. 4403 Commercial St SE/4516 Sunnyside Rd SE: Photograph shows the southwest portion of the *subject property*, including asphalt paved parking lot, stormwater catch basin, and the north side of the former "Firehouse" building.

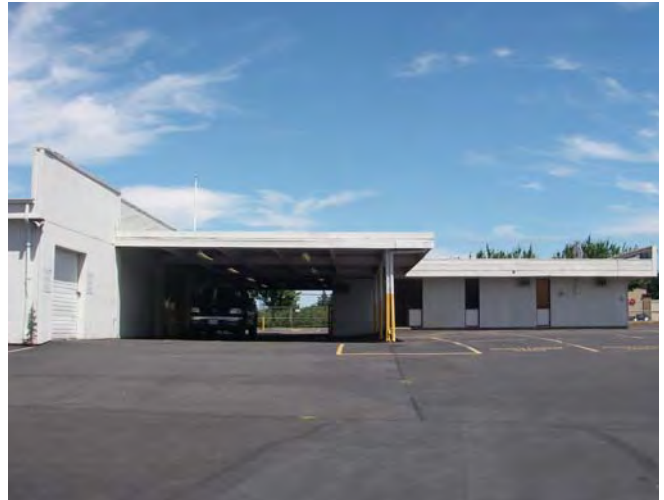
8. 4403 Commercial St. SE: Photograph shows the southerly portion of the Main Building, the breeze way/canopy area, the Annex building, and asphalt-paved parking lot and driveway area to the west of the buildings. View faces east.

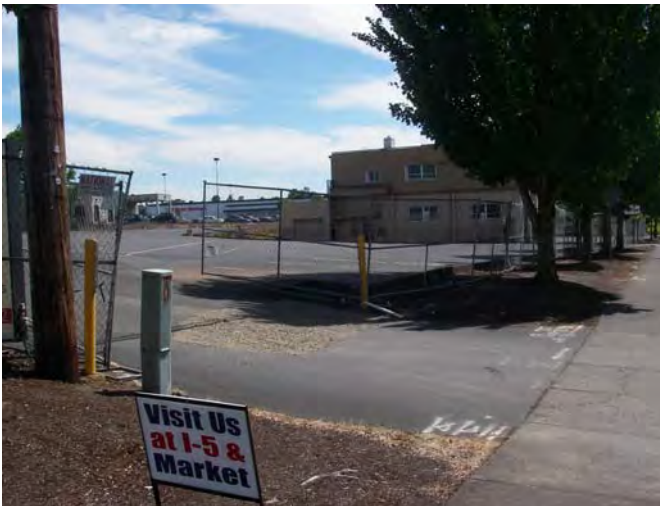
9. 4403 Commercial St. SE: View of driveway entrance and westerly limits of the *subject property* along Sunnyside Road SE. View faces south.

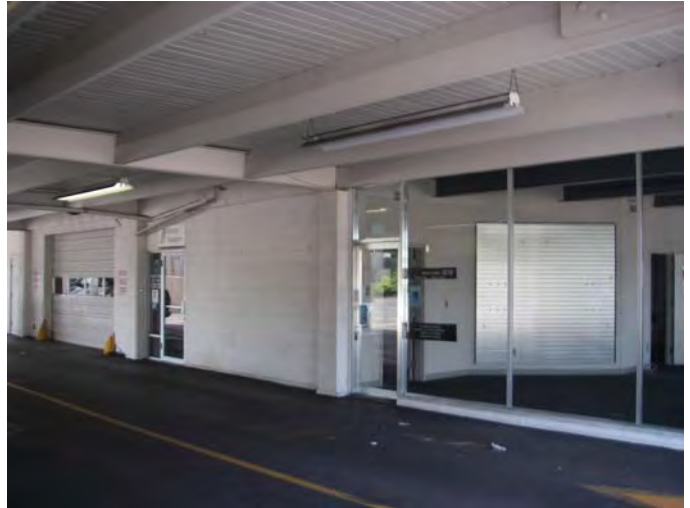
10. 4403 Commercial St. SE: View of the breeze way/canopy area and south side of the Main Building. View also shows fluorescent lighting.

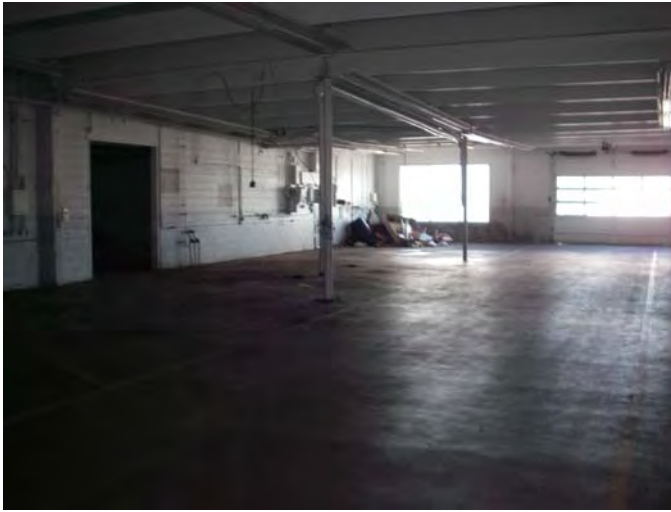
15. 4403 Commercial St. SE: Interior view of the Main Building service area/garage. View is from the southern portion of the garage facing north.

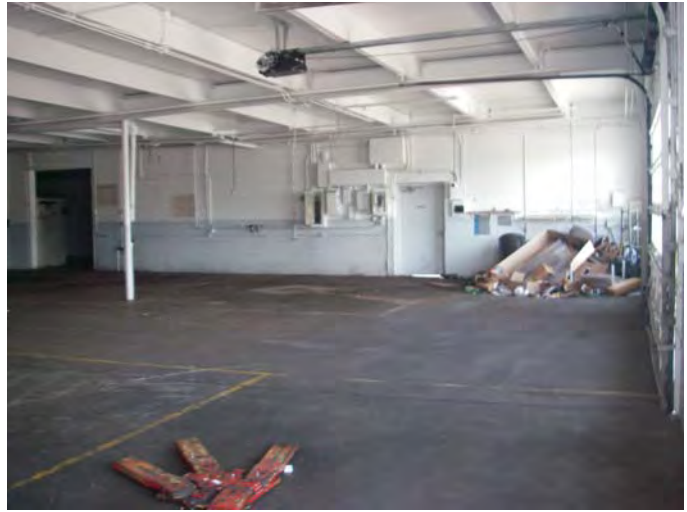
Three (3), empty 55-gallon poly drums and numerous other nonhazardous solid waste were observed in waste stockpiles stored in the Main Building automobile service area/garage (4403 Commercial Street SE). Eight (8) five-gallon buckets of paint and enamel were also observed in the garage area. Several one-gallon containers of general household and automotive chemicals (i.e., paint thinner, leather cleaner, etc.), and five-gallon and smaller containers of paint and stain, were observed to be stored on shelves in the storage closets of the former Firehouse building (4615 Sunnyside Road SE).

16. 4403 Commercial St. SE: Interior view of the Main Building service area/garage. View is of the northern portion of the garage from the northeast corner, and shows a below-ground hydraulic hoist and a nonhazardous trash/debris pile (including 3 empty 55-gallon poly drums).

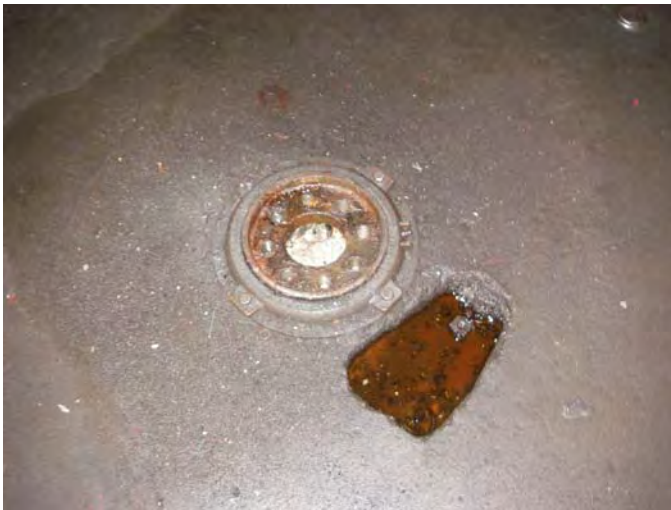
BB&A observed in-ground hydraulic lifts located within the Main Building automobile service area/garage and within the garage of the former Firehouse building. Eight (8) of the nine (9) below ground pistons observed in the Main Building were dismantled above ground; and two (2) of the seven (7) were observed dismantled in the former Firehouse building. However, the pistons and oil reservoirs containing oil may still remain in the ground at some locations. While most regulatory agencies do not regulate in-ground hydraulic lifts, potential environmental hazards may occur when the lifts lose integrity and leak oil into the subsurface soils and groundwater.

- ▶ The presence of in-ground hydraulic lifts (including non-decommissioned and decommissioned) located within the Main Building automobile service area/garage and within the garage of the former Firehouse building. Nine (9) below-ground lifts were observed in the Main Building and seven (7) were observed in the former

Firehouse building. The pistons and oil reservoirs may still remain in the ground at some locations, and may still contain oil. While most regulatory agencies do not currently regulate below-ground hydraulic lifts, potential environmental hazards may occur when the lifts lose integrity and leak oil into the subsurface soils and groundwater.

17. 4403 Commercial St. SE: Representative view of a below-ground hydraulic hoist and freestanding oil on asphalt-paved surface in the Main Building service area/garage.

1. Proper decommissioning and removal of the in-ground components of the former hydraulic lift systems located within the Main Building automobile service area/garage (4403 Commercial Street SE), and within the garage of the former Firehouse building (4516 Sunnyside Road SE), is recommended under the observation of an environmental professional. Further, BB&A recommends a concurrent subsurface investigation to assess potential environmental liability associated with the operation of the in-ground hoists. During removal of the in-ground hoists, evidence of a release (i.e., hydraulic oil) should be evaluated at each location. Soil sampling and analysis may be required of native soils from beneath the hoist in the event that there is evidence of a release. If groundwater is encountered within the hoist cavity, a sample should also be collected and analyzed. Additionally, where pistons and/or oil reservoirs remain in the ground, collection and analysis of oil samples may be required for proper decommissioning and disposal.

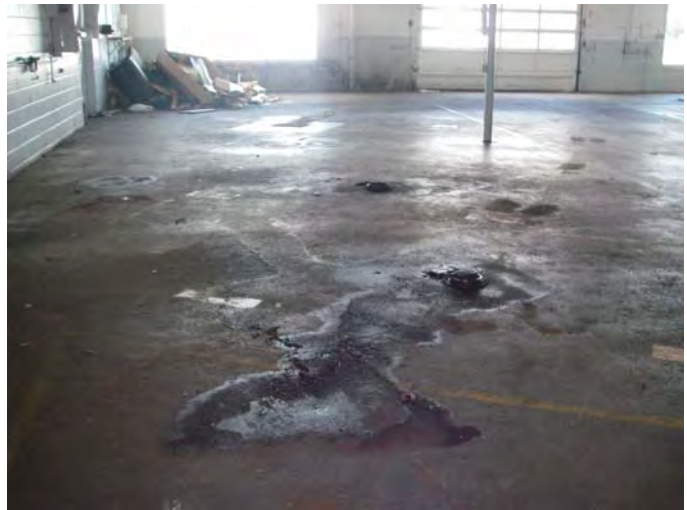
18. 4403 Commercial St. SE: Interior view of the Main Building service area/garage showing below-ground hydraulic hoists, freestanding oil and surface staining, and the non-hazardous trash/debris pile in the distance.

2. A focused Phase II ESA is recommended for the 4403 Commercial Street SE portion of the subject property. The collection of soil and groundwater (if encountered) samples for analytical testing are recommended in the vicinity of the service area/garage of the Main Building at the following locations:
 - a. Within and adjacent to the former cavity footprint of the 1,000-gallon gasoline UST removed from the subject property: Soil samples collected within the former UST cavity footprint should be collected from native soils within the interval where residual soil contamination is known to remain in-place (i.e., 13 to 14 feet BLS), and analyzed for gasoline range TPH by NWTPH-Gx.
 - b. Beneath the oil/water separator: Additionally, liquids within the oil/water separator should be sampled and analyzed for determination of proper handling and disposal.

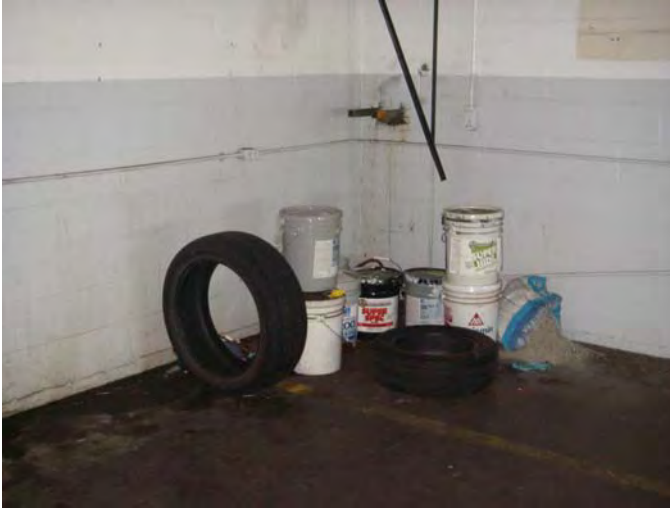
19. 4403 Commercial St. SE: Interior view of the Main Building service area/garage showing five-gallon containers of paint and enamel, tires, and a bag of concrete mix in the southwest corner of the garage.

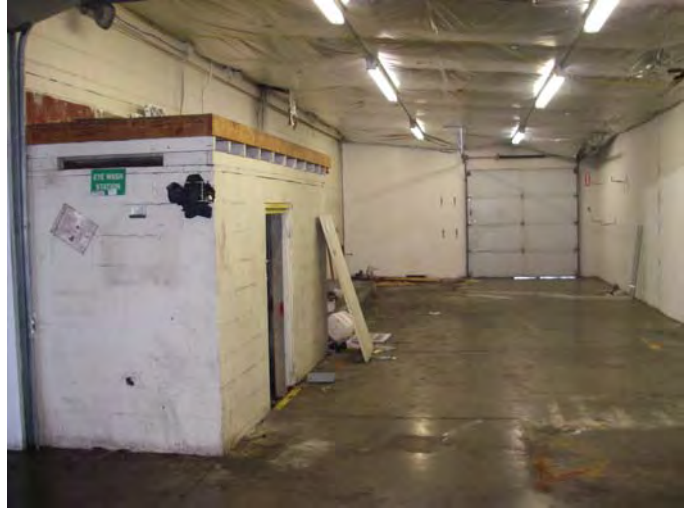
20. 4403 Commercial St. SE: Interior view of the Main Building showing the oil and waste storage area in the western portion of the building.

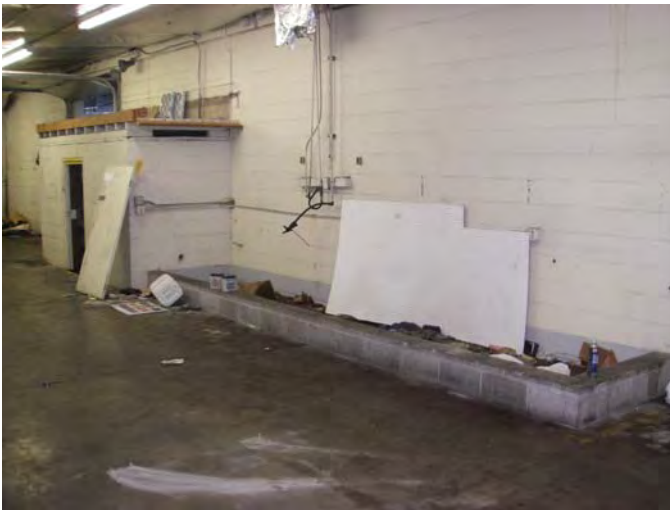
21. 4403 Commercial St. SE: Interior view of the Main Building oil and waste storage area showing secondary containment areas.

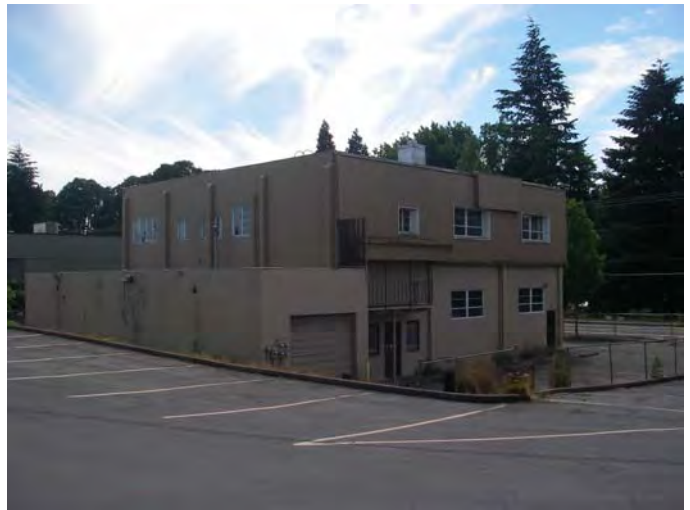
22. 4403 Commercial St. SE/4516 Sunnyside Road SE: Photograph shows asphalt-paved driveway/parking lot and the former "Firehouse" building. View faces southwest.

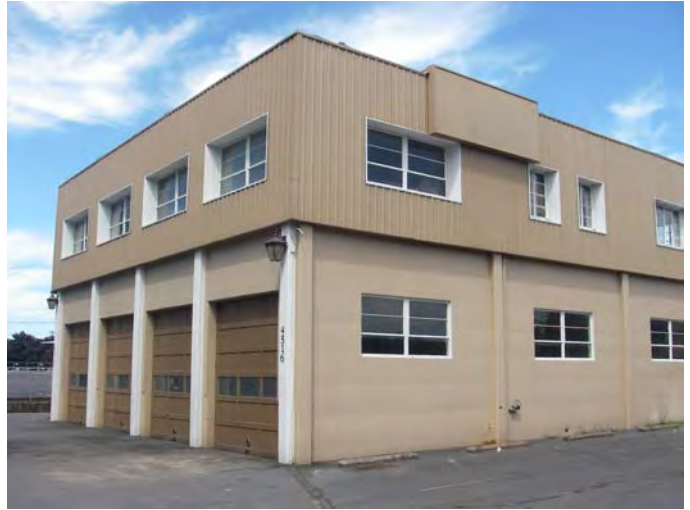
24. 4516 Sunnyside Rd SE: Photograph shows the west and south sides of the former "Firehouse" building. View is from the southwest corner of the *subject property* facing northeast.

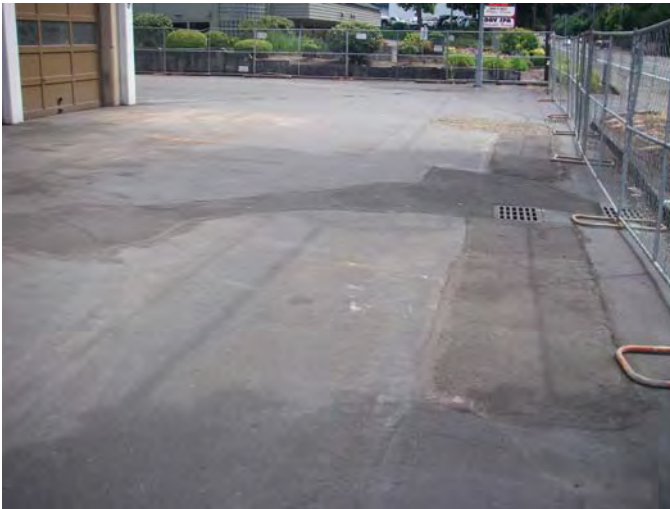
25. 4516 Sunnyside Rd SE: Photograph shows the asphalt-paved driveway and stormwater catch basins to the west of the former "Firehouse" building. View faces south.

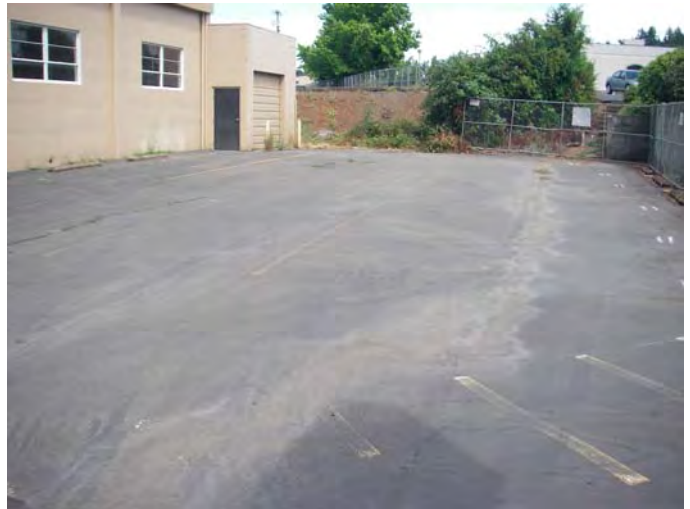
26. 4516 Sunnyside Rd SE: Photograph shows the south side of the former "Firehouse" building and asphalt-paved driveway along the southern boundary of the *subject property*.

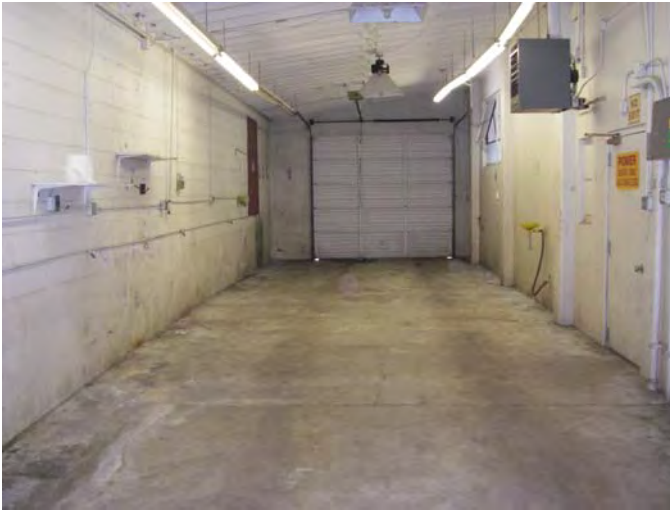
27. 4516 Sunnyside Rd SE: Interior view of the former "Firehouse" building showing the car wash area.

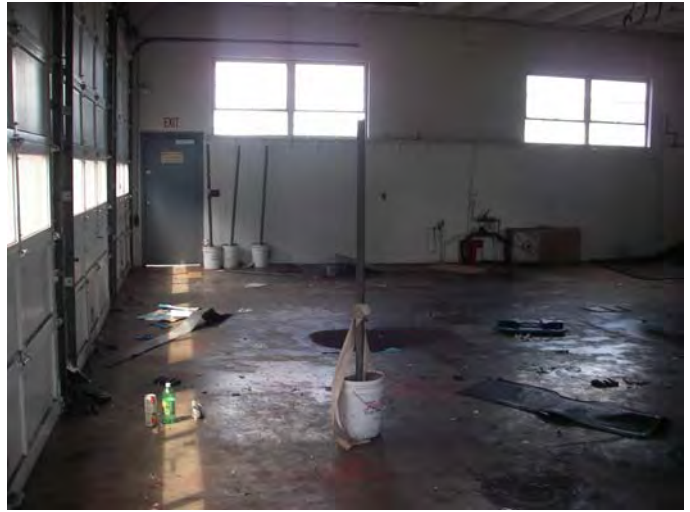
28. 4516 Sunnyside Rd SE: Interior view of the former "Firehouse" building service area/garage. Photograph also shows below-ground hoists, pools of oil and concrete surface staining, and general debris.

3. A focused Phase II ESA is recommended for the 4516 Sunnyside Road SE portion of the subject property. Soil and groundwater (if encountered) samples for analysis should be collected at a minimum of one (1) location to the west (i.e., hydrogeologically downgradient) of the former "Firehouse" garage.

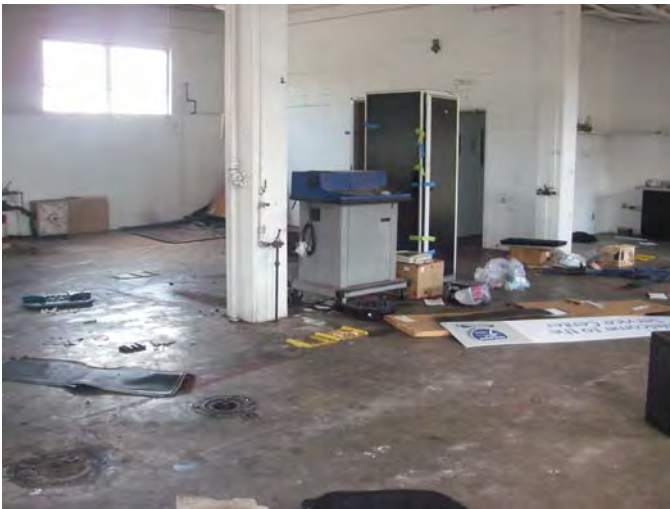
29. 4516 Sunnyside Rd SE: Another interior view of the former "Firehouse" building service area/garage showing below-ground hoists, concrete surface staining, and general debris.

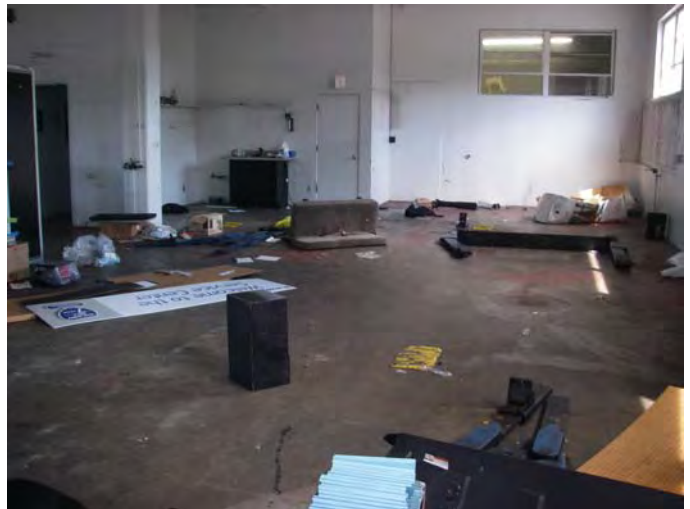
30. 4516 Sunnyside Rd SE: Another interior view of the former "Firehouse" building service area/garage showing below-ground hoists, concrete surface staining, and general debris. Photograph also shows the decommissioned floor drain in the right-central vicinity of the photograph.

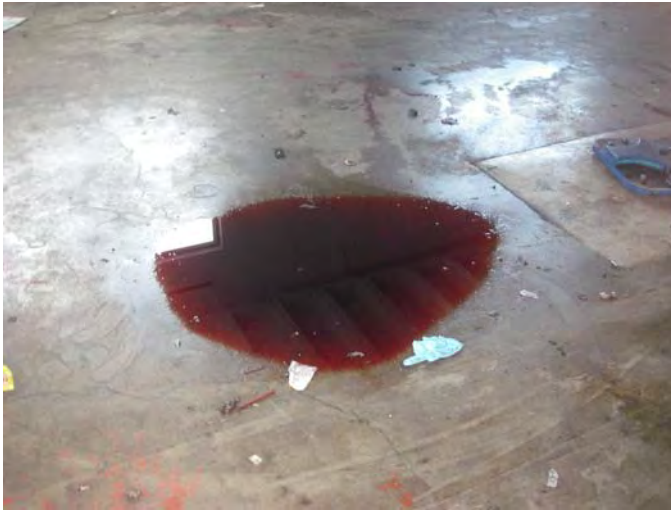
31. 4516 Sunnyside Rd SE: Representative view of freestanding oil observed on concrete surface and adjacent to hydraulic lifts in the former "Firehouse" building.

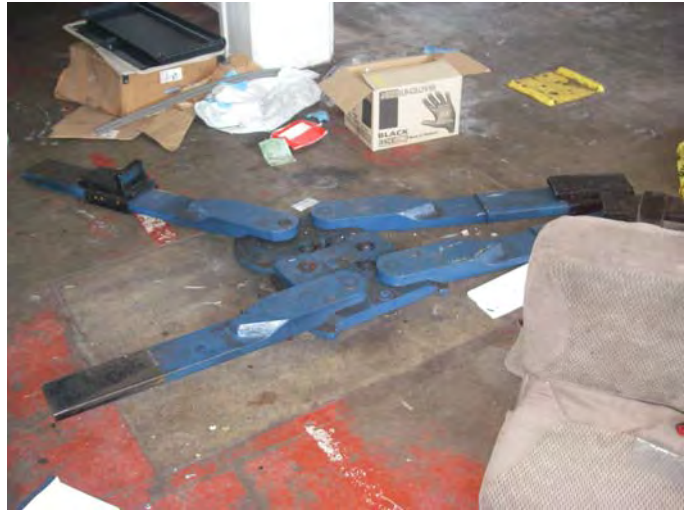
32. 4516 Sunnyside Rd SE: Representative view of intact below-ground hydraulic lifts in the former "Firehouse" building.

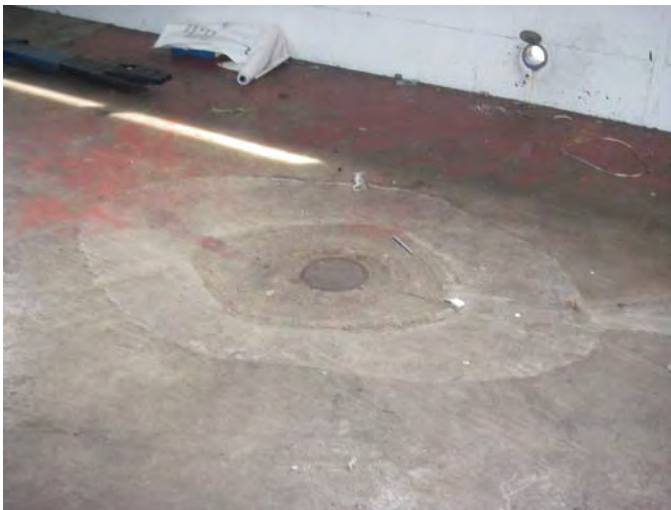
- ▶ One (1) decommissioned floor drain was observed within the garage of the former Firehouse building. The former presence of the floor drain indicates a potential for release to soil and groundwater from illegal dumping.

33. 4516 Sunnyside Rd SE: View of the decommissioned floor drain located in the former "Firehouse" building.

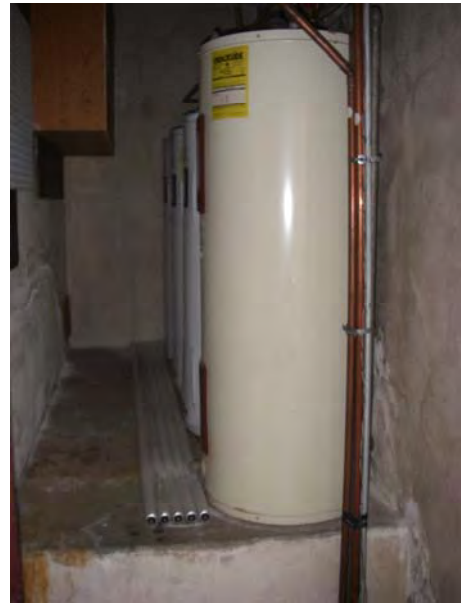
34. 4516 Sunnyside Rd SE: Room with hot water heaters on the second floor of the former "Firehouse" building.

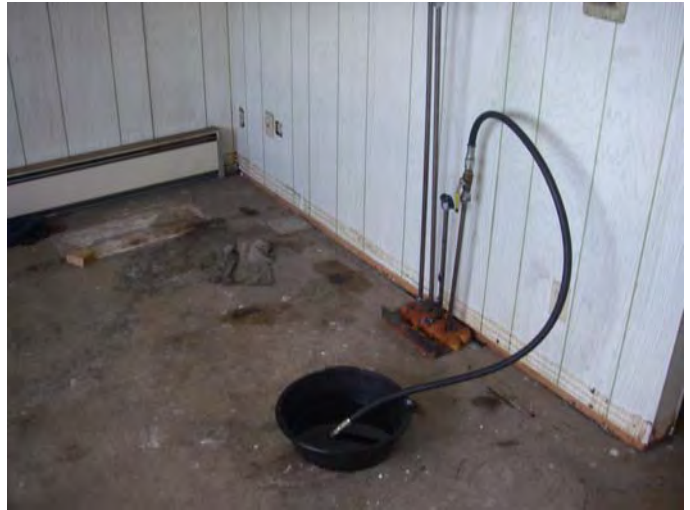
36. 4516 Sunnyside Rd SE: A room within one of four living spaces on the second floor of the former "Firehouse" building utilized to store hydraulic oil drums. Photograph shows hydraulic oil dispenser lines and a pan with some oil.
