Re: Closeout Report – Tax Lots 500 and 600, North Central Avenue and Rossanley Drive, Medford  
Oregon, ECSI Site Identification Number 537

# Closeout Report

Tax Lots 500 and 600, North Central Avenue  
and Rossanley Drive, Medford Oregon

ECSI Site Identification Number 537

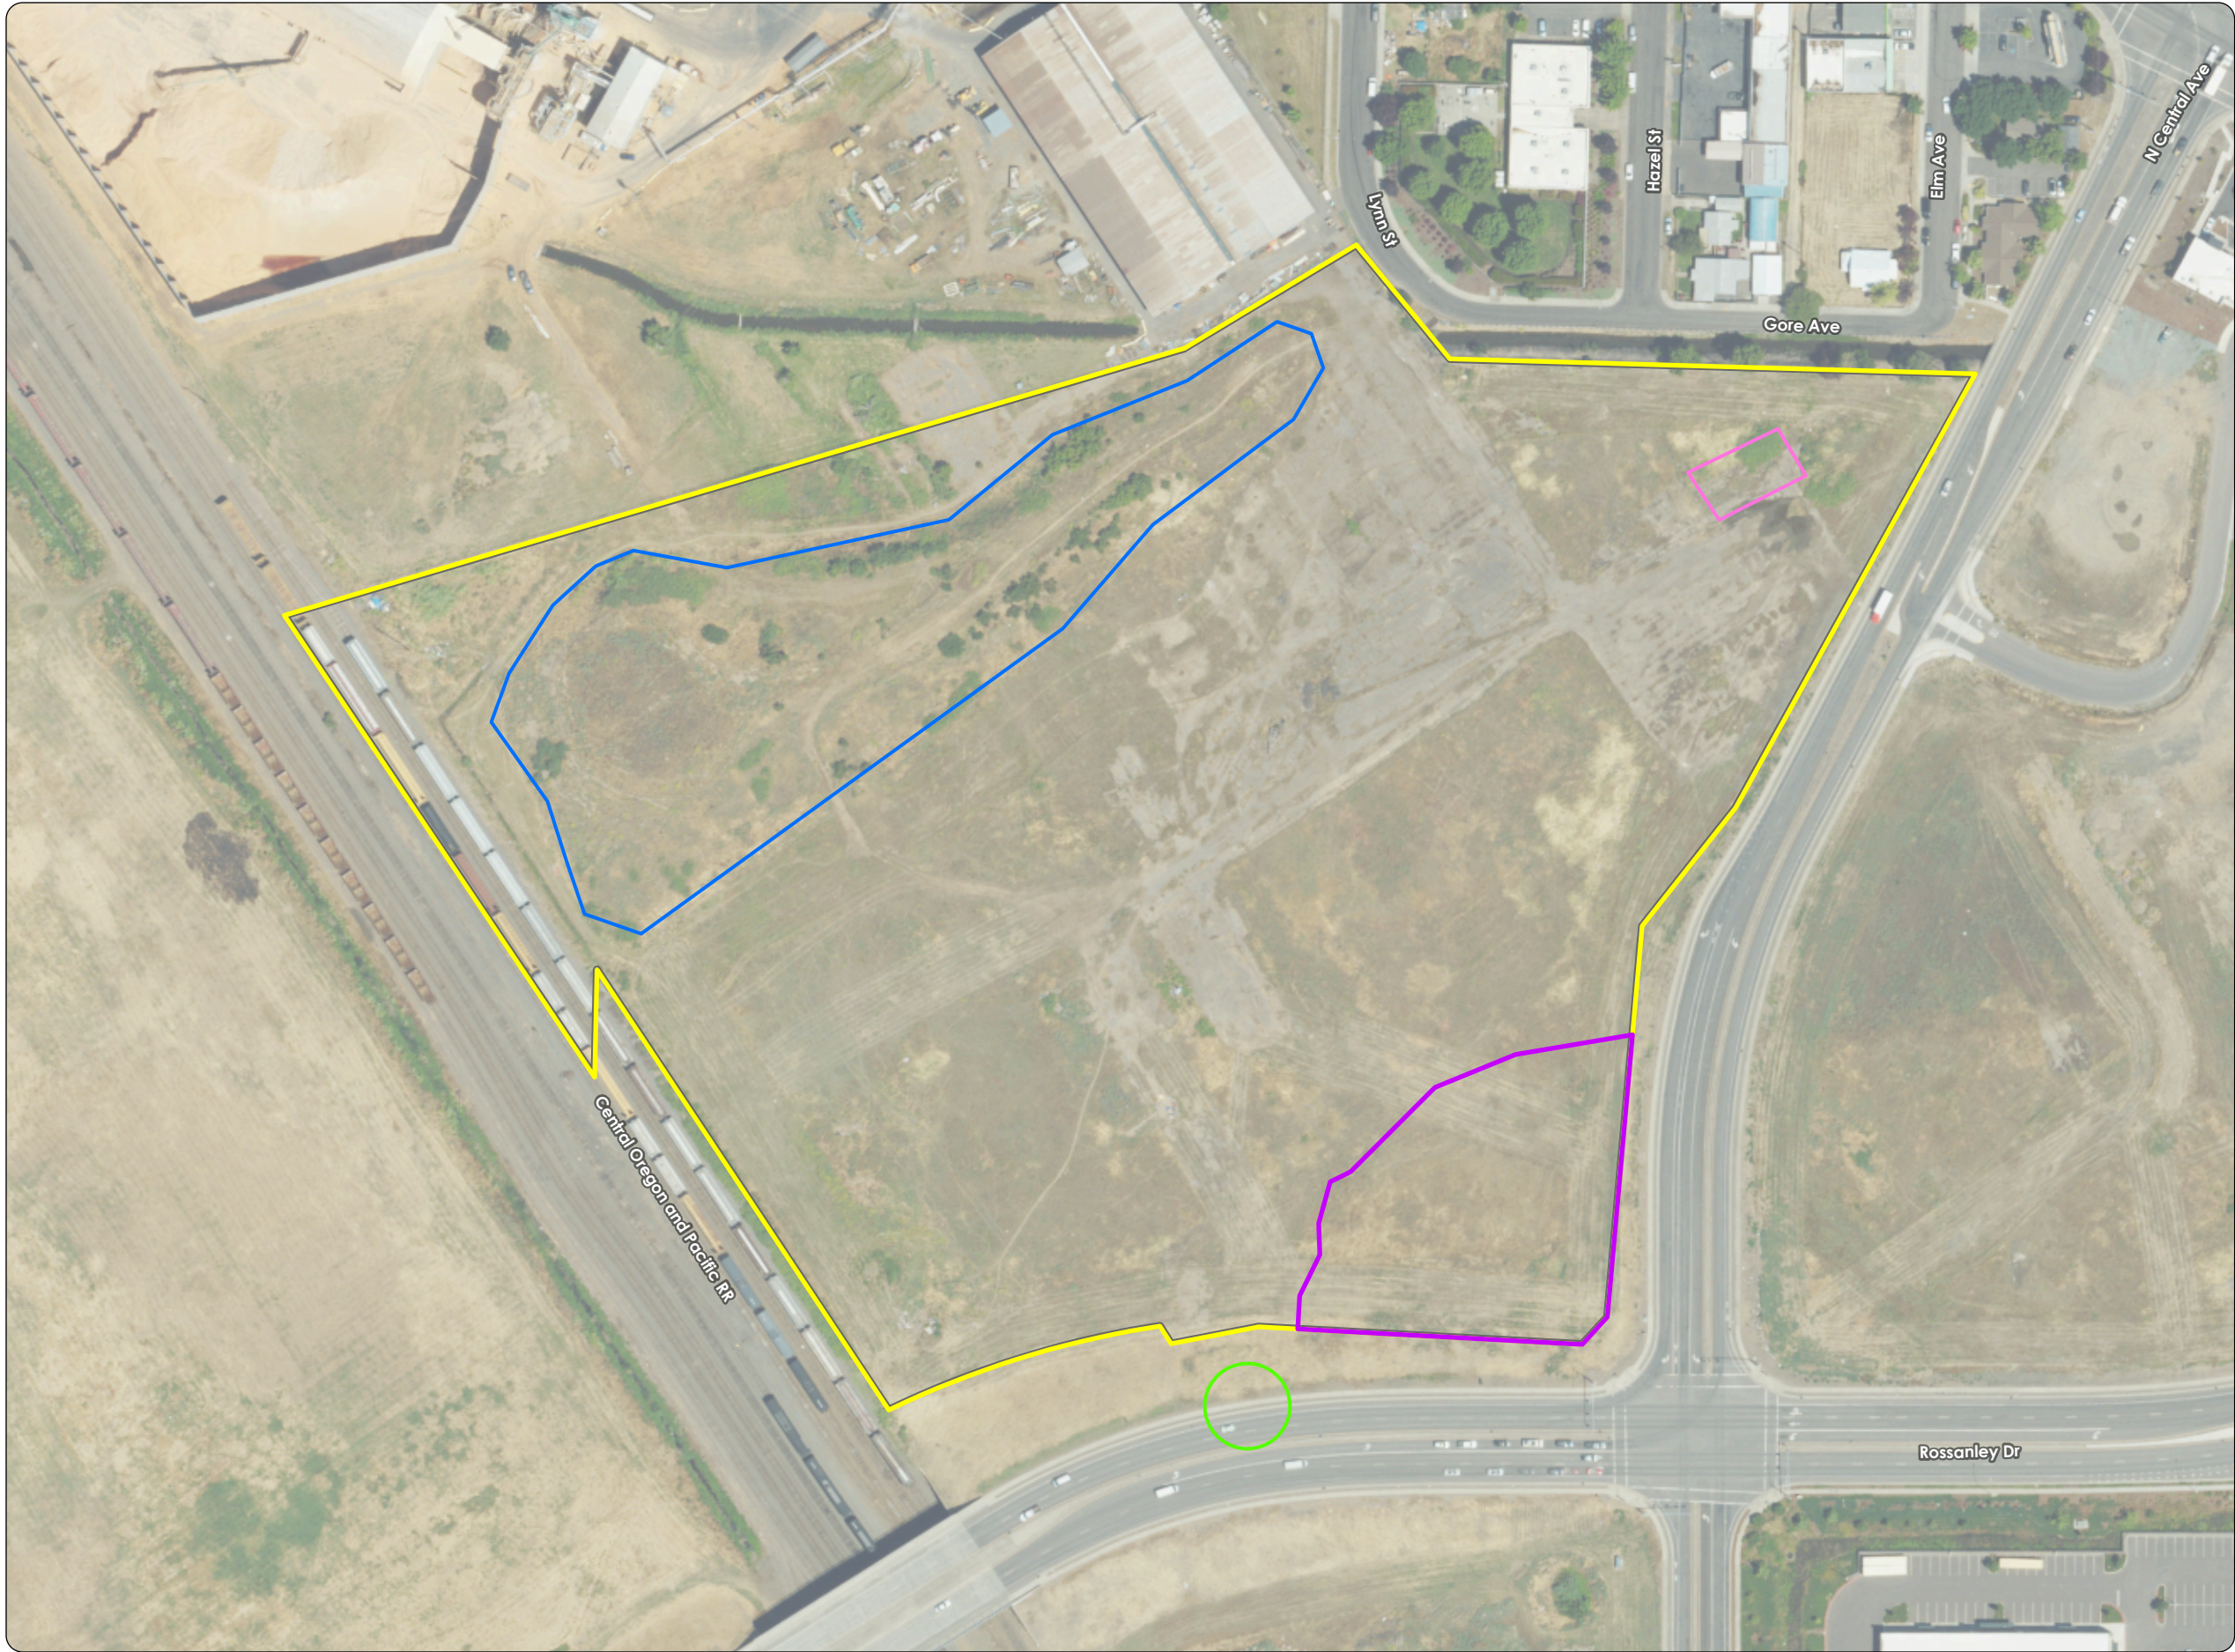
## Figure 1-2 Property Features

The Property was previously the central portion of a 104-acre lumber mill (typically referred to as the “MEDCO site”) that operated from the 1920s until 1988. Historical aerial imagery indicates that structures on the Property that were associated with the MEDCO mill were cleared sometime between 1988 and 2000; previous structures included storage sheds, racks, mills, garages, and a portion of a 10-acre log pond. The Property is currently bare land, partially paved, and partially vegetated with grasses, scrub trees, and shrubs. Figure 1-2 shows current and previous Property features of environmental interest.

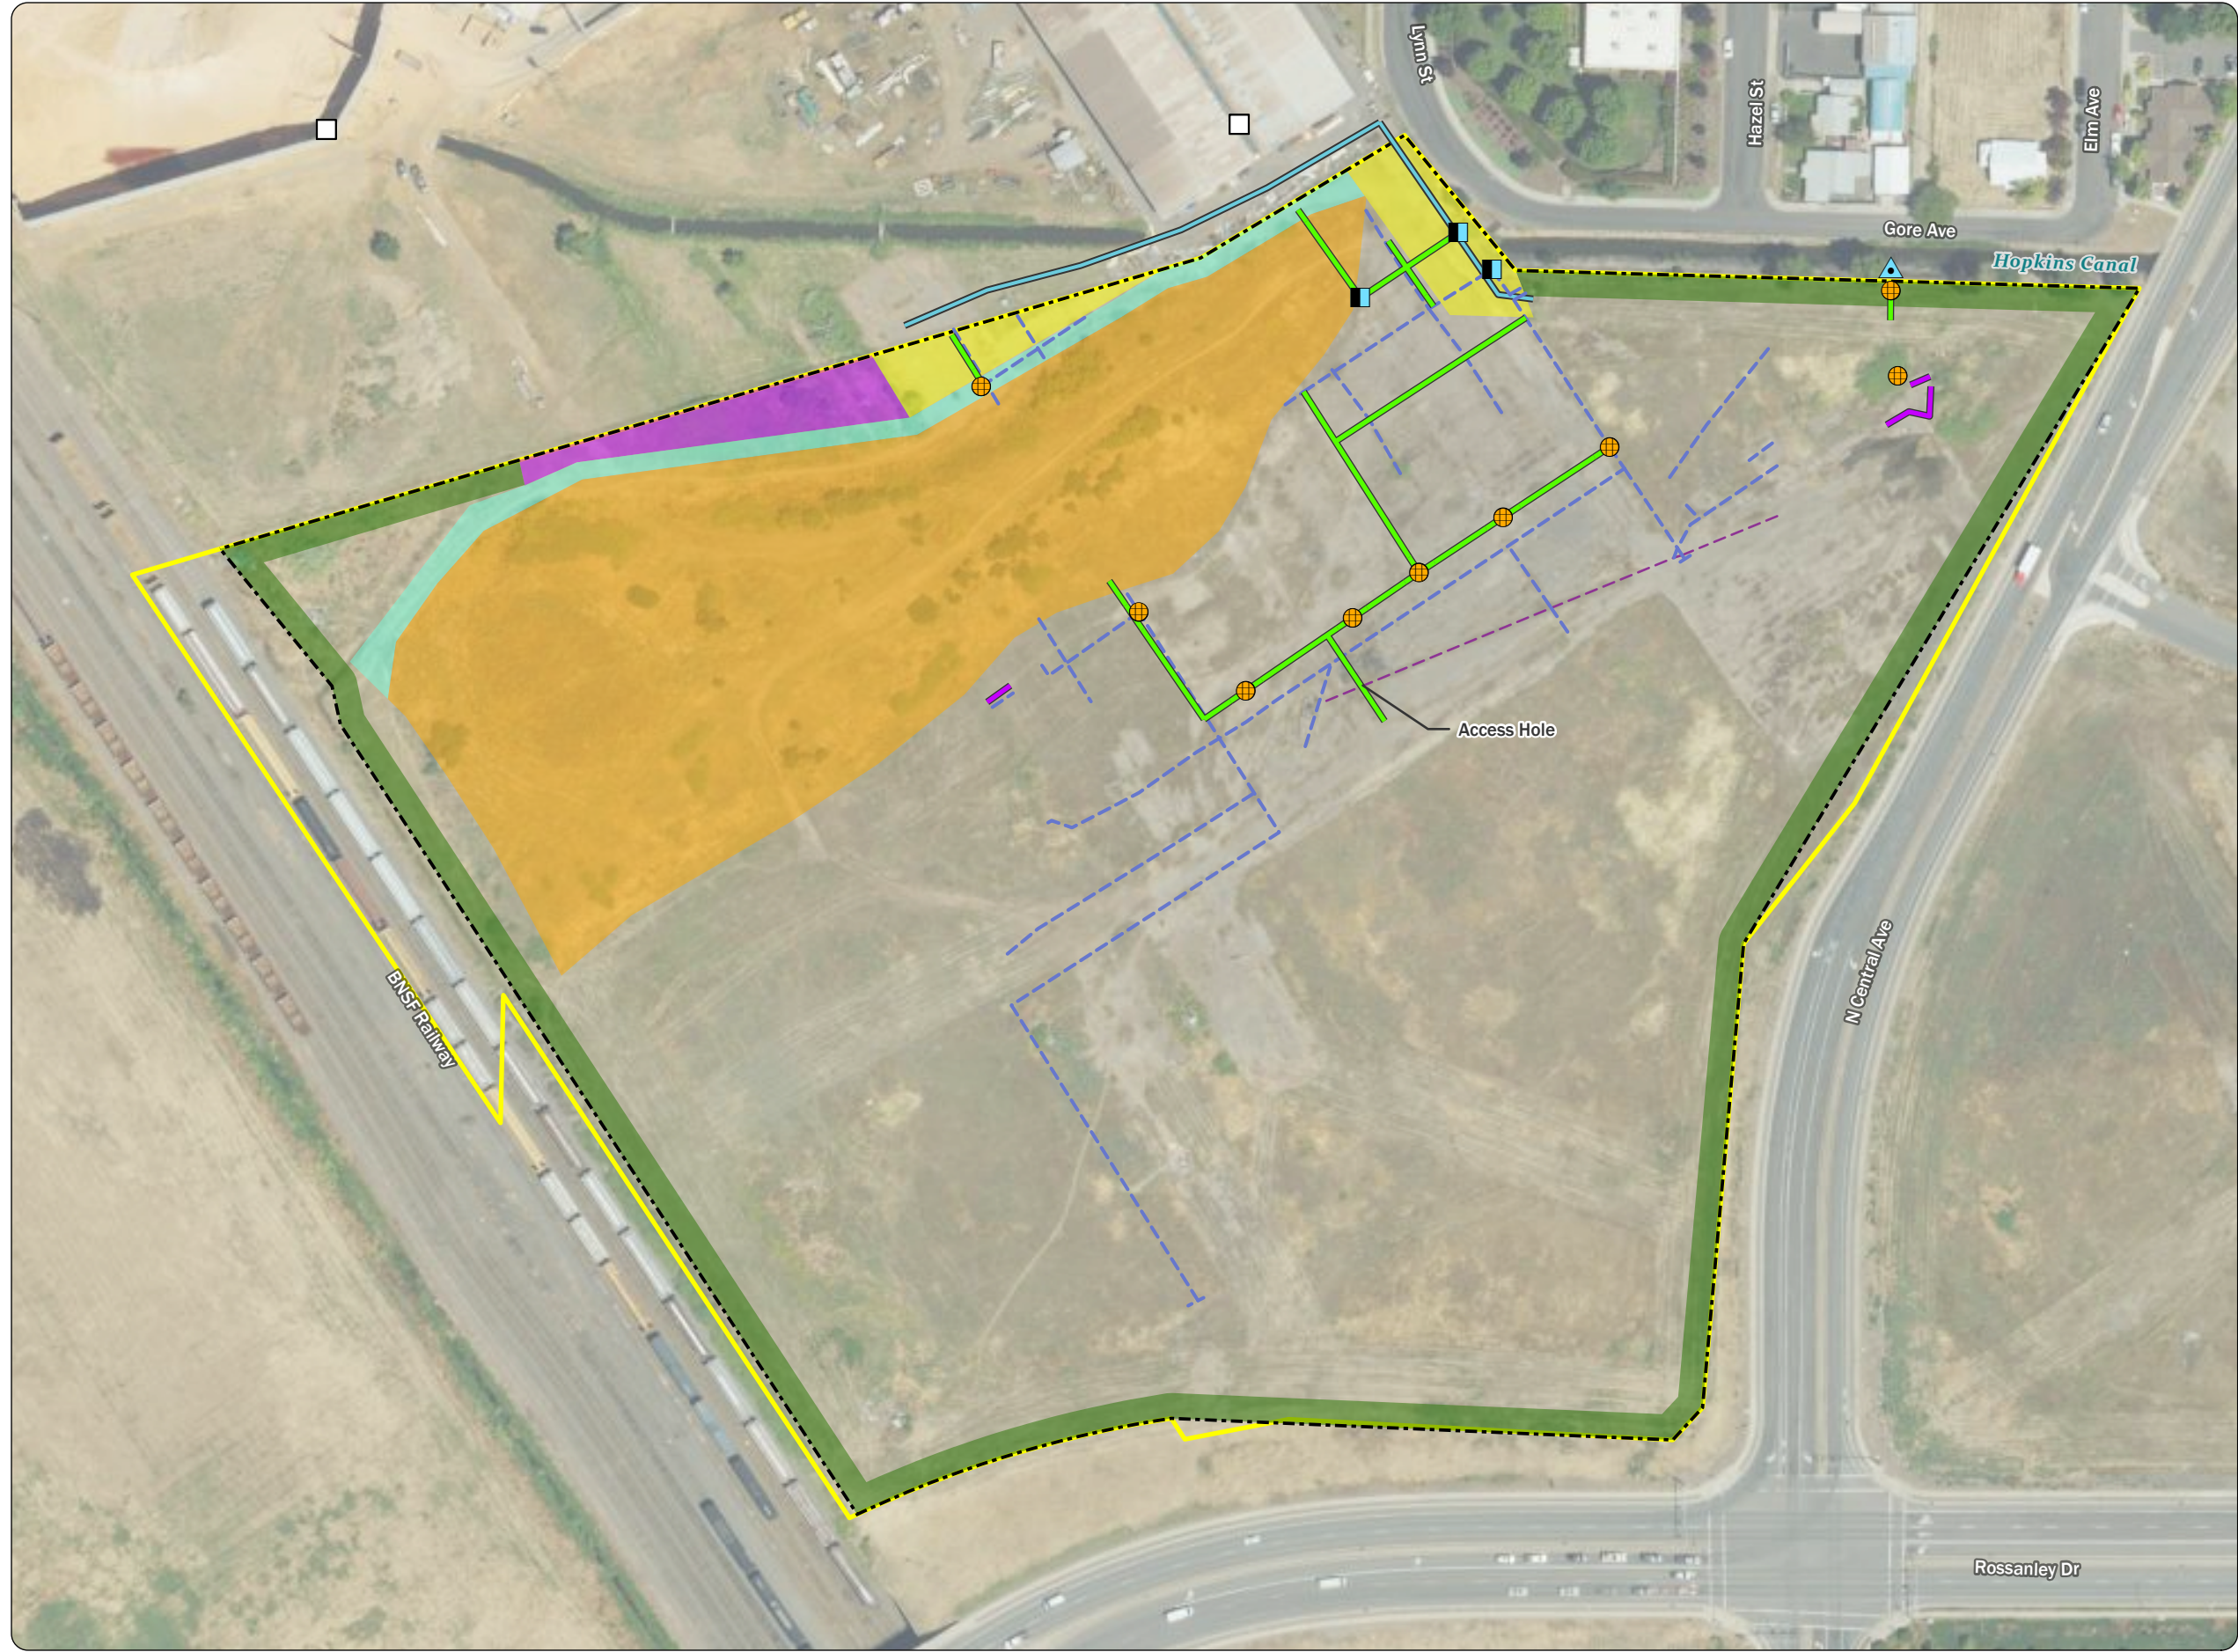
**Figure 2-1  
Completed  
Remedial Actions**  
Roseburg Forest Products  
Tax Lots 500 and 600  
North Central Avenue  
and Rossanley Drive  
Medford, OR

RFP hired Medford Fence Company (MFC) to install fencing around the perimeter of the Property (see Figure 2-1). MFC began the project in August and completed the installation of 7-foot-tall chain link fence topped with barbed wire in December 2024 (see photos in Appendix A). No trespassing signage and gates were installed at key areas along the perimeter. MFC employed mechanical methods, such as an electric auger and other equipment for drilling the post holes and setting the fence poles. No work was performed in the treated soil stockpile area. Less than five cubic yards of soil were impacted as part of the project, and all soil disturbed remained on the Property.

Prior to completion of the fence, RFP retained a private security company to provide 24/7 security on the Property (July through December 2024). As an additional security measure beyond the installation of fencing and gates on the perimeter of the Property, two infrared cameras were installed on the active portion of the RFP mill facility to overlook the Property (see photo in Appendix A). The cameras were installed by RFP personnel between March 10 and 14, 2025, and their locations are indicated on Figure 2-1.

The location of planted landscape vegetation is shown on Figure 2-1, and a representative photo of the plantings is included in Appendix A.

Based on geophysical surveys and visual observations conducted in May 2022 and December 2024, the extent of the remaining stormwater system was delineated.<sup>1</sup> Subsequently, the stormwater system was decommissioned by general contractor, Tom Willis, from February 12 through 14, 2025 as per the *Stormwater Decommissioning Work Plan*. The work was observed and documented by MFA field staff. Soil generated during the work was placed back into the excavations after stormwater features (piping runs, manholes/catch basins, etc.) were grouted in place (see photos in Appendix A). The locations of decommissioned stormwater features are shown on Figure 2-1.

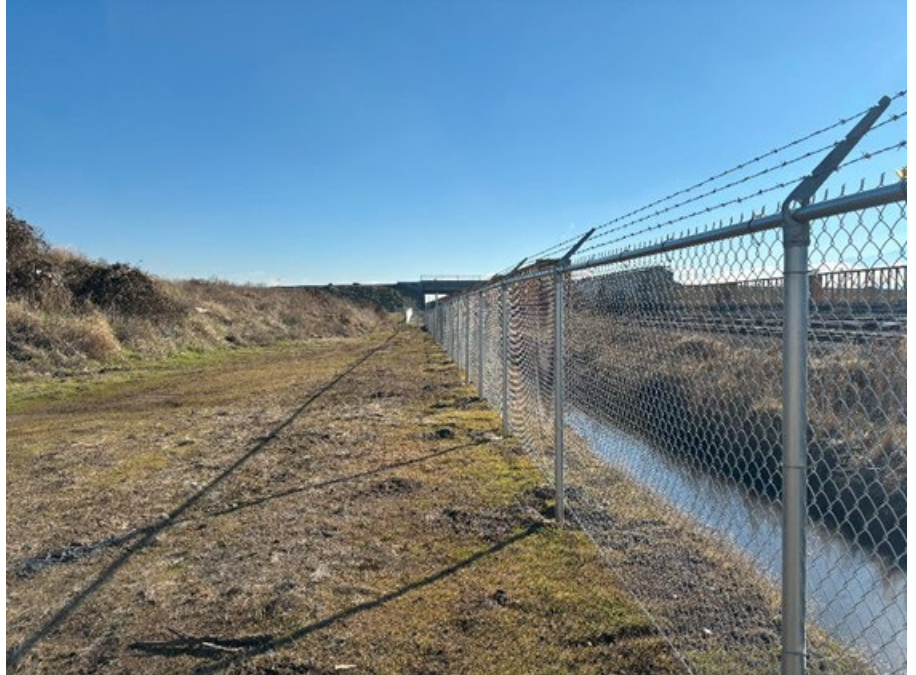
Fence constructed on the west property boundary, facing southeast. Photo date: December 9, 2024.

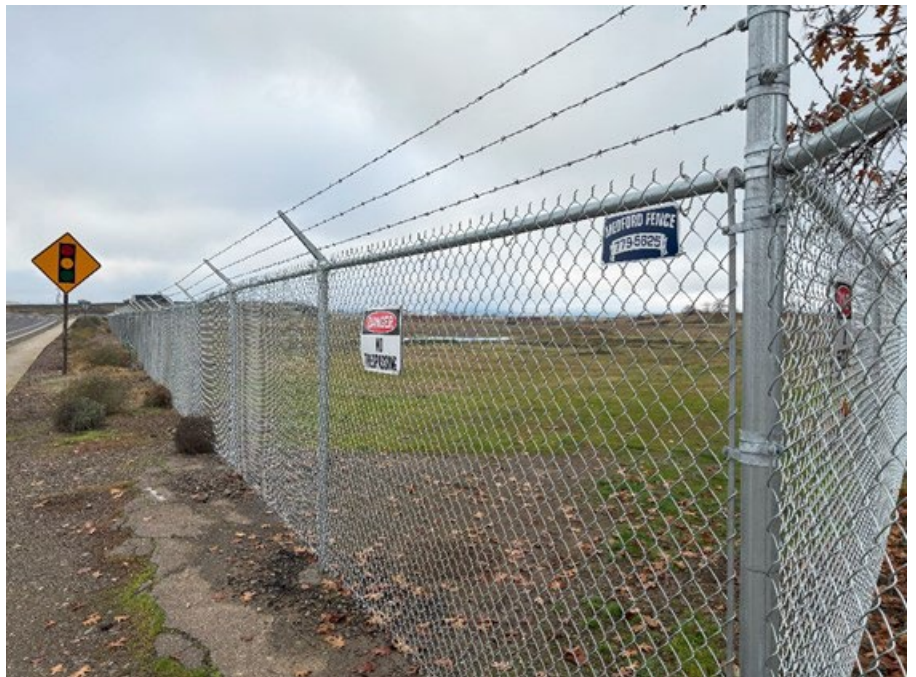
## Photo No. 2.

Fence with signage constructed on the north and east property boundaries, facing southwest. Photo date: December 9, 2024.

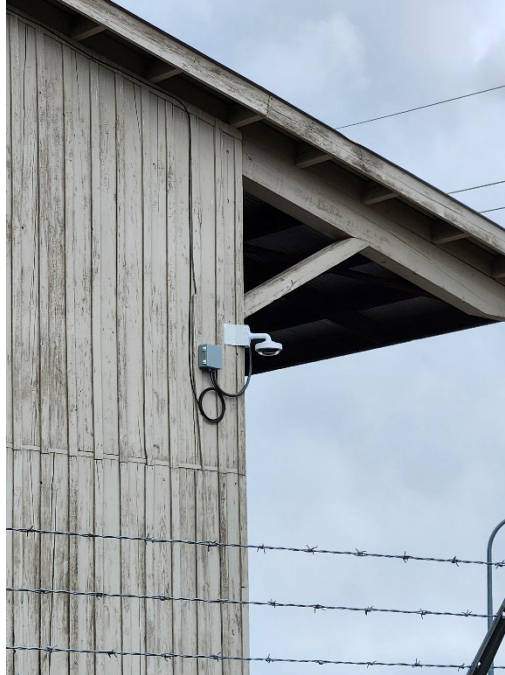
Infrared camera  
installed near north  
property boundary.  
Photo date: April 2,  
2025.

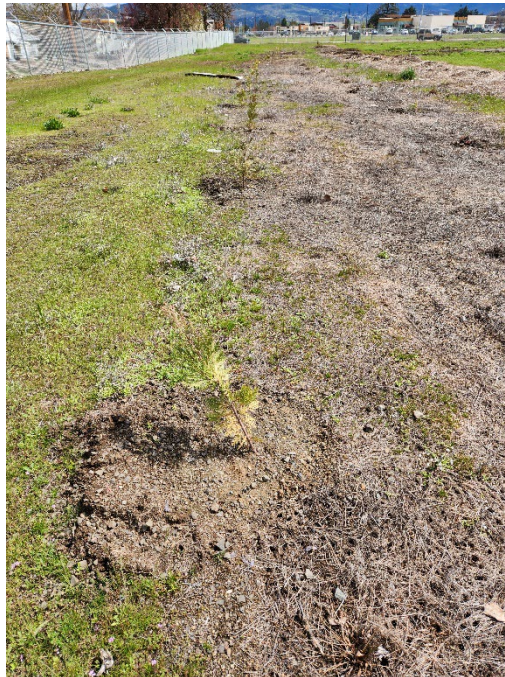
## Photo No. 4.

Planted trees near  
northeast corner of the  
property, facing east.  
Photo date: April 2,  
2025.

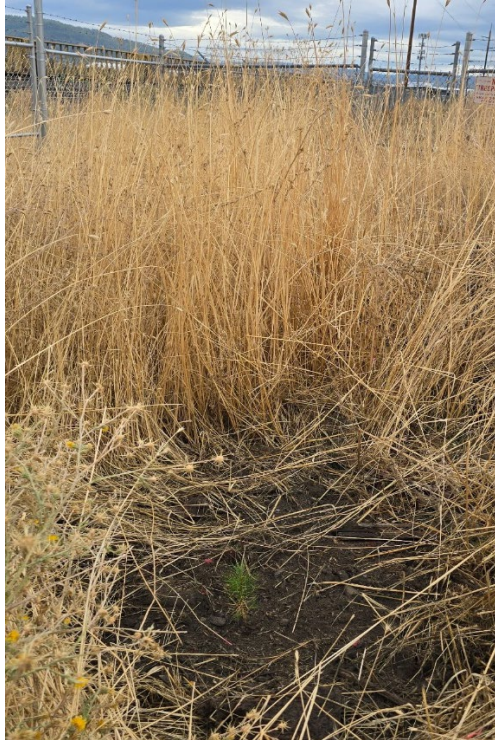
View of example tree  
planting near the  
northwest corner of the  
property. Photo date:  
September 30, 2025.

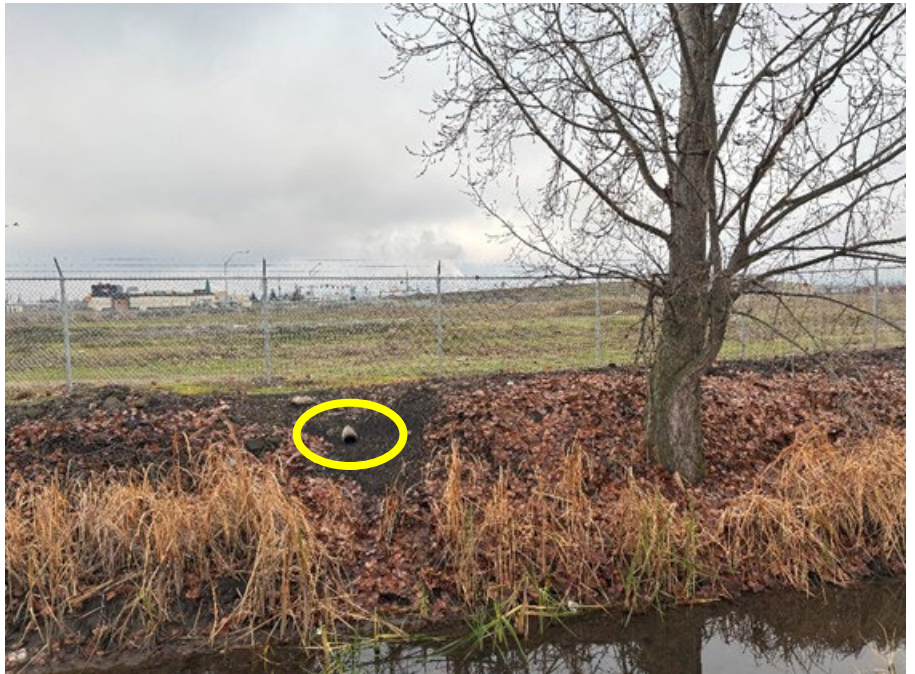
## Photo No. 6.

Stormwater pipe  
discharge location to  
Hopkins Canal on the  
northeast portion of the  
property, facing south,  
prior to stormwater  
system  
decommissioning.  
Photo date: December  
9, 2025.

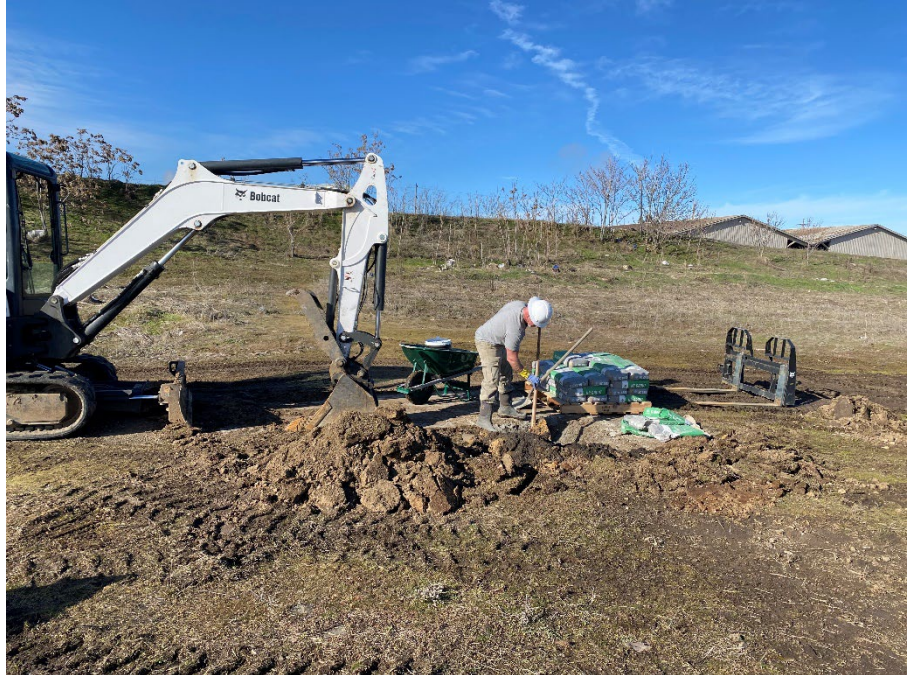
Contractor decommissioning former stormwater system vault, facing northwest. Photo date: February 12, 2025.

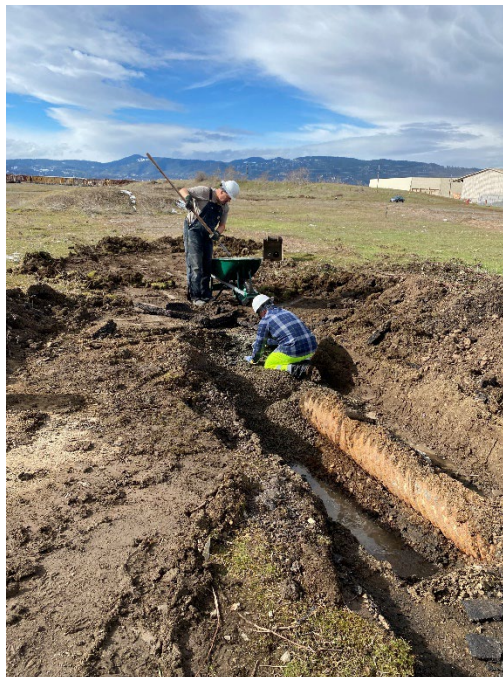
## Photo No. 8.

Contractor decommissioning former stormwater system line, facing west. Photo date: February 13, 2025.

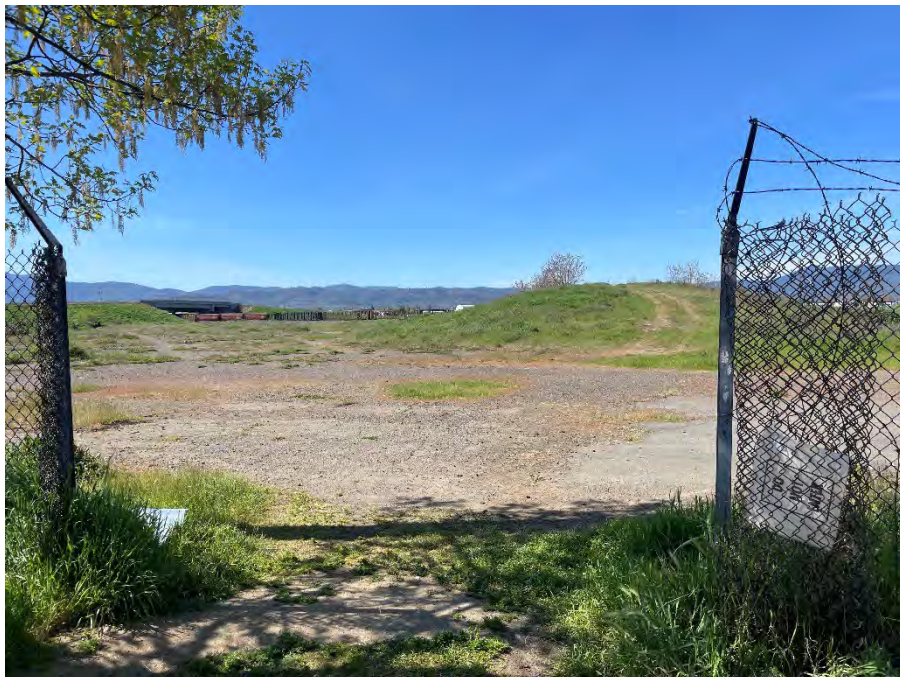
Paved property  
entrance, facing  
west/southwest.

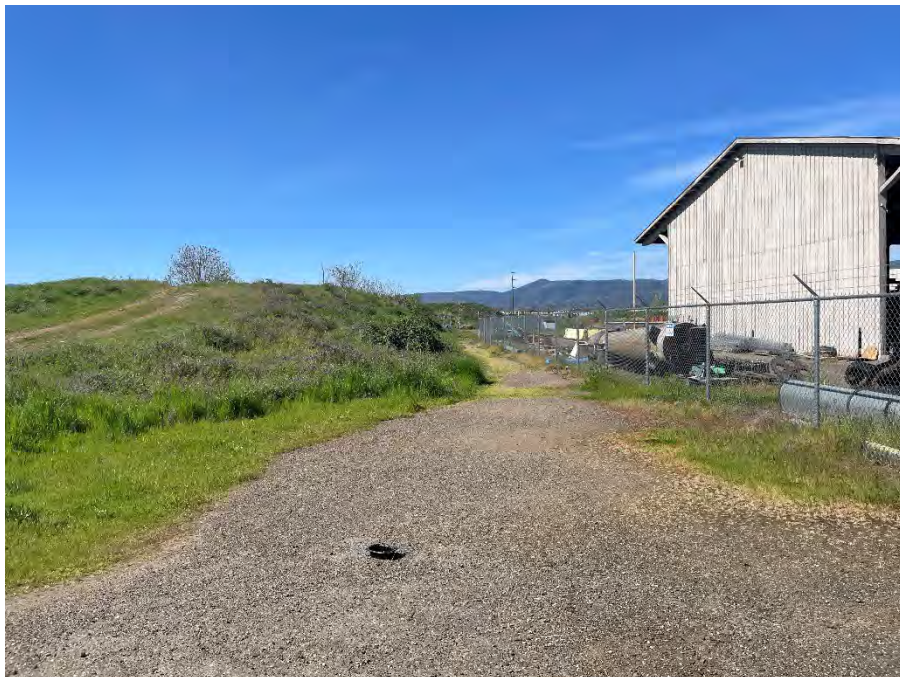
## Photo No. 2.

Vegetated berm and  
gravel access road from  
the paved property  
entrance shown in Photo  
No. 1, facing west.

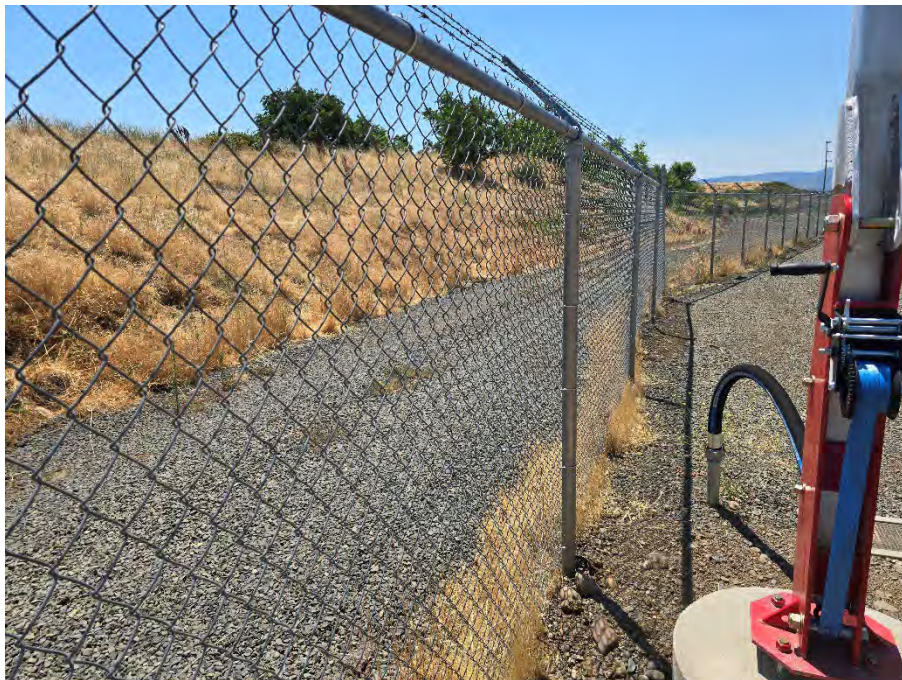
Graveled access road  
(continued from Photo  
No. 2) between the  
north property boundary  
and the vegetated berm,  
facing west/southwest.

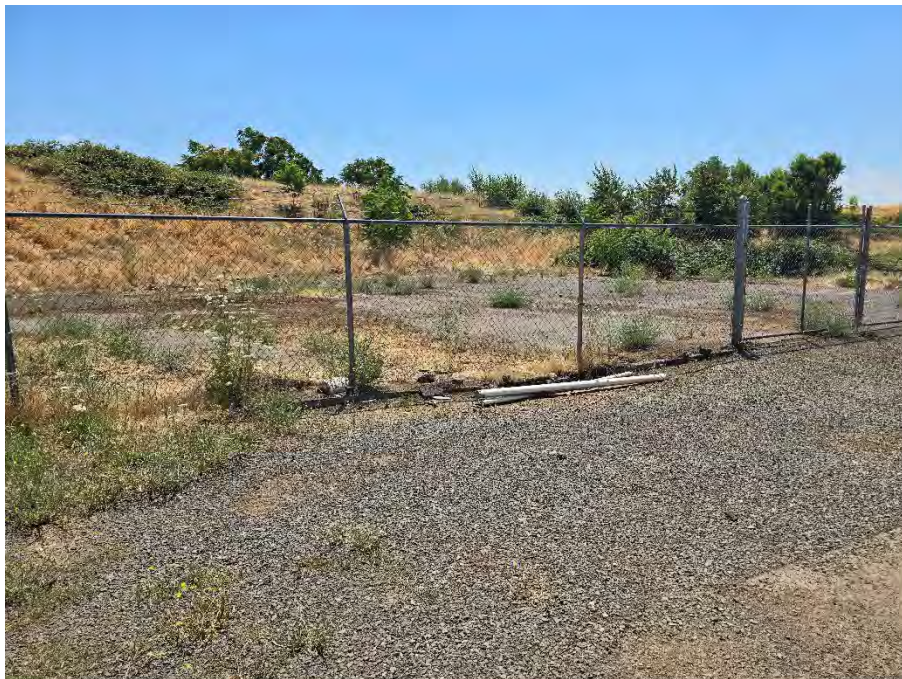
## Photo No. 4.

Paved area between the  
north property boundary  
and the vegetated soil  
berm, west of the gravel  
access road shown in  
Photo No. 3. Photo  
facing south/southwest.

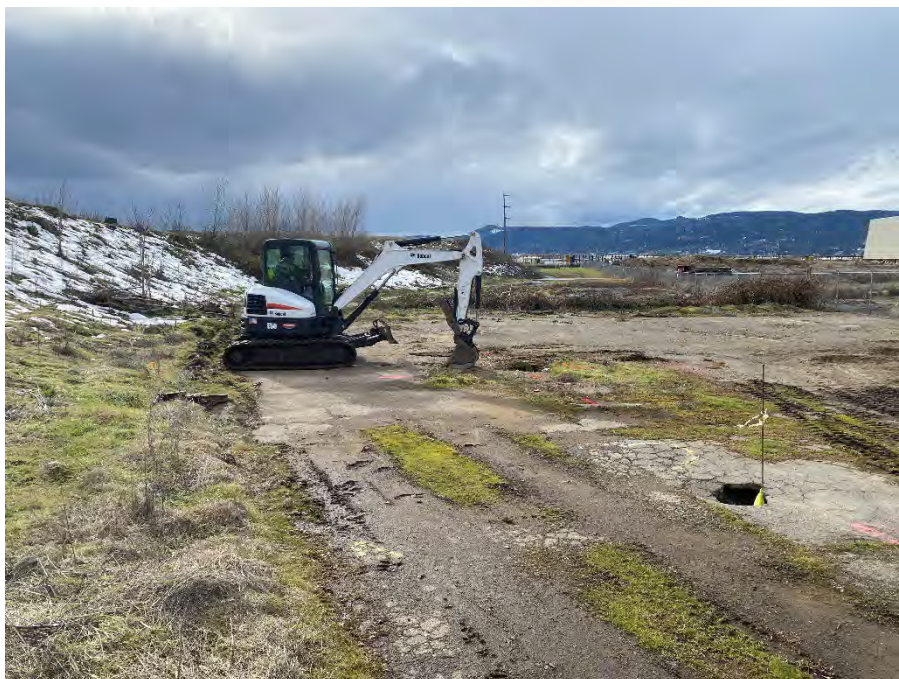
Paved area between the  
north property boundary  
and the vegetated soil  
berm. Photo facing west.

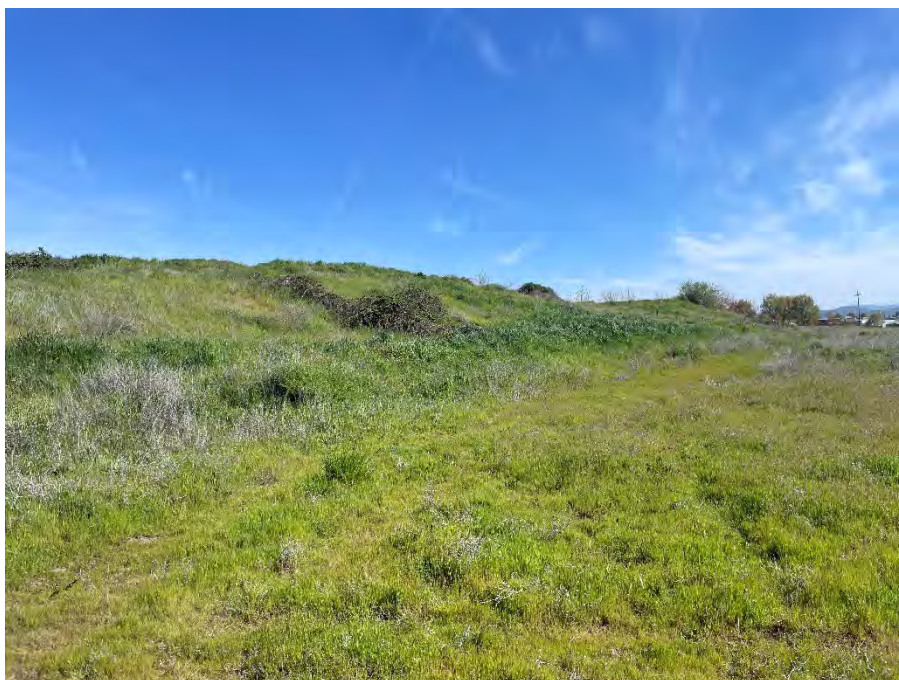
## Photo No. 6.

South side of the  
vegetated berm, facing  
east/northeast.

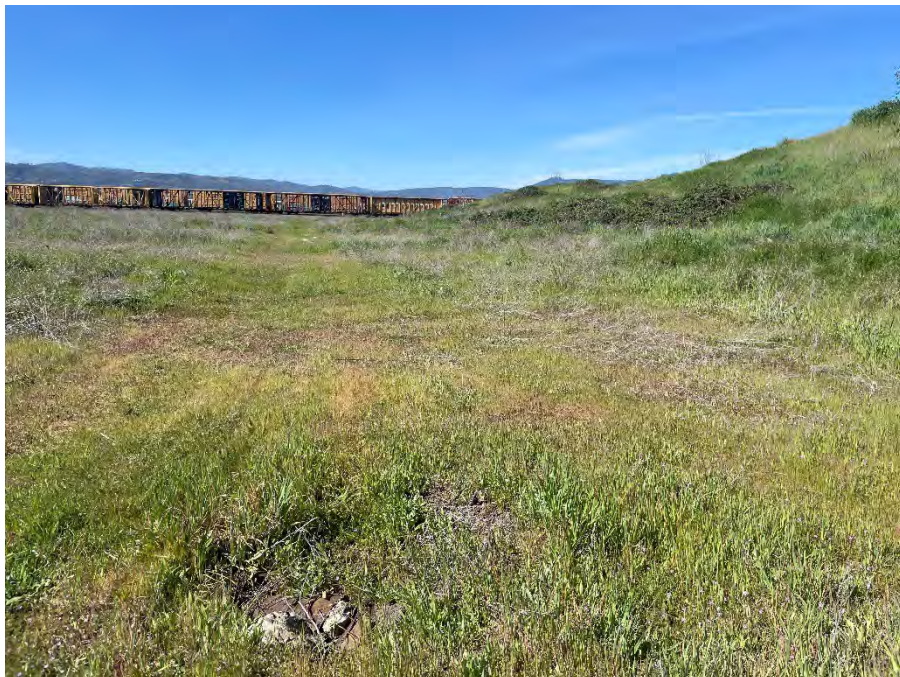
South side of the  
vegetated berm, facing  
west/northwest.

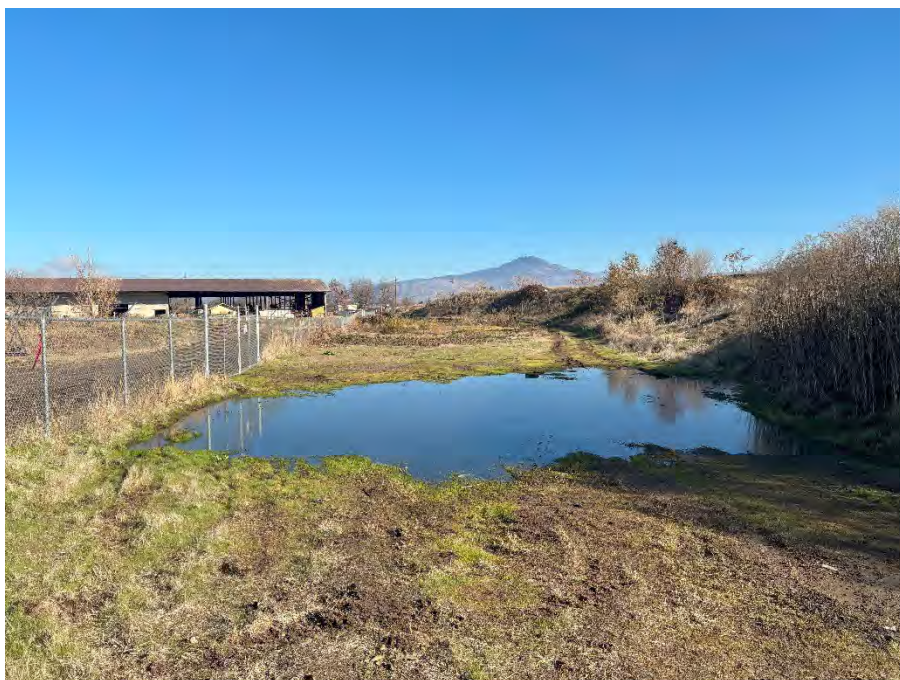
## Photo No. 8.

Grass area between the  
north property boundary  
and the vegetated berm  
(see purple area on the  
Figure). Photo facing  
east.

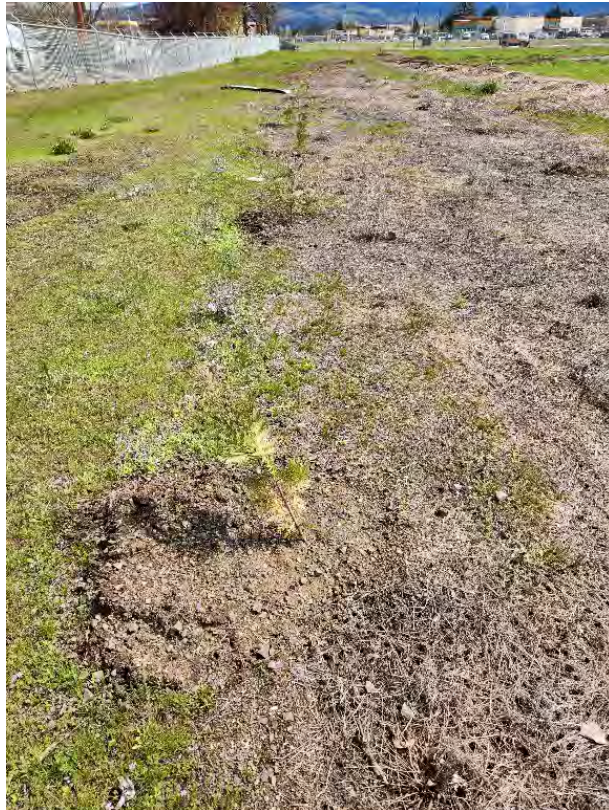
Vegetation (trees) planted along the northeast property fence line in spring 2025. Remaining areas shown in red on the attached Figure to receive similar planting in September, 2025.
