Department Environmental Quality  
Eastern Region Pendleton Office  
800 SE Emigrant Ave., Suite 330  
Pendleton, OR 97801  
(541) 276-4062

RE: **Pre-Enforcement Notice**  
Incident 2025-01551, Red Boy Mining Complaint  
2025-PEN-10006  
Unpermitted Source  
WQ – Grant County

RE: **Incident 2025-01551**, Red Boy Mining Complaint  
DEQ Staff: Anna Morgan-Hayes  
Site Visit: October 7, 2025

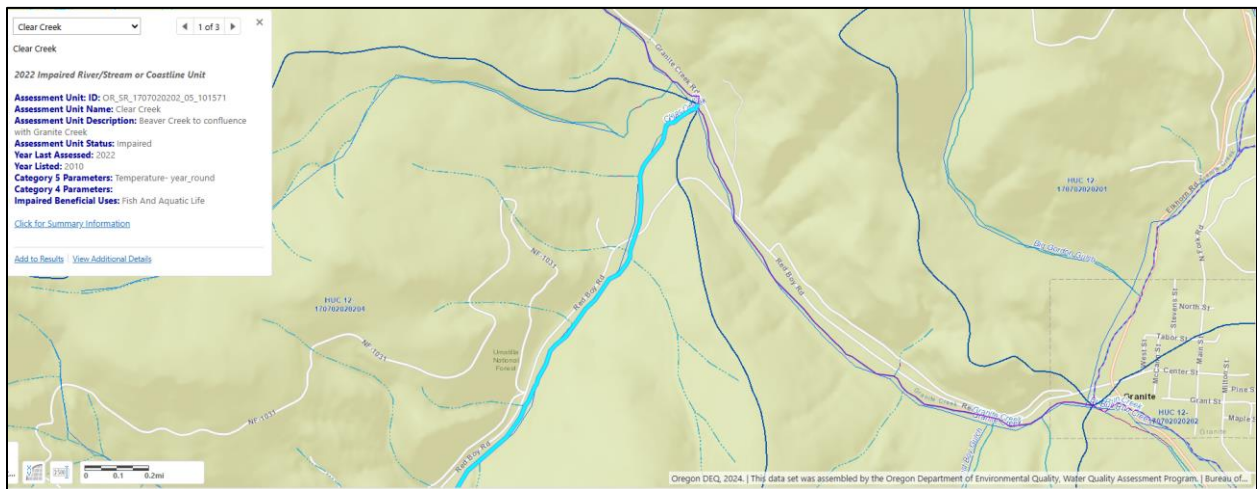
The property encompasses 67 acres, approximately 26 ponds, and is adjacent to perennial streams, Clear Creek, to the immediate east, which confluences with Granite Creek on the north boundary. The property is located within the Clear Creek subwatershed (HUC 12 170702020204) and contains several intermittent streams which flow to Clear Creek. Clear Creek is listed as an impaired stream in the 2022 Integrated Report (Appendix 2).

Figure 2. Stream Location Identifier, Clear Creek, Oregon DEQ, 2024

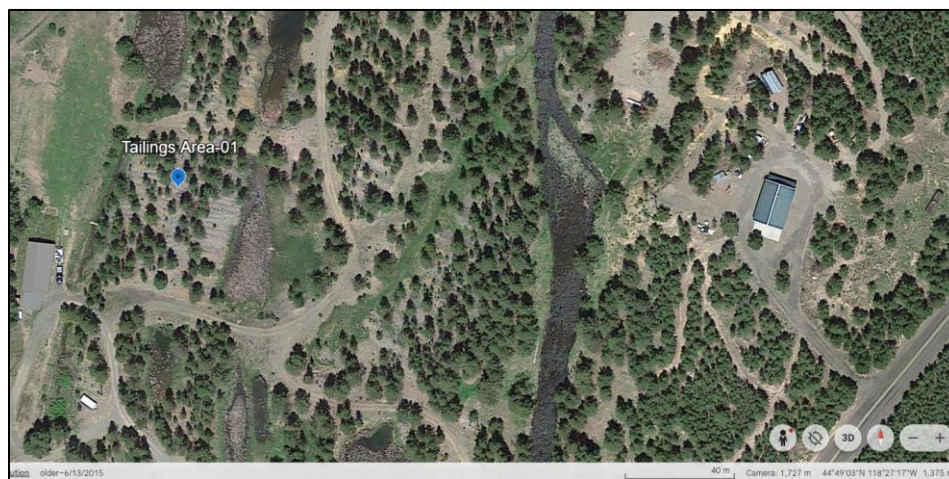
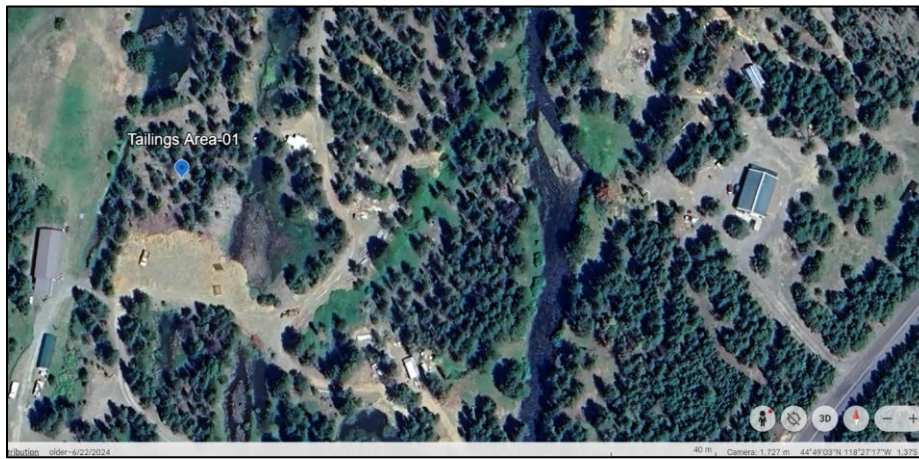
“Tailings Area-01”, located at  $44^{\circ}49'03''N$   $118^{\circ}27'20''W$ , shows an expansion of activity between 2020 and 2024. The most recent imagery available indicates that a dump truck and backhoe were located onsite, along with an area that has been cleared and tailings removed from the site. Previous records (2015) of the dates are provided for reference.

Figure 4. Historic Satellite Imagery at Tailings Area-01, June 13, 2015, Google Earth Airbus

Figure 5. Historic Satellite Imagery at Tailings Area-01, August 30, 2020, Google Earth Airbus

Figure 6. Historic Satellite Imagery at Tailings Area-01, June 22, 2024, Google Earth Airbus

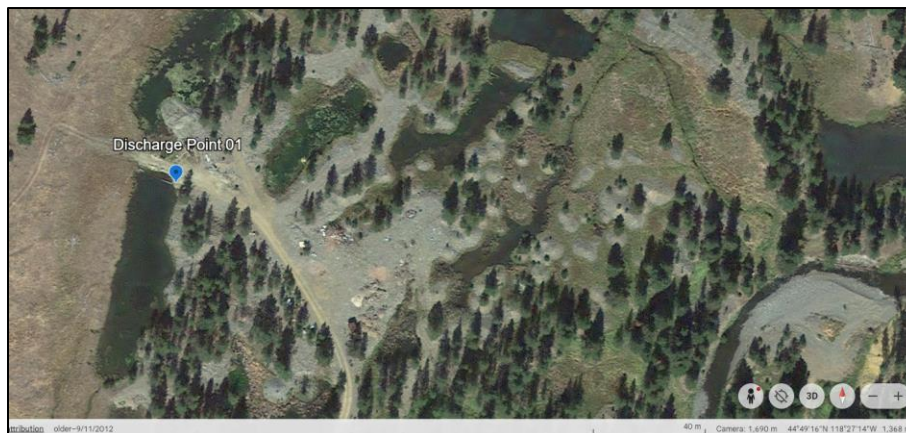
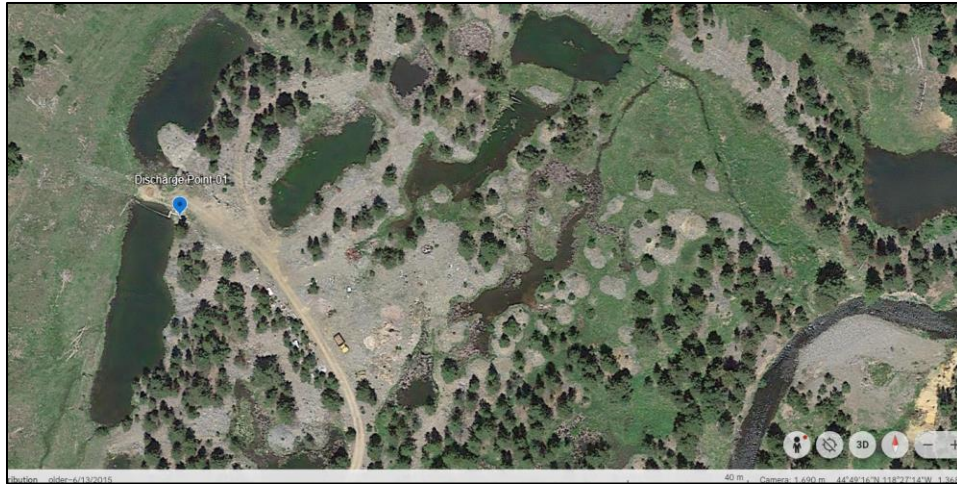
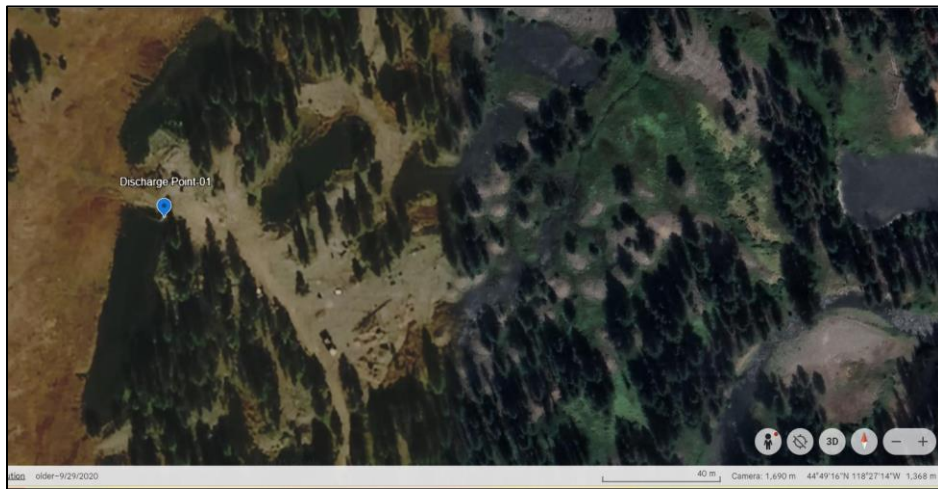
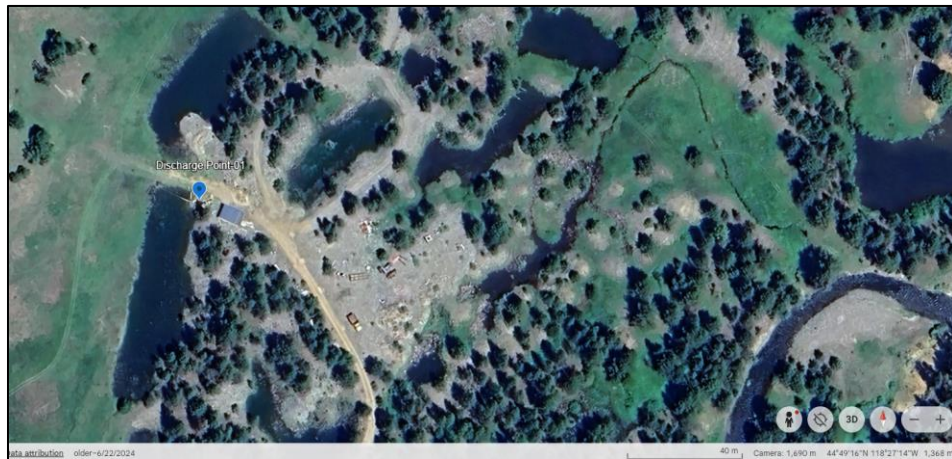
North of Tailings Area-01, a site “Discharge Point-01” located at 44°49'16"N 118°27'16"W, also shows an increase in activity in recent years in and around the site. Imagery indicates an increase in equipment in and clearing of the area east of the Discharge Point-01.

Figure 7. Historic Satellite Imagery at Discharge Point-01, September 11, 2012, Google Earth Airbus

Figure 8. Historic Satellite Imagery at Discharge Point-01, June 13, 2015, Google Earth Airbus

Figure 9. Historic Satellite Imagery, Discharge Point-01, September 29, 2020, Google Earth Airbus

Figure 10. Historic Satellite Imagery, Discharge Point-01, June 22, 2024, Google Earth Airbus

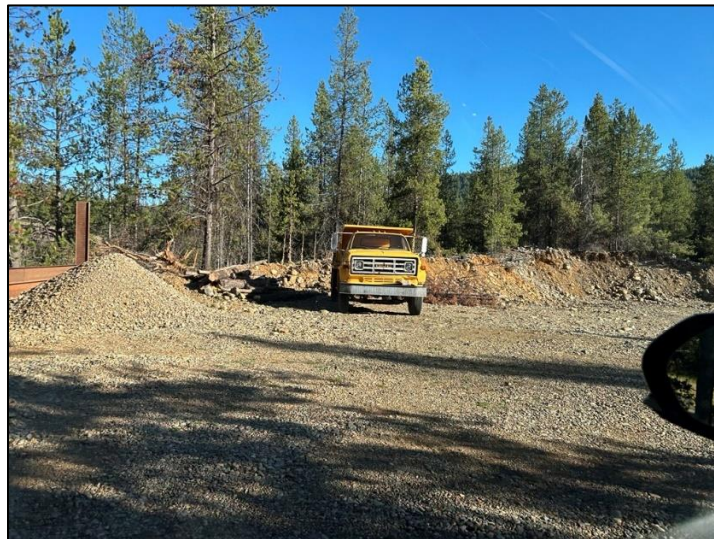
Mining activities were not occurring during the site visit. The property owner confirmed that the activities had seasonally ceased. The first location during the visit was at Tailings Area-01. The property owner described the activity at this location as where a dump truck would gather tailings (Figure 11) which would then be screened through the Grizzly feeders (Figure 12). Observations of the area confirmed that tailings had been systematically processed in this manner.

*Figure 11. Tailings Area-01, Dump Truck, October 7, 2025, facing North approximately 158 yards west of Clear Creek, DEQ*

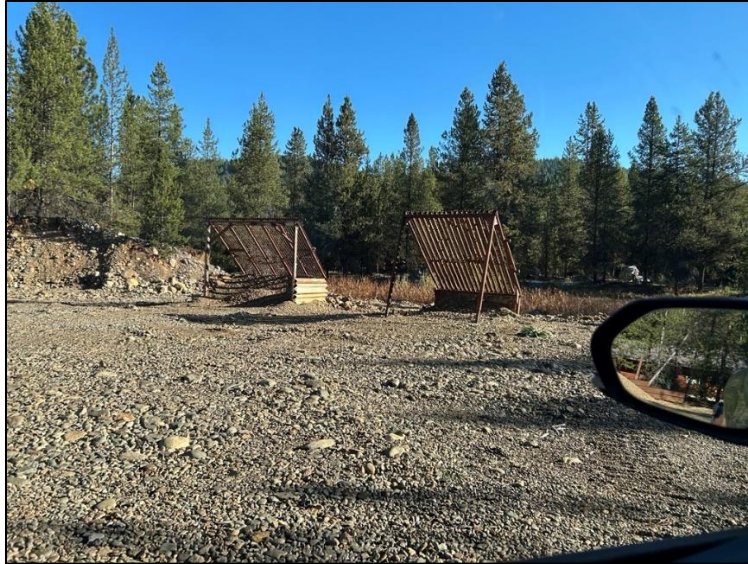
*Figure 12. Tailings Area-01, Grizzly Feeders, October 7, 2025, facing Northeast, approximately 150 yards west of Clear Creek, DEQ*

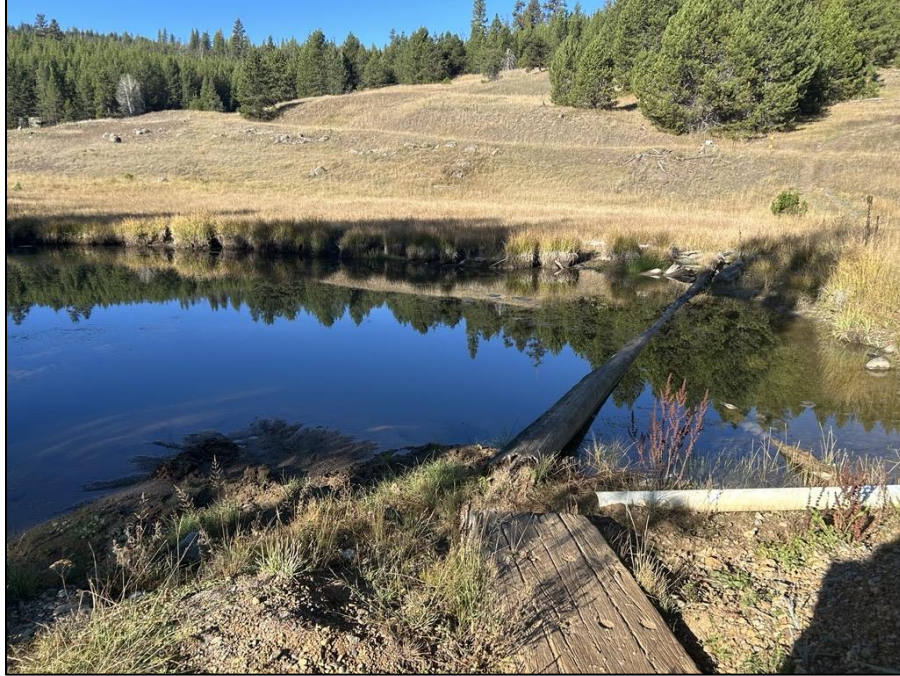
At the second location, Discharge Point-01, the property owner described a process by which the smaller materials were processed through a sluice box using a pump and piped water from the adjacent pond (Figure 13). After processing tailings through the sluice box, fines are discarded on the ground and/or distributed around the property, and water is returned to the pond (Figures 16 and 17). The property owner described aquatic life in the pond as small fish (shiners, a minnow species). Observations of the pond confirmed evidence of piping for discharge and fine sediment around the banks and settled on the bottom (Figure 14).

*Figure 13. Discharge Point-01, Pond and piping, October 7, 2025, facing west approximately 220 yards west of Clear Creek and 260 yards southwest of Granite Creek, DEQ*

### **Immediately cease unpermitted discharge of mining wastewater to waters of the state or to land surface.**

1. There is evidence of unpermitted wastewater discharge into waters of the state from the mining operations at Discharge Point-01 pond since 2024. This pond is used as a settling pond for the unpermitted mining activities and is conveyed through a series of ponds and by seasonal flow to Granite Creek and Clear Creek. Discharging any waste that enters waters of the state, either without a waste discharge permit or from a discharge point not authorized by a waste discharge permit; OAR 340-012-0055(1)(c), a Class I violation.
2. Gold mining less than 10,000 cubic yards was observed as an activity that occurred at the site since 2024. Operating a discharge source or conducting a discharge activity without first obtaining an individual permit or applying for coverage under a general permit for that discharge or disposal activity; OAR 340-012-0055(1)(d), a Class I violation.

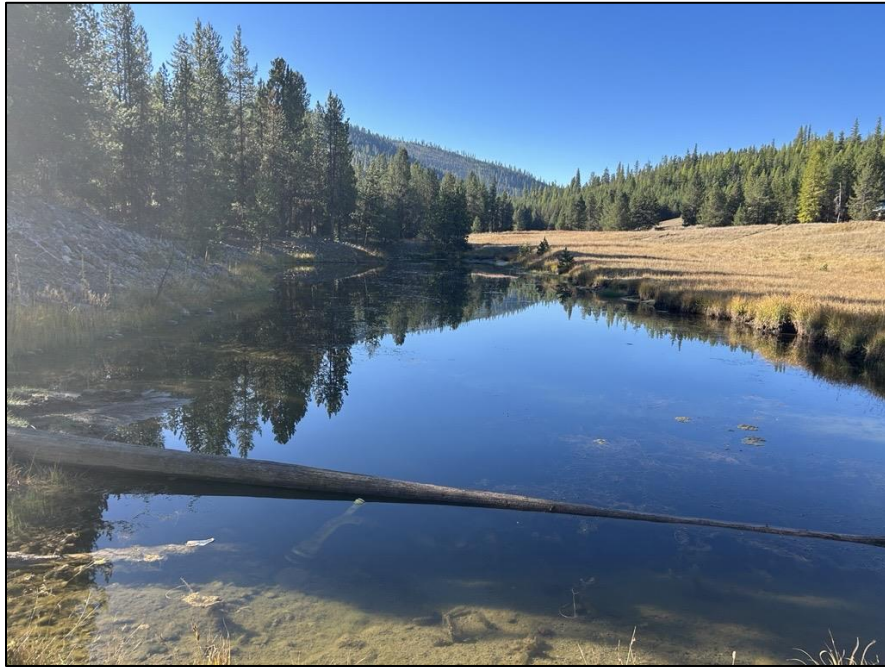
*Figure 14. Discharge Point-01 Pond, piping underwater, October 7, 2025, facing southwest, DEQ*

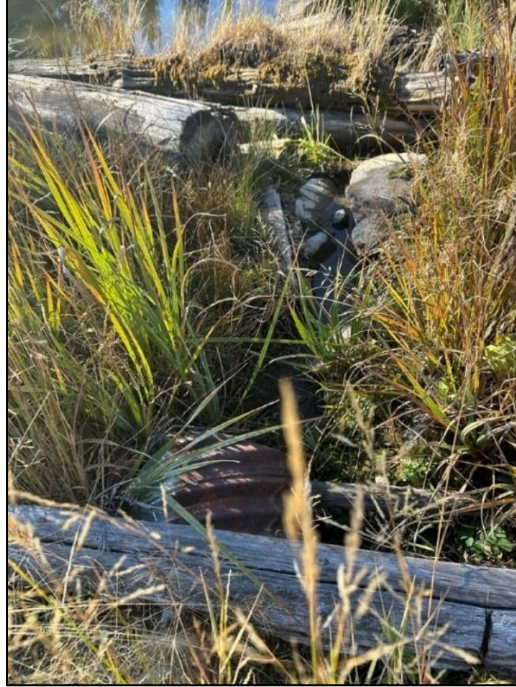
A culvert is located at the north end of the pond, connecting to the pond just north (Figure 15). Visual observations confirm that the natural flow path of water from the pond location is downslope northeast towards Granite and Clear Creek and is influenced by groundwater. The property owner confirmed that high water and overland flow occurred during Spring season. The National Hydrography Dataset flowlines and Statewide flow data provided by the Oregon Department of Forestry both confirm that the ponds are hydraulically connected by stream (Figure 18). The US Fish and Wildlife Service National Wetlands Inventory map the ponds as freshwater ponds and the area with intermittent freshwater emergent wetlands (Figure 19).

*Figure 15. Discharge Point-01, Culvert at north end of pond routing flow to pond north, October 7, 2025, DEQ*

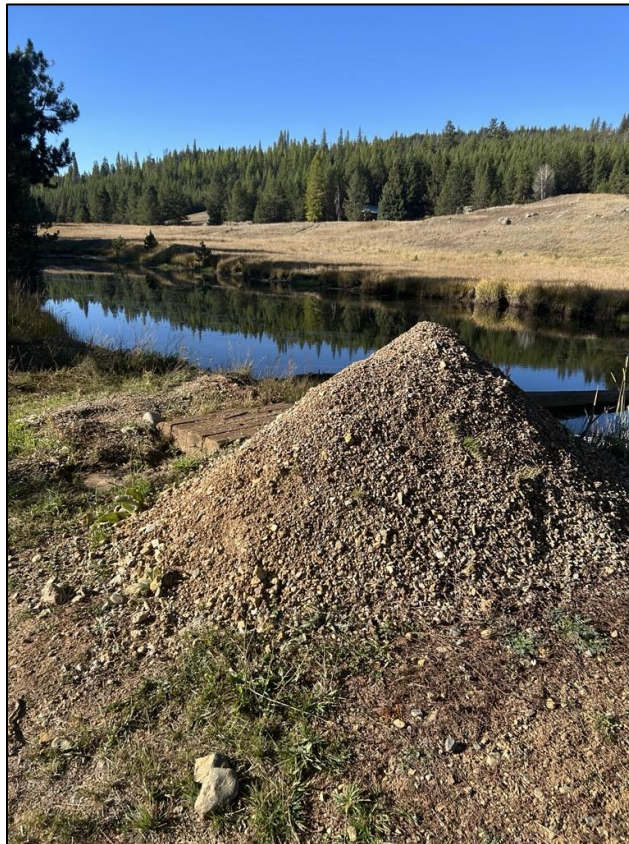
*Figure 16. Discharge Point-01, Discarded fines after processing through sluice box, October 7, 2025, facing southwest, DEQ*

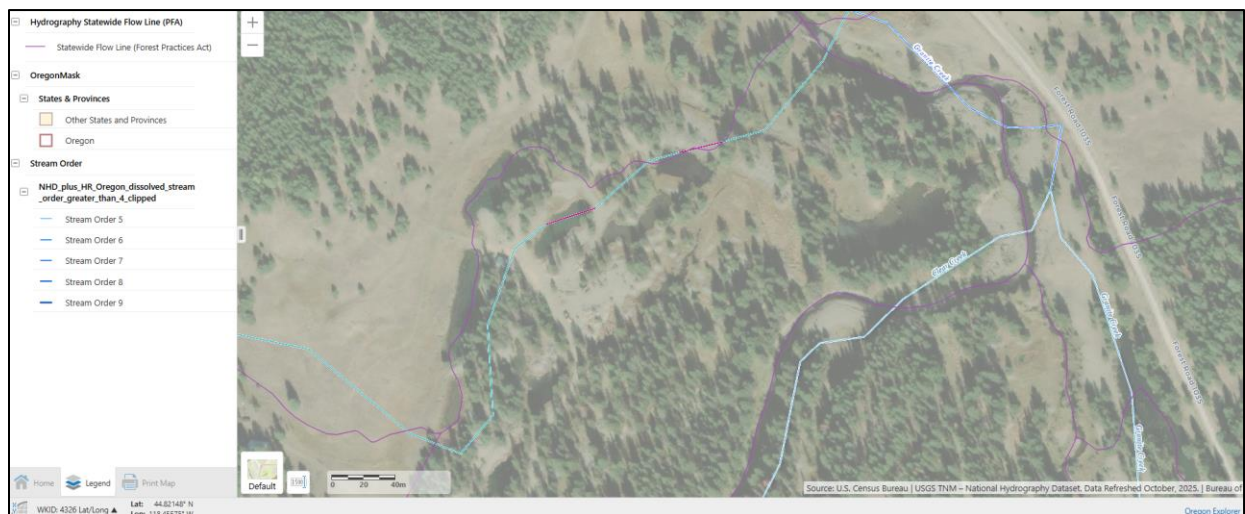
Figure 18. Hydrography Stream Map,
