FOCUSED PHASE II ENVIRONMENTAL SITE ASSESSMENT

McMinnville Honda Dealership

8515 and 3026 Lone Oak Road N.
McMinnville, Oregon

EVREN NORTHWEST, INC.
Project No. 1375-19001-02

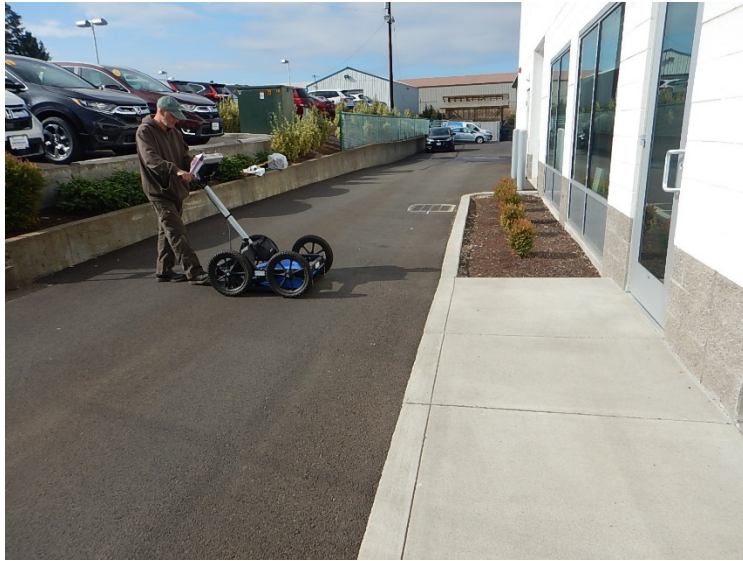
Scanning TL2200 using Ground Penetrating Radar equipment.

Ground Penetrating Radar - GPR uses short impulses of high-frequency radio waves directed into the ground to acquire information about the subsurface. GPR can be used to accurately locate both metallic and non-metallic objects (e.g., USTs, utilities, and drums) from a few inches below the surface to depths of up to 30 feet. GPR may also be effective at delineating trenches and excavations.

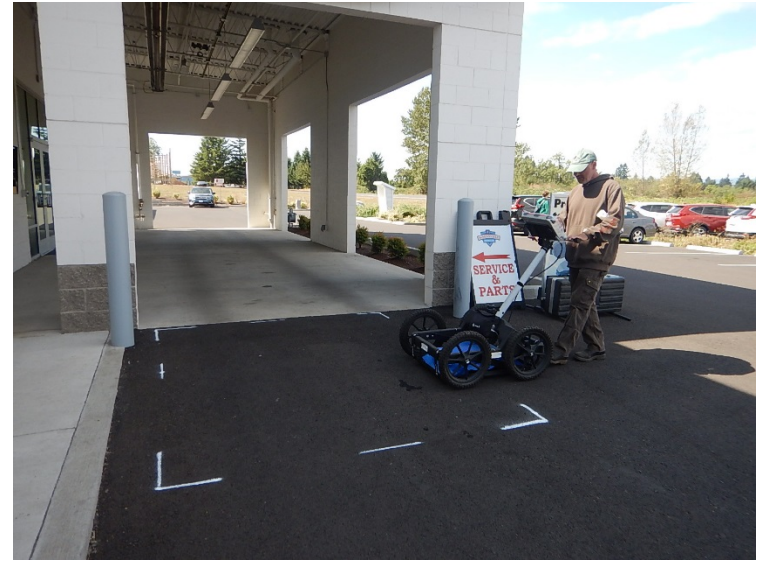
View of magnetic anomaly MA03, interpreted as a former used oil UST area.

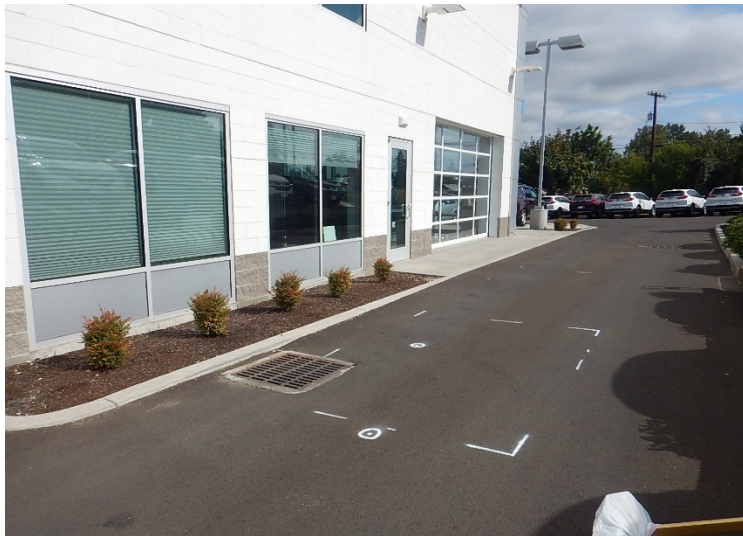
View of magnetic anomaly MA01, interpreted to be the excavation of a reported former gasoline UST.

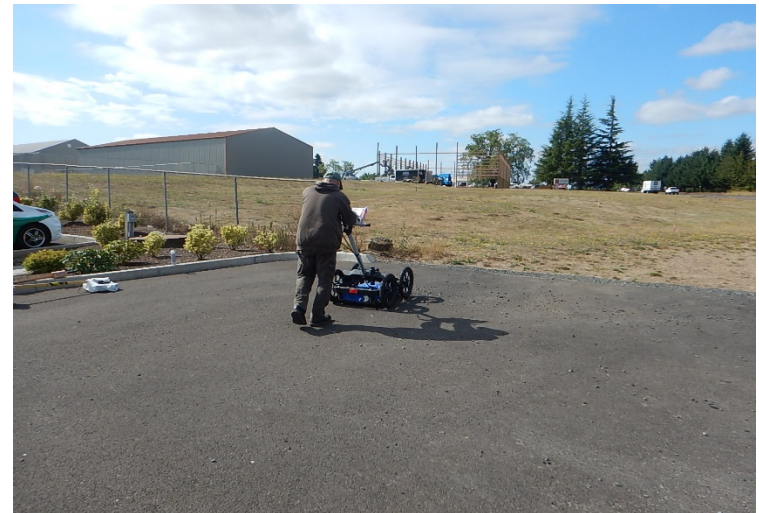
View of magnetic anomaly MA02. Disturbed soils were indicated beneath this area, interpreted to be part of the former Evaporation Pond.

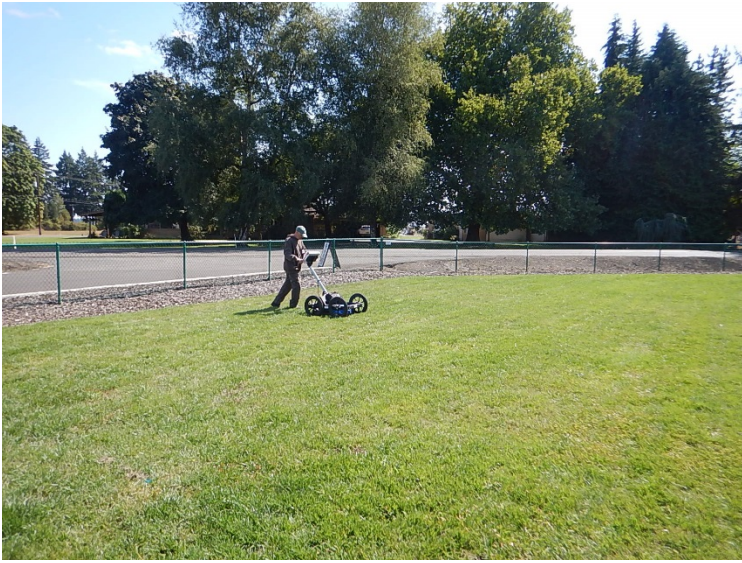
View of the current drain field for the on-site septic system.

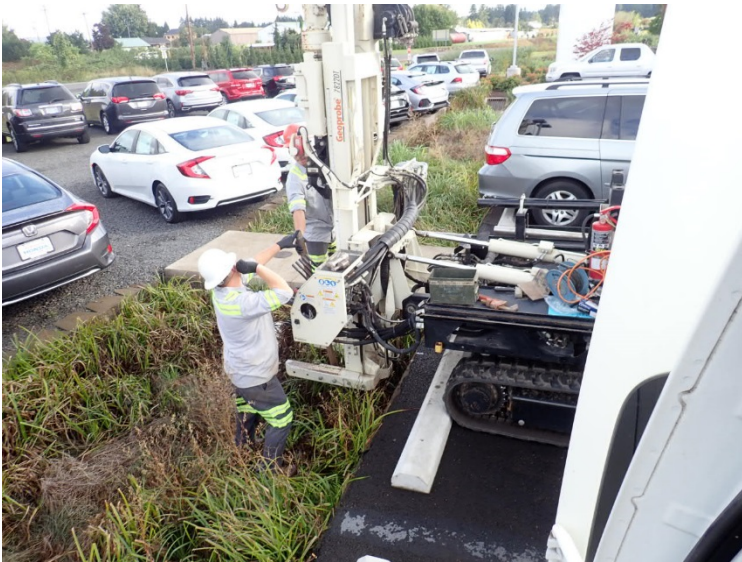
Drilling boring B01 at the storm water bioswale near the western property boundary of TL2200.

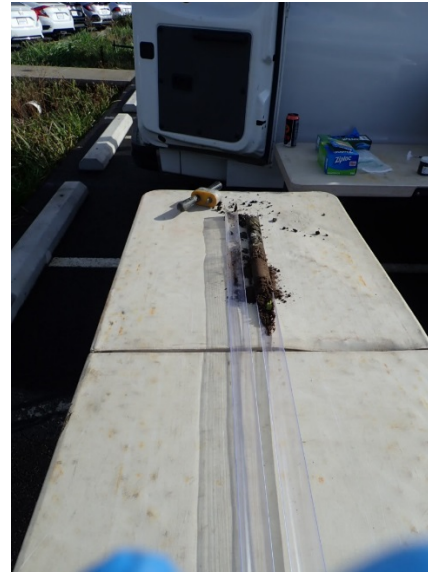
Soil cores retrieved from the drill string were inspected and field screened continuously from the surface to the total depth of each boring.

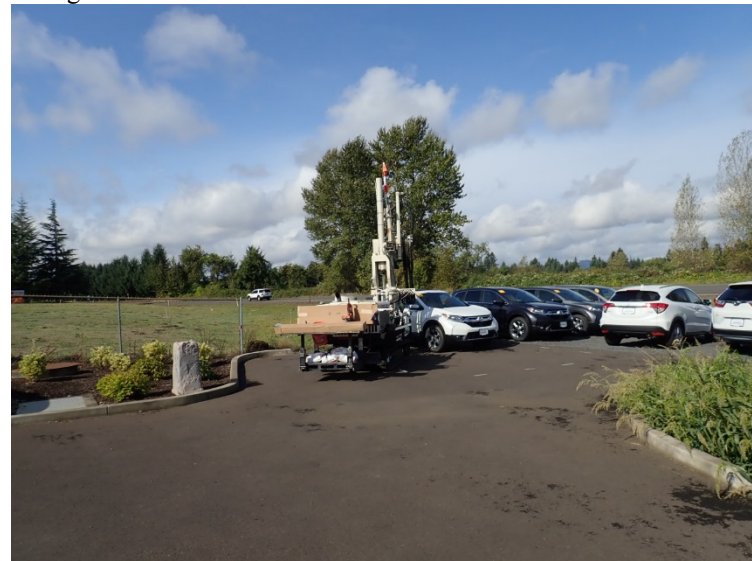
Drilling near the former Evaporation Pond (boring B04).

A moderate petroleum odor and elevated PID readings were noted in boring B04 (area interpreted as former Evaporation Pond) beginning at a depth of seven (7) feet and extending to the soil/ground water interface (at approximately 15 feet bgs). A slight petroleum odor was noted at the 12-foot sample interval in boring B05.

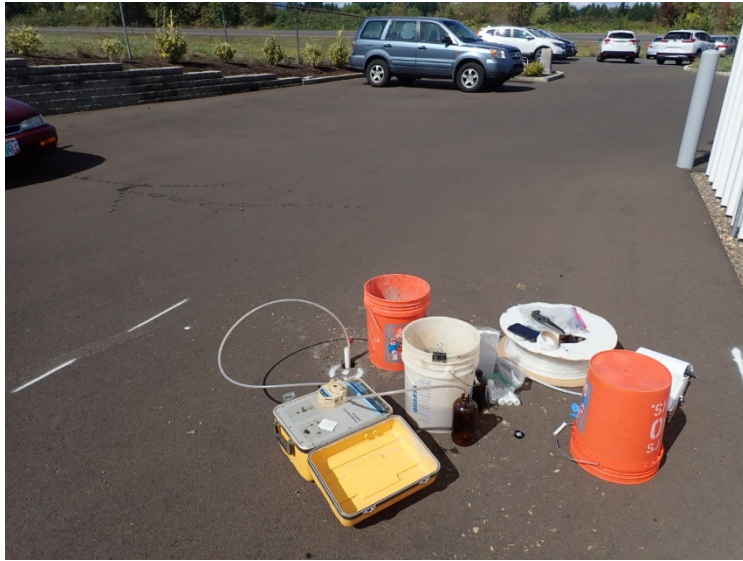
Ground water samples were collected from select borings using a peristaltic pump and dedicated tubing placed in a temporary well casing. Each well was purged prior to sampling.

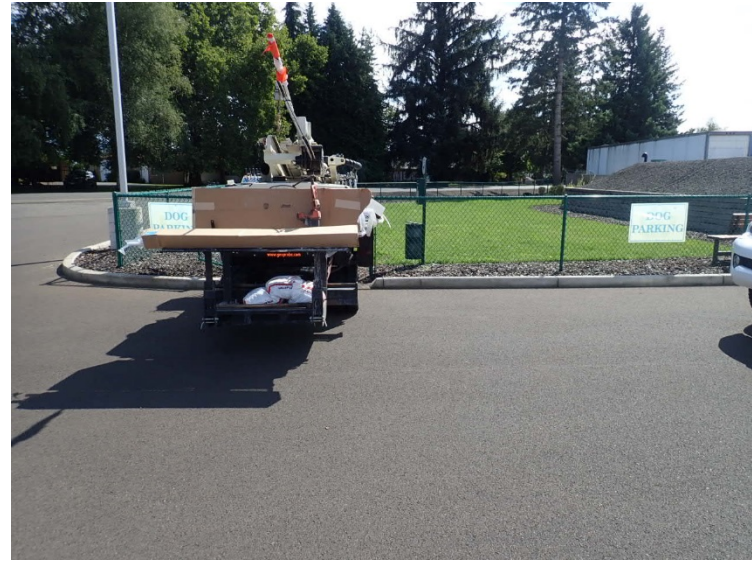
Drilling equipment was steam cleaned between borings to prevent cross-contamination.
