**2009 (Year 2) Monitoring Report  
Santosh Landfill  
Wetland Mitigation Project  
Scappoose, Oregon**

**Prepared for  
Oregon Department of  
Environmental Quality**

**December 30, 2009  
15563-02/Task 4**

Prepared by  
**Hart Crowser, Inc.**

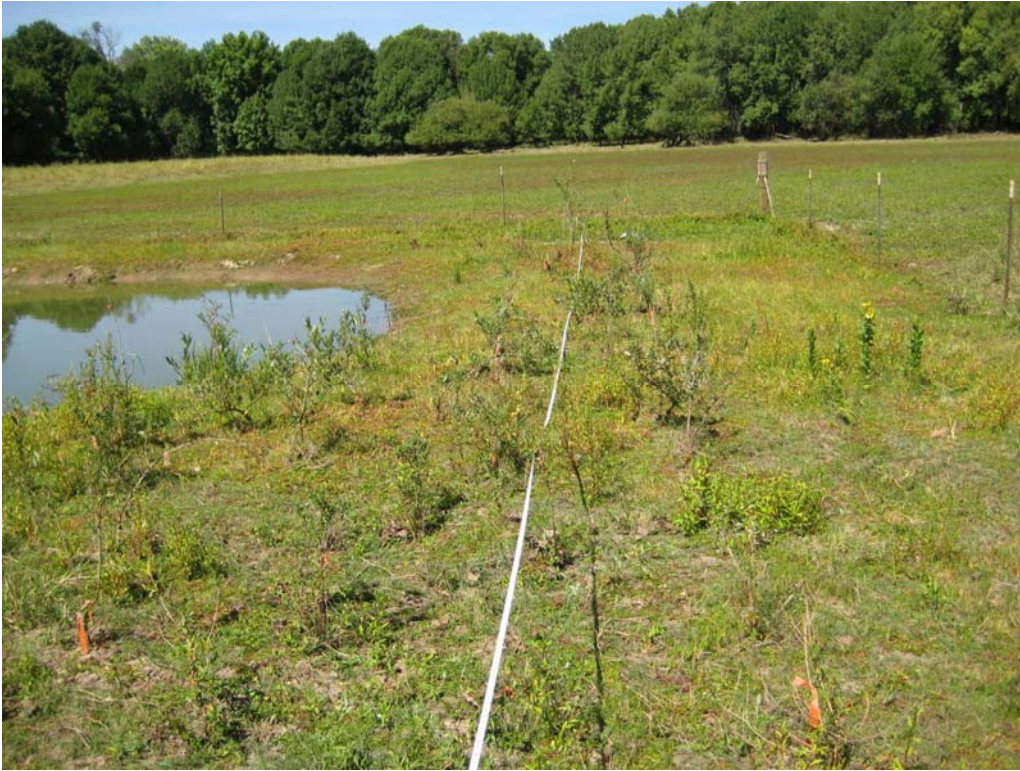
Photograph 1 – Forested and scrub/shrub vegetation at monitoring Transect T2 (view looking northwest).

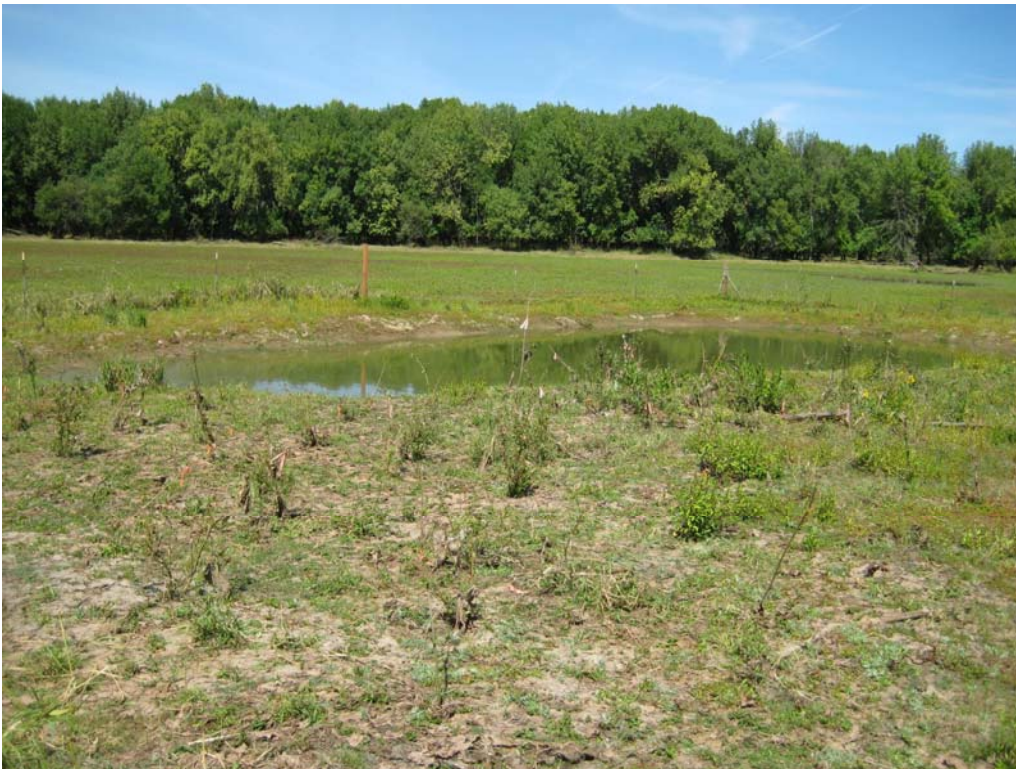
Photograph 2 – This photo shows the emergent portion of the wetland with a forested riparian area in the background, in contrast to the developing forested and scrub/shrub plant community in the mitigation area (taken from photo point P1, view looking north).

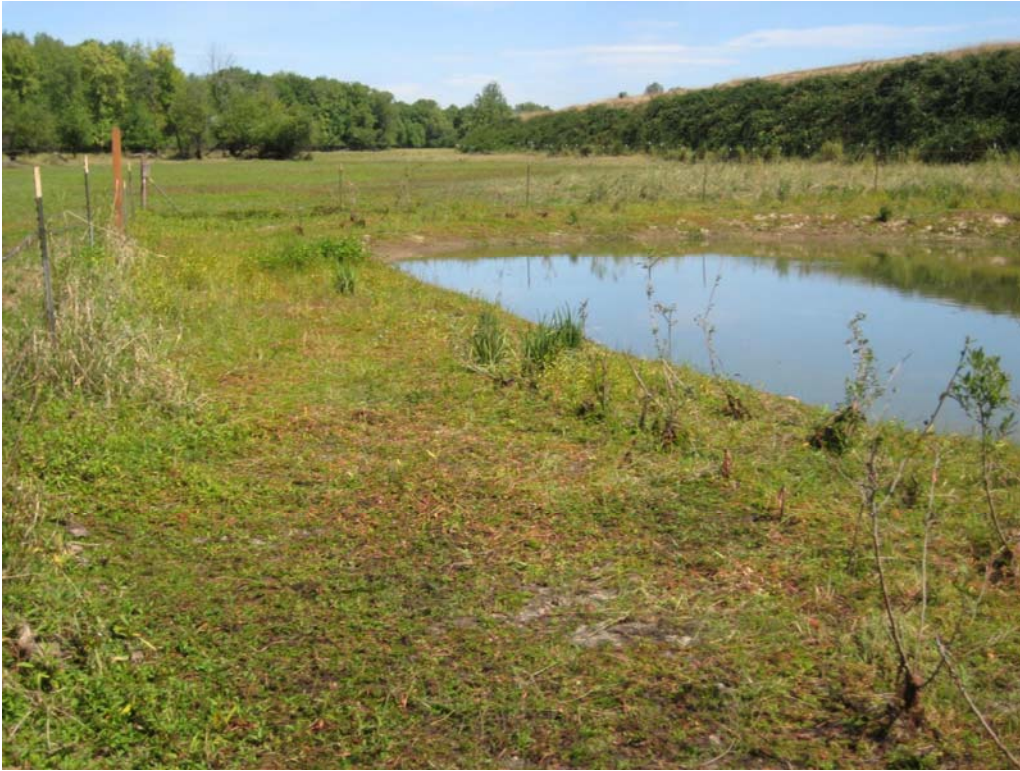
Photograph 3 – The primarily emergent plant community along the edge of the open water from photo point P2 (view looking northeast).

The open water portion of the mitigation area was visually evaluated for aquatic and emergent plant species. A variety of emergent plants and grasses described above were observed colonizing the edge of the open water area.

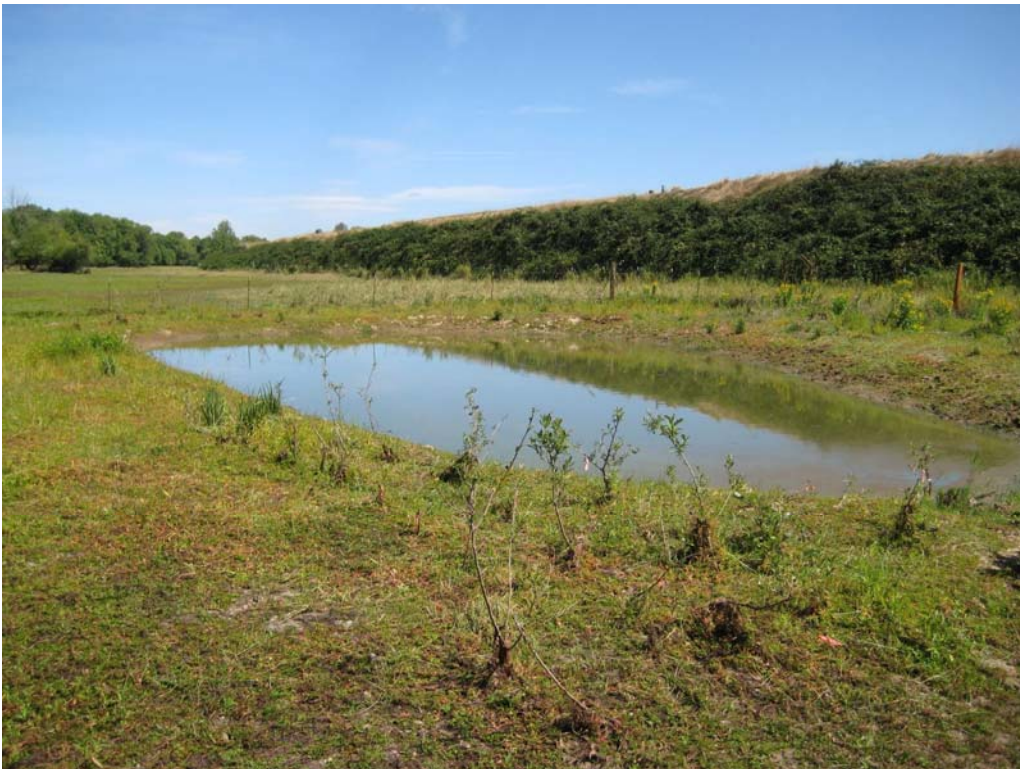
Photograph 4 – An overview of the mitigation site from photo point P2 (view looking east).
