**2011 (Year 4) Monitoring Report
Santosh Landfill
Wetland Mitigation Project
Scappoose, Oregon**

**Prepared for
Oregon Department of
Environmental Quality**

**December 7, 2011
15563-03/Task 2**

Prepared by
Hart Crowser, Inc.

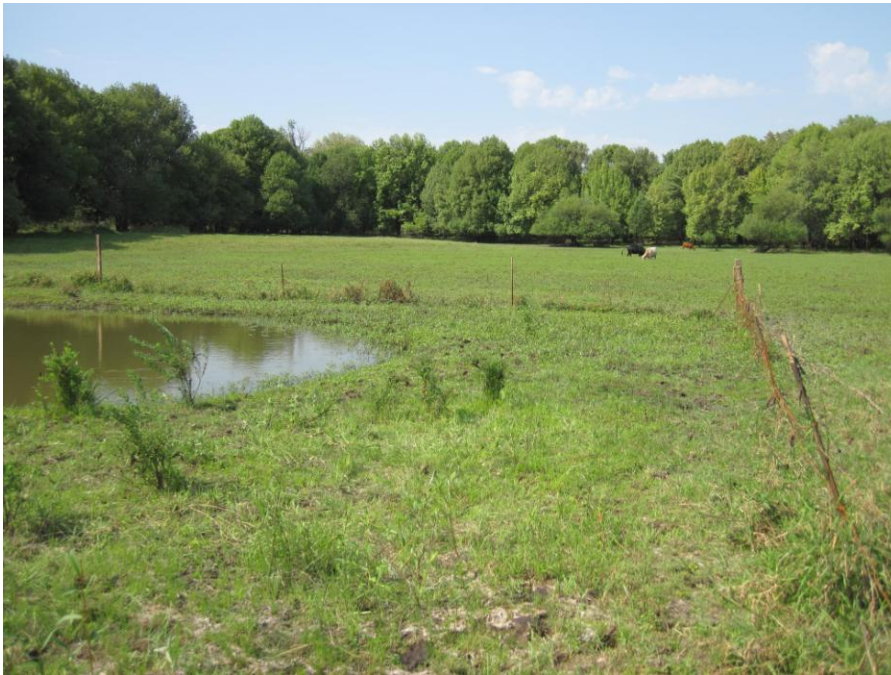
During our site visit evidence of livestock encroachment in the mitigation area was observed. A weak point in the fence allowed cattle to enter the area and resulted in significant losses to trees, shrubs, and herbaceous vegetation. Numerous individual plants were trampled and/or heavily browsed. Additionally, the ground surface and associated herbaceous vegetation were disturbed or altogether eliminated. The fence was promptly repaired and will be closely monitored in the future to avoid future livestock entry into the mitigation area.

Photograph 1 – Forested and scrub/shrub plantings were impacted by grazing in the mitigation area at monitoring Transect T2 (view looking northwest).

We recommend replacement of dead or heavily damaged trees and shrubs to compensate for losses as a result of livestock entry at the site. In addition, regular maintenance of the mitigation area should resume including weeding, invasive species control, and routine inspections of the fence.

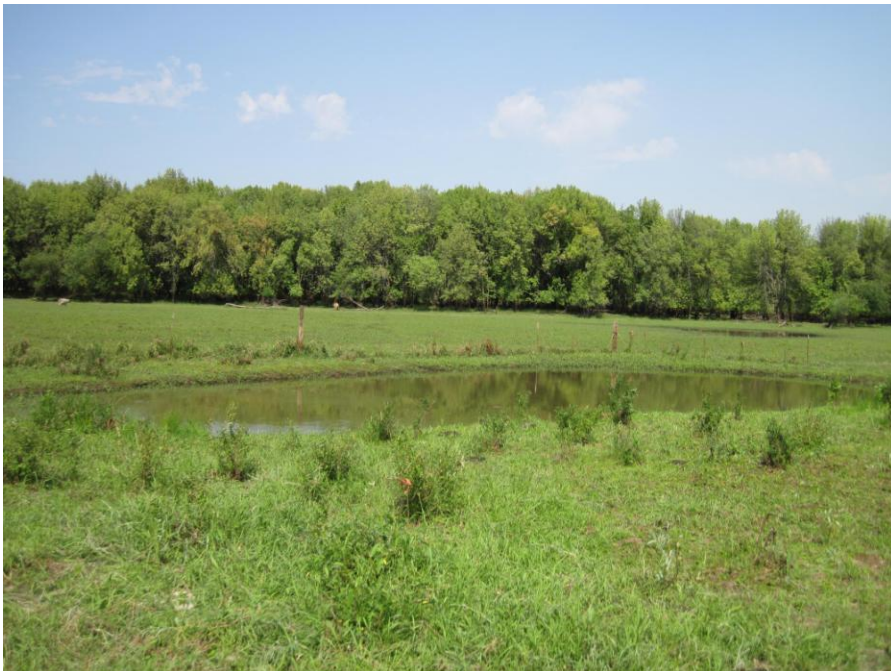
Photograph 2 – Forested and emergent planting areas were impacted by grazing which resulted in plant loss (taken from Photo Point P1, view looking north).

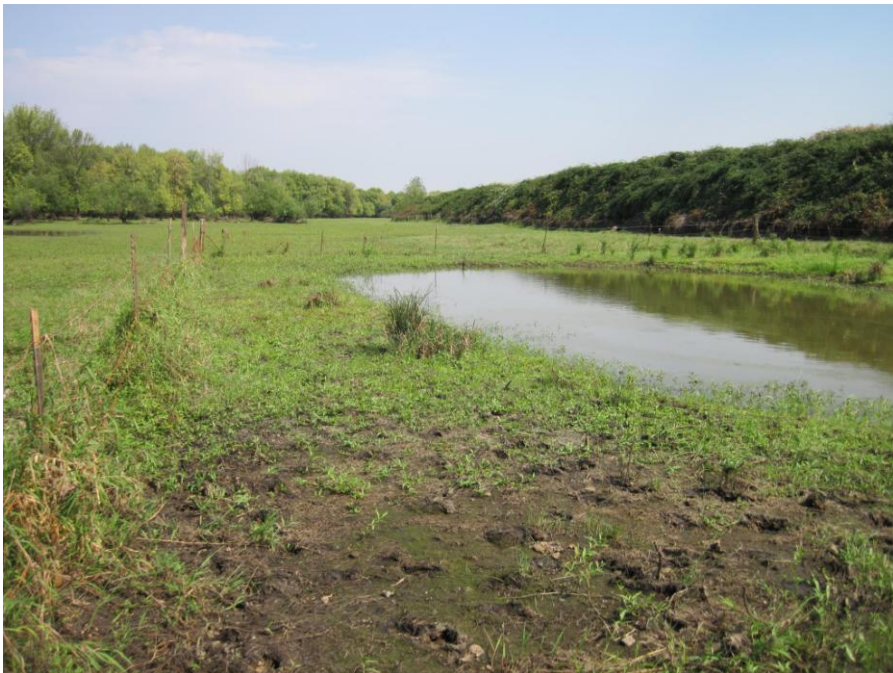
The open water portion of the mitigation area was visually evaluated for aquatic and emergent plant species. A variety of emergent plants and grasses described above were observed colonizing the edge of the open water area in areas that remained relatively undisturbed by livestock encroachment.

Photograph 3 – The primarily emergent plant community along the edge of the open water was heavily impacted by grazing from Photo Point P2 (view looking northeast).

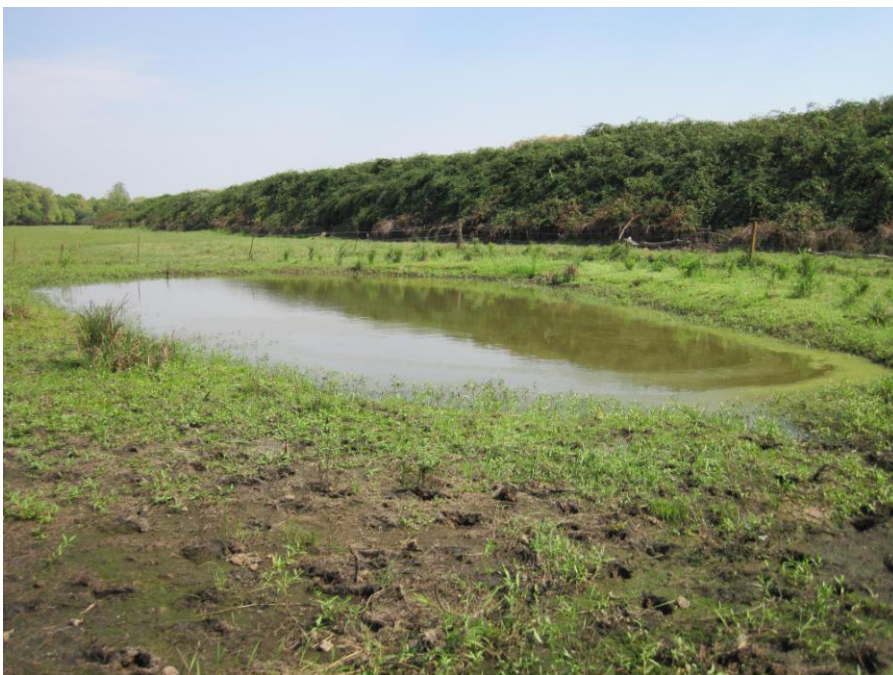
Photograph 4 – An overview of the mitigation site from Photo Point P2 (view looking east).
