RE: Lininger Tru-Mix Sites/Project No. 4014000101

**REPORT OF FINDINGS**

**LININGER TRU-MIX  
Medford, Oregon**

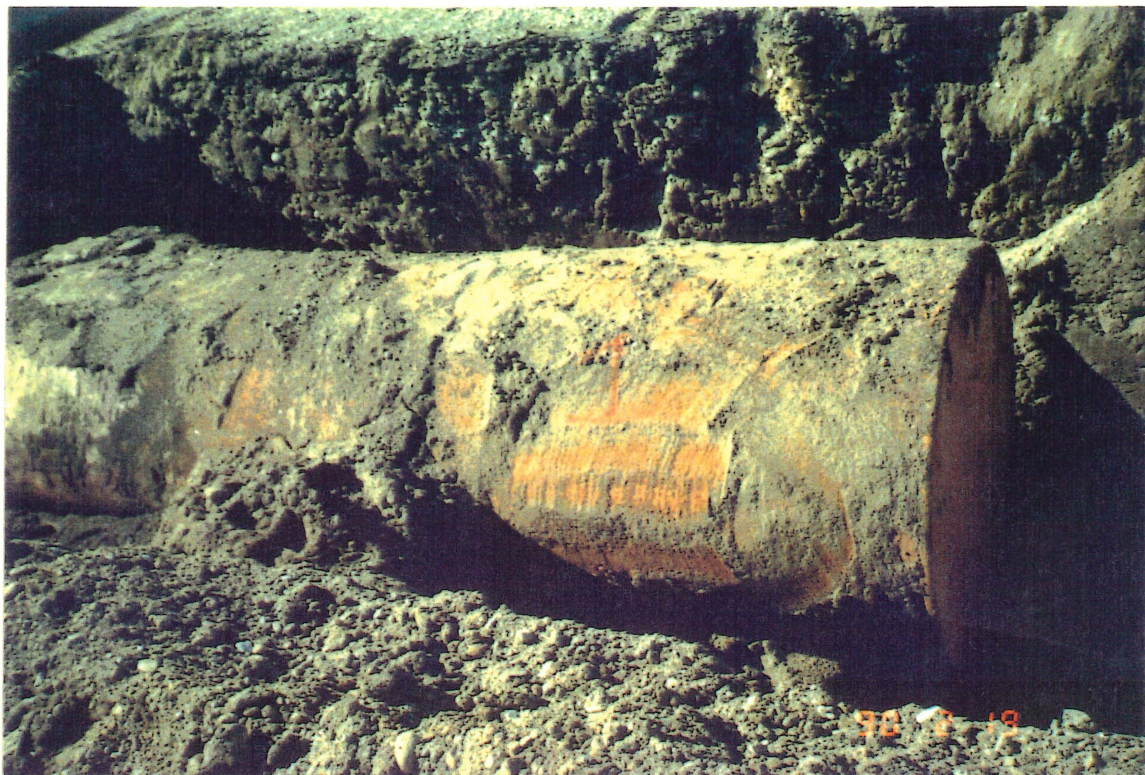
The diesel UST, labeled H-UST-1, did not show evidence of corrosion or tank failure (Figure 3). Soil samples were collected from both ends of the UST in the sand fill material at the base of the excavation, located five feet below grade. The soil at the fill end was stained and a strong petroleum odor was detected. The sample numbered H-UST-1-A was collected at the fill pipe end of the UST. Sample H-UST-1-B was collected at the end opposite the fill pipe. Groundwater was not encountered.

Figure 3: Hamrick site 1,000 gallon UST, labeled H-UST-1. The soil around the fill pipe, left of picture, is visually stained.

The UST labeled H-UST-1 was used to store diesel. The soil TPH concentrations, 49,725 and 2,598 ppm, exceed the DEQ cleanup level. The toluene, xylenes, and ethylbenzene concentrations for the sample designated A, collected below the location of the fill pipe, exceed background concentrations. The observed near surface contamination may be the result of overfills or a fill pipe which has failed. The extent of the contaminated soil which should be remediated is poorly evaluated with the available data, but the soil in and around the UST excavation should be included in a remediation plan.

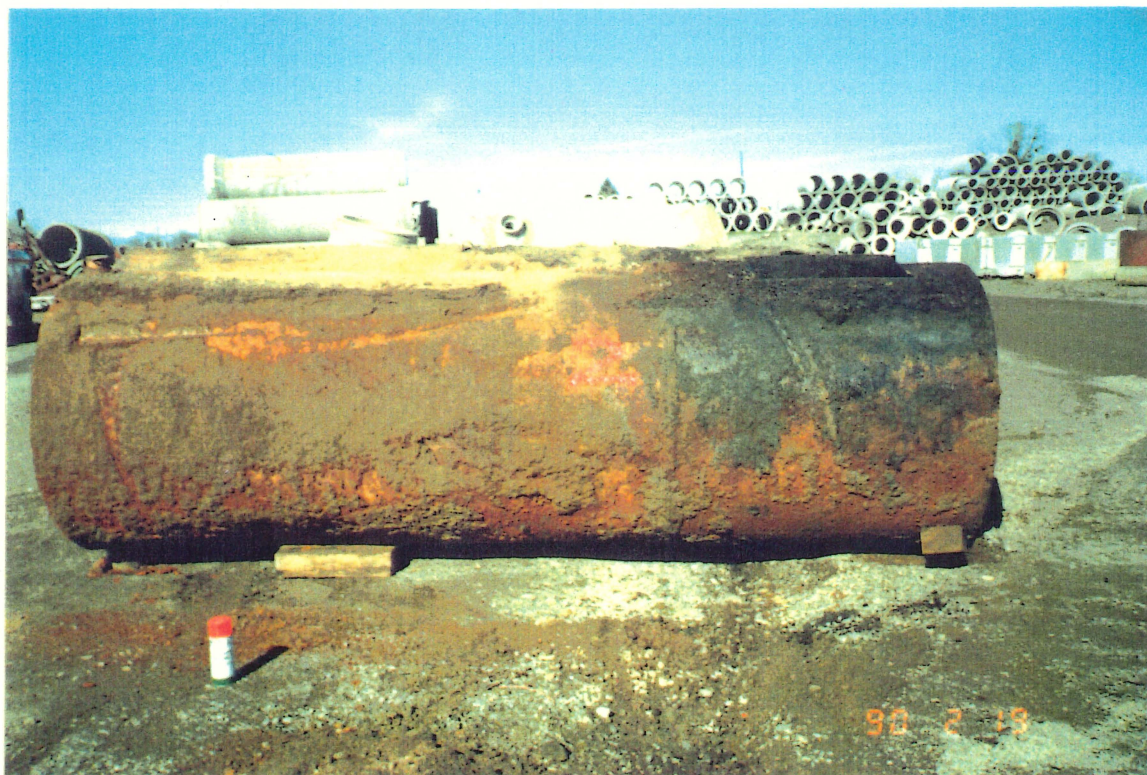
The waste oil UST, labeled H-UST-2, showed evidence of corrosion and was heavily stained on the fill end (Figure 4). Soil samples were collected from both ends of the UST in the sand fill material at the base of the excavation, located four feet below grade. The soil at the fill end was stained black and a petroleum odor was detected. The sample numbered H-UST-2-A was collected at the fill end of the UST. Sample H-UST-2-B was collected at the end opposite the fill line. Sample H-UST-2-GW represents groundwater which was encountered at four feet below grade.

Figure 4: Hamrick site 1,000 gallon UST, labeled H-UST-2. The fill end of the UST is heavily stained.

The UST labeled H-UST-2 was used to store waste oil. The soil TPH concentration of 12,817 ppm for the sample designated A, collected below the fill end of the UST, exceeds the cleanup level. The xylenes concentration for this sample is elevated above background. The field observations and analytical data suggest that the contamination is the result of overfills. The contaminated soil which is heavily stained below the location of the fill screen should be remediated.

The groundwater sample collected from H-UST-2, sample designation GW, has a xylenes concentration which is elevated relative to background. The observed contamination in the groundwater is probably related to the soil contamination, thus the source of groundwater contamination should be removed once the soil is remediated.

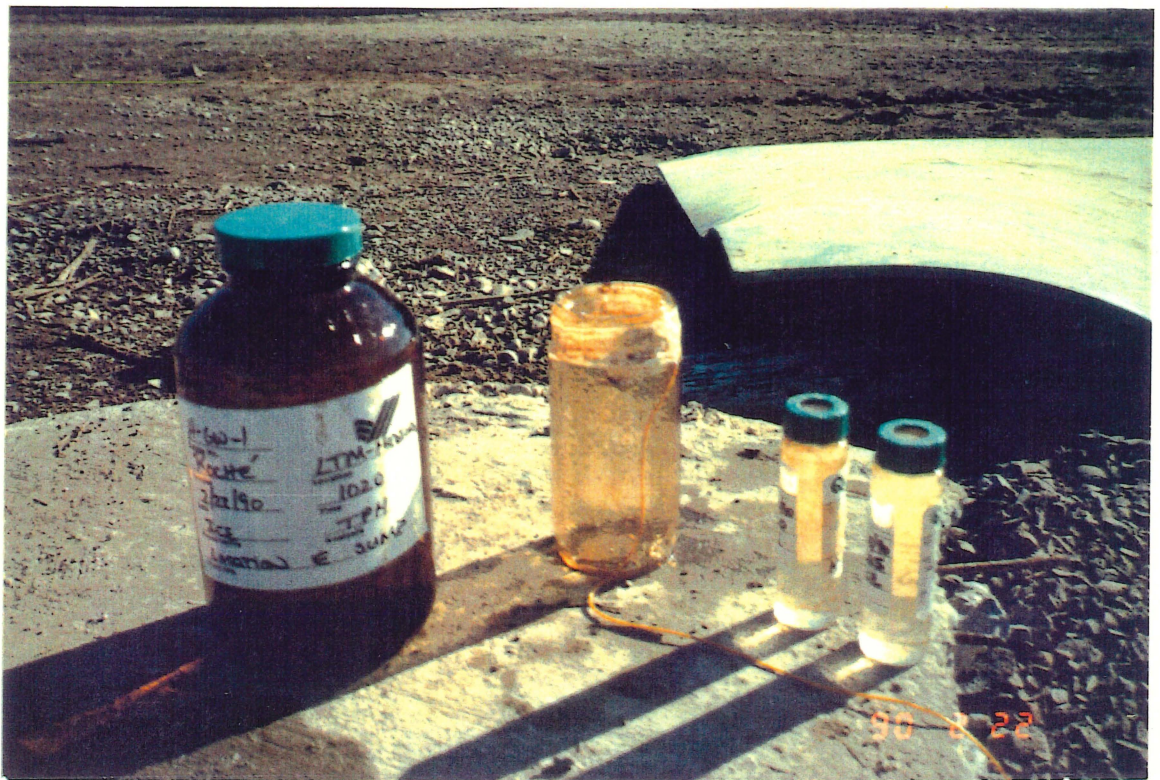
Globular masses of petroleum product were observed on the groundwater in the sump labeled H-GW-1 (Figure 5). A strong petroleum odor was also noted. The groundwater in sump H-GW-2 had a petroleum film and odor. The groundwater in H-GW-3 did not visually appear contaminated by petroleum product.

Figure 5: Bottle coated with petroleum product after being used to sample groundwater sump H-GW-1 on the Hamrick site.

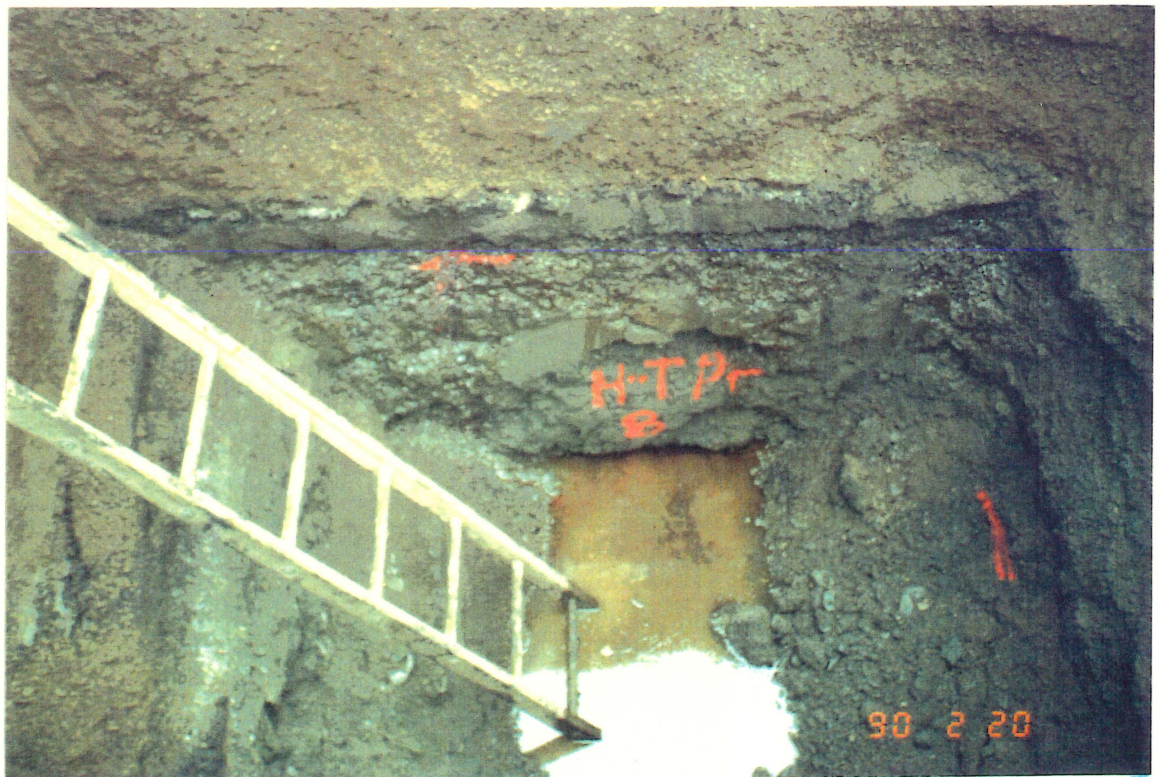
The depth at which groundwater was encountered ranged from four to 12 feet below grade in the test pits. A petroleum film was observed on groundwater in all of the test pits except H-TP-16. The groundwater observed in test pits H-TP-8 and H-TP-9 contained heavy oil and a lighter petroleum product.

Figure 8: Hamrick site test pit H-TP-8. Petroleum-rich water is leaking out of the gravelly layer at the upper paint line. The paint lines are soil sample points. Groundwater, intercepted at 8.0 feet below grade, contains heavy oil and a lighter petroleum product.

The soil in test pits H-TP-8 and H-TP-9, located near the storage tanks, was stained heavily and petroleum-containing water was leaking out of gravelly layers. The high TPH concentrations in these test pits appears to be related to the tanks and the past practices of dumping asphalt material on the ground. The groundwater sample collected from test pit H-TP-9 does not show elevated levels of TPH and BTXE.

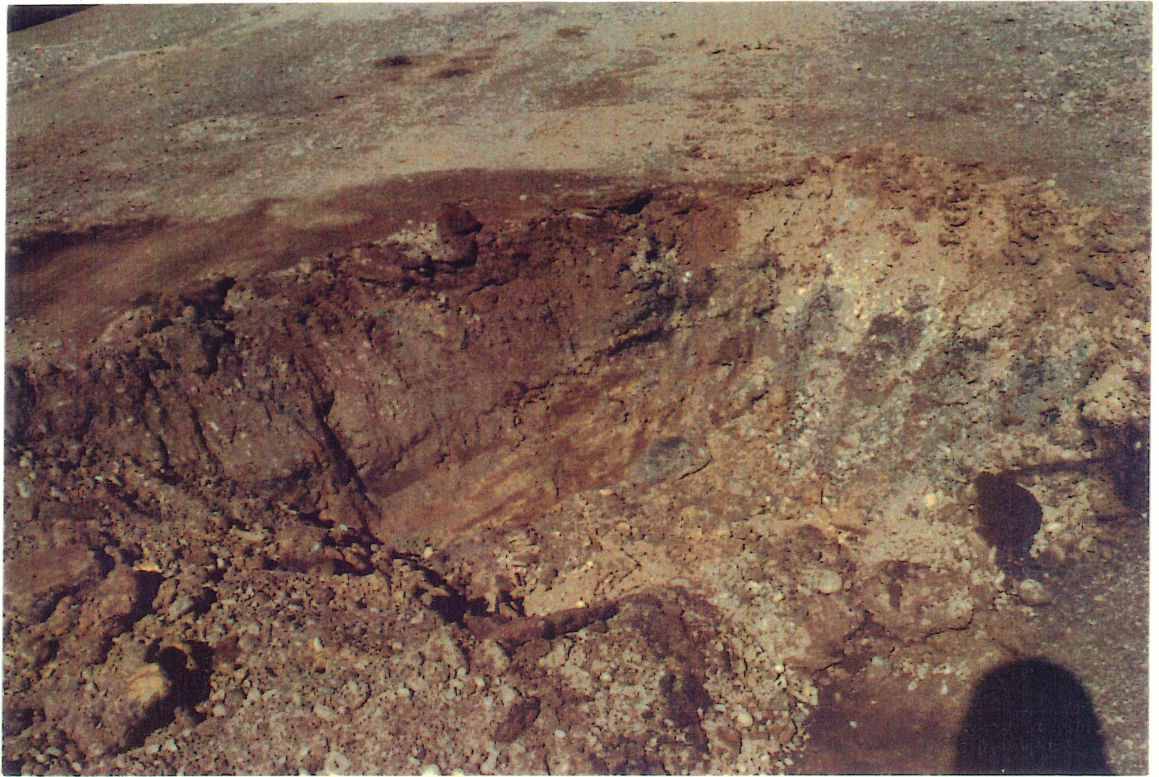
Test pits V-TP-1 through V-TP-7 were excavated proximal to the asphalt plant (Figure 11). The subsurface stratigraphy consisted of fill gravels and sands underlain by tan sandstone which is part of the Umpqua Formation. The thickness of the fill gravels and sands ranges to depths of approximately three feet. The fill material in the test pits was generally only stained at the surface and little or no petroleum odor was detected (Figure 12).

Figure 12: Villas site test pit V-TP-1. Sand and gravel fill material, stained at the surface, is underlain at 1.5 feet below grade by sandstone.

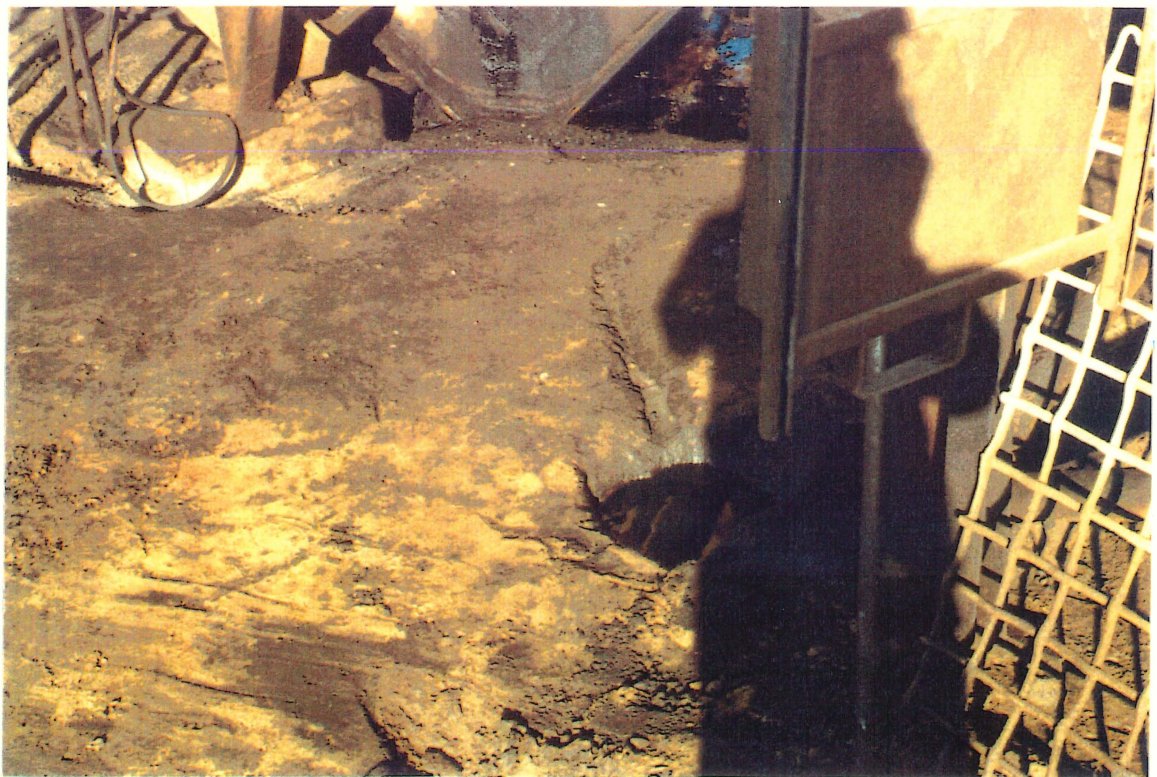
Test pit V-TP-6 was excavated proximal to the asphalt slat conveyor. This area has the most extensive surface staining. A shallow man-made hole was filled with a diesel/water mixture and used to clean hand shovels. There is no containment system around the hole (Figure 13).

Figure 13: Hole, excavated and filled by Villas site personnel, containing a diesel/water mixture.

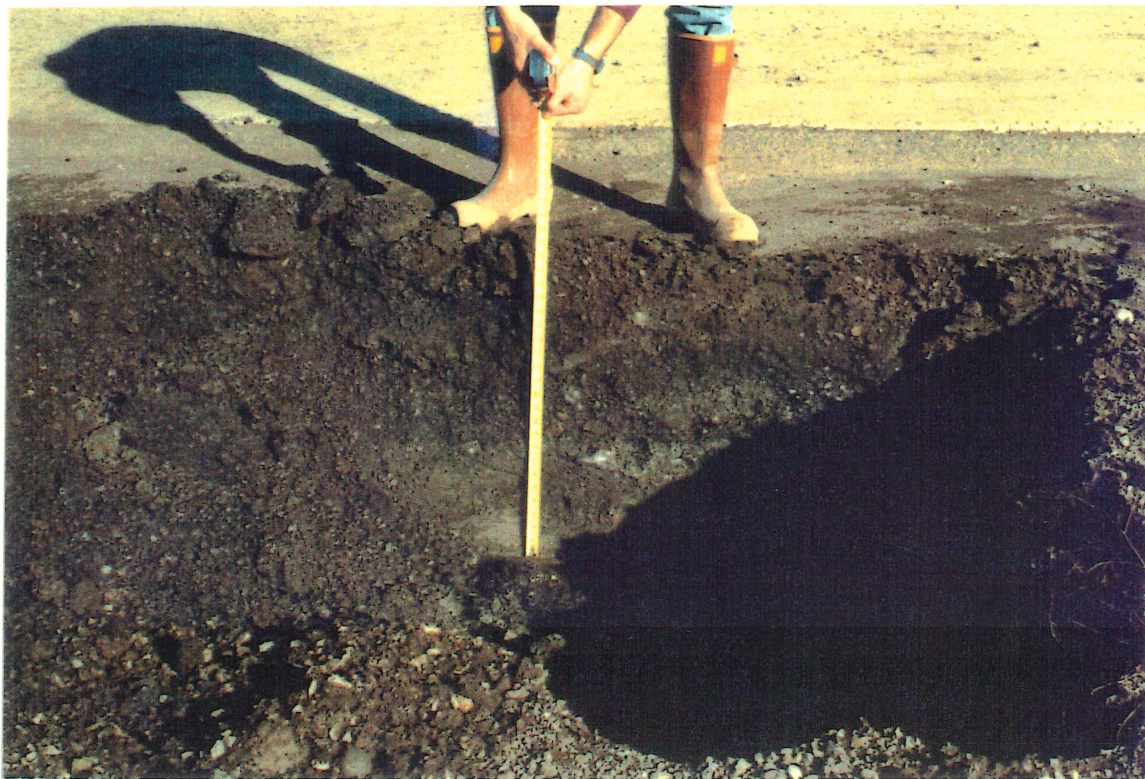
Figure 14: Visually contaminated gravelly silt layer on the Villas site.

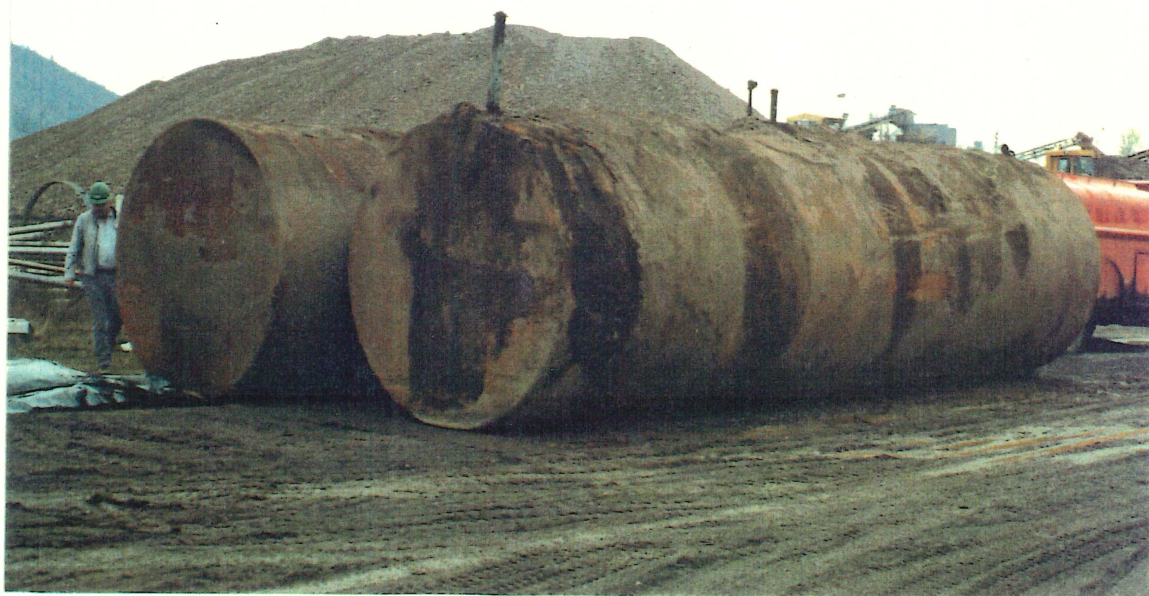
The UST's showed some surfacial corrosion, but evidence of tank failure was not observed. The UST's were both heavily stained on the fill pipe end (Figure 16).

Figure 16: Kirtland Road UST's. The tanks are visually stained on the fill pipe end.

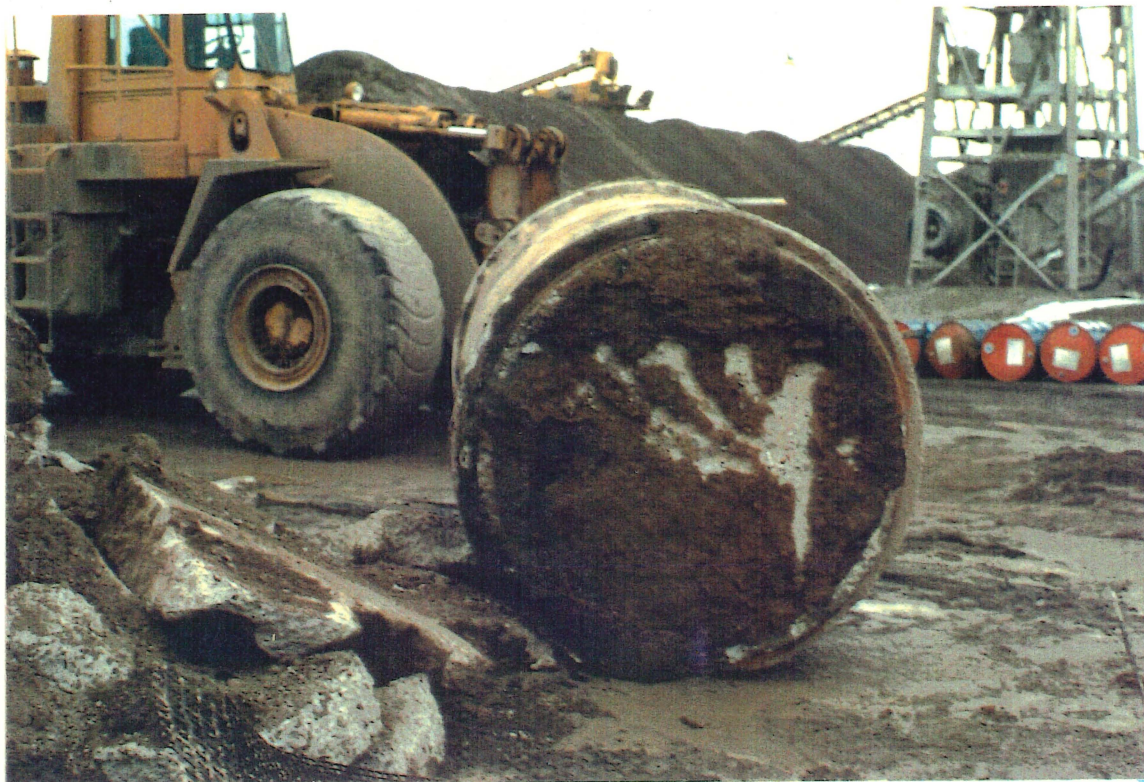
Samples labeled K-WOS were collected from the sump excavation. The subsurface stratigraphy in the excavation consisted of sandy clay underlain at 11 feet by gravel (Appendix B). The soil was stained and had a strong petroleum odor from the surface down to the base of the excavation at approximately 13 feet, where groundwater was intercepted. The groundwater, sample K-WOS-GW, had a visible petroleum film.

Figure 17: Kirtland Road waste oil sump. View is from the base of the sump.

The soil TPH concentrations in the waste oil sump excavation decrease with depth; but all of the soil from the surface to approximately 14 feet below grade exceeds the DEQ required cleanup level for TPH and needs to be remediated. During the field investigation much of the stained soil was removed from the excavation and placed on plastic sheets.

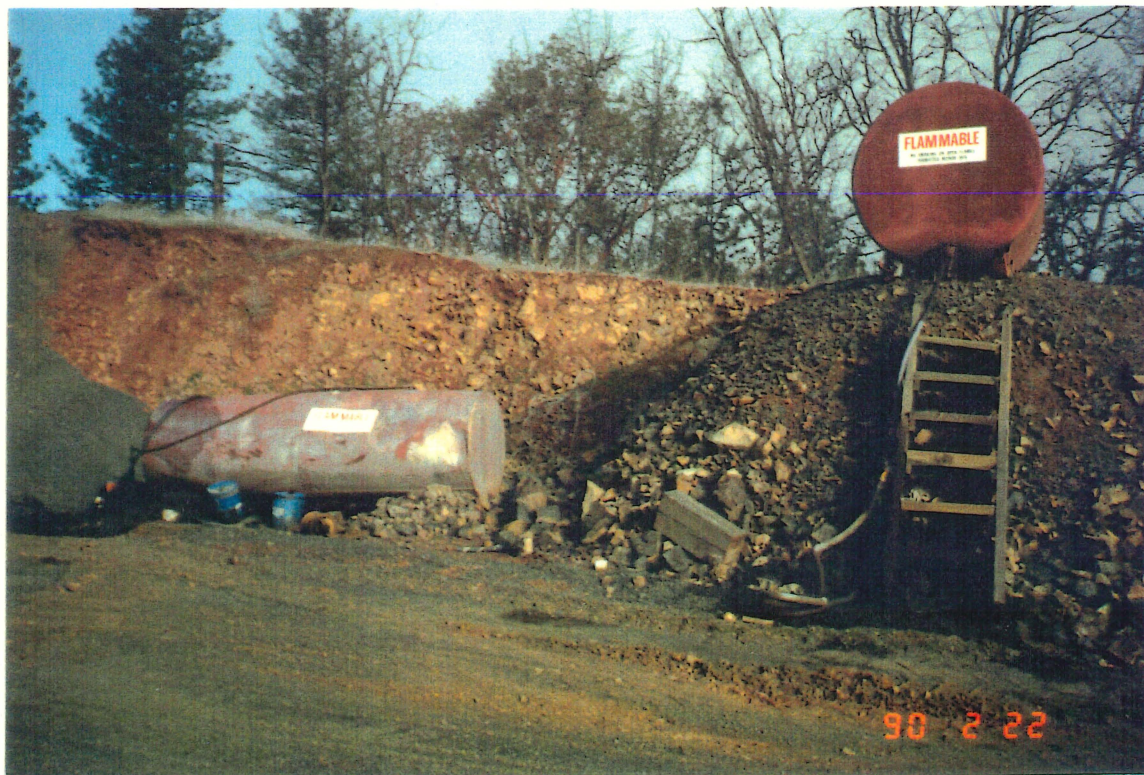
Figure 19: Above ground storage tanks at the 140 Quarry site. The surface soil around the distribution lines is heavily stained.

A soil sample was collected near the above ground diesel tanks and analyzed for TPH. The sample was collected at two feet below grade. The soil TPH concentration was 1,613 ppm. This concentration exceeds the DEQ required cleanup level. The contamination appears to be at least partially related to leaking valves on the base of the 7,500 gallon diesel tank. The lateral extent of the shallow contamination is poorly evaluated. A volcanic unit encountered at three feet below grade should limit the vertical extent of the contamination.

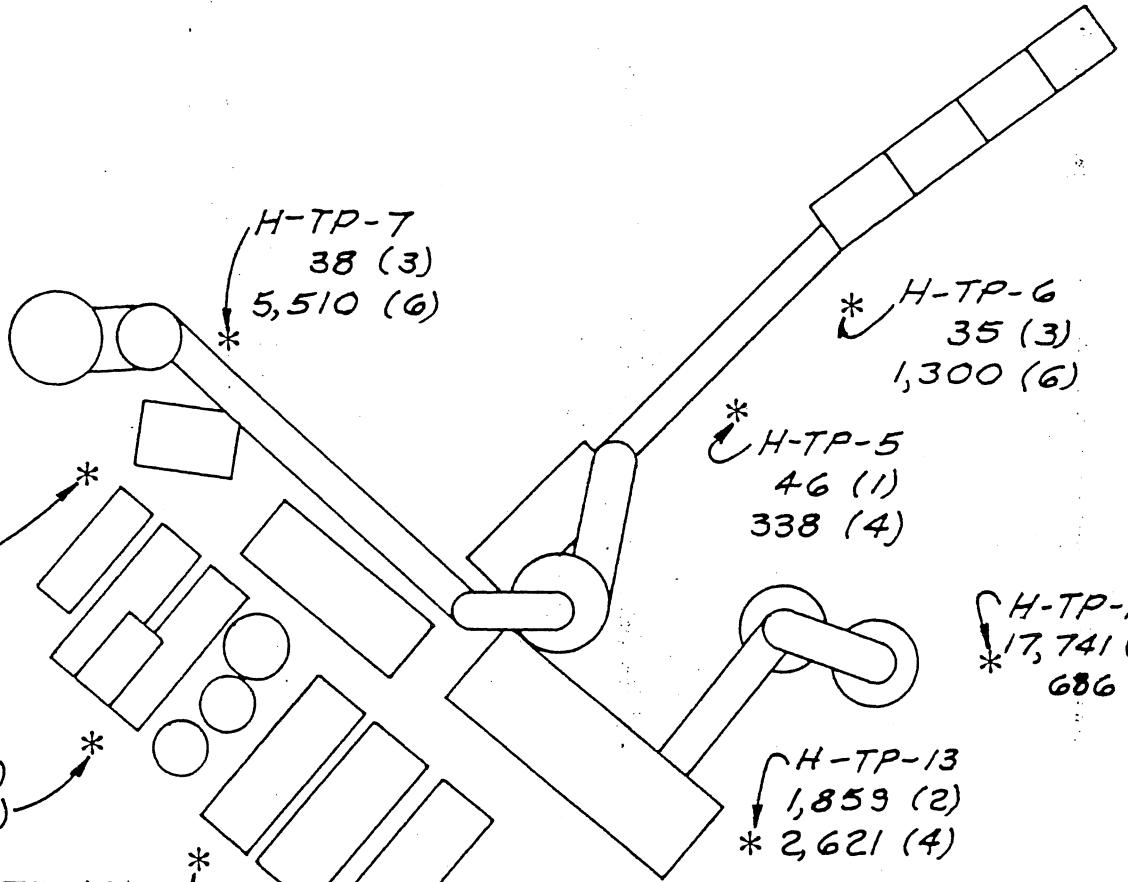
FIGURE 21

DESIGN BY	RLR	CHECKED BY	TEB	ASPHALT PLANT SOIL TPH CONCENTRATIONS LININGER TRU-MIX HAMRICK SITE	APPROVED	
SURVEY BY		SCALE	NO SCALE		DATE	
DRAWN BY	RAW	DWG. NO.

The groundwater sample collected from test pit H-TP-18, located west of the asphalt plant, contained 272.2 ppm TPH. The overlying soil contained only small amounts of TPH contamination. This may indicate that the TPH contamination on the groundwater is from a different source area, possibly the asphalt plant. The observed groundwater contamination is high enough that it should be considered in a remediation plan.

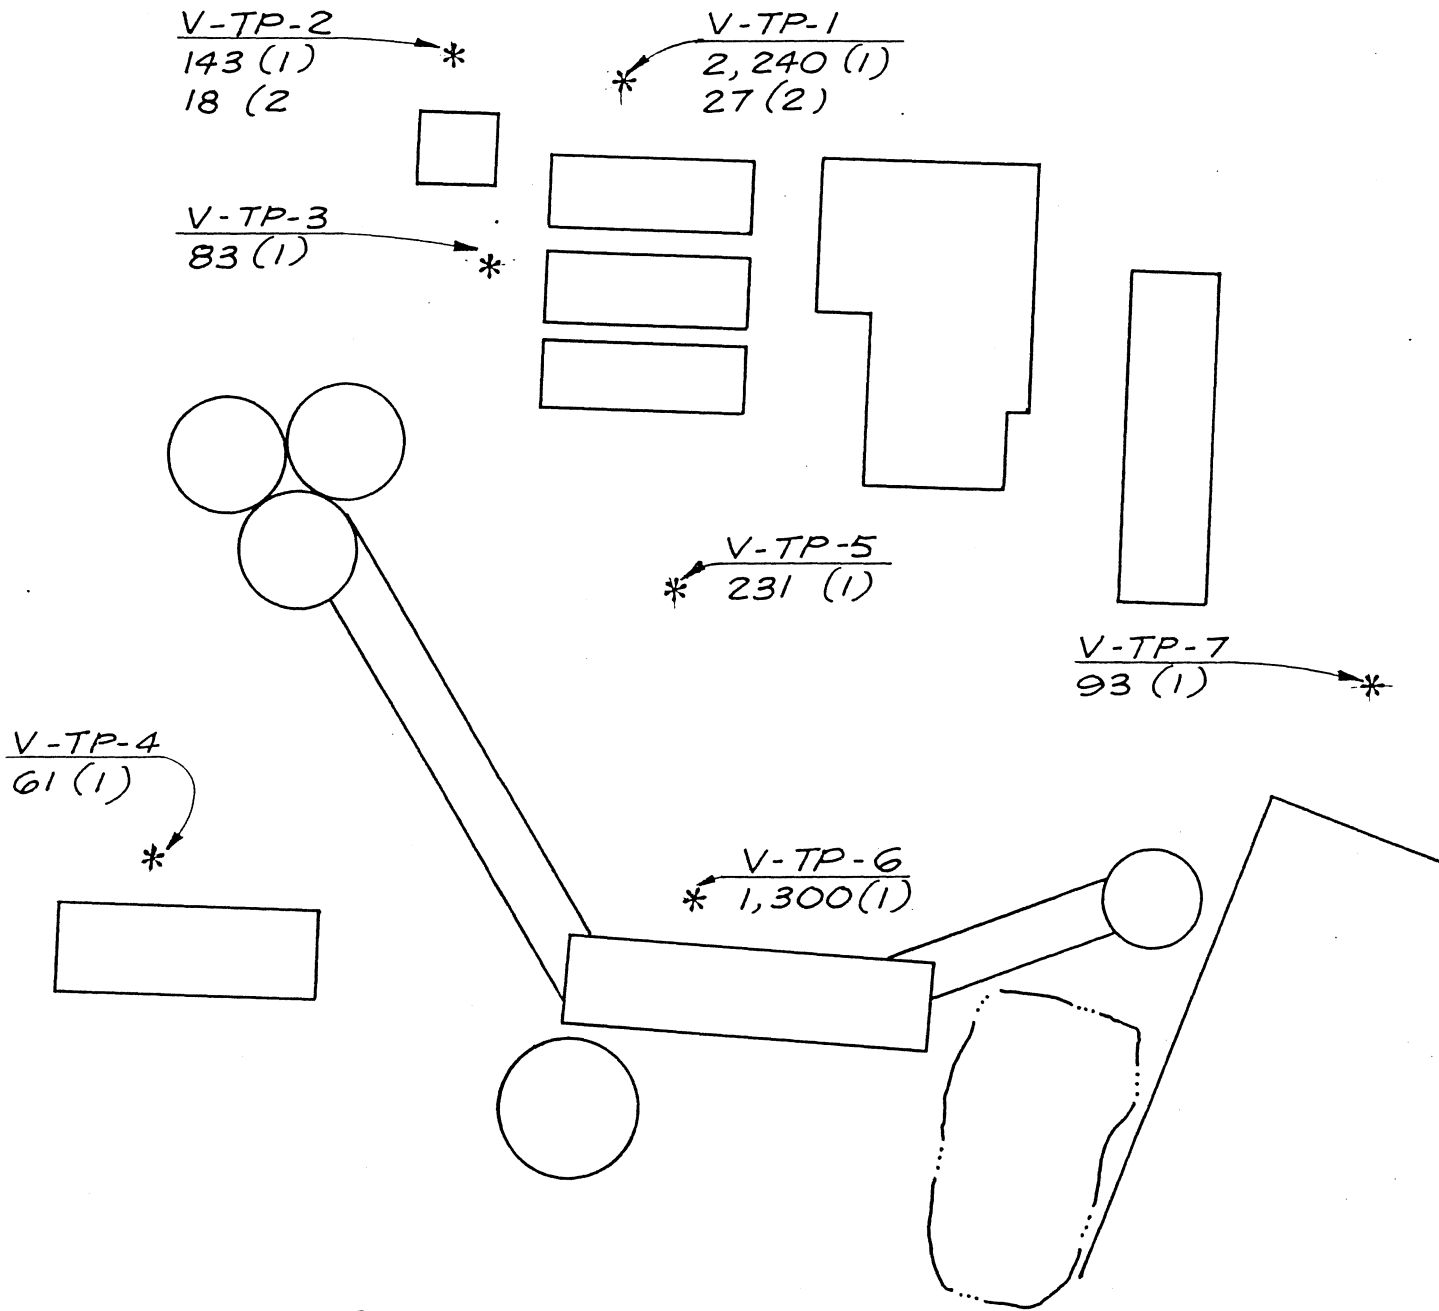
FIGURE 22

KEY: 143 (1) CONCENTRATION  
(DEPTH BELOW GRADE)

DESIGN BY	RLR	CHECKED BY	TEB	<b>ASPHALT PLANT          SOIL TPH CONCENTRATIONS          LININGER TRU-MIX          VILLAS SITE</b>	APPROVED	
SURVEY BY		SCALE	NO SCALE		DATE	
DRAWN BY	TV	DWG. NO.

V-TP-1, located proximal to an above ground asphalt tank, was the most highly contaminated test pit excavated at the Vilas site (Figure 22). The soil sample collected at one foot below grade had a TPH concentration of 2,240 ppm. The observed TPH contamination apparently is isolated to the shallow surface soils, as evidenced by the TPH concentration of 27 ppm detected at a depth of two feet.
