TECHNICAL MEMORANDUM

To: Mr. Larry Burke, Davis Wright Tremaine LLP
From: Brad Berggren and Samantha Biles
Date: March 23, 2015
Subject: February 2015 Focused Soil Removal, Salem Park Parcel

This memorandum was prepared to document soil removal activities completed by the City of Salem remediation contractor (Emery & Sons) between February 18th and 20th, 2015, as well as present the results of soil quality samples collected from the base of the soil excavation area on February 19, 2015. PNG was present to observe and document the soil removal, collect soil samples, and observe and document surface restoration of the excavated area. The soil removal, sampling, and excavation restoration activities were completed in accordance with PNG's Work Plan (2015) as approved by DEQ.

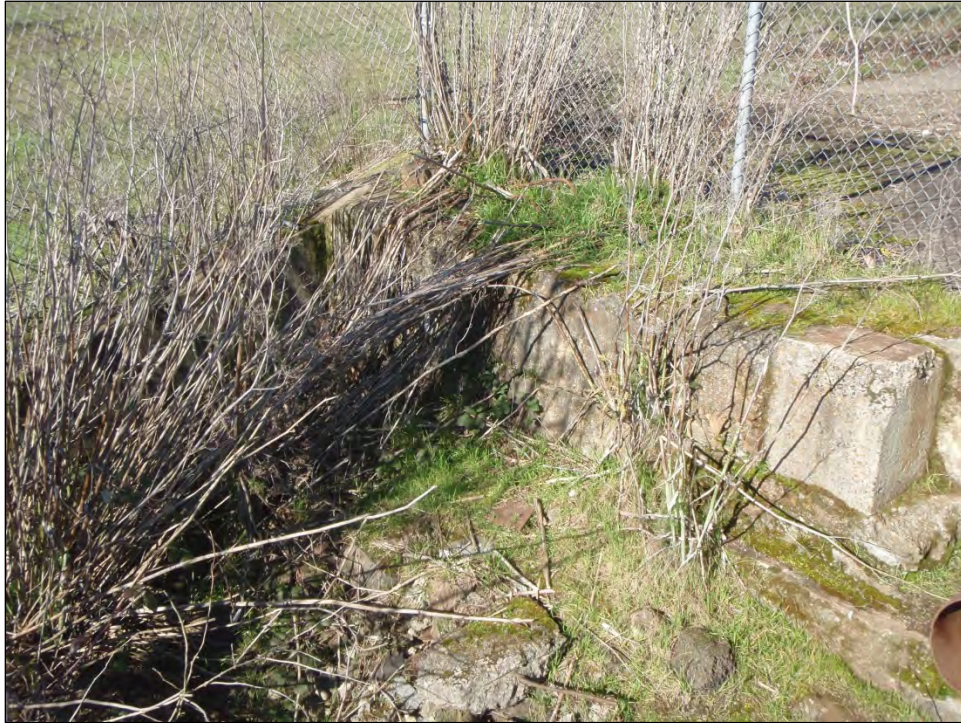
Photo A. View of project site in vicinity of Plot 1.

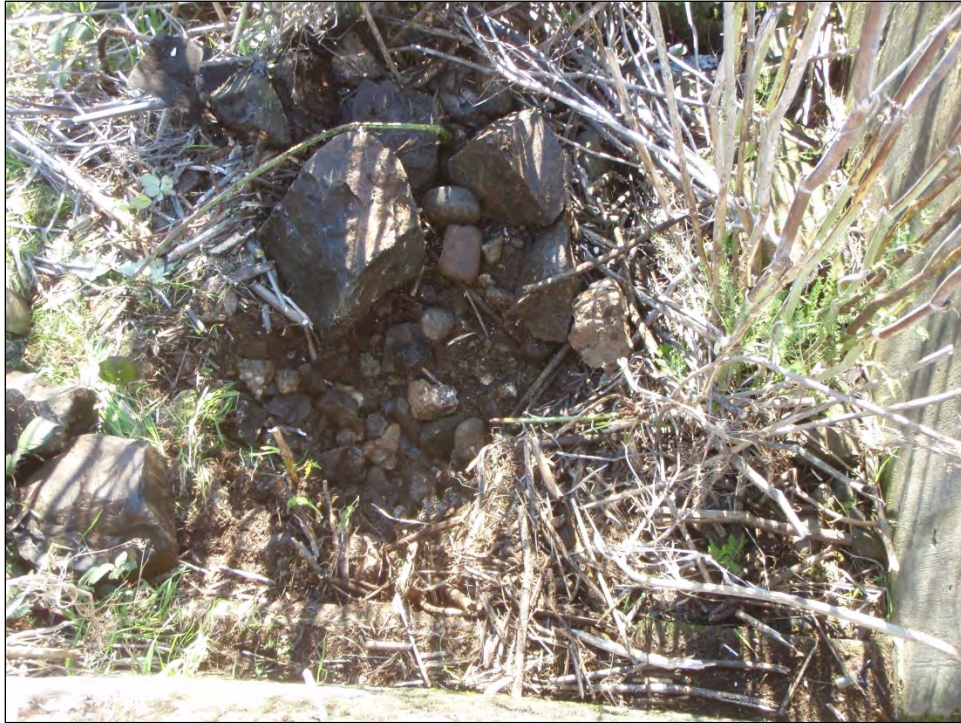
Photo G. Plot 1 location after digging amidst the cobble, rubble, and debris.

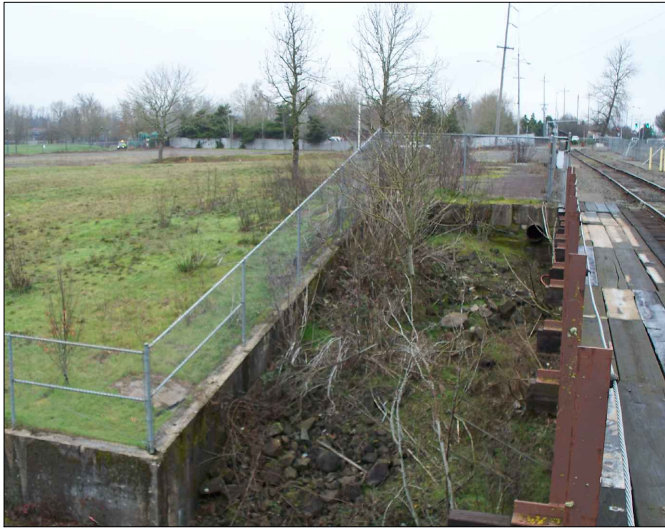
PHOTO 1
Soil removal area and adjacent property prior to commencement of excavation.

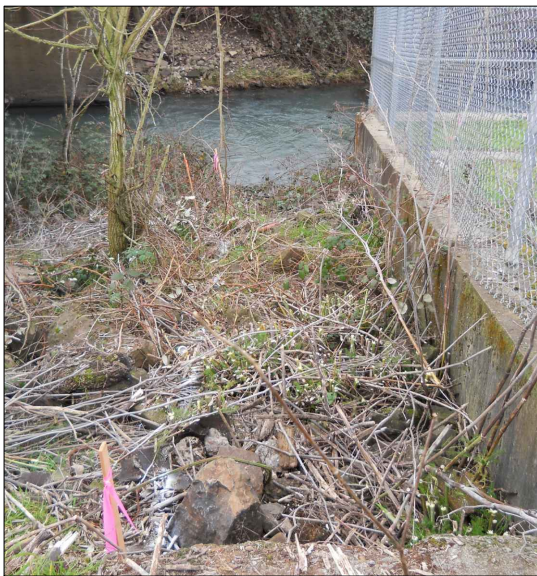
PHOTO 2
Soil removal area after demarcation of property boundary as seen from the northern retaining wall.

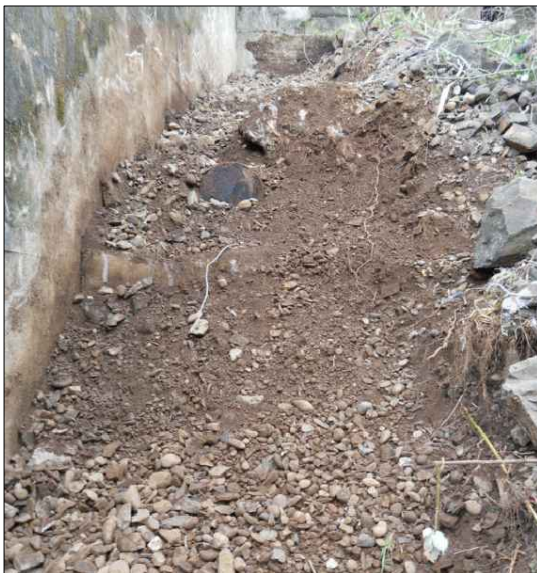
Observation of the final excavation area suggested the underlying material consisted of fill as evidenced by the presence of brick, concrete, rebar and general debris.

PHOTO 3
Completed soil removal prior to restoration as seen from the OHWM.

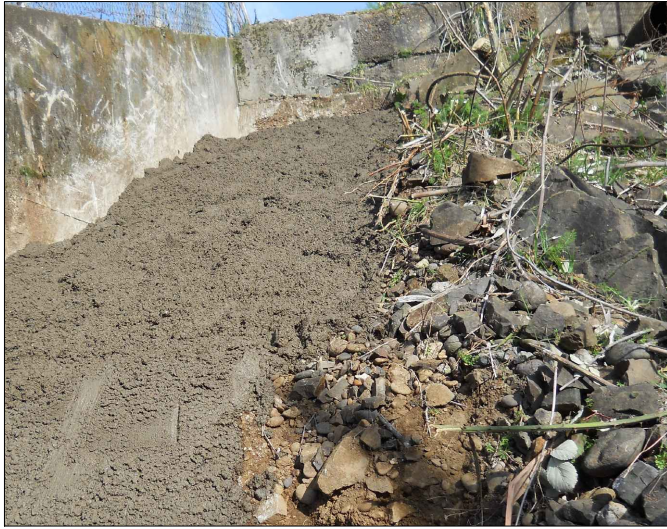
PHOTO 4
Placement of CDF as part of cover and site restoration.

The surface of the soil excavation area was restored on February 20, 2015 consistent with the DEQ approved work plan. Initially, a non-woven geotextile fabric was laid on the base of the excavated area. Subsequently, the geotextile was covered with 10.5 cubic yards of control density fill (CDF) resulting in a surface thickness of approximately one foot. The CDF was overlain by ten cubic yards of rip-rap rock material (approximate thickness of one foot over the restoration area). The rip-rap was placed while the CDF was still wet, allowing the rocks to become seated in the top of the CDF for greater stability.

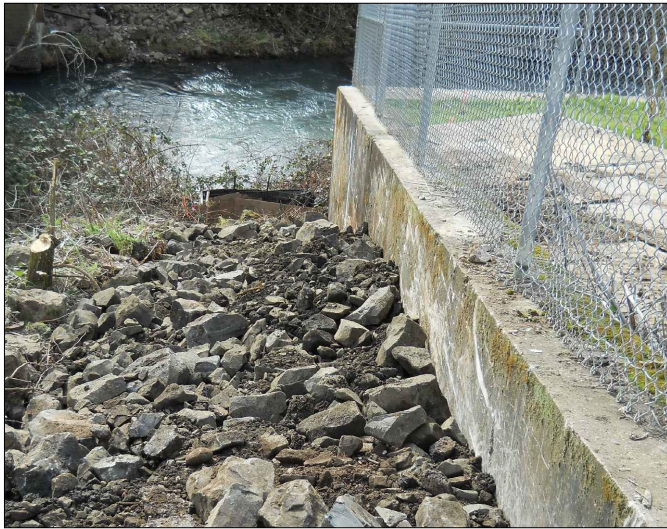
PHOTO 5
Completed restoration as seen from the northern retaining wall.

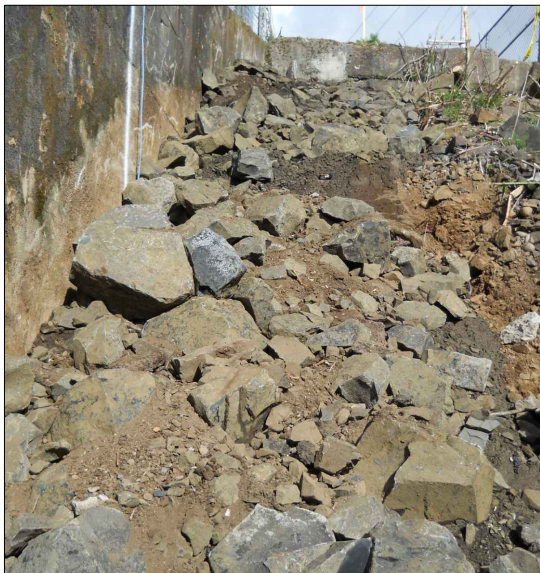
PHOTO 6
Completed restoration as seen from the southern extent of the excavated area.
